**Report No. CDOT-DTD-R-2005-01**

**EVALUATION OF THE FRP-RETROFITTED ARCHES IN THE  
CASTLEWOOD CANYON BRIDGE**

**December 2004**

**COLORADO DEPARTMENT OF TRANSPORTATION  
RESEARCH BRANCH**

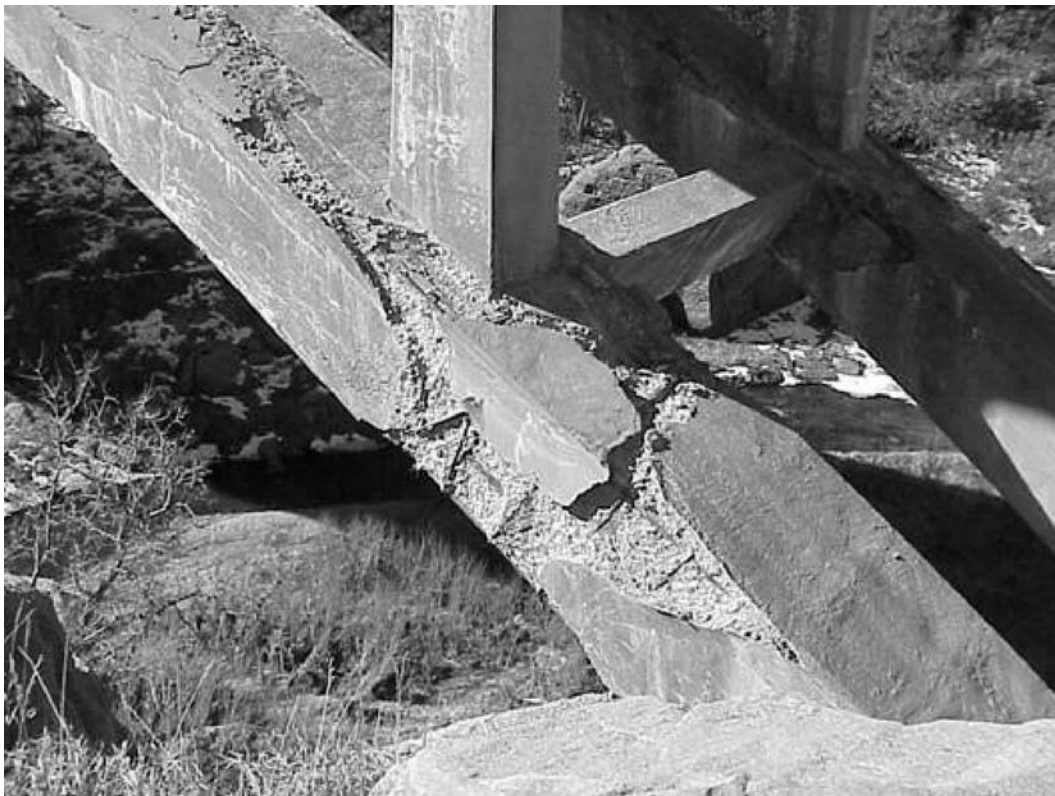
In 2003, the bridge was severely dilapidated and in need of repair, enlarging, and strengthening. Parts of the soft concrete had spalled off the deck, columns, and arches, and the rebars were badly rusted. (See Figure 1-3 and Figure 1-4.) During the summer of 2003, the original arch was repaired, the spandrel columns were replaced, the bridge deck was replaced and widened from about 35' to 43'-0" including railings, and the overall length was increased from 373'-6" to 404'-5".

Figure 1-3 Spalling concrete and exposed steel before repair

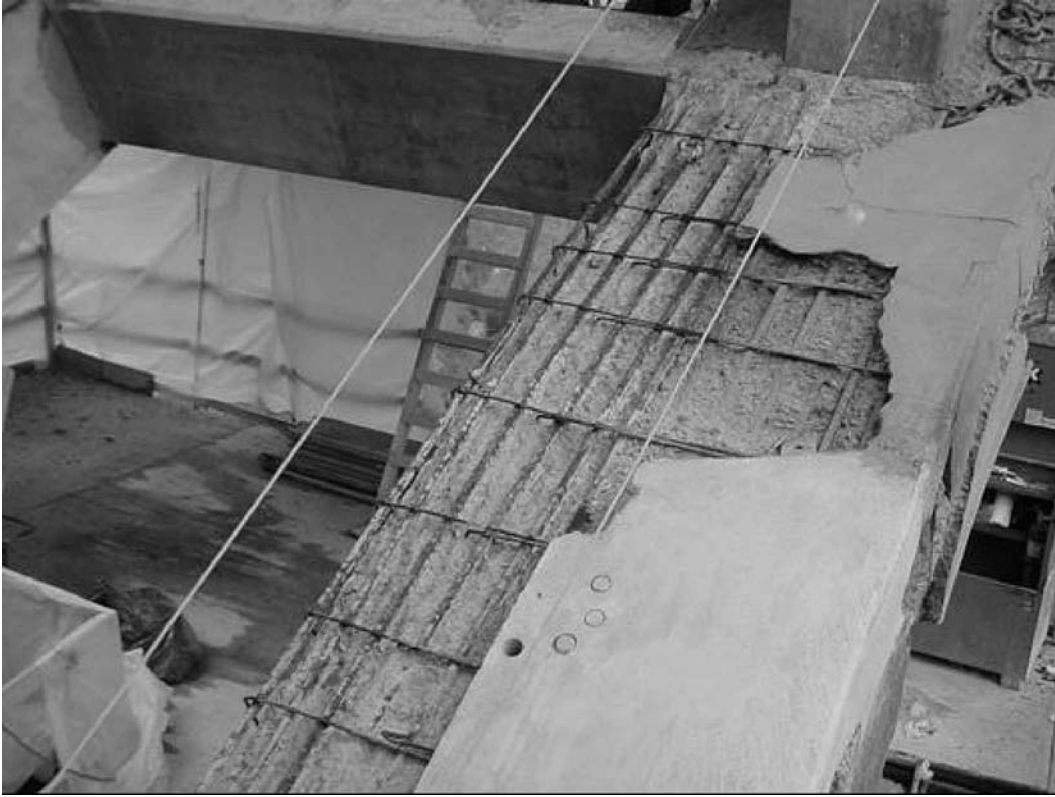
**Figure 1-4 Spalling concrete and exposed steel during construction**

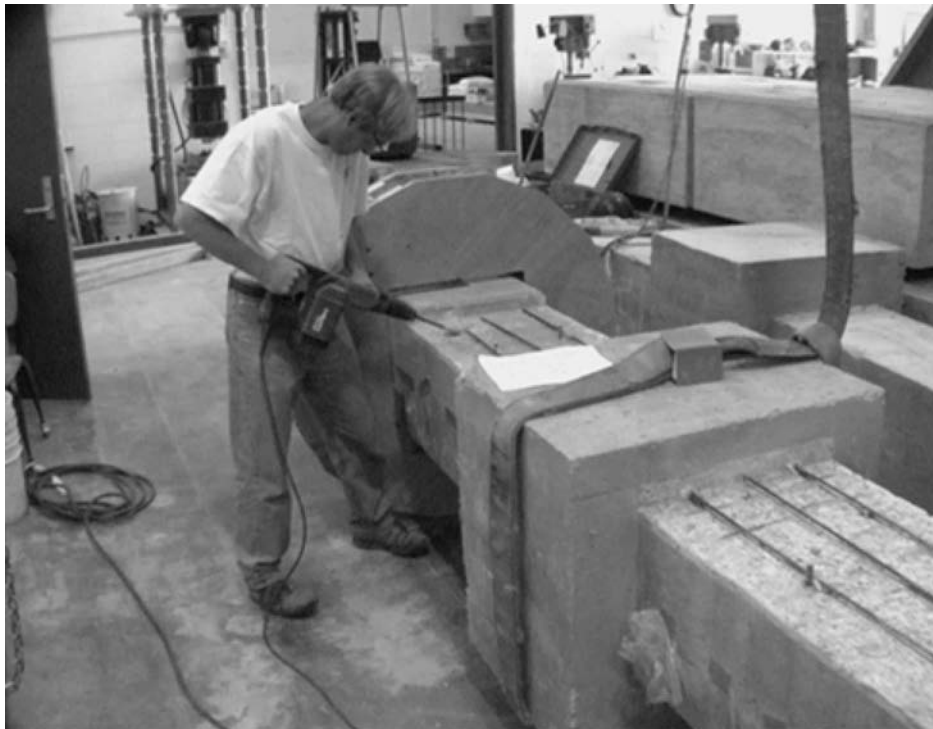
After the forms were removed, the concrete in the blockouts of the FR specimen had to be roughened and cleaned to prepare the surfaces for the application of the shotcrete. The surfaces were chipped with a power chisel, care being taken to avoid striking the rebar, until the surface was rough and all loose concrete had been removed. (see Figure 1-37). The surface was thoroughly cleaned and then soaked with wet rags and sealed with plastic for at least 24 hours prior to placing the shotcrete.

**Figure 1-37 The surface of the FR specimen was roughened and prepared for shotcrete. The specimen was turned upside-down by rolling on large plywood wheels, like the one supporting the far end of the specimen, to avoid disturbing the shotcrete before it had fully cured.**

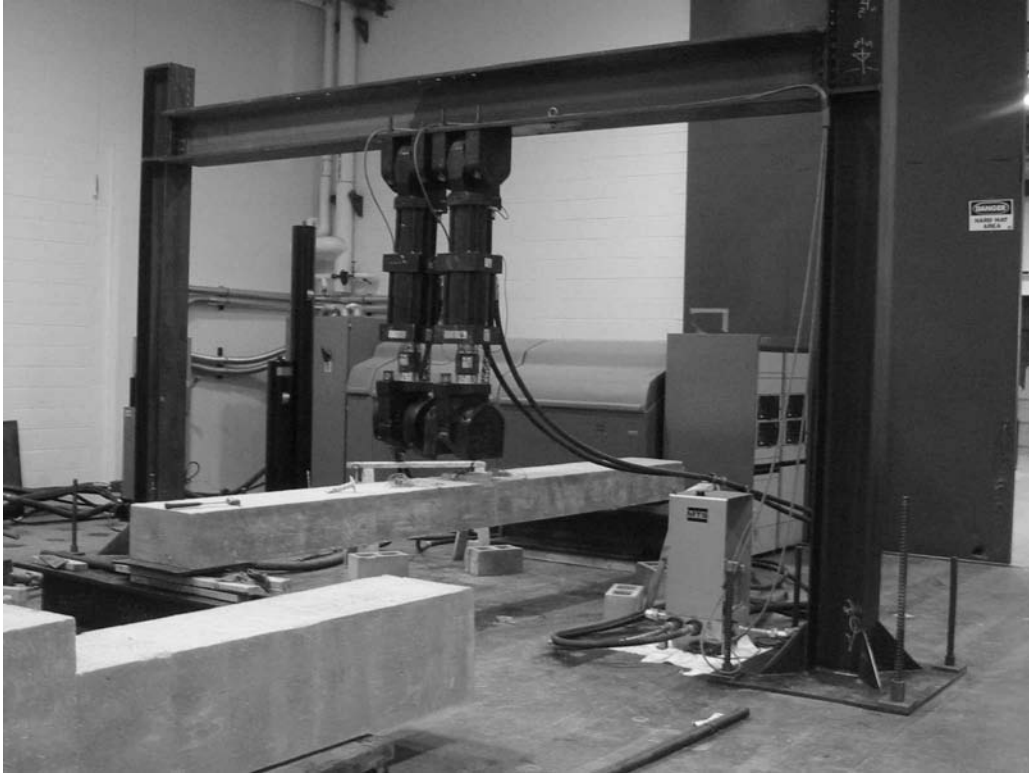
**Figure 1-43 Center load reaction frame (Axial load frame not shown)**

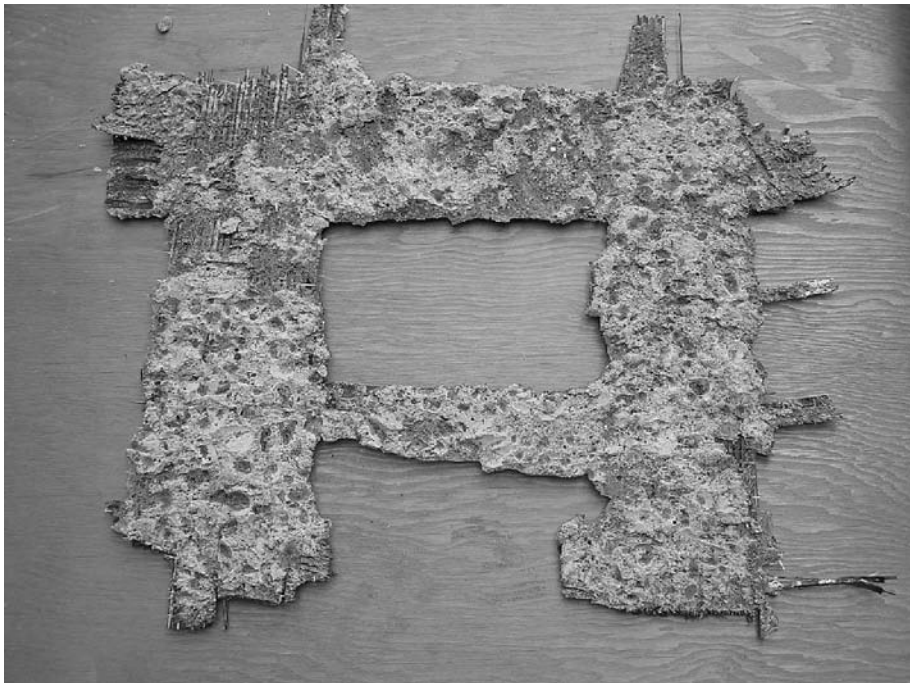
**Figure 1-54 Concrete attached to the debonded tension Fibrwrap (AR specimen)**

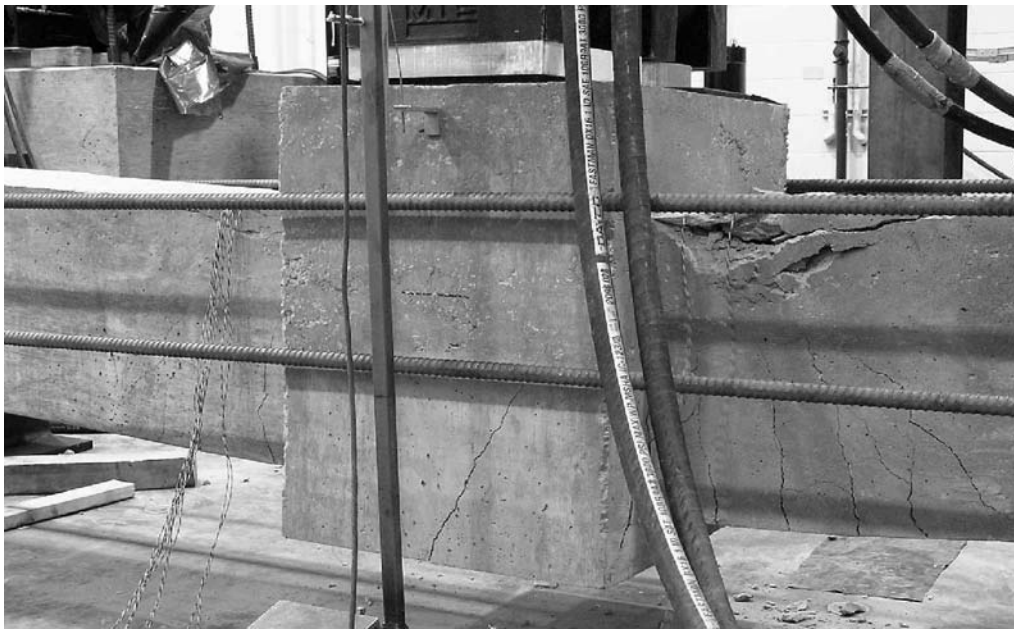
**Figure 1-58 Cracking and spalling around central block (FC specimen)**

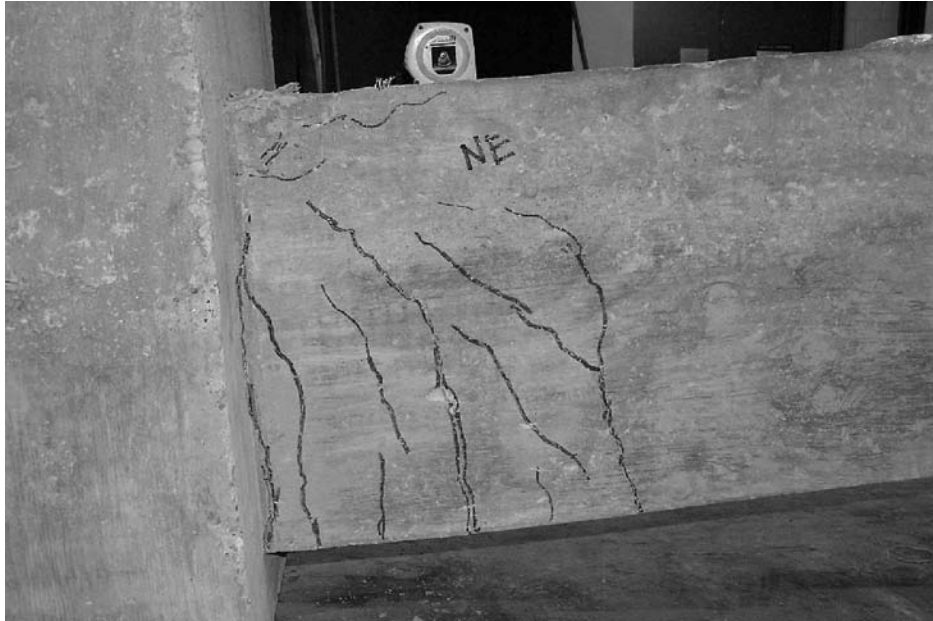
**Figure 1-59 Final crack pattern at non-critical side of specimen (FC specimen)**

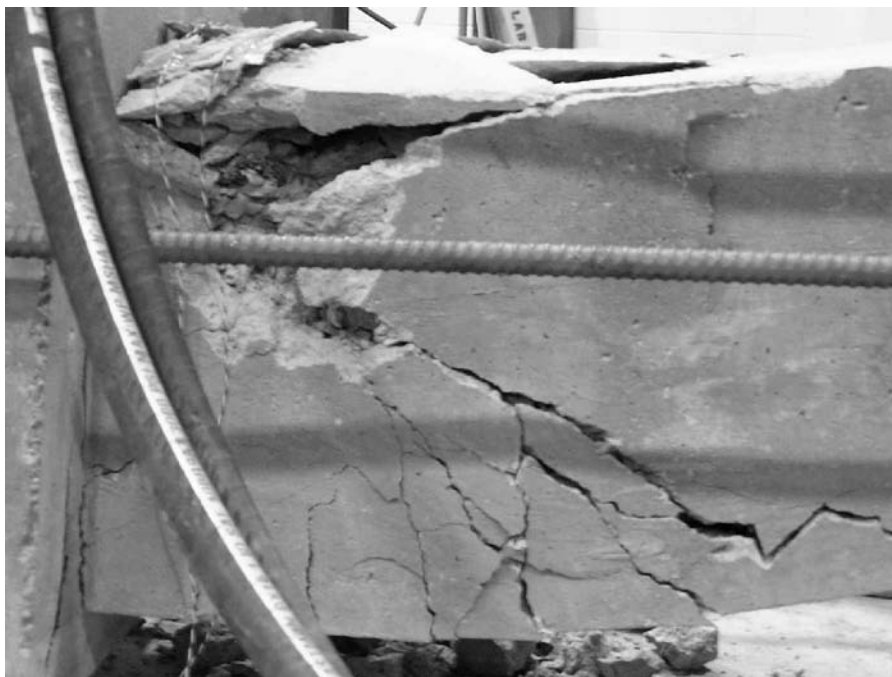
**Figure 1-60 Final crack pattern at critical side of specimen (FC specimen)**

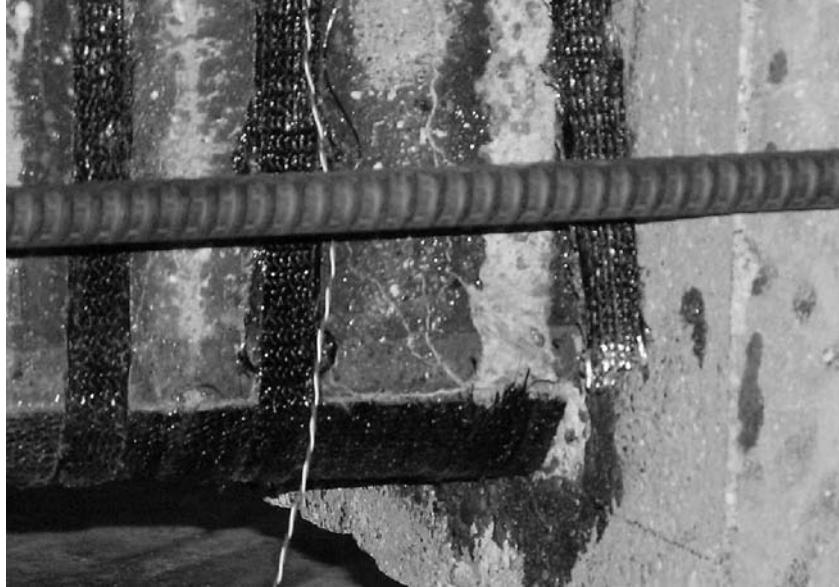
**Figure 1-64 Ruptured transverse Fibrwrap where shotcrete pulled away from FR specimen**

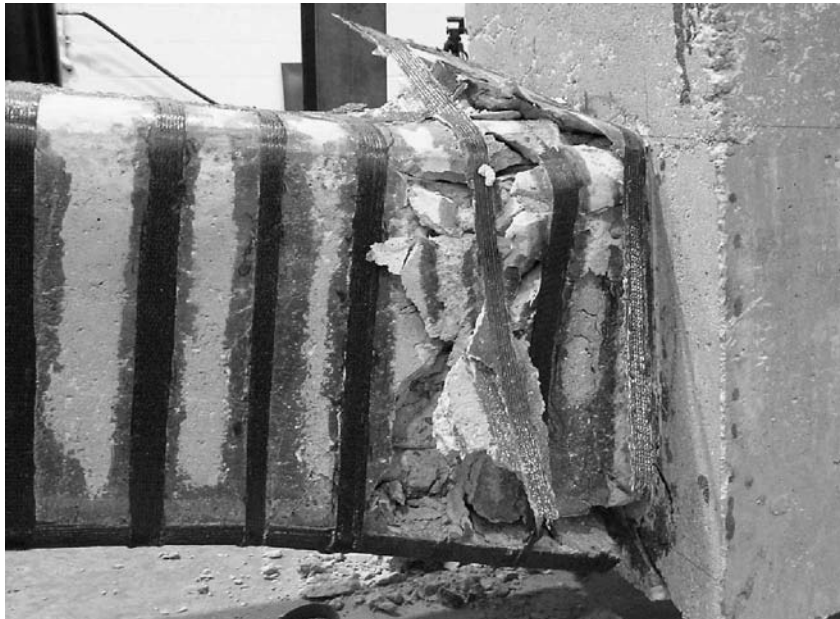
**Figure 1-65 Critical section of FR specimen**

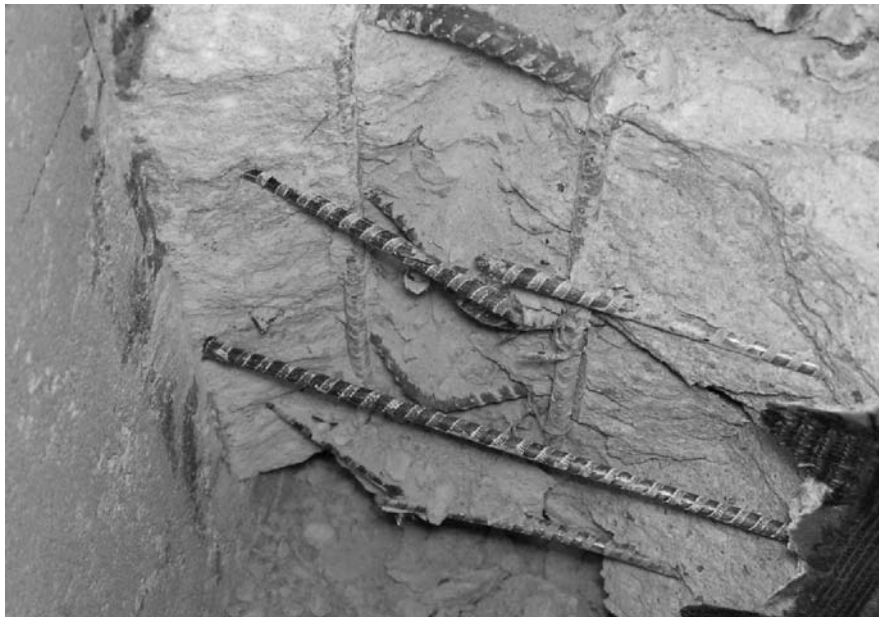
**Figure 1-67 Buckled rebars and ruptured Leadline at the top of the FR critical section**  
(Note: specimen is lying on its side and loose debris has been cleared away.)

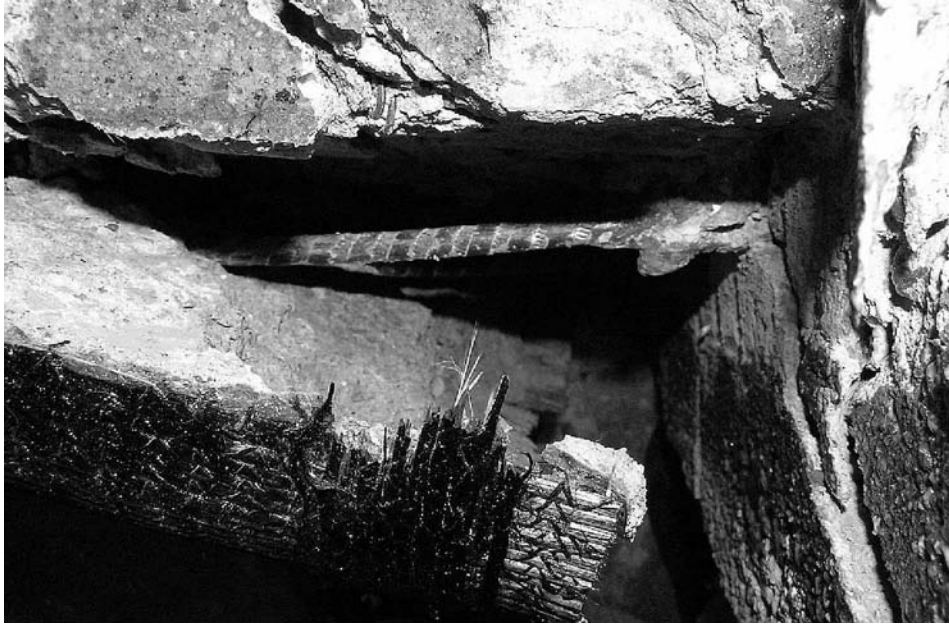
**Figure 1-68 FR specimen tension Leadline between concrete and shotcrete**

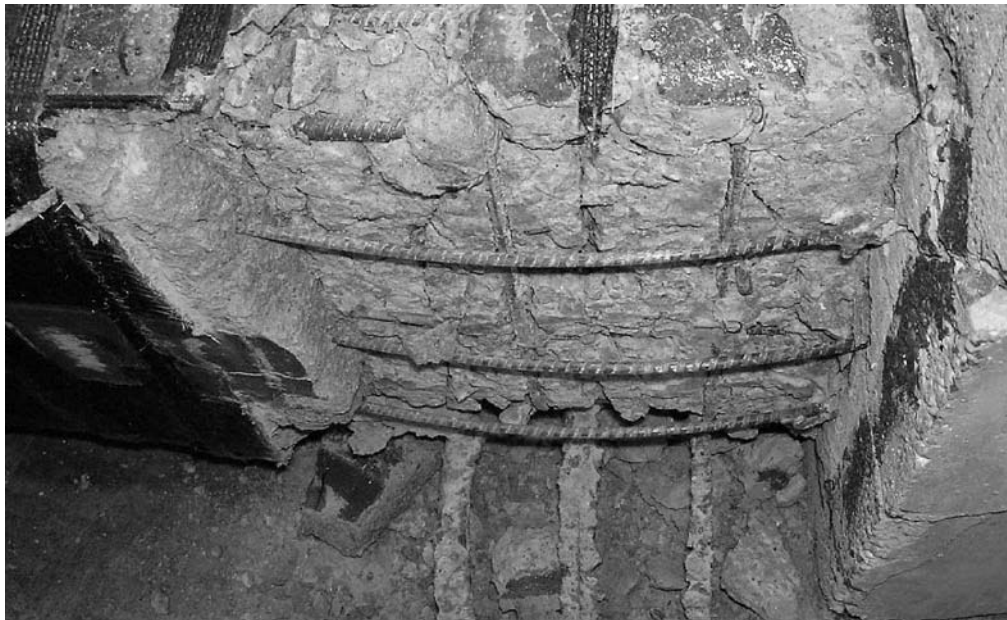
**Figure 1-69 FR specimen tension Leadline with loose shotcrete patch removed**

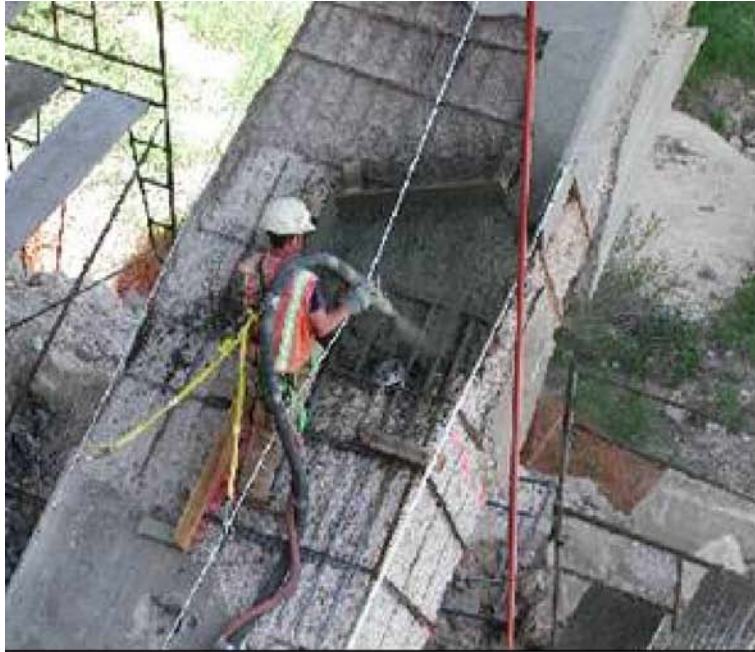
**Figure 3-12 Shotcreting over corrosion instrument**

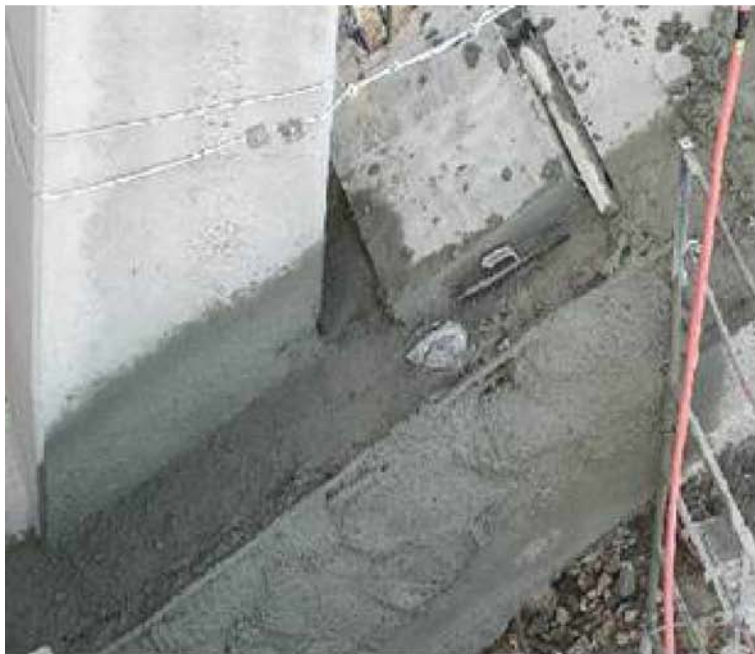
**Figure 3-13 The embedded corrosion instrument (ECI-1)**
