DOT/FAA/CT-91/10

# Turbine Aircraft Engine Operational Trending and JT8D Static Component Reliability Study

March 1992

Final Report

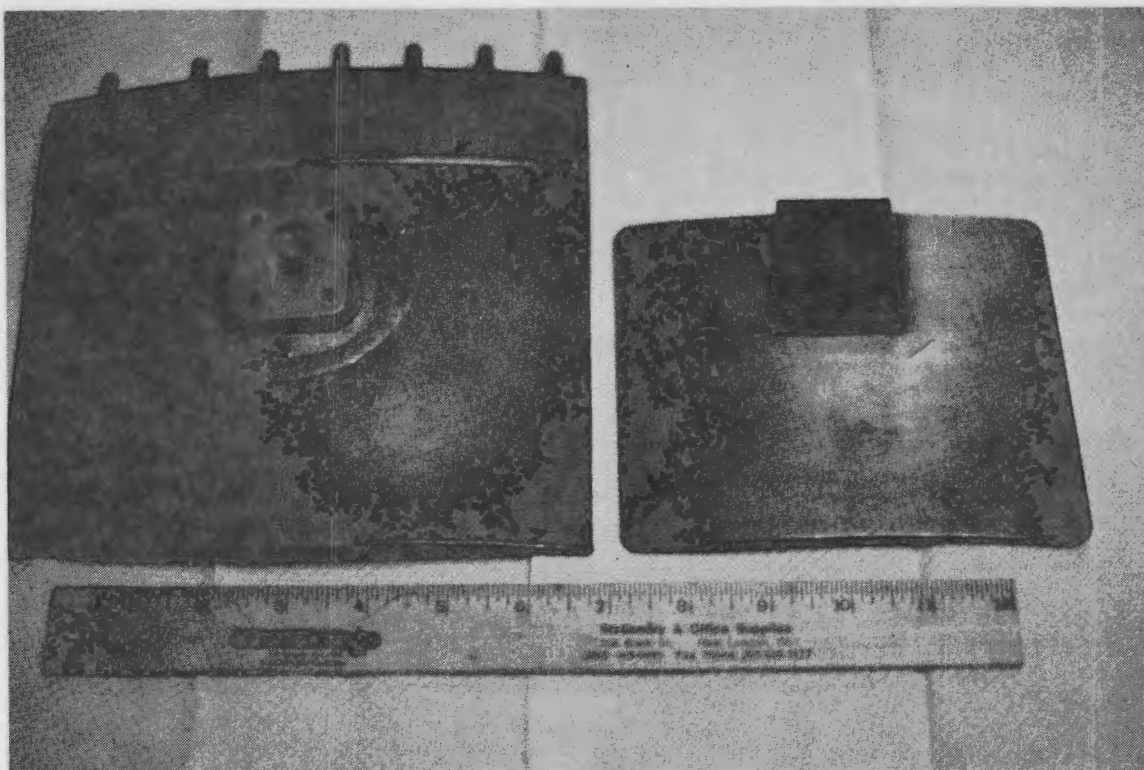
FIGURE 7 - JT8D BOSS WELD SPECIMEN (LEFT) AND CALIBRATION STANDARD (RIGHT)

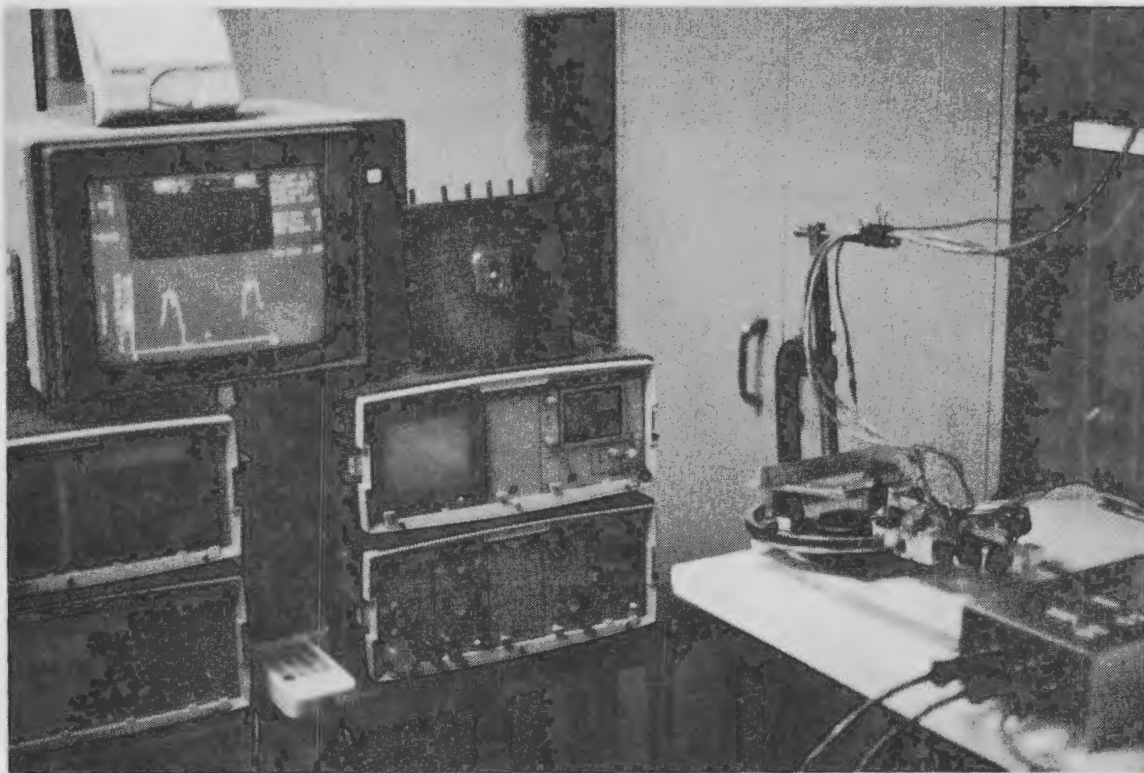
FIGURE 9 - ULTRA IMAGE III <sup>TM</sup> WITH PROTOTYPE SCANNER  
TESTING ON CALIBRATION STANDARD
