# **Field Trials for Cost-Effective Strengthening of SC Load Posted Bridges**

## **FINAL REPORT**

**FHWA-SC-26-03**

**August 2026**

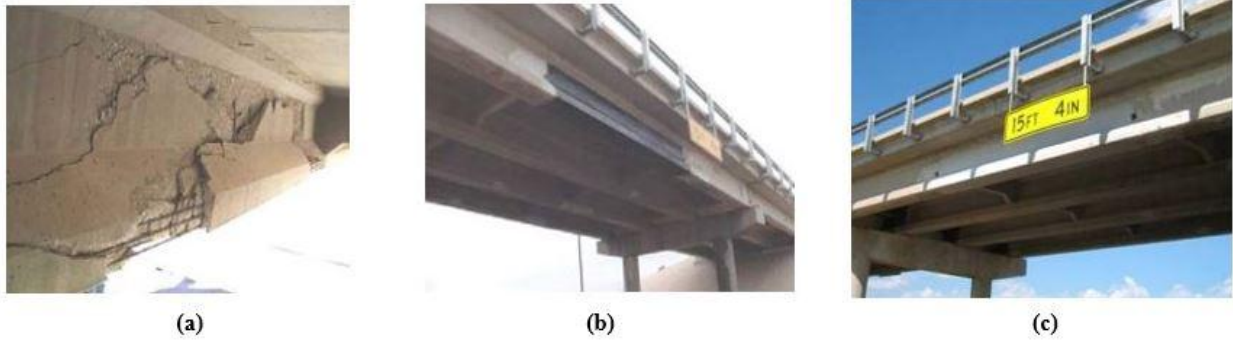
**Figure 2.2 Bridge girder repair with externally bonded CFRP laminates: (a) impact-damaged beam; (b) continuous CFRP U-wrap after installation; (c) five years after repair (Yang et al. (2011)).**

Yang et al. (2011) reported the utilization of externally bonded CFRP laminates as a repair technique for damaged concrete bridges. The first case was an exterior girder of a bridge impacted by an over height vehicle resulting in fracturing the entire web and bottom flange and severing one of the 44 prestressing strands (Figure 2.2a). Following the completion of concrete repairs, epoxy injection of cracks, and material curing one ply of CFRP U-wrap was attached to the web and bottom flange of the girder as shown in Figure 2.2b. After five years no signs of delamination or other CFRP composite deterioration were found (Figure 2.2c).

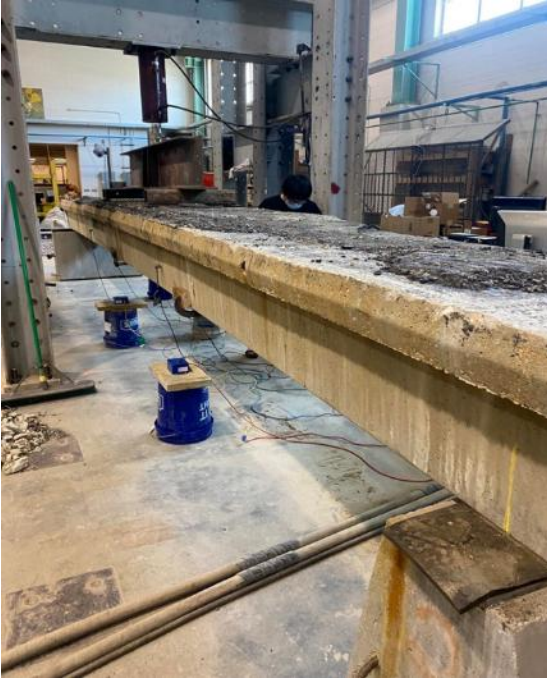
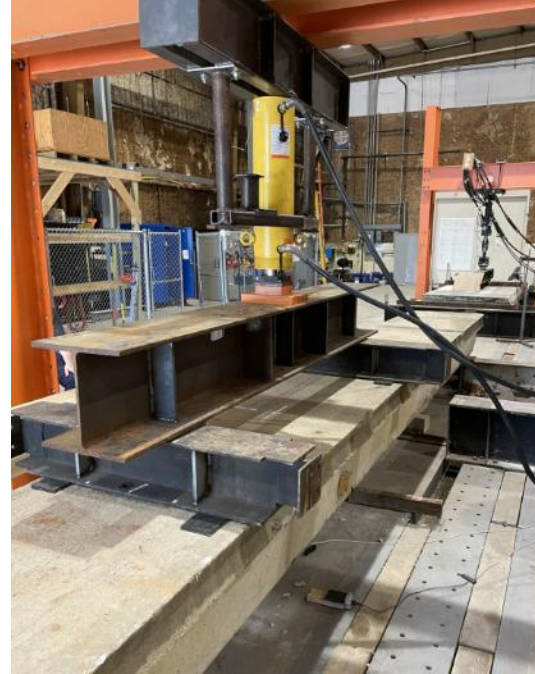
*Figure 3.3 Skinny leg channel girder test setup; (left) University of South Carolina, (right) Clemson University.*

supported bearing condition. Steel members spread the load from the actuator to the channel, with neoprene bearing pads at contacts with the channel. These points of contact are designed to rest directly over the channel legs (also referred to as channel ‘stems’). The load cell used to record applied load is situated at the center line of the spreader beam. String potentiometers were used to measure vertical deflection at midspan. Load was applied using a hydraulic cylinder. Computer data acquisition systems were used to continuously record data. At CU, load was recorded using a pressure gauge in the hydraulic line; otherwise, the setup was the same at USC and CU. Figure 3.3 provides photographs of representative tests.

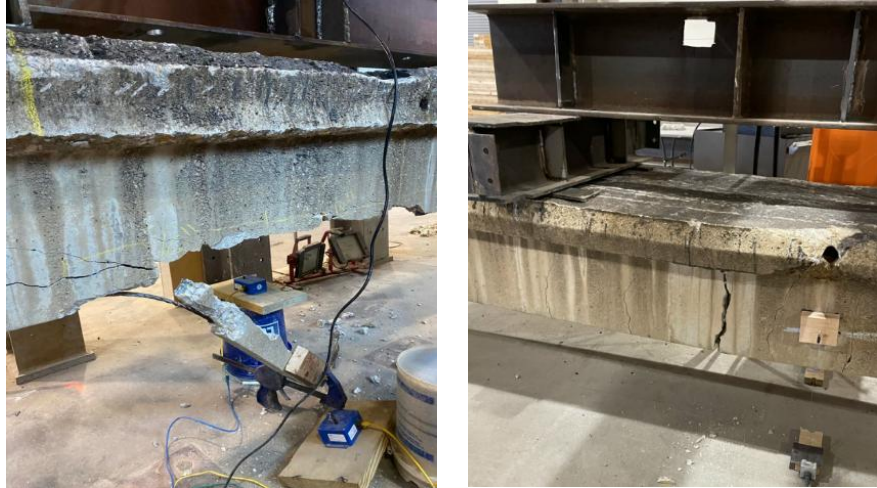
*Figure 3.5 Flexural cracking and strand rupture near midspan.*

Behavior at or near failure included strand yielding and rupture preceded by flexural cracking in the maximum moment region. An effort was made to correlate visually evaluated channel condition (amount of concrete cracking and spalling, strand corrosion) to tested capacity (Table 3.2; Figures 3.5 and 3.6). The damage level in each channel was characterized as either low, medium, or high. As expected, correlation was found with the strongest girders having the least damage.

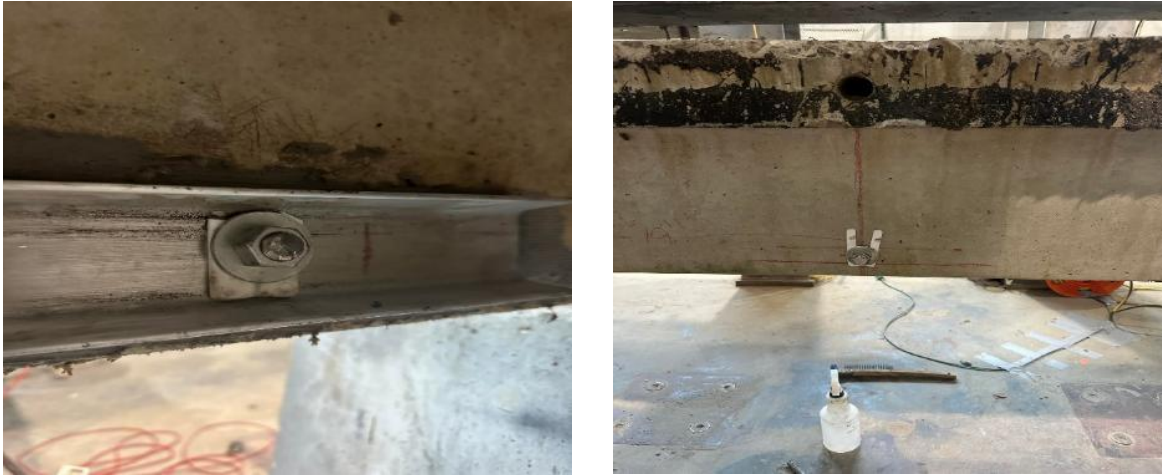
***Figure 4.3 Aluminum channels bonded and through-bolted with aluminum threaded rods.***

AA shapes were attached to specimen SEB using the same materials and procedure as described for specimen SE. In addition, the shapes were bolted to the concrete at the ends and midspan using 5/8 in. diameter 6061 aluminum threaded rods (Figure 4.3). The rods were installed through 3/4 in. diameter holes drilled through the beam webs. Ground penetrating radar was used to locate the prestressing strands and to coordinate the drilling locations. Holes were cleaned with an air compressor before installing the aluminum rod. The aluminum threaded rods were secured using aluminum hex nuts which were tightened using a wrench.

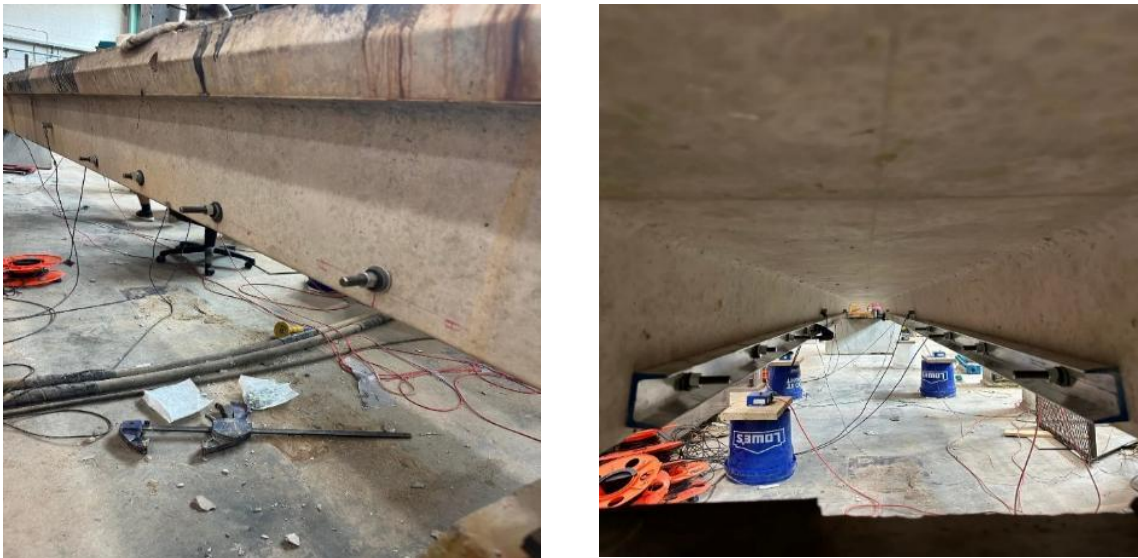
***Figure 4.4 Aluminum channels through-bolted with steel threaded rods.***

For specimen SB, only mechanical attachments were used to connect the AA shapes (epoxy was not used). Each end was attached using four 5/8 in. diameter ASTM 192 Grade B7 steel threaded rods. The intent of switching from aluminum rods (specimen SEB) to steel rods (SB) was to increase the capacity of the bolted attachments. The size and quantity of steel rods were selected with the intent to approach the yield capacity of the AA shape prior to failure. The locations and spacing of the rods are shown in Figure 4.1 and Figure 4.4. In field applications, care should be taken to mitigate the possibility of galvanic corrosion resulting from the combination of steel bolts and aluminum. The use of sealants, tapes, and/or gaskets is recommended for consideration.

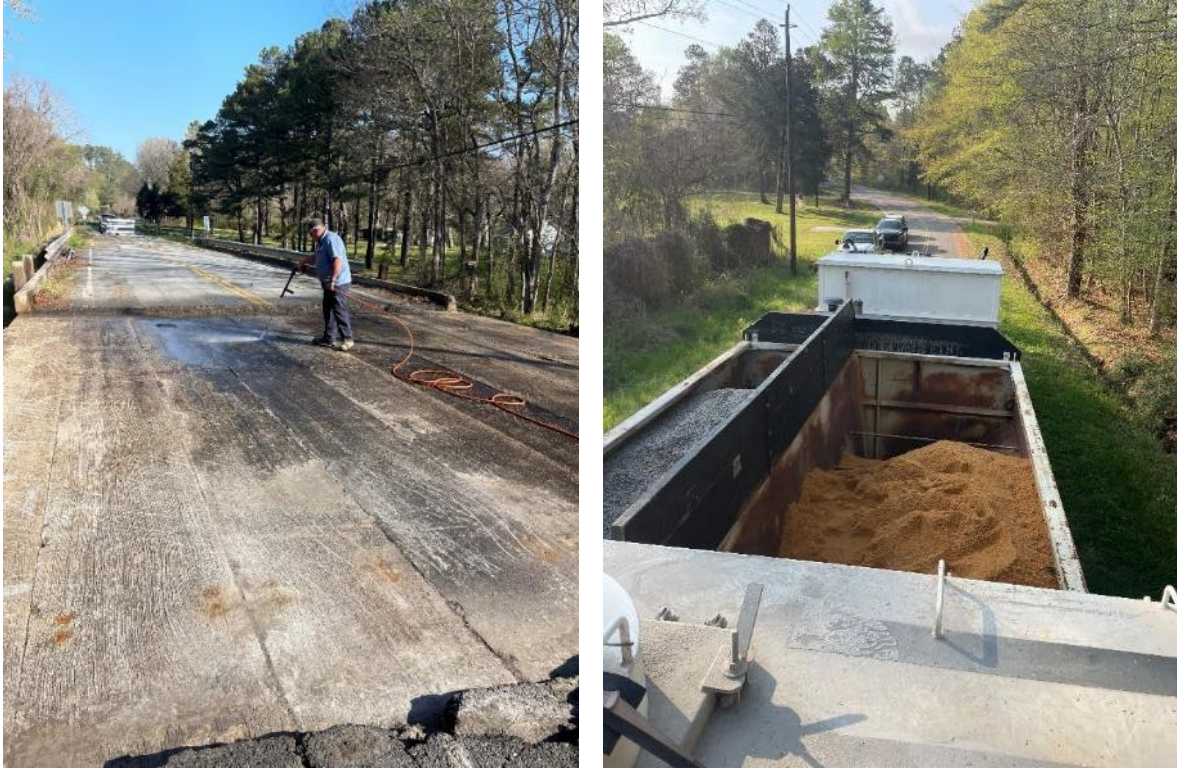
**Figure 6.4 Pressure washing the surface and joints (left); LMC materials (right).**

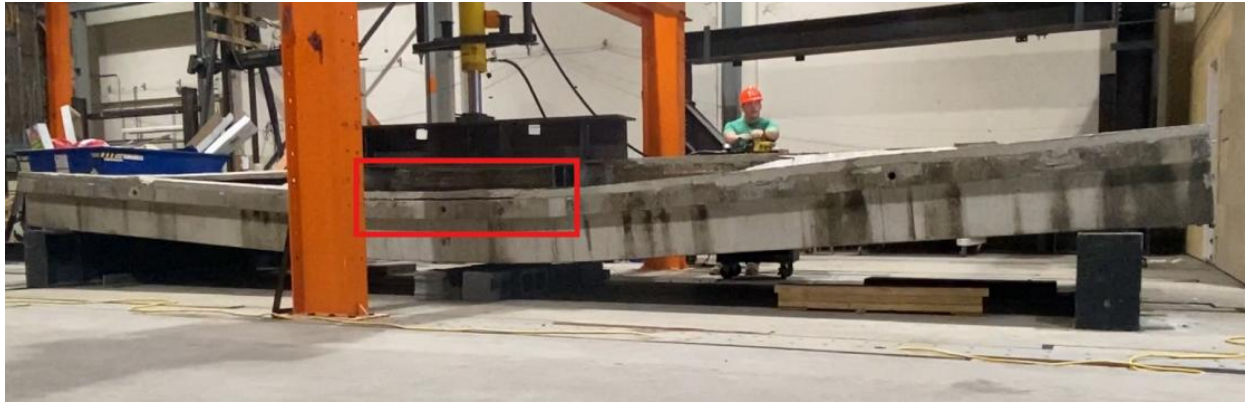
***Figure 0.2 Delamination of LMC on girder L1.***

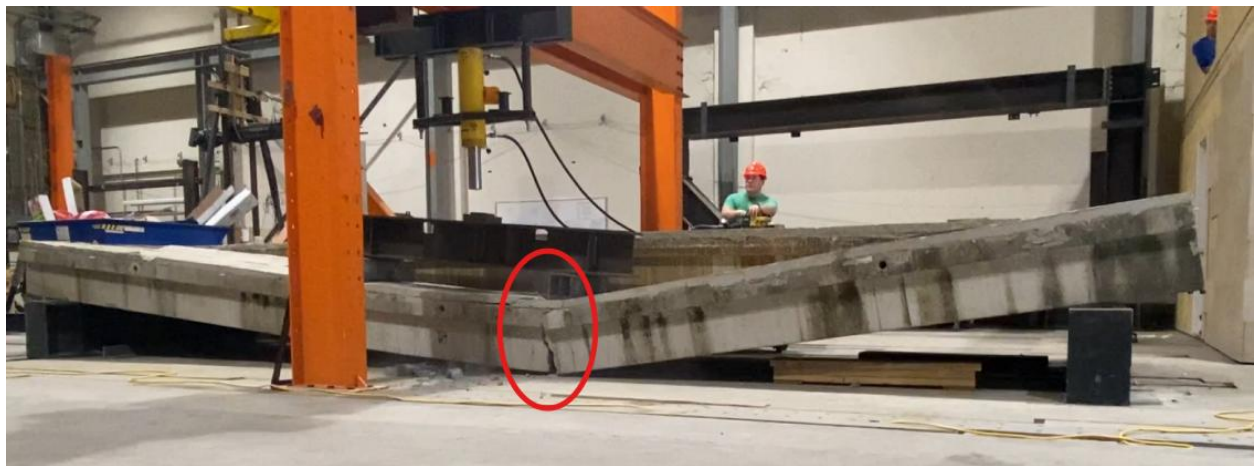
***Figure 0.3 Failure of girder L1 due to strand rupture below load point.***

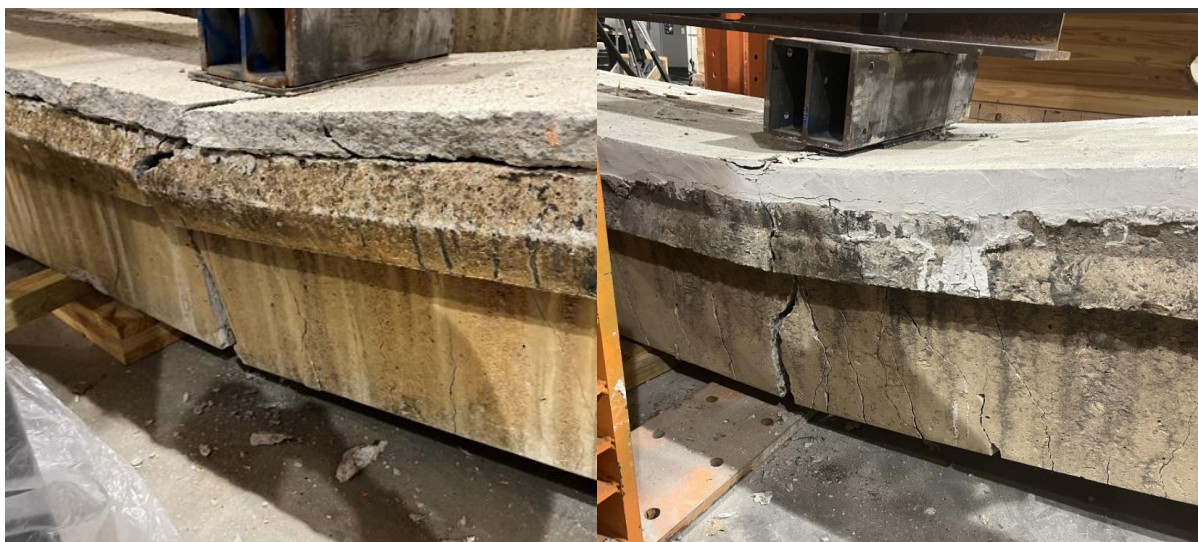
***Figure 0.4 Failure of specimen L2 (left); and L3 (right).***

The failure of specimen L2 also involved LMC delamination and strand rupture. A portion of the LMC-topping delaminated from L2 at a moment of 240 kip-ft. The delamination was accompanied by an abrupt drop in load. Testing continued after the delamination; however, the moment never exceeded the previous peak. Specimen L2 withstood over 11 in. of displacement before strands ruptured at the section below one of the load points (Figure 7.4).

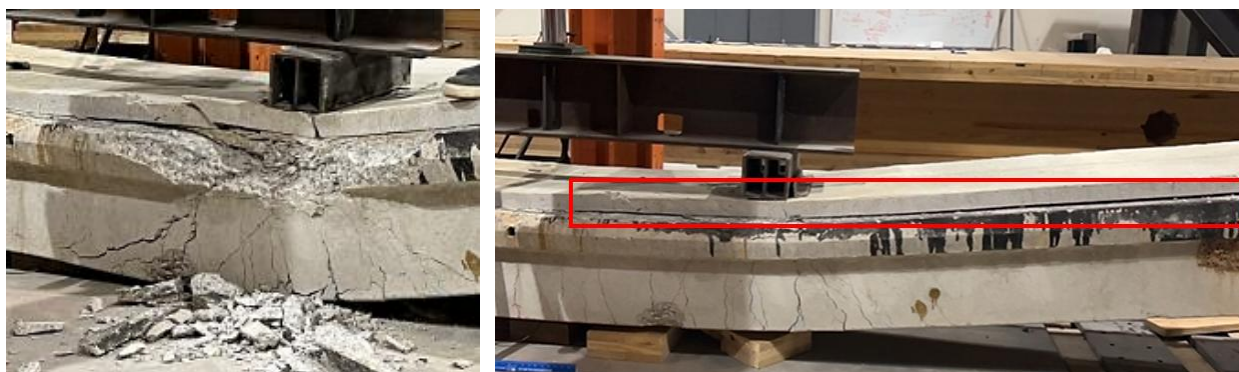
*Figure 7.5 Flexural failure of L4 (left); and topping delamination before failure (right).*

Specimen L4 originated from the same bridge, underwent the same surface preparation, and used the same LMC mix as Specimen L3. Unfortunately, data from the L4 test was lost due to sudden loss of power during testing. However, test notes, photos, and videos indicate that the topping slab delaminated from one half of the span at approximately the same time as the peak load was reached. The specimen continued to displace until the top of the precast crushed in compression (Figure 7.5).

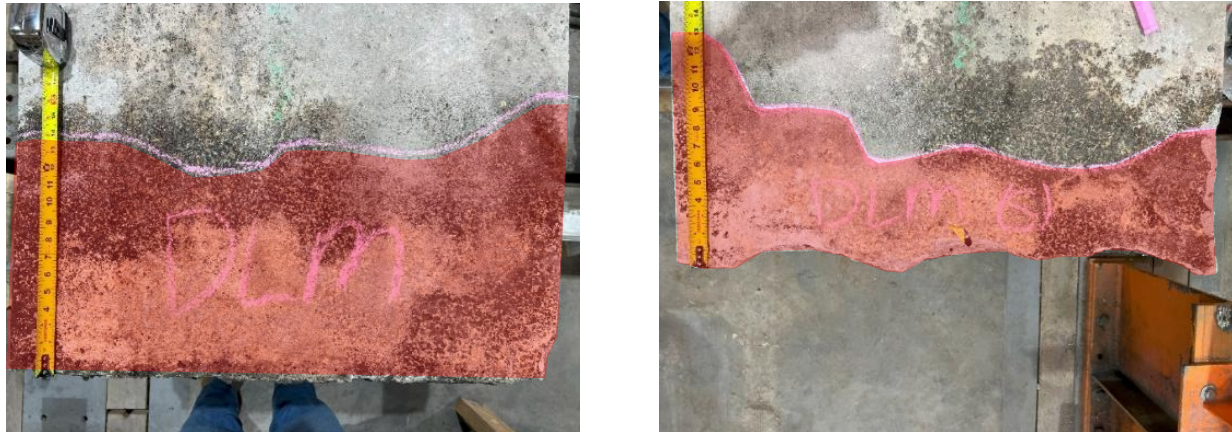
**Figure 8.3 CL1 LMC delamination (highlighted in red) at north end (left); and south end (right).**

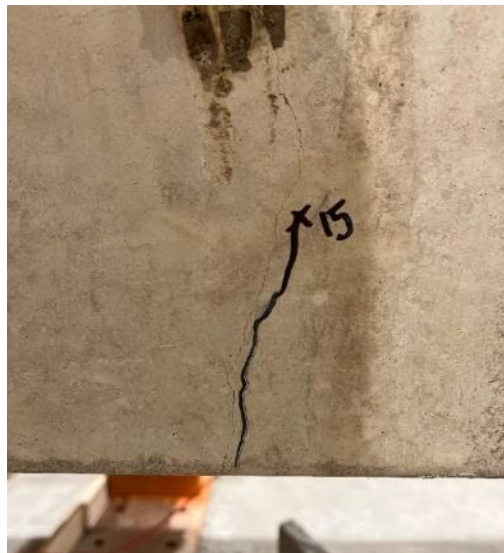
***Figure 8.5 CL1: Flexural cracking at midspan after initial service level cycles.***

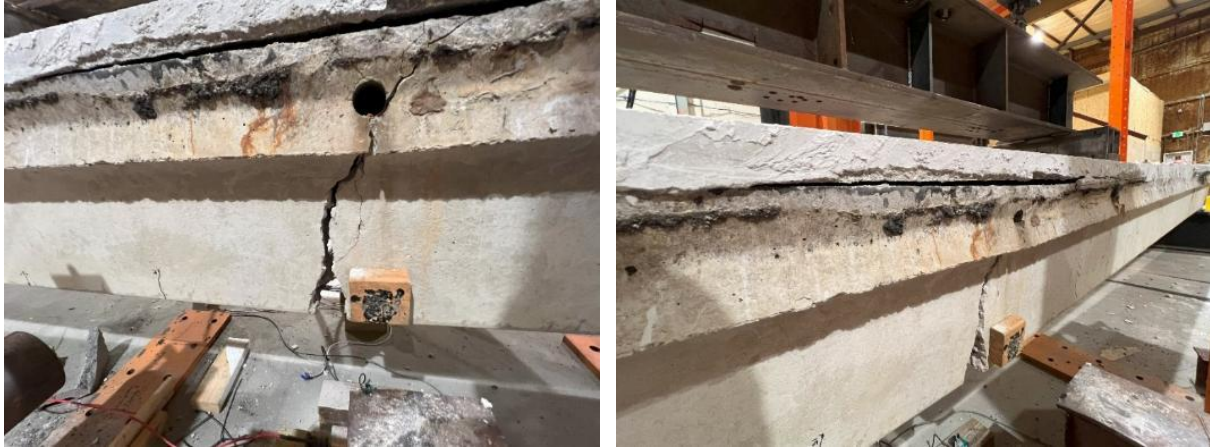
**Figure 8.8 Flexural cracking and LMC delamination after 619,028 cycles.**

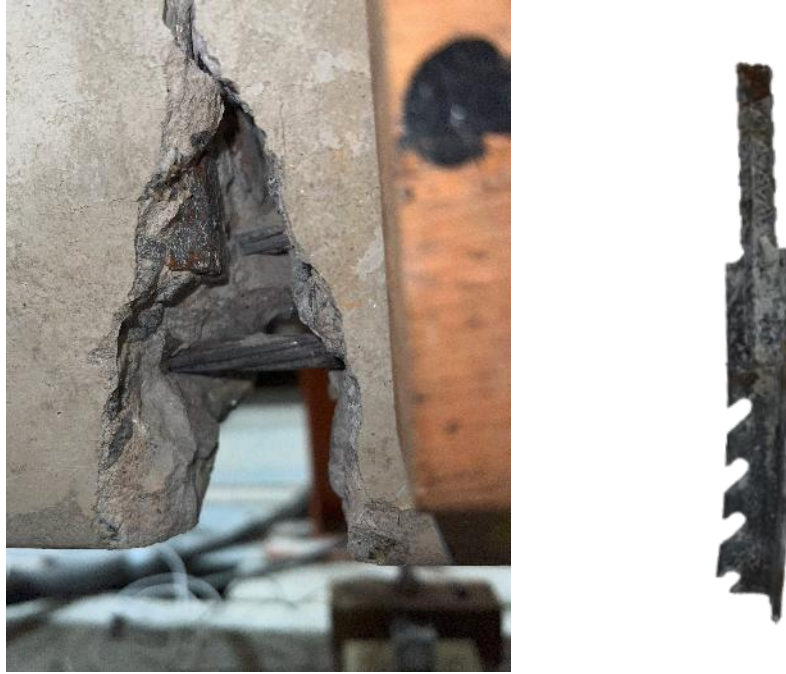
*Figure 8.9 Hold-down device and ruptured strands (left) and hold-down device (right).*

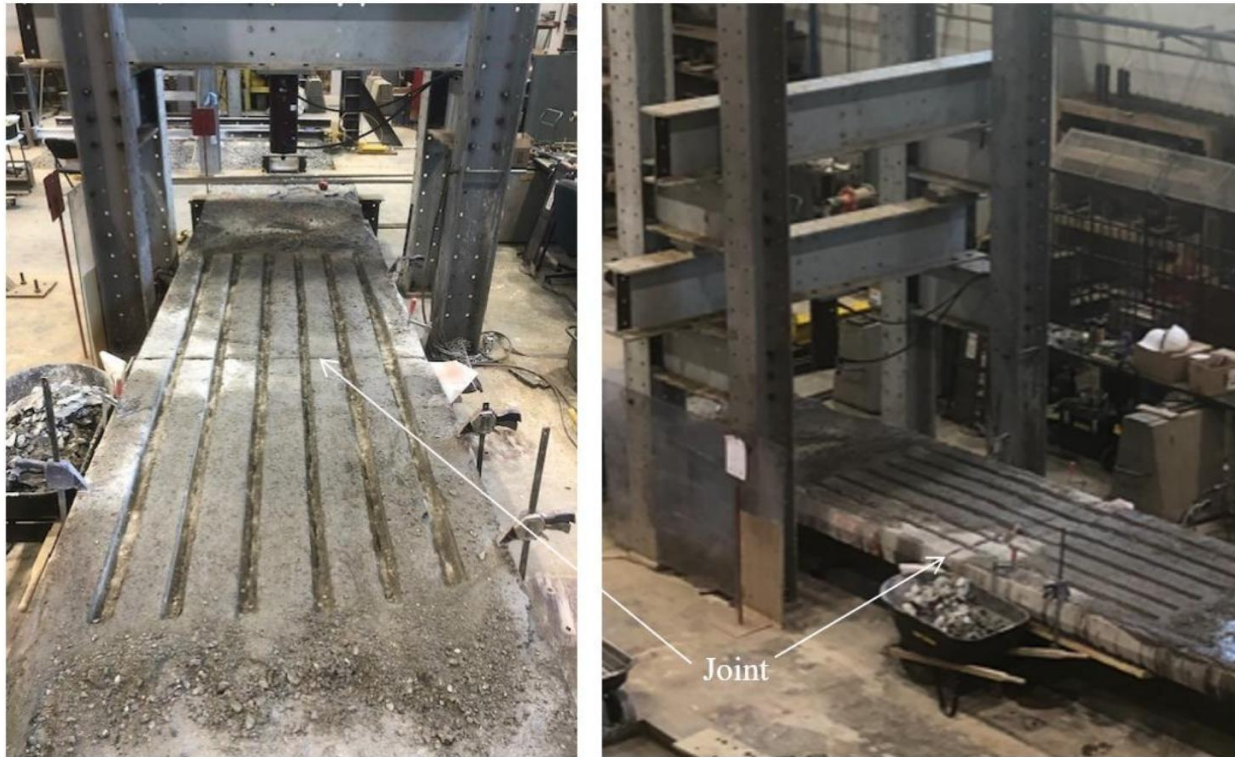
***Figure 9.2 Lab specimen with near-surface mounted (NSM) bars.***

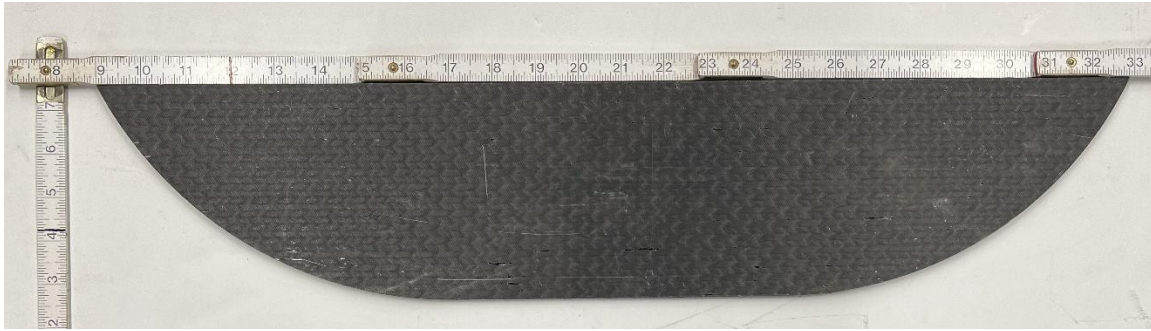
***Figure 9.3 V2 composites T-biscuit.***

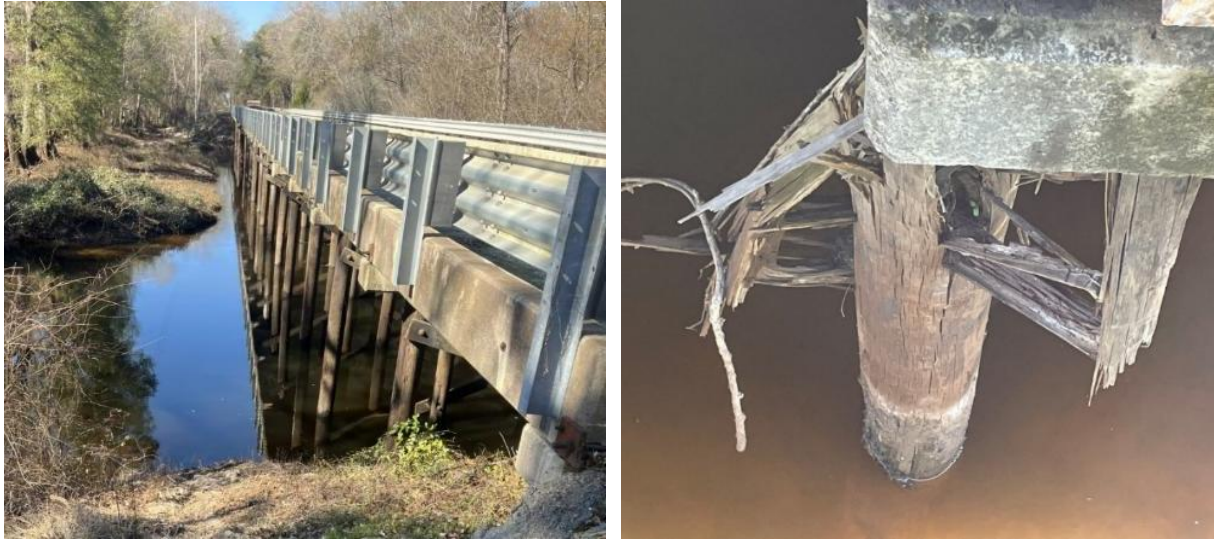
***Figure 9.5 Four-hole swamp bridge (left) and pile failure (right).***

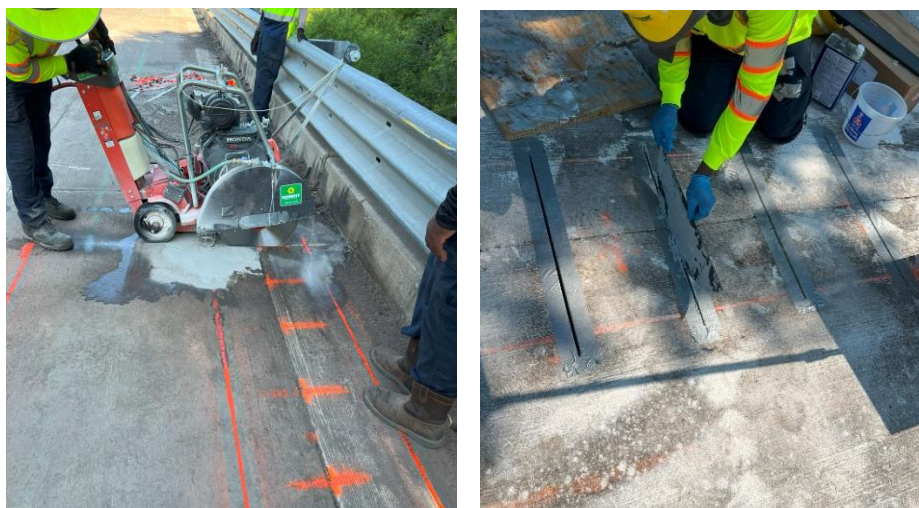
***Figure 9.12 Cutting grooves (left) and installing biscuits (right).***

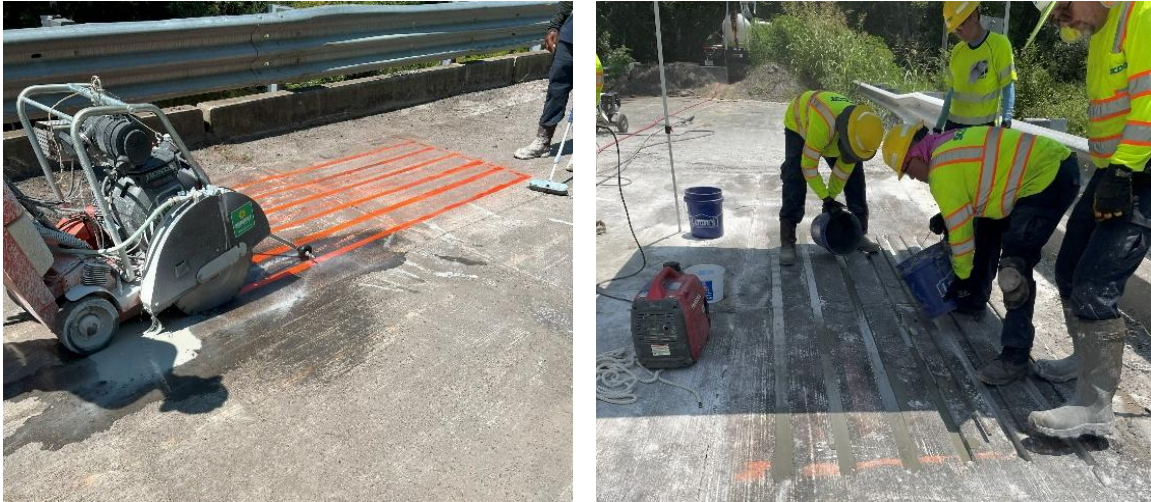
**Figure 9.13** *Cutting slots (left), NSM bar and grout installation (right).*
