**Report No. CDOT-DTD-R-2005-01**

**EVALUATION OF THE FRP-RETROFITTED ARCHES IN THE  
CASTLEWOOD CANYON BRIDGE**

**December 2004**

**COLORADO DEPARTMENT OF TRANSPORTATION  
RESEARCH BRANCH**

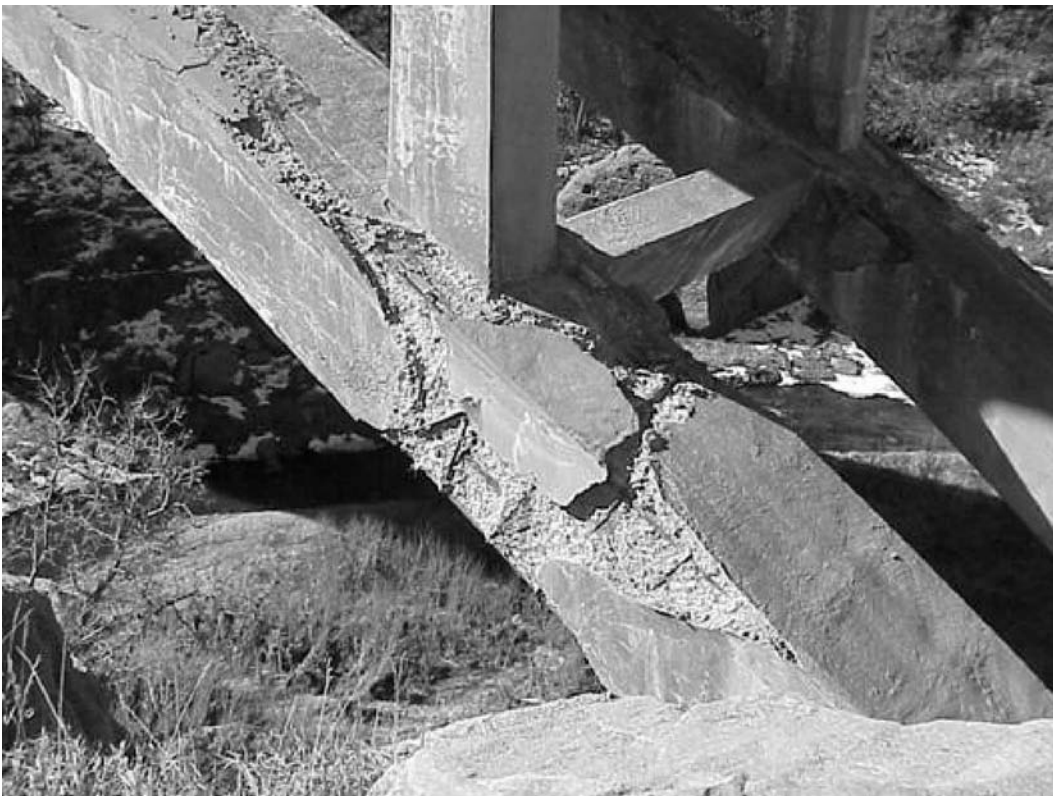
Figure 1-3 Spalling concrete and exposed steel before repair

In 2003, the bridge was severely dilapidated and in need of repair, enlarging, and strengthening. Parts of the soft concrete had spalled off the deck, columns, and arches, and the rebars were badly rusted. (See Figure 1-3 and Figure 1-4.) During the summer of 2003, the original arch was repaired, the spandrel columns were replaced, the bridge deck was replaced and widened from about 35' to 43'-0" including railings, and the overall length was increased from 373'-6" to 404'-5".

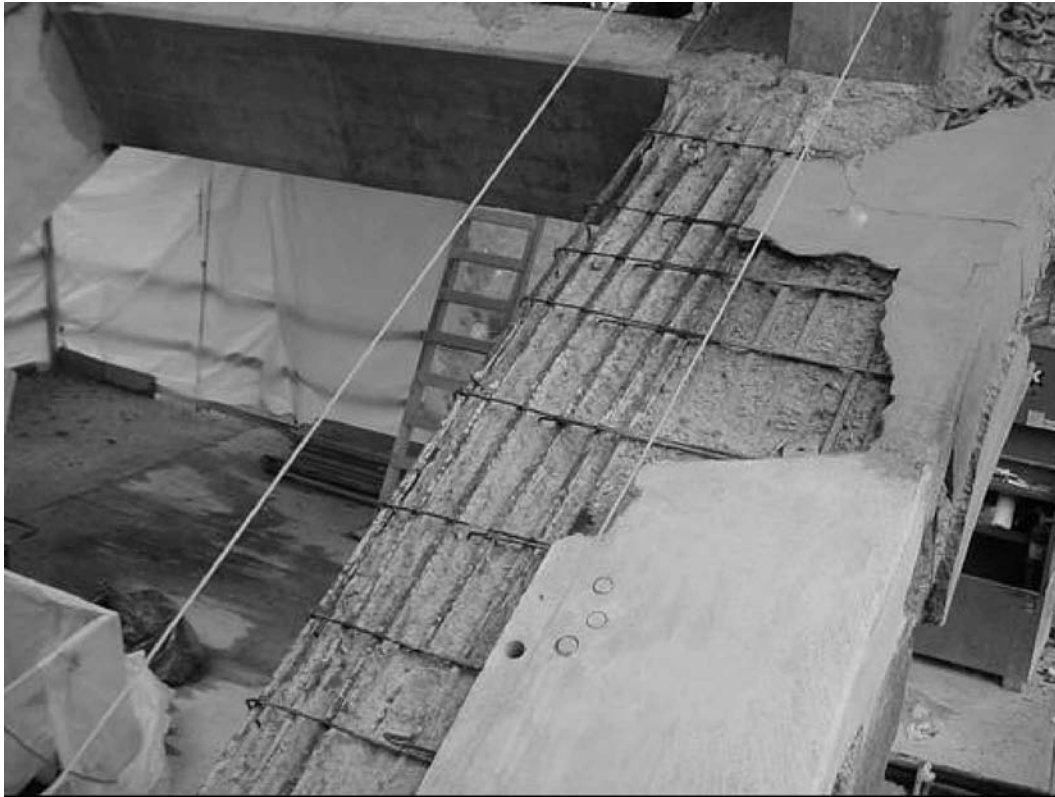
**Figure 1-4 Spalling concrete and exposed steel during construction**

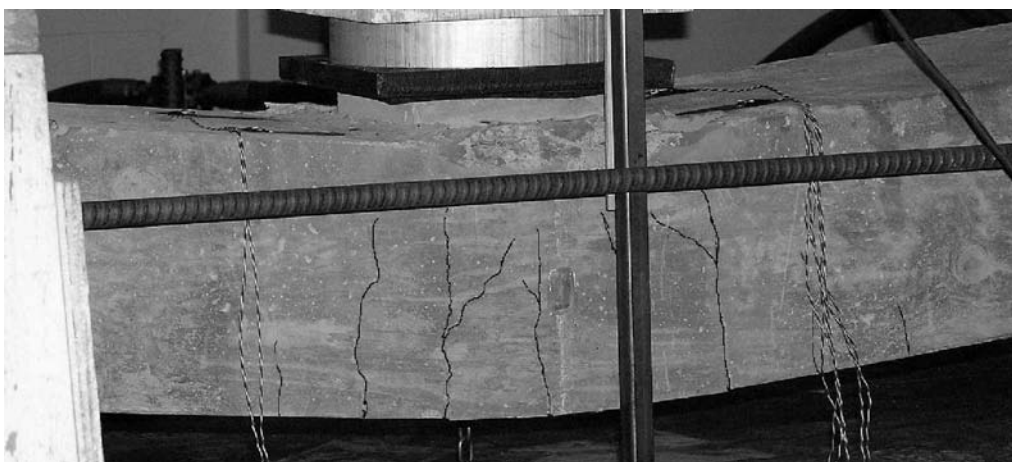
**Figure 1-48 Crack pattern at end of test (AC specimen)**

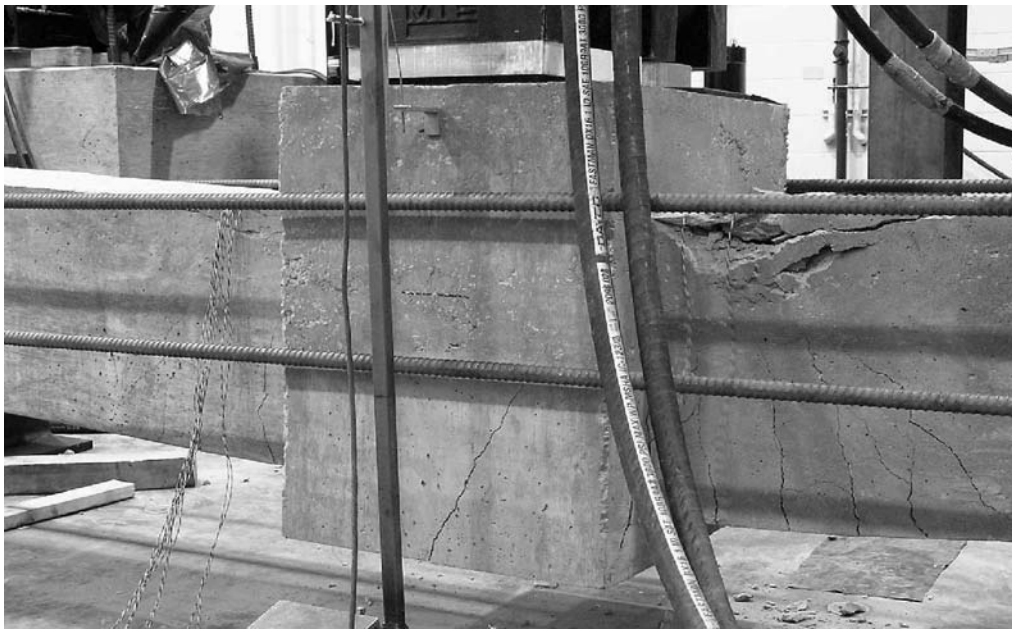
**Figure 1-58 Cracking and spalling around central block (FC specimen)**

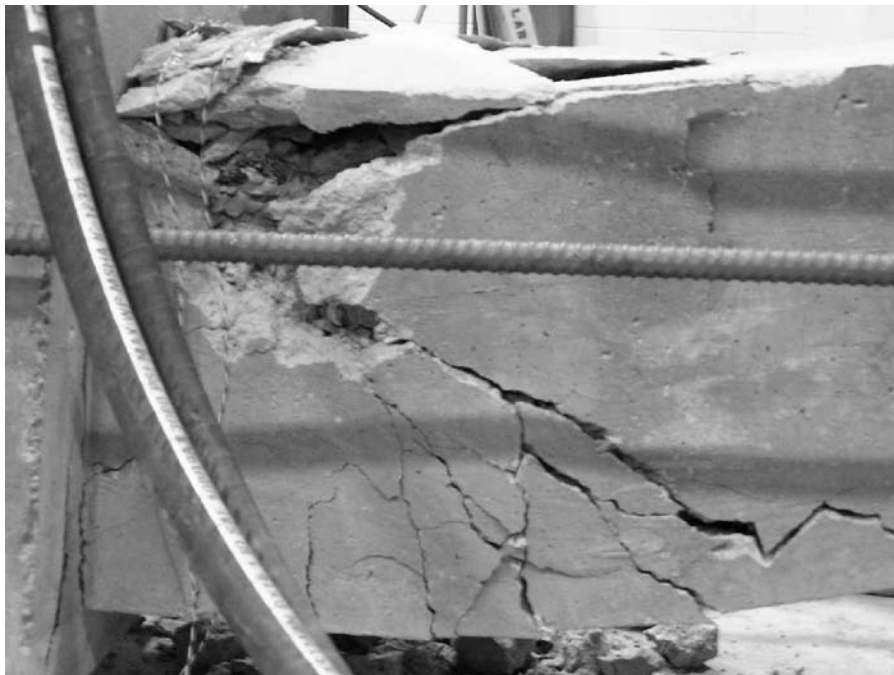
**Figure 1-60 Final crack pattern at critical side of specimen (FC specimen)**

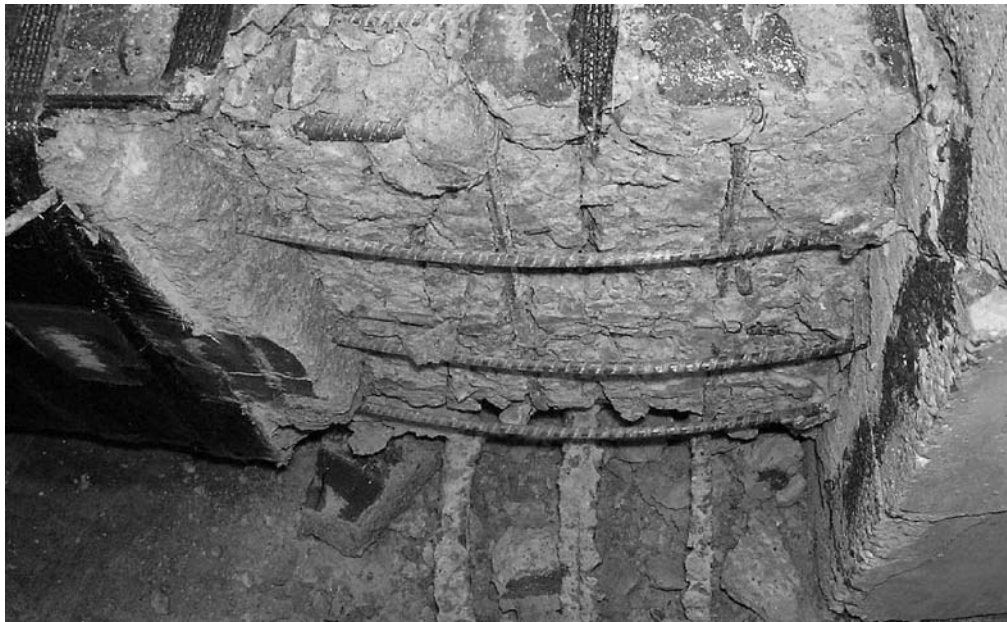
**Figure 1-69 FR specimen tension Leadline with loose shotcrete patch removed**
