**Report No. CDOT-DTD-R-2004-13**  
**Final Report**

# **RECESSED STRIPING IN CONCRETE PAVEMENT**

**COLORADO DEPARTMENT OF TRANSPORTATION  
RESEARCH BRANCH**

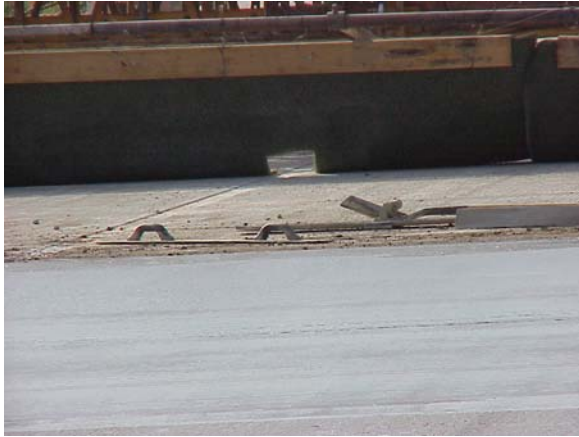
**Figure 3. Gaps were cut in the drag to keep the groove smooth.**

the paver so the drag didn't round the edges of the grooves. 2. At the grooves, remove the tines from the tining machine so the bottoms of the grooves would provide a smooth surface for paint and tape.

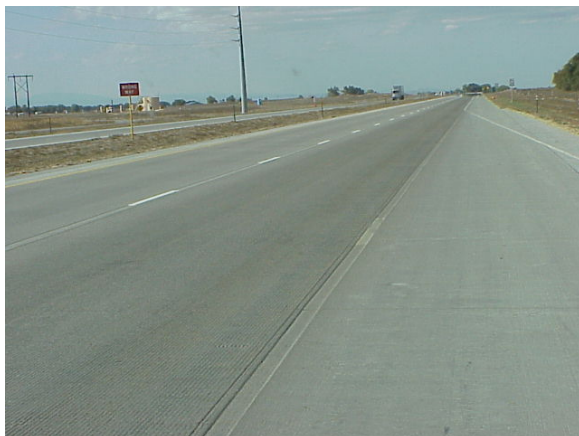
**Figure 4. At accel/decel lanes the stripes were placed outside the grooves.**

When an extra lane is added for a short distance to serve as an accel/decel lane at an intersection, the shoulder stripe curves outward to a new position nearer the outside edge of the pavement. Since the positions of all of the grooves are permanently set at a fixed distance from the edge of the pavement by their welded locations on the screed, there is no way to adjust the position of the shoulder stripe groove to allow for the extra

lane. At these locations, whether they are on the left or right shoulder, the groove continues at its fixed location relative to the edge of the concrete. The painted stripe leaves the groove at the beginning of the new lane and is painted on the surface of the concrete for the length of the additional lane. The shoulder stripe then bends back toward the center of the concrete at the end of the acceleration lane and rejoins the shoulder stripe groove when the lane ends.

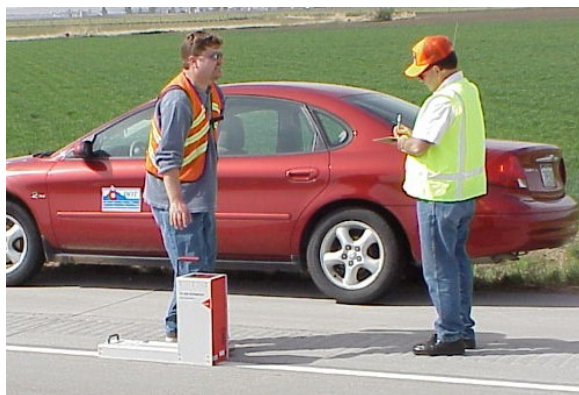
**Figure 5. The Delta LTL2000 measures retroreflectance in any light condition.**

Both types of pavement markings went through several winters with no noticeable wear from traffic or snowplows. Retroreflectance measurements were taken using a Delta LTL2000 Retrometer. This description is on the first page of the Delta Retrometer manual: “The LTL2000 Retrometer is a portable field instrument, intended for measuring the retroreflection properties of road markings in car headlight illumination, the value R1 (coefficient of retro reflected luminance)

is used. R1 is a measure of the lightness of the road marking as seen by drivers of motorized

vehicles in car headlight illumination. The road is illuminated at an angle of  $1.24^\circ$  and the reflected light is measured at an angle of  $2.29^\circ$ , which corresponds to an observation distance of 30 meters. Thus relevant for a motorist viewing situation under normal conditions.” The retroreflectance numbers generated by the LTL2000 are milli-candellas per lux per square meter.

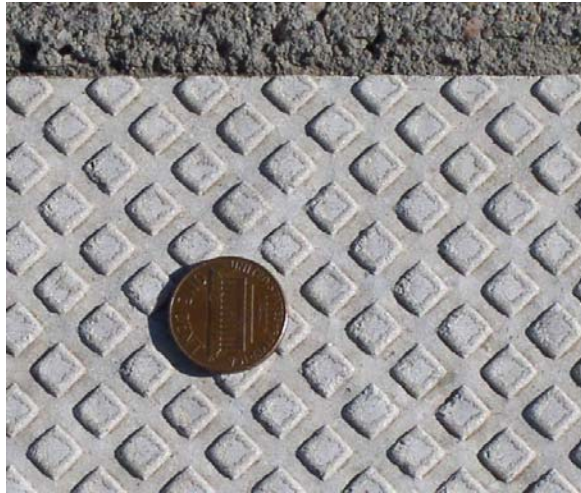
**Figure 6. Even after 3 years, the tape was still bright.**

diamonds are quickly damaged by snowplows. In the eastbound lanes, the tape in the grooves remained in excellent condition with no plow damage to the raised diamonds. **Figure 6** shows the right shoulder tape after three winters. There is no visible wear; however, the surface appeared slightly less bright than when it was new, possibly due to the tape being a little dirty – it had been exposed to the elements for three years. After three winters, retrometer readings averaged 514 for the white tape in the right shoulder and 479

After three winters all of the tape in the eastbound lanes remained in very good condition. There was only one very small – about six inches long – piece that had been damaged by something being dragged over the tape and tearing it. As **Figure 6** shows, the reflective tape was slightly dirty; however, the retroreflectance numbers for the three-year-old tape were higher than those for new epoxy paint.

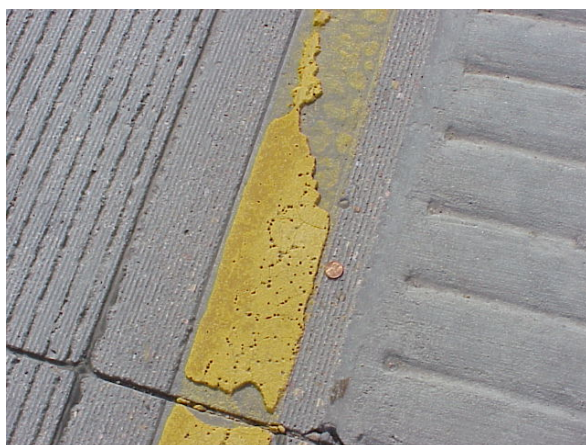
**Figure 7. The thermoplastic failed due to adhesion loss.**

The thermoplastic markings in the grooves in the westbound lanes had good retroreflectivity readings, 299 to 378 for white and 154 to 209 for yellow, and showed no traffic or snowplow damage. However, the thermoplastic material, which was between  $1/8^{\text{th}}$  inch and  $3/16^{\text{th}}$  inches thick, was extensively cracked and had started to separate from the surface of the pavement.

Postage stamp-sized pieces were easily picked

up off the pavement. There were extensive areas of the skip stripe where the wind blast from passing traffic had removed nearly all of the thermoplastic material.

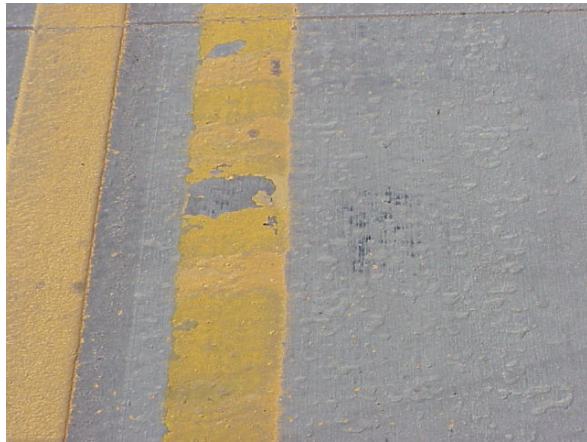
**Figure 8. Epoxy paint in a groove in perfect condition next to damaged paint on the surface.**

The left stripe in **Figure 8** is in a groove; the right stripe is on the surface of the pavement.

Retroreflectivity readings for the two stripes are nearly the same – the one in the groove averaged 69.8 for five readings; the one on the surface

averaged 70 for five readings. However, as can be seen in the photo, the paint on the surface of the pavement has begun to come off of the concrete.

The areas of the surface stripe (the one on the right) that appear brighter yellow are where the stripe was scraped by snowplows. The places where the paint is gone seem to be part of the scraped areas. However, it is impossible to say whether the snowplows directly caused the missing paint or simply removed paint that was already loose. Most of the paint that shows evidence of scraping was still firmly stuck to the concrete. It is not known whether the same method was used to clean the surface for both stripes before the epoxy was installed; however, the paint and beads in the stripe in the groove were completely undamaged after repeated plowing operations and showed no signs of losing adhesion to the concrete.
