**Report No. CDOT-DTD-R-2004-03**  
**Final Report**

**LONG-TERM DURABILITY OF FIBER-REINFORCED  
POLYMERS (FRPS) AND IN-SITU MONITORING OF FRP  
BRIDGE DECKS AT O’FALLON PARK BRIDGE**

**COLORADO DEPARTMENT OF TRANSPORTATION  
RESEARCH BRANCH**

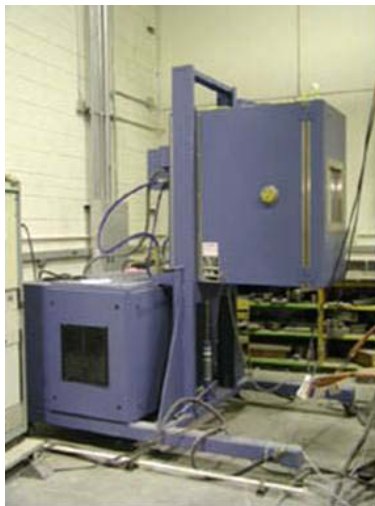
Figure 1. The environment chamber used in the project

ASTM C666 (Standard Test Methods for Resistance of Concrete to Rapid Freezing Thawing) was used in the present study for the freeze-thaw conditioning of GFRP specimens, although the testing procedures specified by ASTM C666 were originally designed for the durability of concrete. An environmental chamber manufactured by Russells Technical Products was used for the freeze-thaw conditioning. It is shown in Figure 1.

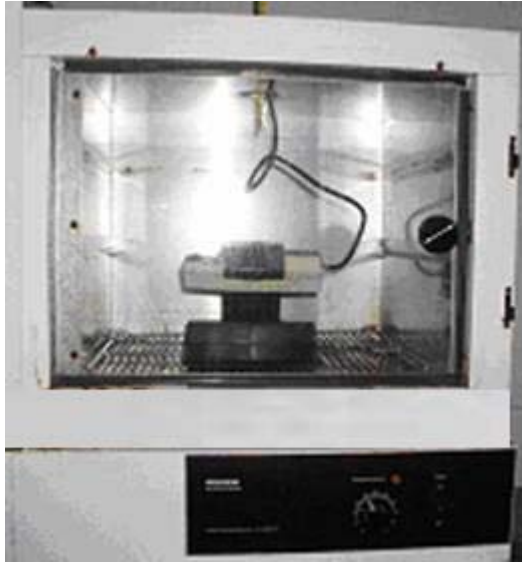
Figure 5. Ultraviolet Radiation Apparatus

A standard ultraviolet (UV) resistance test based on ASTM G53 was used to simulate the weathering effect, particularly the deterioration of GFRPs caused by sunlight. The testing cycles are specified in ASTM D 5208. Three specimens were exposed to the cyclic fluorescent ultraviolet radiation in an environmental chamber for 90 days based on the Cycle C procedure of ASTM D 5208. The temperature in the chamber was kept at 50°C. The test chamber and the ultraviolet light are shown in Figure 5.

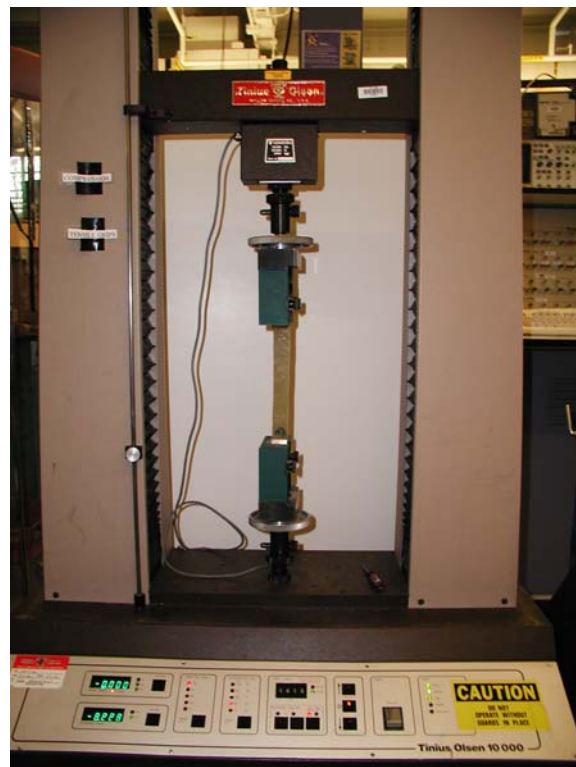
Figure 6. Experimental setup for uniaxial tension test of a GFRP specimen

The uniaxial tension test was carried out after the conditioning of the specimens was complete in order to investigate the degradation of the GFRPs exposed to environmental conditions. The uniaxial tension tests were performed on a Series 10,000 Bench UTM (Tinius Olsen Machine), as shown in Figure 6. The machine was equipped with a 10,000 lb load-cell. The specimens were inserted between the two grips of the testing machine and then loaded in tension until fracture occurred. To prevent any possible slip during loading, lateral pressure was applied at the grips. The tensile load was applied in the longitudinal direction, as shown in Figure 6. The specimens were subjected to uniaxial loading in tension with a displacement rate of 10 in/min. The load  $P$  and the elongation of the specimens were recorded. After the nominal stress and nominal strain were calculated, the Young's modulus and the tensile strength of the specimens were obtained.

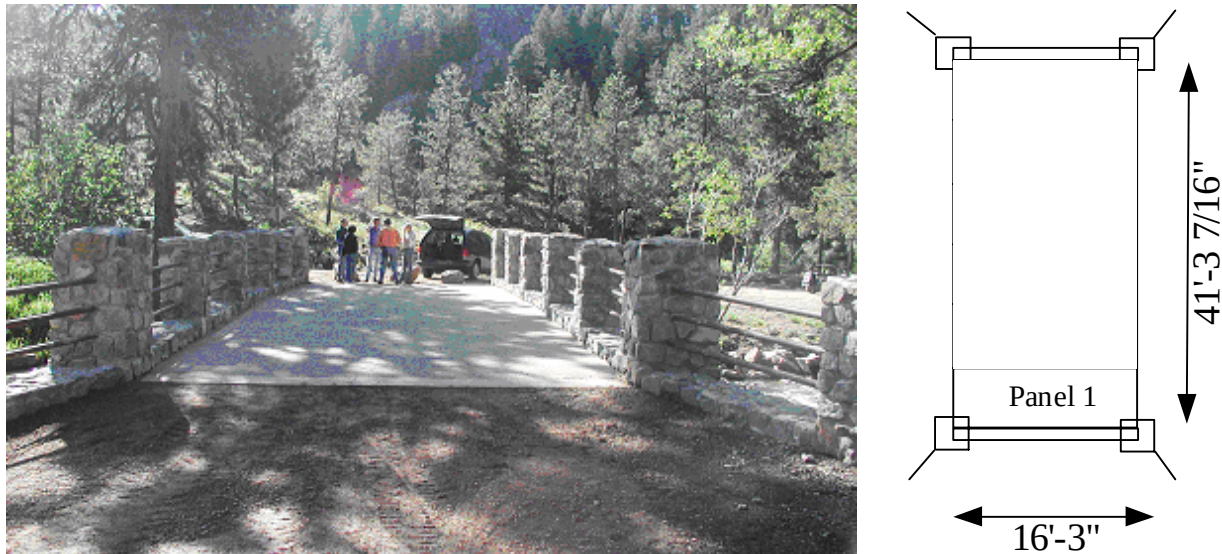
Figure 13. The bridge in O'Fallon Park, Denver, Colorado

1, 500, 000 pounds). Permanent fiber optic sensors were embedded into Panel 6 during the manufacturing of the panels. A plan view and the dimensions of the bridge are sketched in Figure 13. Design details can be seen in Reference 21.

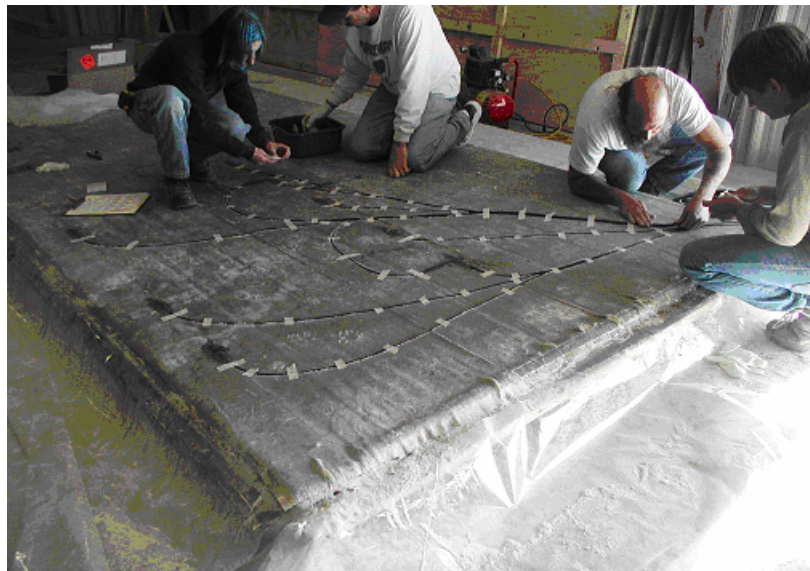
Figure 15. Installation of fiber optic sensors in the FRPH panel

A Fabry-Perot fiber optic strain sensor was chosen in the project. When a gage is bonded to a substrate, a strain variation in the axial direction of the strain gage will produce a variation of the cavity length, which can be converted into a numerical strain value. A total of twenty strain sensors were embedded at Panel 1 (seen in Figure 13) longitudinally and transversely so that various load effects could be observed, including dead loads, live loads, snow loads and wind loads. The gages were permanently installed as shown in Figure 15 so that long-term effects due to settlement and creep can also be monitored over time. The detail of placement of fiber optic sensors on the panel is shown in Figure 16.
