**Report No. CDOT-DTD-R-2003-10**

# **MAILBOXES AND MOUNTING SYSTEMS**

**COLORADO DEPARTMENT OF TRANSPORTATION  
RESEARCH BRANCH**

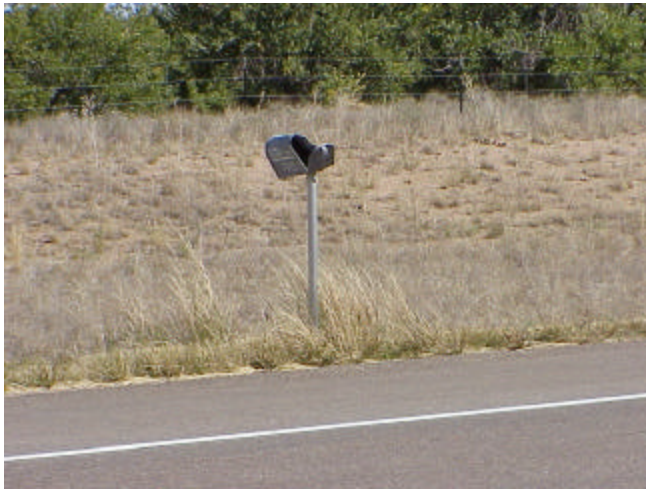
**Figure 1. Mailboxes mounted near high-speed highways are susceptible to damage from the blast of snowplow during the winter.**

A mailbox located next to a rural high-speed highway is in a harsh environment. During the winter, when snowplow clear the highway, the heavy, wet snow and ice in the blast from their blades can do considerable damage to the mailboxes, often bending them to the point that they become unusable (**Figure 1**).

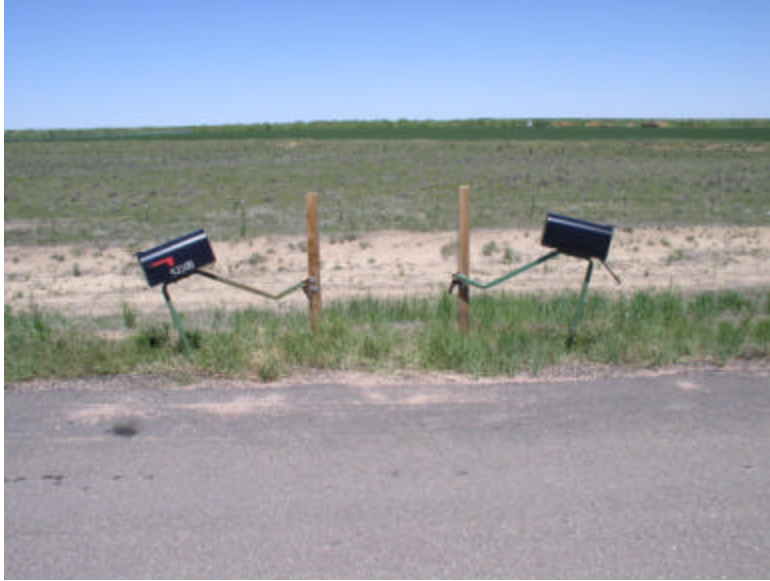
**Figure 3. The Roadside Safety Devices mounting system does not reliably return to the centered position.**

**The Roadside Safety Devices system** – Mailboxes mount to a long metal arm that attaches to a pivot bolted to a 4” x 4” wood post. This system is designed to allow the box and arm to swing away from the plow blast. The assembly should then re-center itself after the plow has passed. As the picture shows, the mailboxes were not damaged during the winter. However the system does not return the box to

the centered position reliably. Both of these boxes would be difficult for the mail carrier to reach.

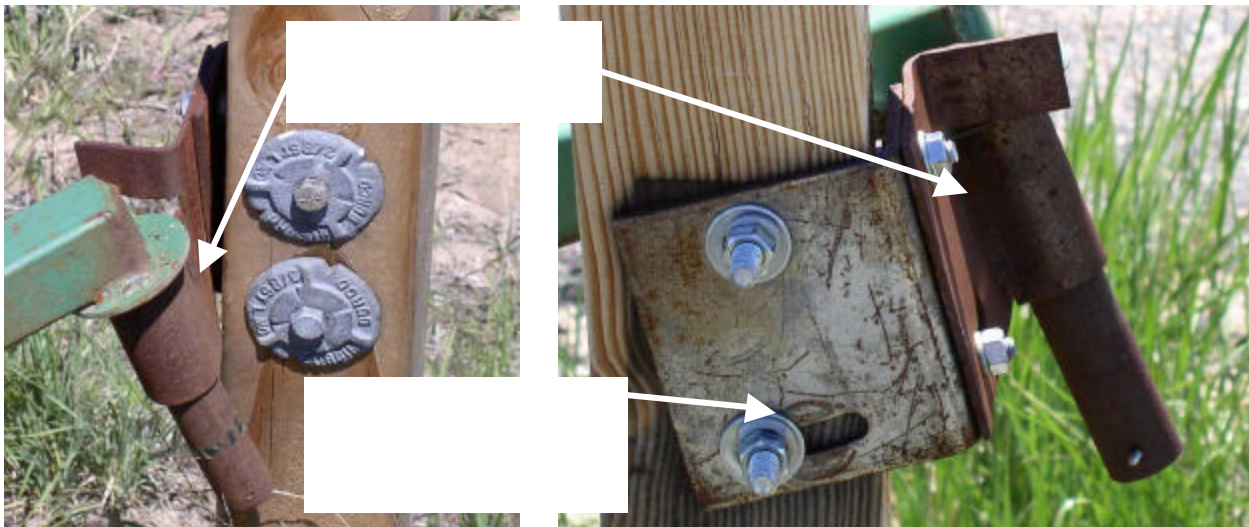
Close examination of the two-piece pivot mounts on the two boxes in **Figure 3** showed two

**Figure 4. Close-up pictures of the two mounts in Figure 3. Both brackets are bent. The bracket in the right picture has gone out of adjustment at the bolts facing the camera.**

problems with the system. The first is due to the fact that on both mounts in **Figures 3 and 4** there is some bending in the mounting bracket piece that holds the pivot sleeve. The bracket on the left post is bent so the pivot sleeve tilts to the left as viewed from the highway; the bracket on

the right is bent at the same point but so the pivot tilts to the right viewed from the highway. The bent bracket changes the angle of the pivot sleeve which changes the normal position of the pivot arm and the mailbox.

The second problem is with the adjustments to locate the normal position of the arm and box. Initial position adjustment of the system is done by setting the relative angles of the two-piece mounting brackets that bolt to the wood post. The adjustments, made by two pairs of bolts, set the initial positioning of the pivot sleeve so the arm returns to the centered position after it is pushed to the side. In the picture on the right of **Figure 4**, marks made on the bracket by the pair of bolts facing the camera show the initial position of the bracket and that the position has changed. Natural expansion and contraction of the wood post, due to changes in its moisture level as the weather changes, will make it nearly impossible to keep these two bolts tight enough to hold this adjustment. This system has the longest arm of the mountings evaluated. That long arm provides considerable leverage against the two adjustments held only by friction between the mount pieces and the wood post.

A wooden post in contact with the soil will expand and contract as its moisture content changes. For this reason, it is important that a mounting system that contains both metal and wood parts be designed so the adjustments of the system cannot be affected by dimensional changes in the wood parts. No amount of tightening will prevent bolts that clamp slotted adjustable metal parts to wood parts from loosening when the moisture content of the wood part drops and the wood shrinks.

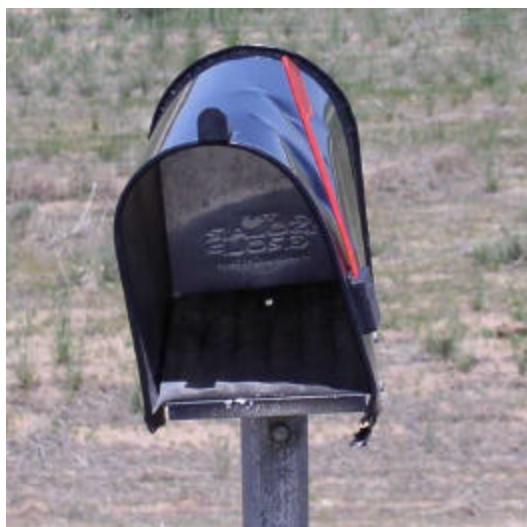
**Figure 6. Damaged metal boxes on rigid post mounts. The post on the left is set at the edge of the pavement, while the two on the right are set about 8' from the edge of the shoulder with a small gravel turn-out to allow close access to the boxes.**

**Figure 6** shows new metal boxes mounted on straight rigid posts. The post in the picture on the left is at the edge of the pavement. The box was replaced

last fall but, as the picture shows, did not stand up well to the winter. The two boxes in the right picture are set about eight feet from the edge of the pavement with a small gravel turn-out to allow mail carrier and homeowner access to them. The near box, while not as severely damaged as the one in the left picture, is slightly bent. Possibly the extra distance from the highway provided a measure of additional protection for these two boxes – the small one almost certainly provided some protection for the large one behind it.

Plastic mailboxes were able to withstand the battering better than the metal ones installed for this evaluation – especially on rigid mountings. Costs are very similar between metal and plastic boxes, so the added durability of the plastic boxes makes them more cost-effective in any location where the box is likely to be hit by plow blasts – even on the “self centering” systems, but especially on all types of rigid mounts. If specific needs require the use of a metal mailbox for some reason, it should be located somewhere away from the highway, such as on a driveway or a wide turn-out, if possible.
