**Report No. CDOT-DTD-R-2002-4**  
**Final Report**

# **Corrosion Effects of Magnesium Chloride and Sodium Chloride on Automobile Components**

**Prof. Yunping Xi and Zhaohui Xie**

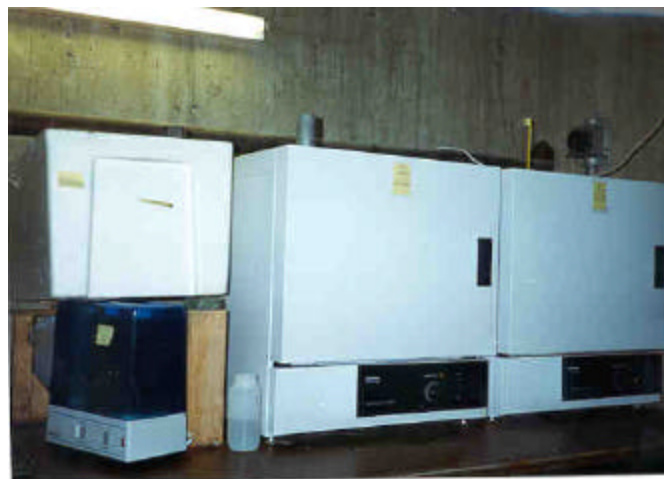
**Figure 3: Experimental setups.**

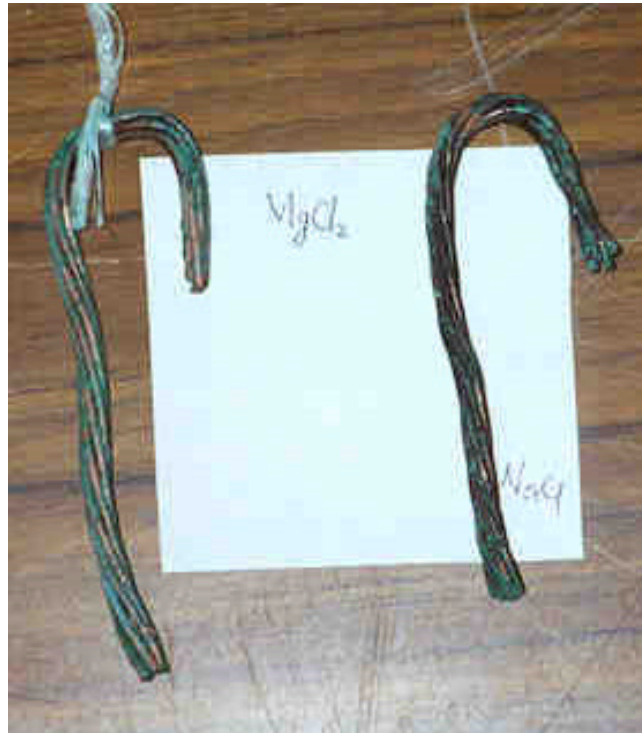
The corrosion tests for copper tubes by both SAE J2334, In the test, two different chloride solutions were used with the same concentration (3.0 wt.%). Different corrosion damages were observed. The corroded coupons are shown in Figures 14. The photo indicate that  $\text{MgCl}_2$  causes more severe corrosion to the copper specimens than  $\text{NaCl}$ . The coupons subjected to  $\text{MgCl}_2$  solution had more green rust ( $\text{CuO}$ ) on the corroded surface than that subjected to  $\text{NaCl}$  solution.

**Figure 14: Corroded copper wires after SAE J2334 testing**

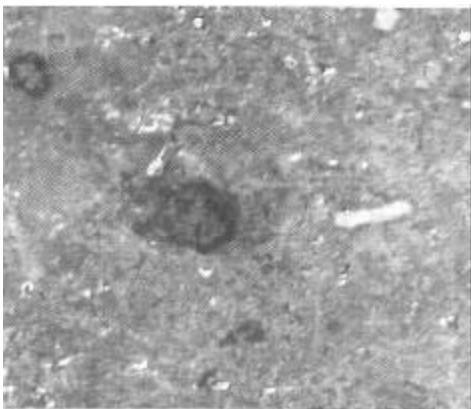
In order to understand and further explain some of the test results, chemical and microscopic analyses were performed. Figure 16a through Figure 16h are the microscope photographs of the corroded coupons subjected to the cyclic exposure corrosion test. It can be seen that regardless of the corrosion medium used, the same morphological feature of the corrosion products is observed for the same metal. Different amounts of the corrosion products can be seen for different metals under attacks by different chlorides. All corrosion products are in amorphous or glass states.

**Figures 16: Microscope photographs of the corroded coupons subjected to the cyclic exposure corrosion test**

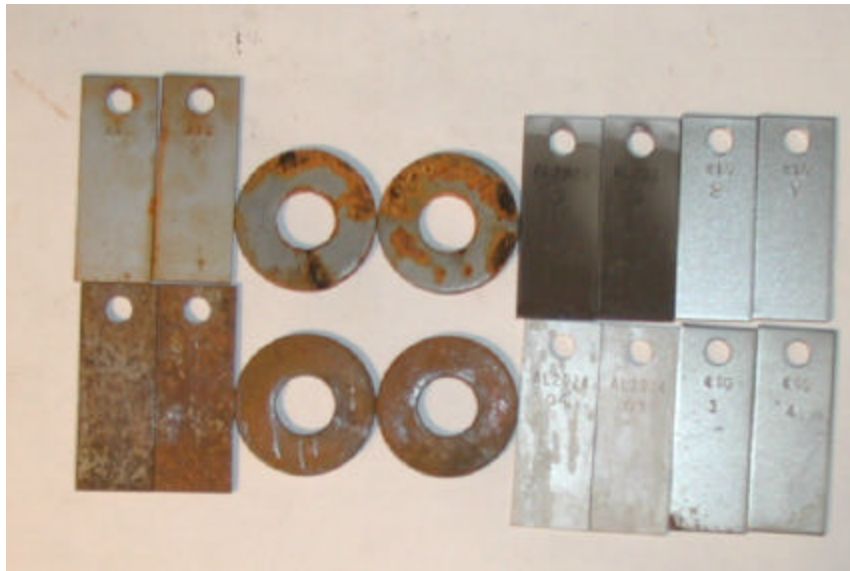
The NACE test with distilled water was started from July 22, 2001. The testing period of the NACE test was extended significantly to compare with the testing period of the SAE test. After 109 days, the NACE test was stopped and the corrosion rate was measured. The calculated corrosion rates for the two tests are shown in Fig. 2-9. Comparing the SAE test to the NACE test with distilled water, it is evidenced that the SAE test had resulted in one to two times higher degrees of corrosion to the washers and A36 coupons. This suggests that the SAE test provides a much more aggressive testing environment than the NACE method, which may be due to the elevated temperature or high humidity, or the combination of the two. The appearance of the coupons before cleaning is shown in Fig. 2-10.

**Fig. 2-10 Coupons exposed to distilled water**  
(Upper: from the NACE test of 109 days, lower: from the SAE test of 81 days)

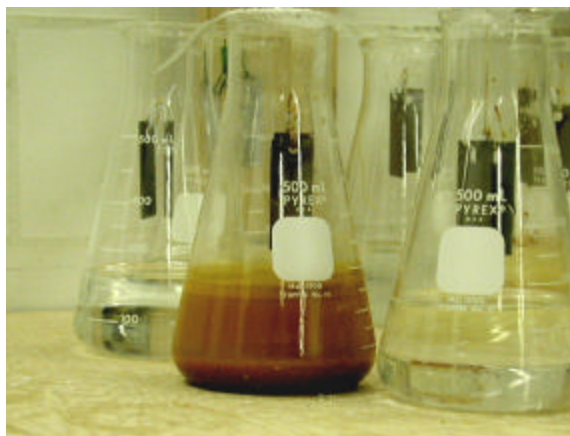
**Fig. 2-11a. The NaCl solution in the NACE test (at 69 days)**

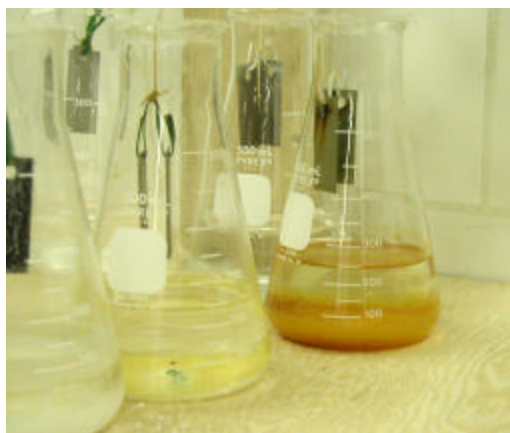
**Fig.2-11b The  $MgCl_2$  solution in the NACE test ( at 69 days)**

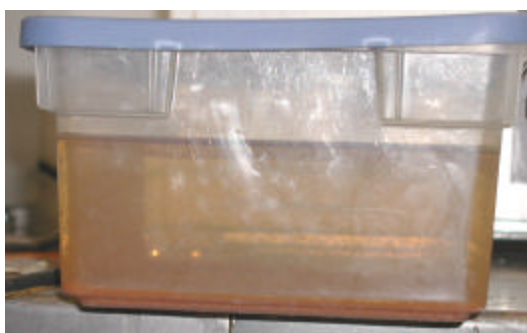
**Fig. 2-13a The 3 wt.%  $\text{MgCl}_2$  solution used in the SAE test after 20 days**

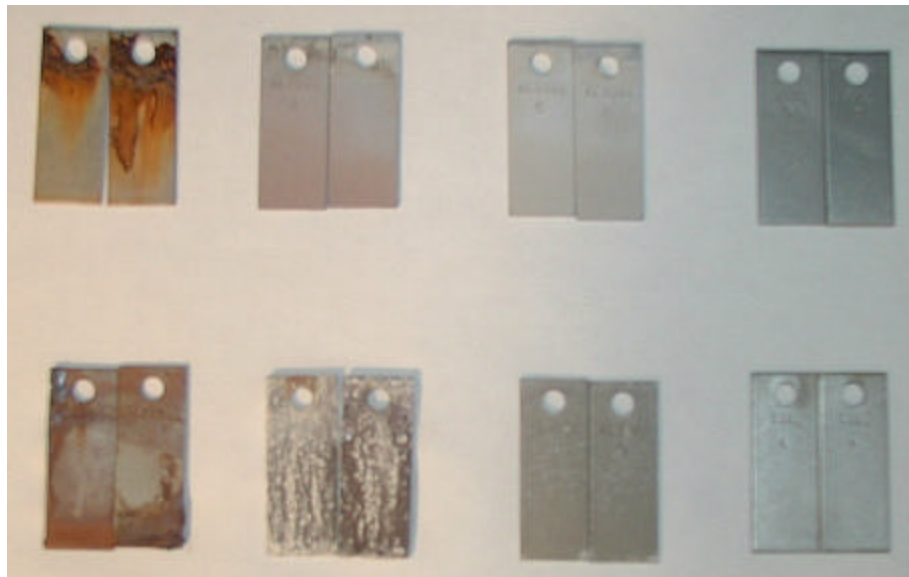
**Fig. 2-16 Coupons after the NACE test**

(Upper: exposed to the MgCl<sub>2</sub> solution, lower: exposed to the NaCl solution)

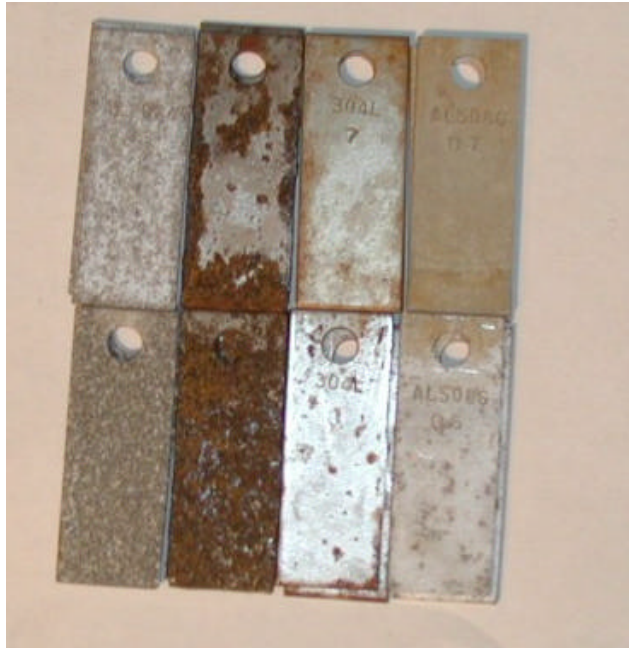
**Fig.2-17 Coupons after the SAE test**  
(Upper: exposed to the NaCl solution, lower: exposed to the  $\text{MgCl}_2$  solution)
