1. Title and Subtitle  
**Trip Generation Rates for Various Sites**
2. Author(s)  
Ruijie “Rebecca” Bian, Ph.D., P.E.;  
Peter R. Stopher, Ph.D.; Hany Hassan,  
Ph.D., P.E.; Abdualлах Bayomi, MSc.

5. Report No.  
**FHWA/LA.26/725**
6. Report Date  
July 2026
7. Performing Organization Code  
LTRC Project Number: 24-2SS  
SIO Number: DOTLT1000509
8. Type of Report and Period Covered  
Final Report  
January 2024 to March 2026

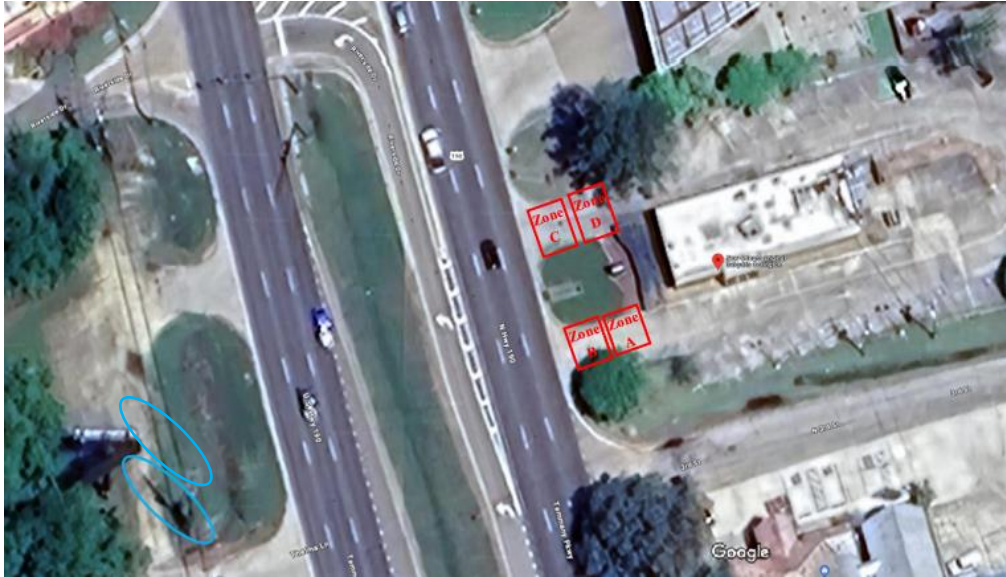
**Figure 4. Detail of New Orleans Original Daiquiris, North Hwy 190, Covington**

This business is located at 2700 North Highway US 190 in Covington. This location is somewhat challenging. The only utility pole that is usable for the micro-radar device is on the west side of US 190, as shown in Figure 4 by the blue circle. This pole is 232 feet from the entrance driveway and 251 feet from the exit driveway.

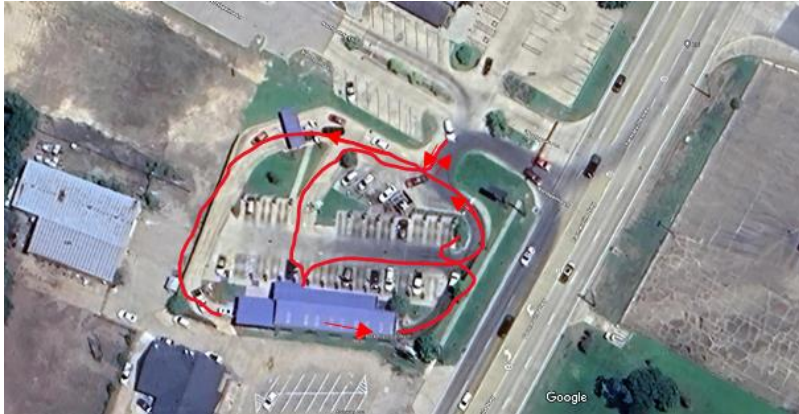
Figure 6. Detailed view of Rocketfast Car Wash, Ruston

Two cameras were used to record video for this location. Counts were made from both videos. Most of the counts from the two cameras are identical or differ by only one vehicle. These discrepancies arose partly because of vehicle obstructions at certain times and partly because it is unclear whether the two cameras were fully synchronized.

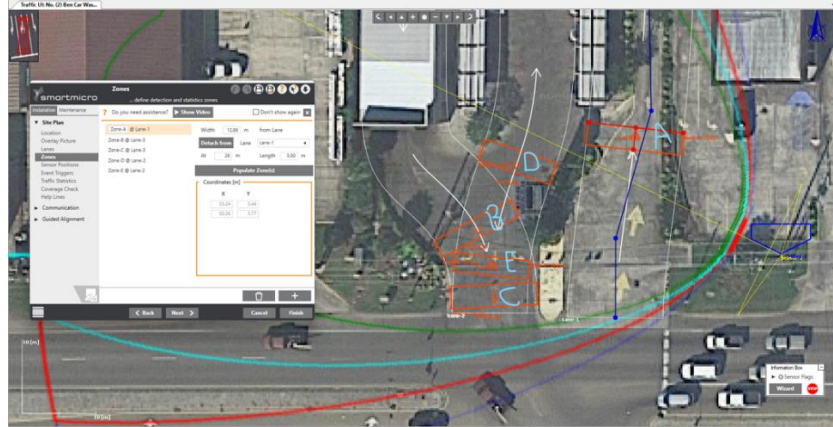
**Figure 55. Counting locations for the oblique positioning of the radar device at the car wash site, July 11-14, 2024**

The second location involved mounting the radar at an oblique angle to the car wash driveways. The counting zone locations are shown in Figure 55. This test was done to determine whether an oblique position of the radar device would work, because there were sites for the main survey where no pole was available opposite the areas where counts are needed.

The results of this test are provided in Table 70. Again, radar counts are provided for both counting Zones B and C. Overall, the results of this test show that the radar detected vehicles entering through counting Zone A, although the counts tended to be overestimated compared with the head-on position. However, the exiting counts were severely underestimated. This shows that the oblique position did not work very well as configured. It is possible to improve these results by changing the geometry of the counting zones so that their length is much greater perpendicular to the radar view, providing the radar with more time to detect the vehicles.

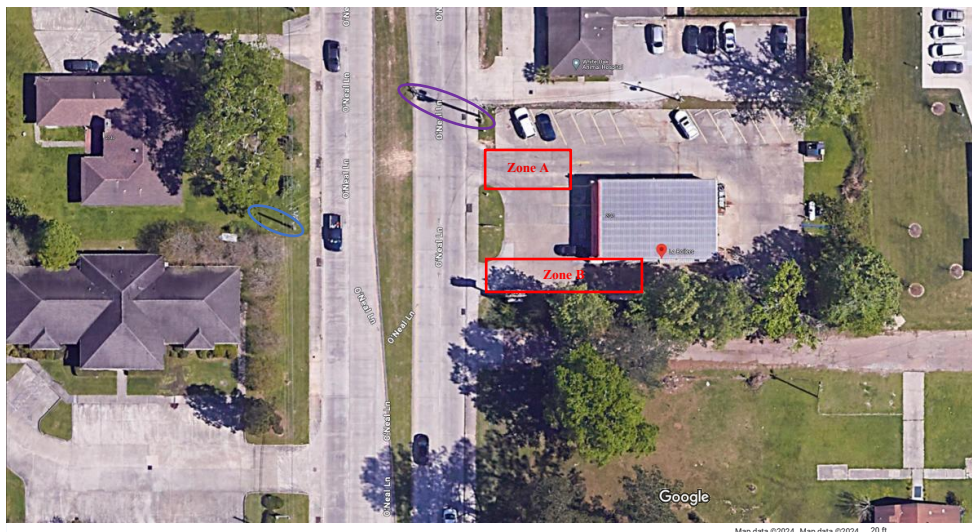
The measurement zones are shown as red rectangles, labeled Zone A and Zone B. These should be adequate to measure vehicles using the drive-thru and those parking in front of the site.

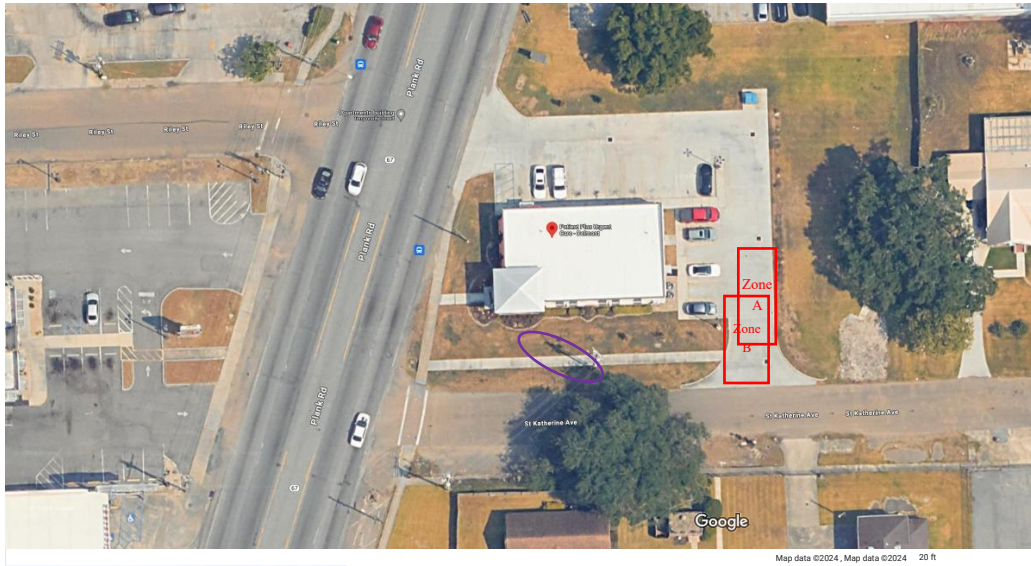
**Figure 60. Second device location for Delmont Patient Plus Urgent Care, Baton Rouge**

The second location would be the utility pole at the corner of St. Katherine Avenue. This is approximately 173 feet from the St. Katherine Avenue entrance and exit. The measurement zones for the St. Katherine Avenue entrance and exit would need to be configured as shown in Figure 60. The video camera would be located as shown in Figure 60. This is a somewhat oblique location, necessitated by the lack of utility poles along the south side of St. Katherine Avenue. The only other possibility would be to set the radar device on the same pole as the video camera, but this is even more oblique.

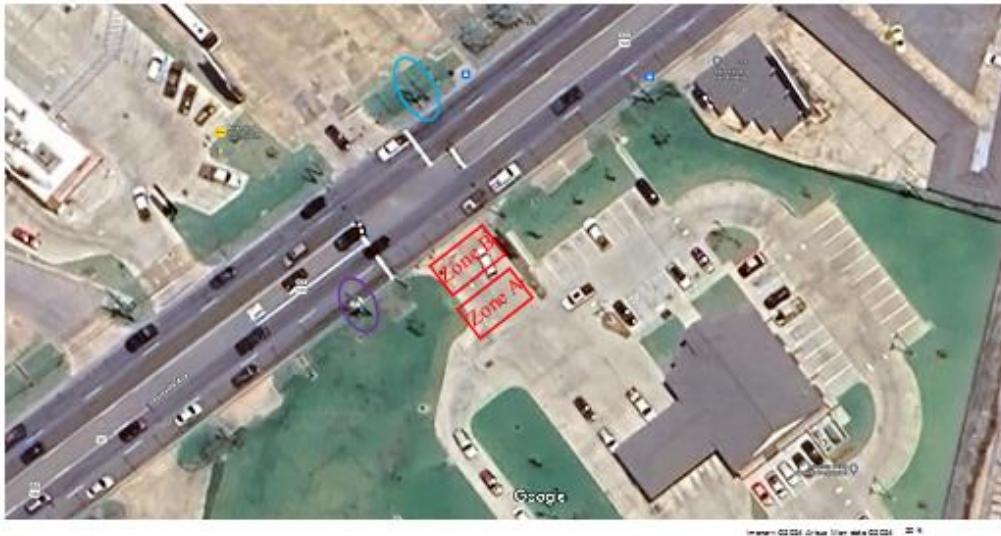
**Figure 61. US 80/US BUS 165/Louisville Avenue entrance to Ouachita Valley Federal Credit Union, Monroe**

For the first location on Louisville Avenue, the best location for the radar device is on the traffic light pole across the road from the main entrance, shown in Figure 61. This pole is approximately 80 feet from the center of the driveway. The video camera should be mounted on the traffic light pole to the south of the driveway, circled in purple in Figure 61. One video camera should be sufficient.

The counting zones should be set up as shown in Figure 61, with Zone A for entering vehicles and Zone B for exiting vehicles.

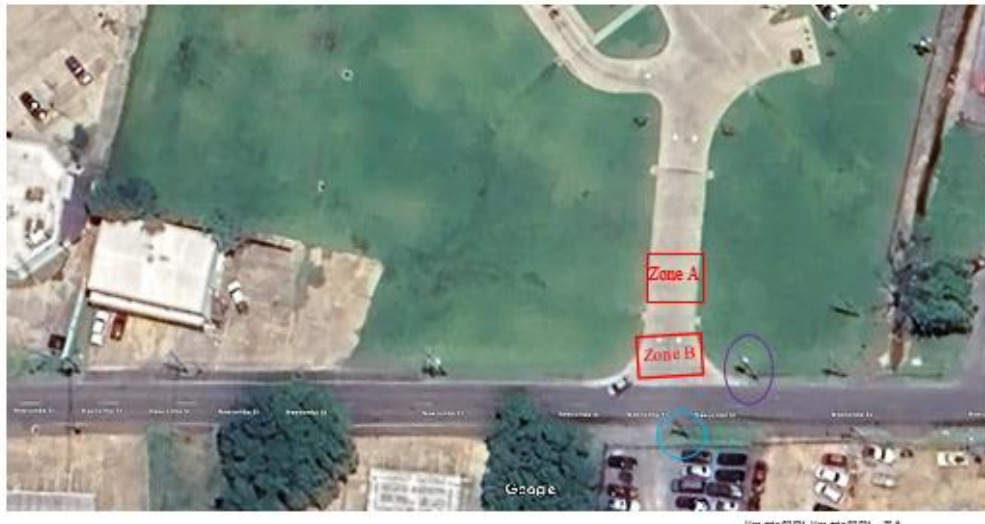
**Figure 62. Newcombe Street entrance to Ouachita Valley Federal Credit Union, Monroe**

For the Newcombe Street location, there is a utility pole that is ideally located right across from the entrance to the credit union, as shown in Figure 62. The SMATS radar should be mounted on the utility pole on the opposite side of Newcombe Street, as shown circled in blue. This is 34 feet from the entrance. This utility pole appears to be covered with a creeper, and some work may be required to cut away some of the vine to allow attachment of the radar device. The counting zones should be set up as shown, with Zone A being the entering traffic and Zone B being the exiting traffic. The video camera should be located on the utility pole circled in purple. It is located just 32 feet from the center of the entrance.

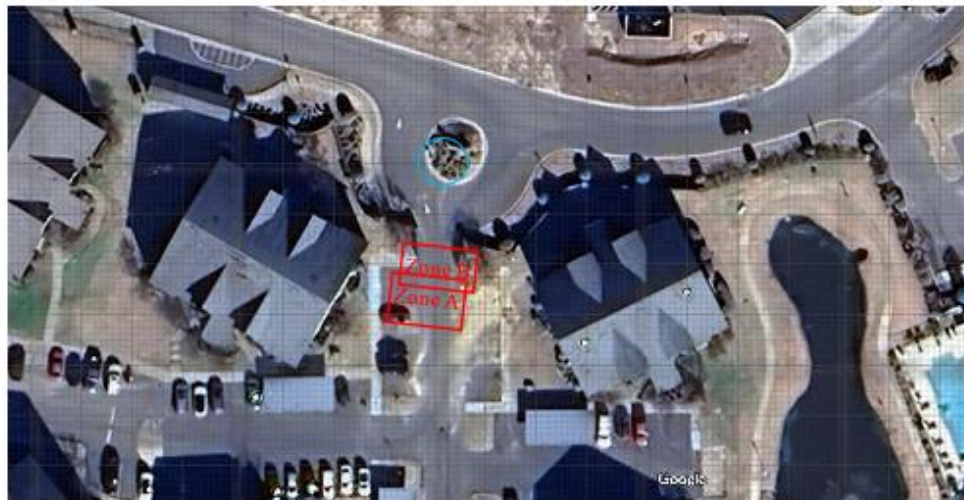
**Figure 65. Ashford Drive entrance to Ashford Place apartment complex, West Monroe**

The counting zones should be set up as shown in Figure 65.

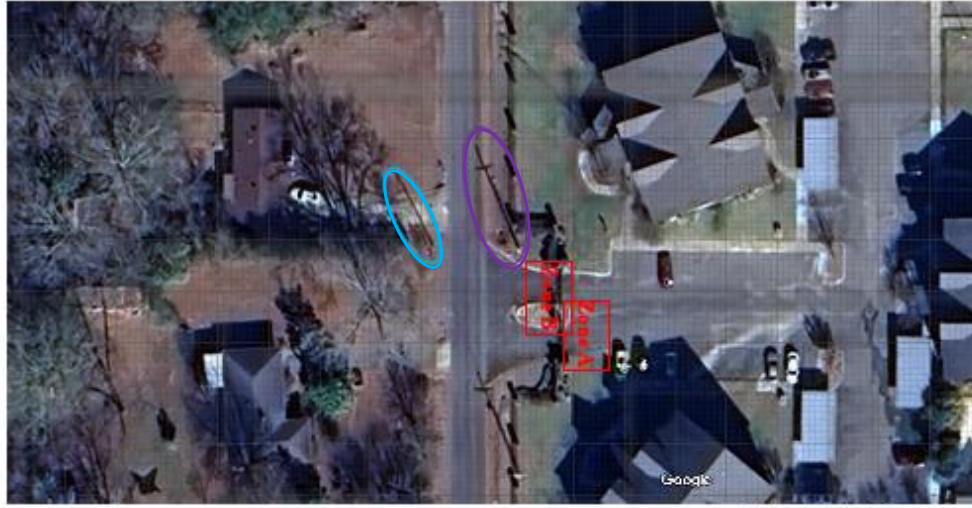
**Figure 66. Netherlands Street entrance to Ashford Place apartment complex, West Monroe**

At the Netherlands Street location, a utility pole is ideally located directly across from the entrance to the Ashford Place apartment complex, as shown in Figure 66. The SMATS radar should be mounted on the utility pole on the opposite side of Netherlands Street, as shown circled in blue. This is 64 feet from the entrance. The counting zones should be set up as shown,

with Zone A for entering traffic and Zone B for exiting traffic. The video camera should be located on the utility pole circled in purple. It is located just 32 feet from the center of the entrance.

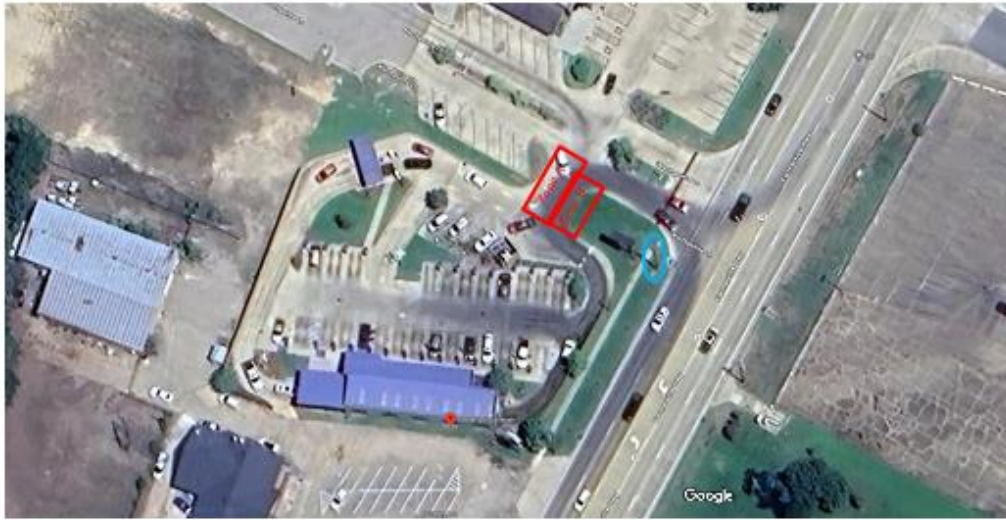
The counting zones are shown in red. Zone A is for incoming vehicles and needs to intercept vehicles going into the pre-wash bays and those bypassing them and entering directly into the payment booths. Zone B is for exiting vehicles and needs to be positioned so that it does not count entering vehicles. It should be noted that both entering and exiting vehicles will be traveling away from the radar. No vehicles will be traveling towards the radar. The distance from the utility pole to the center of the driveway is 83 feet. Zone B will be somewhat closer than this, and the center of Zone A will be slightly further away.

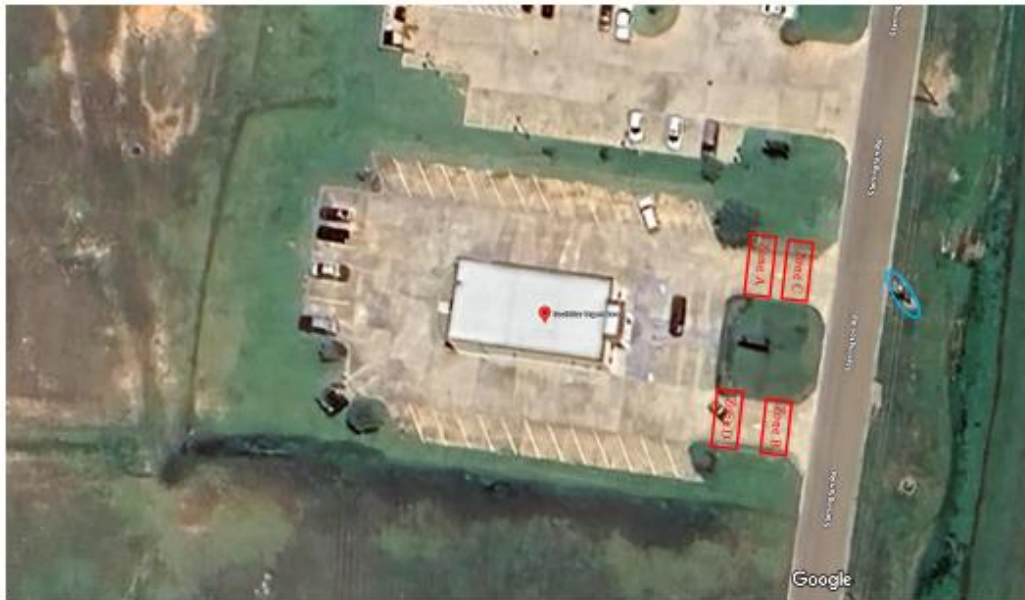
The counting zones are shown in red. Zone A is for entering traffic in the entrance driveway, and Zone D is for traffic entering the exit driveway. Similarly, Zone B is for exiting traffic in the exit driveway, while Zone C is for traffic exiting from the entrance driveway. The utility pole is located 58 feet from the entrance driveway and 88 feet from the exit driveway. The position for the CountCam4 is not ideal, as it will be looking head on at entering traffic and at an angle for exiting traffic. However, there are no alternative poles on the west side of Sterlington Road, which would have been ideal.

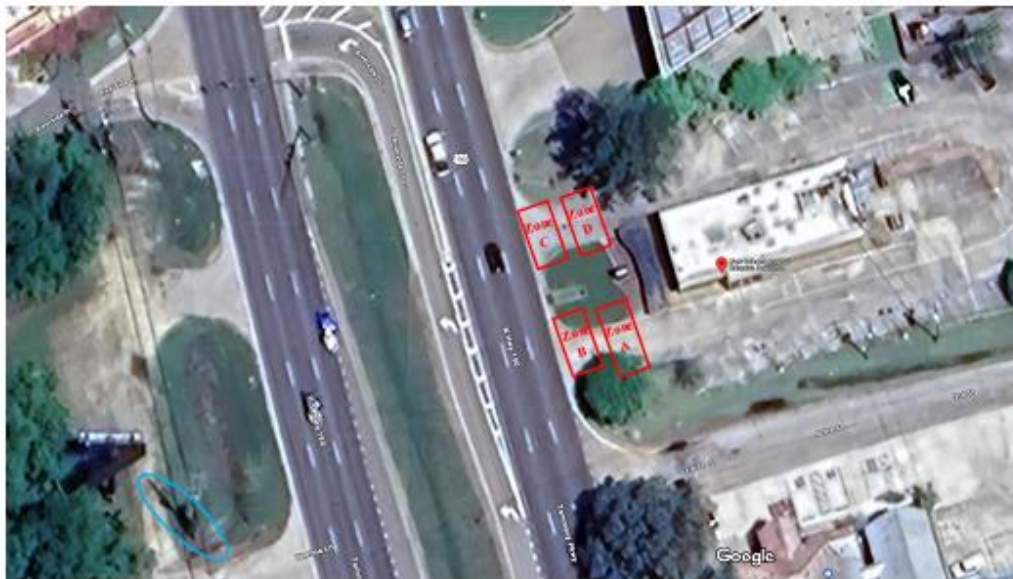
The counting zones are shown in red. Zones A and D are for entering vehicles, and Zones B and C are for exiting vehicles. There are no directional markers; therefore, we must assume that vehicles will enter and exit both driveways.

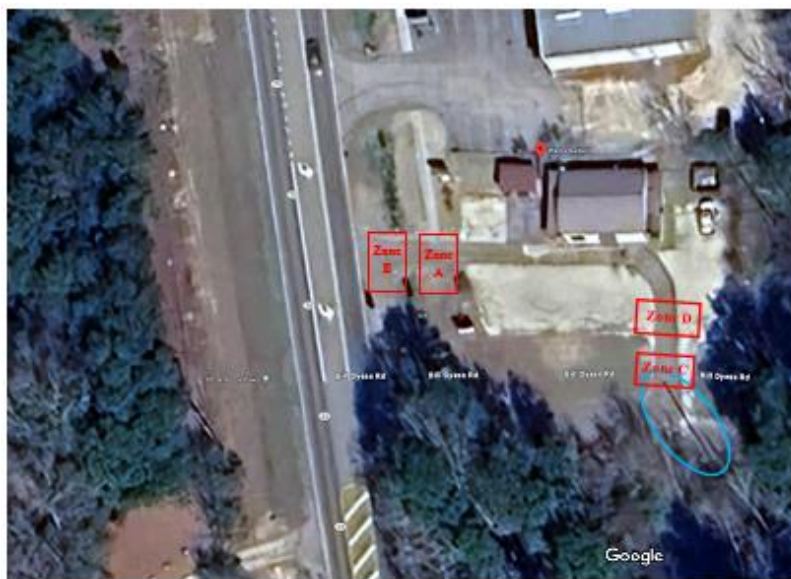
Figure 71. Wacky Daiquiri, Folsom

This site is located on the corner of LA 25 and Bill Dyess Road in Folsom. There are entrances/exits on both LA 25 and Bill Dyess Road. The available utility poles are not well-positioned for this site. The best pole, which is difficult to see in the Google Maps view, is located on the back boundary of the property. This is circled in blue in Figure 71. The counting Zones are shown in red in Figure 71. Zones B and C are for exiting traffic, and Zones A and D are for entering traffic. Zones C and D may present some difficulty because of the angle from the utility pole.

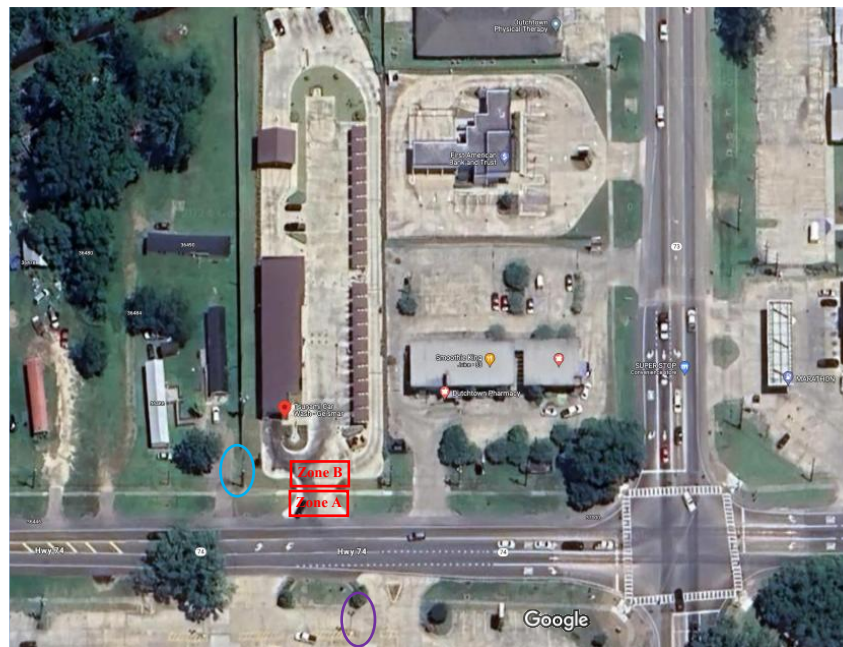
**Figure 73. Tsunami Carwash, Geismar**

Tsunami Carwash is located on LA 74 in Geismar. It has a single entrance and exit, but the location of utility poles for use in measuring these are problematic. The only suitable one appears to be the one marked in a blue circle in Figure 73, because this has a better angle of view than the poles along LA 74. The counting zones are marked as Zone A for entering vehicles and Zone B for exiting vehicles. Zone B needs to be located far enough towards LA 74 to avoid counting vehicles that exit from the carwash building and make a U-turn into the vacuum bays. The utility pole circled in purple would be the best place to locate the video camera so that it can record vehicles entering and exiting the carwash. Monitoring of this site should be from 6:30 a.m. until 7:30 p.m. on weekdays only. Monitoring should commence at noon on Wednesday, October 2, and continue until Friday, October 4, at 7:30 p.m, then resume at 6:30 a.m. on Monday, October 7, and continue until noon on Wednesday, October 9.

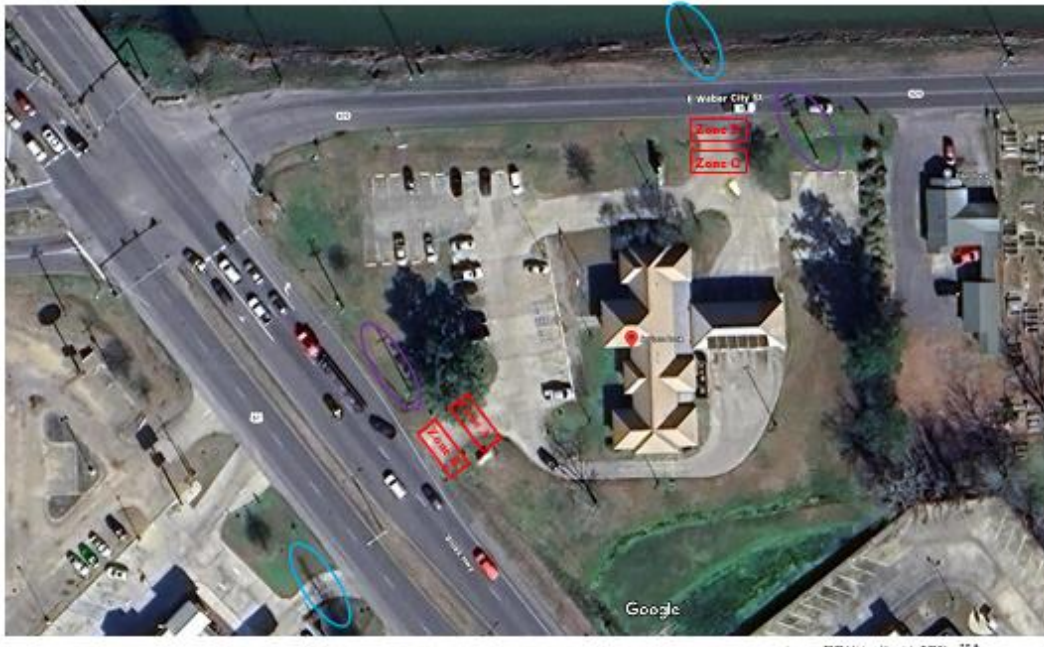
**Figure 74. Regions Bank, Gonzales**

This is a large site on the corner of US 61 (Blues Highway/Airline Highway) and LA 429 (East Weber City Road). There are two entrances/exits, one on each of these major highways. The site is shown in Figure 74. This site requires two SMATS radar devices and two CountCAM4s. There are utility poles and light standards conveniently located for these.

For the entrance/exit off US 61, the best location for the SMATS radar is on the light standard in the median strip opposite the entrance/exit, as marked in the blue circle. This is located 73 feet from the middle of the driveway to the bank. The suggested counting zones are indicated in red and marked as Zone A (entry) and Zone B (exit). The CountCAM4 camera for this driveway should be located on the utility pole to the northwest of the driveway, circled in purple. This is located 30 feet from the center of the driveway.

For the entrance/exit off LA 429, the best location for the SMATS radar is the utility pole that is almost opposite the driveway, also circled in light blue. This is located 58 feet from the center of the driveway. The counting zones are shown in red and marked Zone C (entry) and Zone D (exit). It should be noted that some vehicles may exit the drive-thru windows and turn left at the island to either park in the parking areas to the west of the site or exit to US 61. These vehicles should not be counted at this location. The utility pole circled in purple to the east of this driveway would be ideal for locating the CountCAM4. This pole is 66 feet from the center of the driveway.

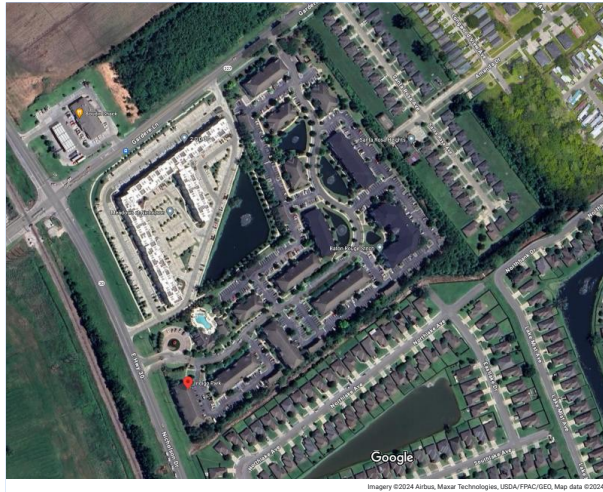
**Figure 75. Indigo Park Apartment Complex, Baton Rouge**

This apartment complex is located near the corner of Gardere Lane and Nicholson Drive, although another apartment complex is actually on the corner. There are two entrances/exits to this complex, one on Nicholson Drive and one on Gardere Lane. The main entrance/exit is the one on Nicholson. The complex is shown in Figure 75.

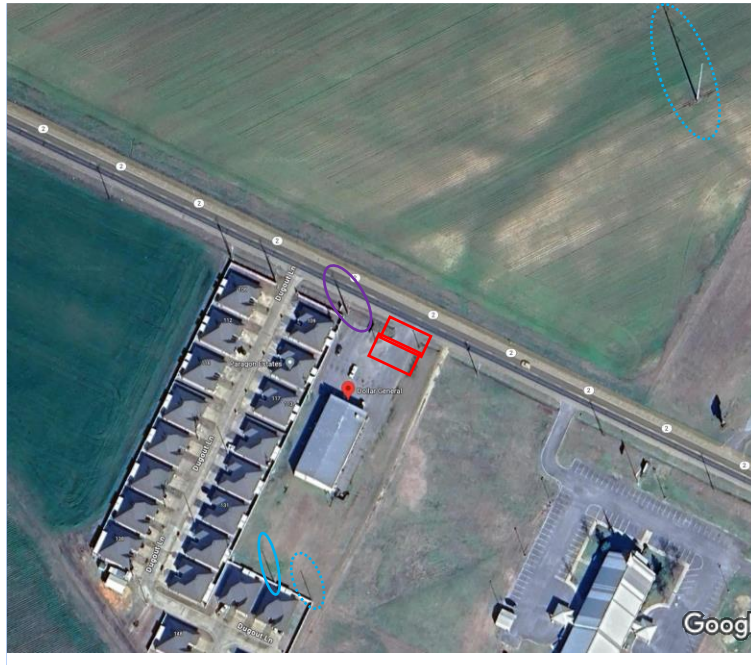
**Figure 78. Dollar General, Sterlington**

Dollar General is located on the south side of LA 2 in Sterlington. This site does not have utility poles in good locations. There are three potential locations to mount cameras, as shown in Figure 78. The preferred pole is shown with a solid blue line and is 180 feet from the center of the entrance/exit driveway, while the two alternative locations are shown with a dotted blue line.

The two red boxes are the counting zones: the one closest to LA 2 for exiting vehicles, and the one nearest the store for entering vehicles, assuming we are using the utility pole in the solid circle.

The utility pole circled in purple would be best for the CountCAM4 installation, where the camera would be aimed across the driveway. This is 91 feet from the center of the driveway.

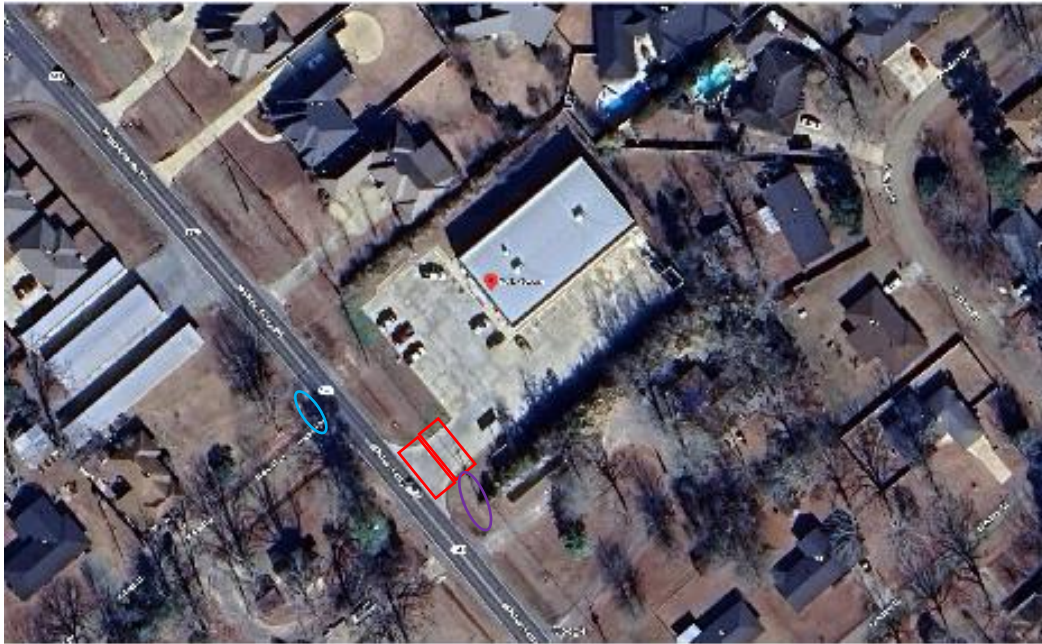
The utility pole circled in purple would be the best location for the video camera to be installed. This pole is 47 feet from the center of the driveway, so it should provide a good location for the manual counts.

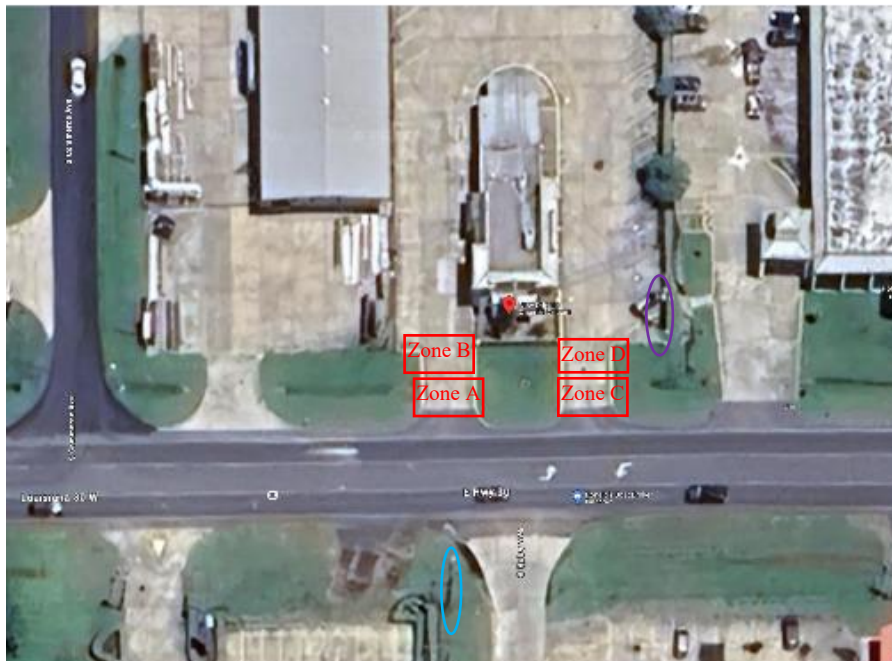
Figure 80. New Orleans Original Daiquiri, Gonzales

This site is located on LA 30 West in Gonzales, near the I-10 and LA 30 interchange. The site has two adjacent driveways that are not marked as in or out, but are presumably available for both maneuvers. This will require four count zones. The site is shown in Figure 80.

There is a utility pole across LA 30 from the site that should work for the SMATS radar. It is circled in blue on Figure 80. It is 127 feet from the east driveway and 110 feet from the west driveway. The counting zones are shown in red for entering and exiting traffic. Zones A and C are for exiting traffic, and Zones B and D are for entering traffic.

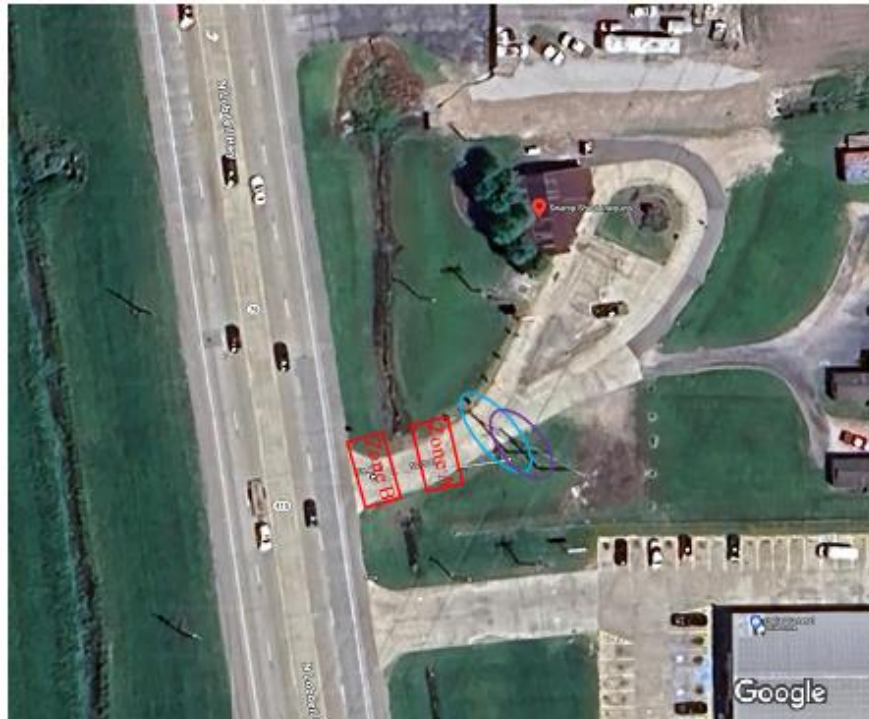
**Figure 81. Swamp Shack Daiquiris, Port Allen**

This site is located on LA 76 at LA 415 in Port Allen. It has a single entrance, as shown in Figure 81. The best utility pole to use for mounting the SMATS radar is the one circled in blue. As shown, this is 80 feet from the entrance to the daiquiri shop. The counting zones are shown in red. Zone A is for entering traffic, and Zone B is for exiting traffic.

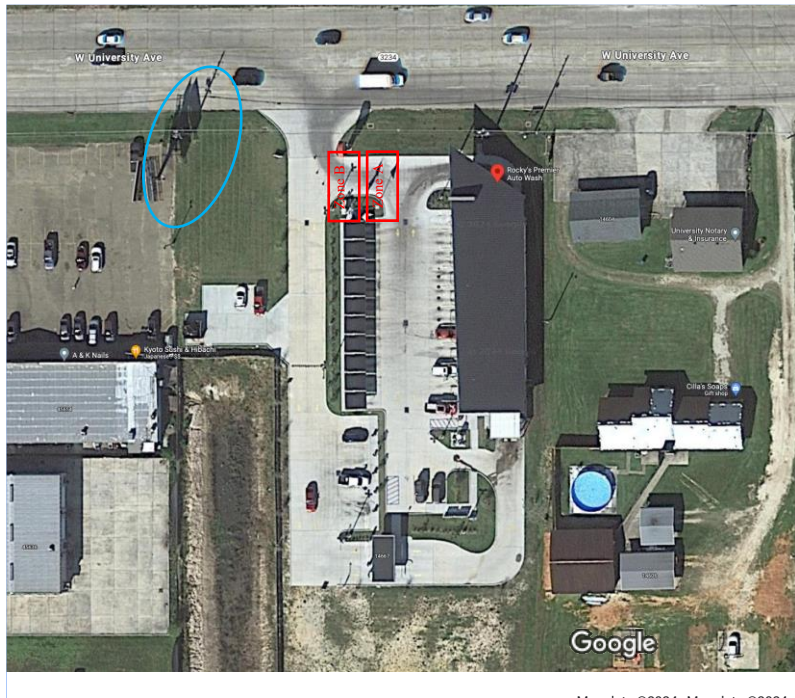
**Figure 82. Rocky's Premier Auto Wash, Hammond**

This site is located on West University Avenue in Hammond. It has a single driveway entrance and exit, as shown in Figure 82. The best location for the radar device is on the utility pole circled in light blue. The counting zones are shown in red in Figure 82. The utility pole is 102 feet from the middle of the driveway. Zone A is for entering vehicles, and Zone B is for exiting vehicles. The CountCAM4 camera should be co-located with the radar device.

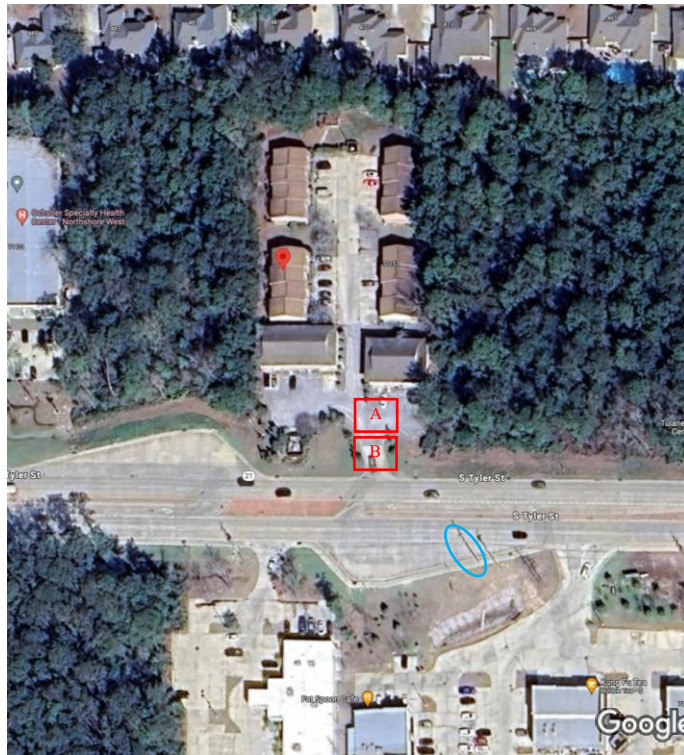
**Figure 83. Acadian Village Apartment Complex, Covington**

This apartment complex is located at 71153 LA 21 in Covington. It has a single entrance/exit, as shown in Figure 83. The utility pole circled in pale blue is the best location for the radar. It is 170 feet from the driveway. The red boxes, A (entering traffic) and B (exiting traffic), are the counting locations. The camera should be co-located with the radar device.

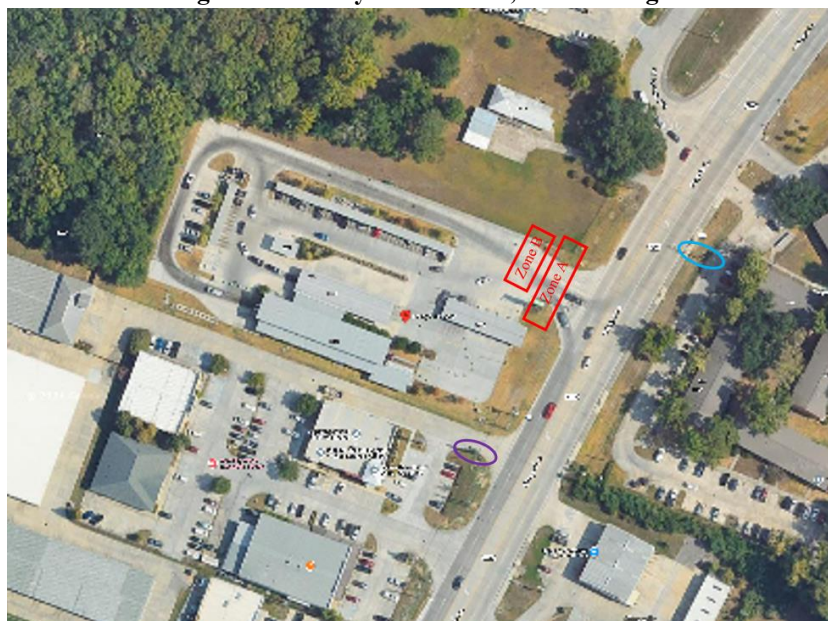
**Figure 85. Benny's Car Wash, Baton Rouge**

This site is located on Siegen Lane in Baton Rouge. The site has a single driveway from Siegen Lane, and no other land use is served by it, as shown in Figure 85. There is a utility pole that is convenient for this driveway and is circled in light blue. It is 148 feet from the middle of the driveway. The counting zones for this driveway are shown as Zone A for exiting traffic and Zone B for entering traffic.

The CountCAM4 video camera should be located on the utility pole circled in purple. This utility pole is 135 feet from the center of the driveway. It is closer to the pole that is to the north of the driveway.

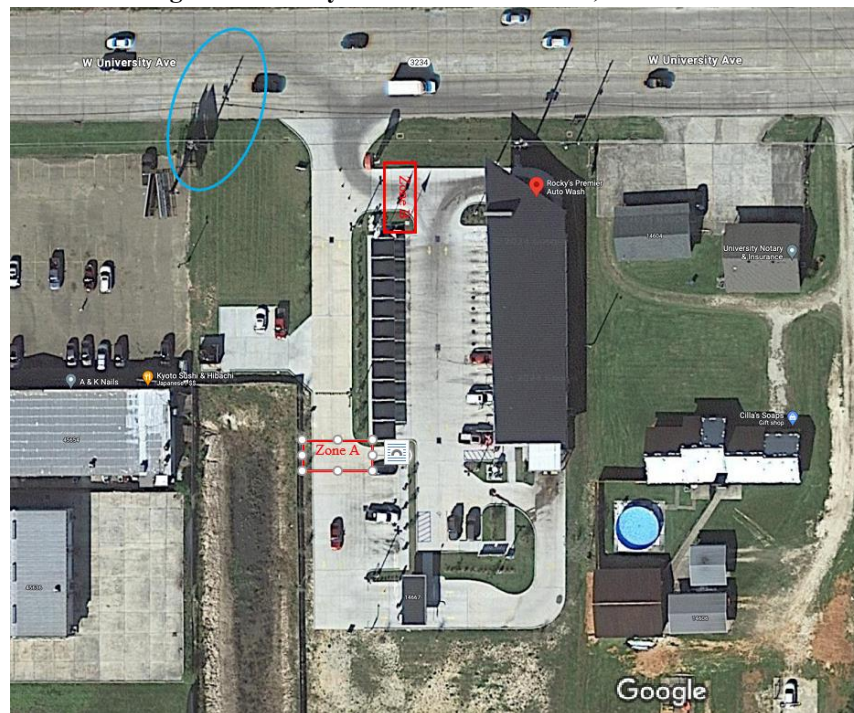
**Figure 86. Rocky's Premier Auto Wash, Hammond**

This site is located on West University Avenue in Hammond. It has a single driveway entrance and exit, as shown in Figure 86. The best location for the radar device is on the utility pole circled in light blue. The counting zones are shown in red in Figure 86. The utility pole is 102 feet from the middle of the driveway. Zone A is for entering vehicles, and Zone B is for exiting vehicles. The CountCAM4 camera should be co-located with the radar device.

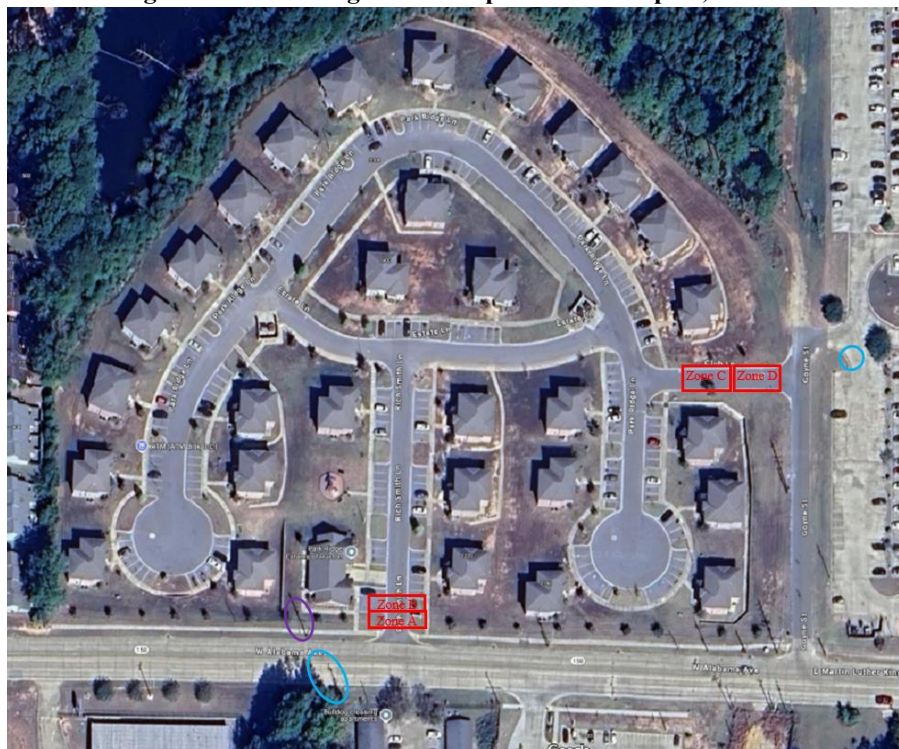
There is a utility pole that could be used for the West Alabama Avenue driveway on the opposite side of the road from the driveway, circled in light blue at the bottom of the picture. It is 108 feet from the middle of the driveway. The counting zones for this driveway are shown in red. The closest one should be for entering traffic, and the further one for exiting traffic. This radar should be mounted at six meters due to potential traffic on West Alabama Avenue. The second radar, if needed, will need to be on the LTRC trailer, where the blue circle is shown on the right of the picture. It is 90 feet from the driveway and should be mounted at three meters. The two counting zones are shown for entering and exiting traffic.

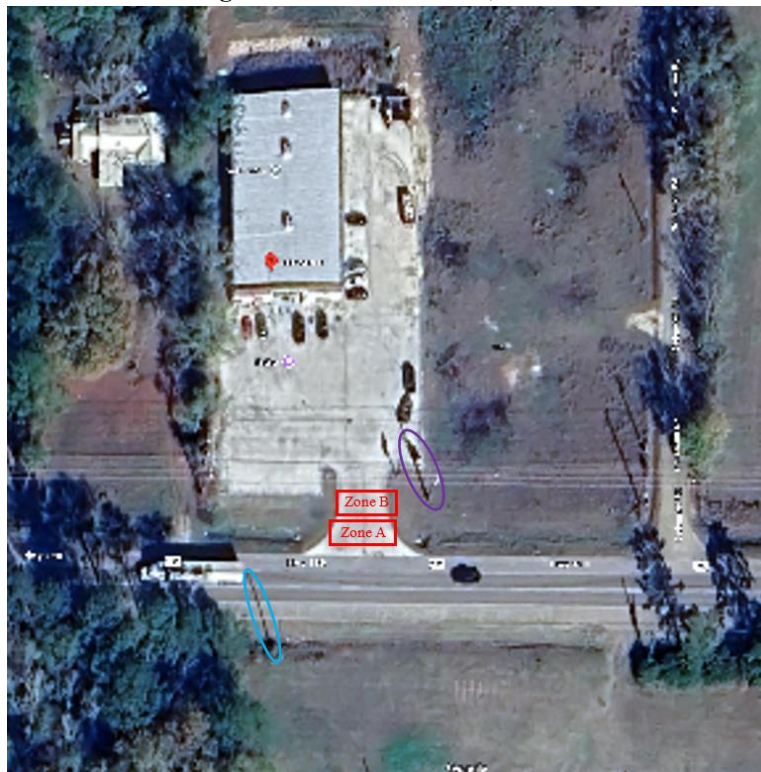
**Figure 88. Dollar General, Robert**

This site is located on US 190 in Robert, as shown in Figure 88. There is a single driveway, and there is nothing near the site that should complicate its measurement. US 190 is a two-lane road at this location and should not have a high volume of traffic.

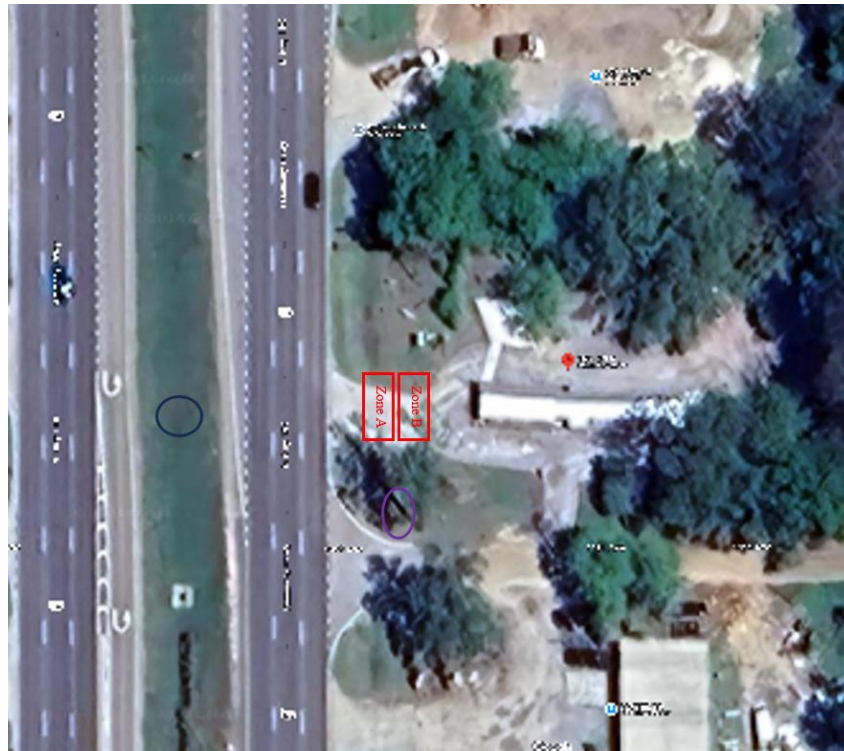
**Figure 89. Bayou Boil N Geaux, Covington**

This site is located on US 190 in Covington. It has a single driveway entrance and exit, as shown in Figure 89. The best location for the radar device is on the LTRC trailer, located where the dark blue circle is shown on the median of US 190. This will put the radar approximately 73 feet from the driveway. Mounting as high as possible on the trailer is best, because the traffic on US 190 may be quite heavy. Zone A is for entering vehicles, and Zone B is for exiting vehicles. The CountCAM4 camera should be located on the light/utility pole circled in purple. This is approximately 28 feet from the middle of the driveway.

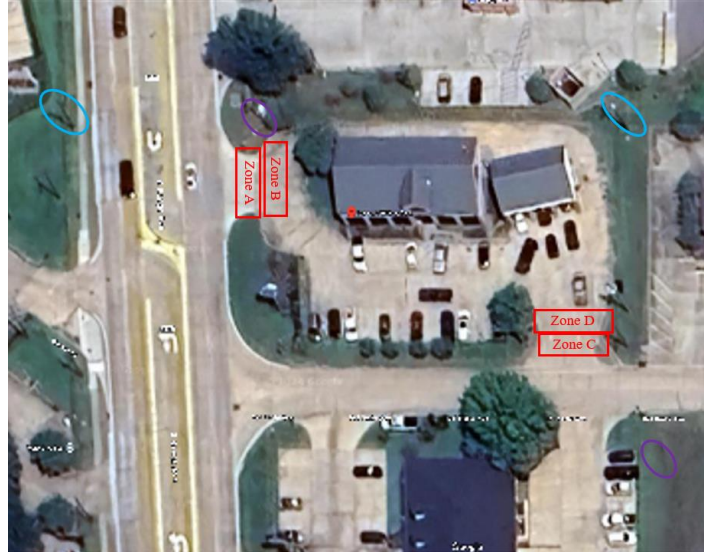
Figure 90. Hancock Whitney Bank, Denham Springs

This site is located on South Range Avenue in Denham Springs. The site has two entrances, one from South Range Avenue and one from Del Norte Avenue, as shown in Figure 90.

There is a utility pole that could be used for the Range Avenue entrance on the opposite side of the road from the driveway, circled in light blue on the left of the picture. It is 97 feet from the middle of the driveway. The counting zones for this driveway are shown as Zone A for exiting traffic and Zone B for entering traffic. This radar should be mounted at six meters due to traffic on Range Avenue. The second radar should be mounted on the utility pole at the rear of the bank, facing the Del Norte Avenue entrance. It is 120 feet from the driveway and should be mounted at three meters. Zone D should be for entering traffic and Zone C for exiting traffic.

Two CountCAM4 cameras are required for this site. One should be mounted on the utility pole just north of the driveway from South Range Avenue, circled in purple. The second should be on the utility pole to the east of the Del Norte Avenue driveway, also circled in purple. The cameras are 34 and 33 feet from the centers of their respective driveways.

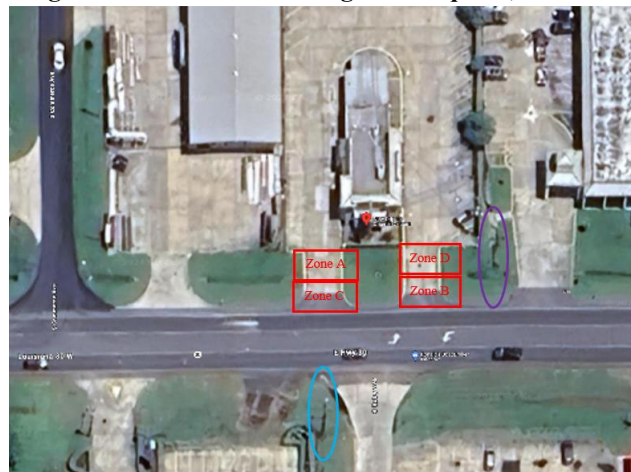
**Figure 92. New Orleans Original Daiquiris, Gonzales**

New Orleans Original Daiquiri is located at 1810 LA 30 in Gonzales. The site is shown in Figure 92. Although there are no signs or driveway markings, it is likely that traffic will enter predominantly through the east driveway and exit through the west driveway. However, this cannot be guaranteed.

There is a utility pole opposite the west driveway that is suitable for mounting the radar device. This pole is located approximately 77 feet from the center of the west driveway and 104 feet from the center of the east driveway. The counting Zones are A and D for exiting traffic and C and B for entering traffic. The CountCAM4 camera should be mounted on the utility pole circled in purple. This pole is 46 feet from the center of the east driveway and 108 feet from the center of the west driveway.

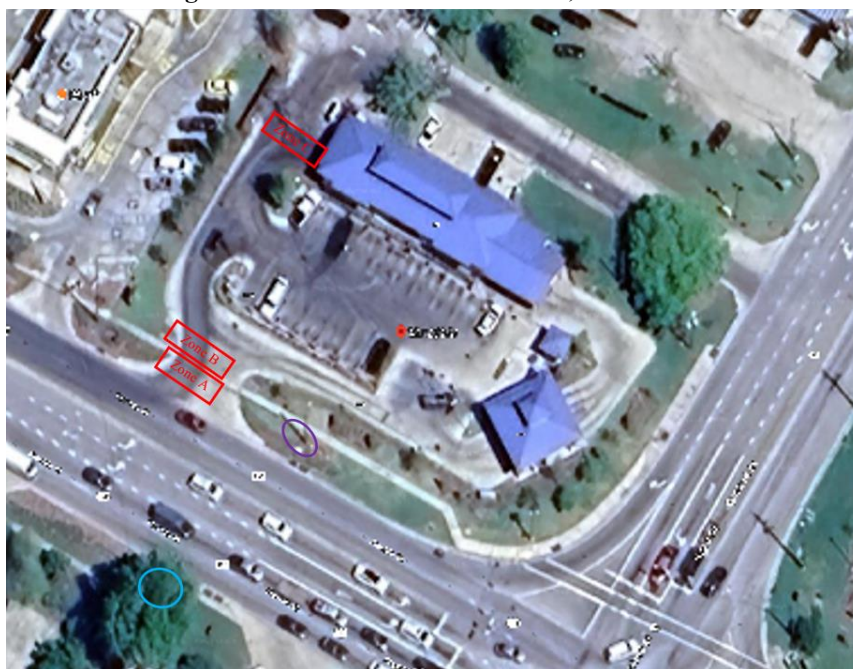
Figure 95. Pelican Pointe Car Wash, Mandeville

This site is located on Florida Street in Mandeville. The site has a single driveway from Florida Street, but may also have access from the McDonald's driveway along the north side of the car wash, as shown in Figure 95.

There is a utility pole that is possible for this driveway, hidden in Figure 95 by the large tree and is circled in light blue. It is 104 feet from the middle of the driveway. The counting zones for this driveway are shown as Zone A for exiting traffic and Zone B for entering traffic. If possible, another counting zone for entering traffic at Zone C should be used. This will cover vehicles entering from the McDonald's driveway to the north of the building. This zone must be north of

the exit from the car wash tunnel, so as not to count vehicles progressing through the tunnel. The radar should be mounted at six meters for this location. The CountCAM4 video camera should be located on the utility pole circled in purple. This utility pole is 55 feet from the center of the driveway.

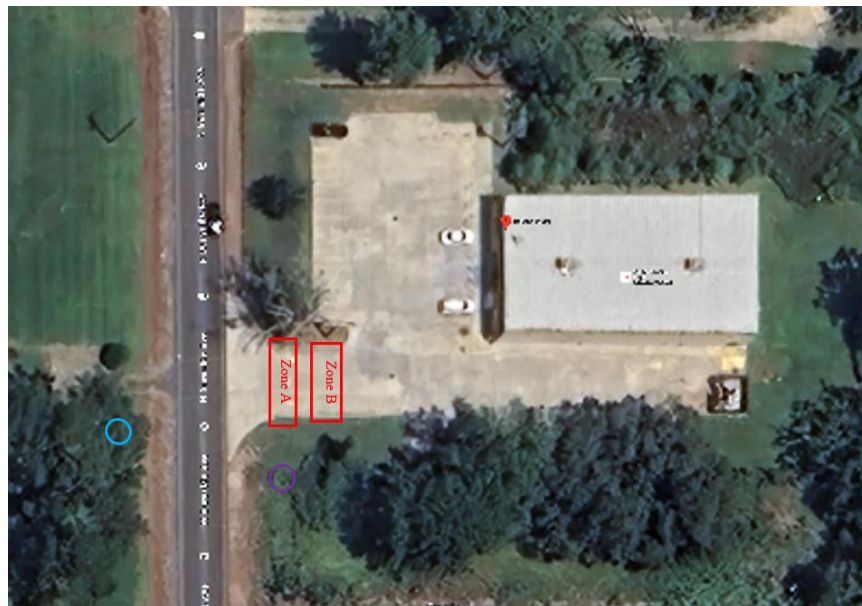
Figure 97. Dollar General, Prairieville

This site is located at 16208 N Burnside Avenue (LA 44) in Prairieville. The site is on a two-lane road and is shown in Figure 97.

There is a utility pole under the trees approximately where the pale blue circle is shown in Figure 97. It is approximately 70 feet from the middle of the driveway. The counting zones for this driveway are shown red in the driveway. The closest one (A) should be for entering traffic and the further one (B) for exiting traffic. The radar should be mounted at three meters.

A CountCAM4 camera should be mounted on the utility pole south of the driveway, circled in purple. The camera will be approximately 100 feet from the center of the driveway. This is further than is ideal, but there is nothing else available.
