1. Title and Subtitle  
**Trip Generation Rates for Various Sites**
2. Author(s)  
Ruijie “Rebecca” Bian, Ph.D., P.E.;  
Peter R. Stopher, Ph.D.; Hany Hassan,  
Ph.D., P.E.; Abdualлах Bayomi, MSc.

5. Report No.  
**FHWA/LA.26/725**
6. Report Date  
July 2026
7. Performing Organization Code  
LTRC Project Number: 24-2SS  
SIO Number: DOTLT1000509
8. Type of Report and Period Covered  
Final Report  
January 2024 to March 2026

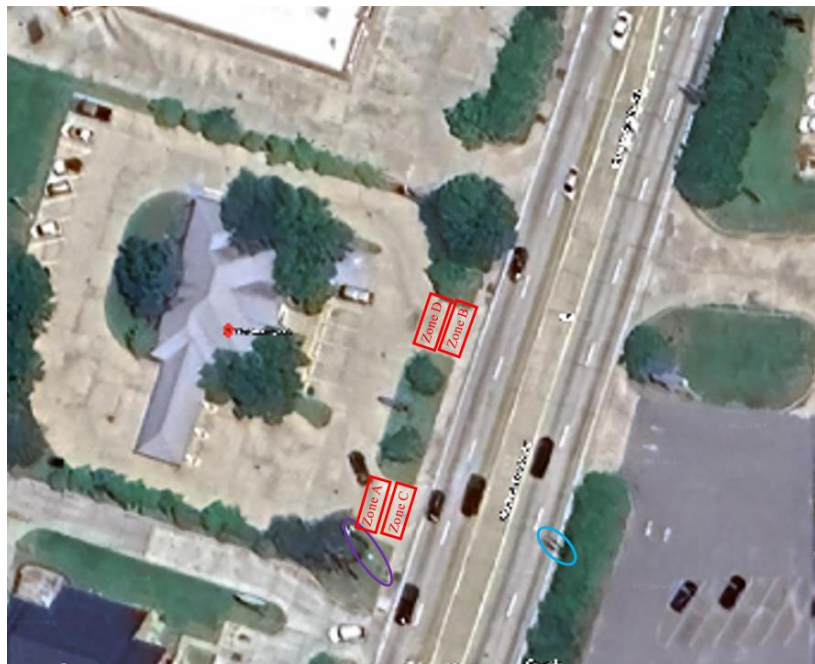
There is a utility pole opposite the south driveway that is suitable for mounting the radar device. This pole is located approximately 83 feet from the center of the south driveway and 117 feet from the center of the north driveway. The counting Zones are A and D for exiting traffic and C and B for entering traffic. Because Walker Road South is a four-lane roadway with a center turning lane, the radar should be mounted at six meters. Also, it should be noted that the drive-thru, which is likely the busiest entrance and exit, is served best by the south driveway. The CountCAM4 camera should be mounted on the utility pole circled in purple. This pole is 35 feet from the center of the south driveway and 122 feet from the center of the north driveway.

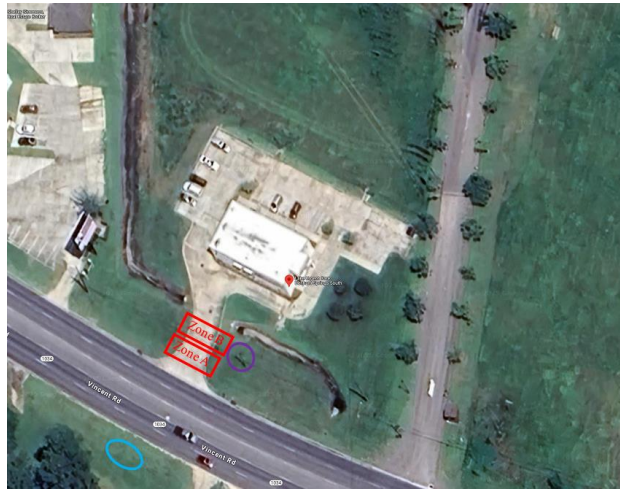
**Figure 99. Lake Urgent Care, Denham Springs**

This site is located at 8249 Vincent Road in Denham Springs. The site is on a five-lane road and is shown in Figure 99.

There are no utility poles on the south side of Vincent Road, so this site will need to use the LTRC trailer. It should be located approximately in the blue circle, opposite the driveway to the urgent care site, and on the public right of way to the south of Vincent Road. This location is approximately 95 feet from the middle of the driveway. The counting zones for this driveway are shown in red in the driveway. The closest one (A) should be for entering traffic, and the further one (B) for exiting traffic. The radar should be mounted at six meters to ensure that traffic on Vincent Road does not block the radar.

A CountCAM4 camera should be mounted on the utility pole east of the driveway, circled in purple. The camera will be approximately 46 feet from the center of the driveway.

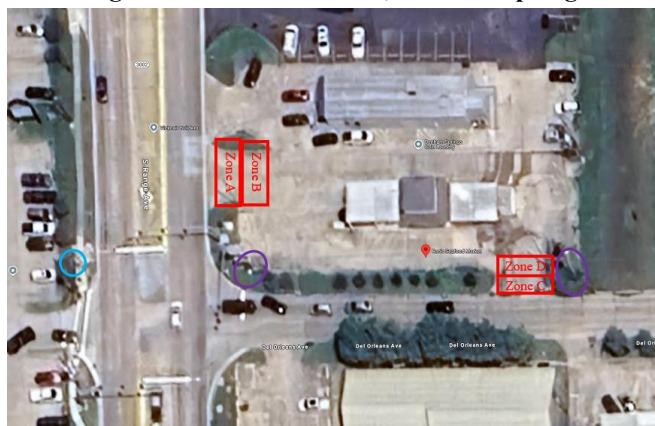
**Figure 100. Ron's Seafood, Denham Springs**

Ron's Seafood Market is located at 1160 South Range Avenue in Denham Springs. The site is shown in Figure 100. It has two driveways, one from Range Avenue and one from Del Orleans Avenue.

The traffic signals at the intersection of Del Orleans Avenue and South Range Avenue are the best option for mounting the radar, although the traffic signals have been changed since the pictures available from Google Maps. The counting Zones are A and C for entering traffic and B and D for exiting traffic. Because of the traffic on South Range Avenue, the radar should be mounted at six meters. One CountCAM4 camera should be mounted on the traffic light pole circled in purple to the south of the driveway, and one should be mounted on the utility pole on Del Orleans Avenue to the east of the driveway, also circled in purple. The first pole is 26 feet from the center of the Range Avenue driveway, and the second is 30 feet from the center of the east driveway from Del Orleans Avenue.

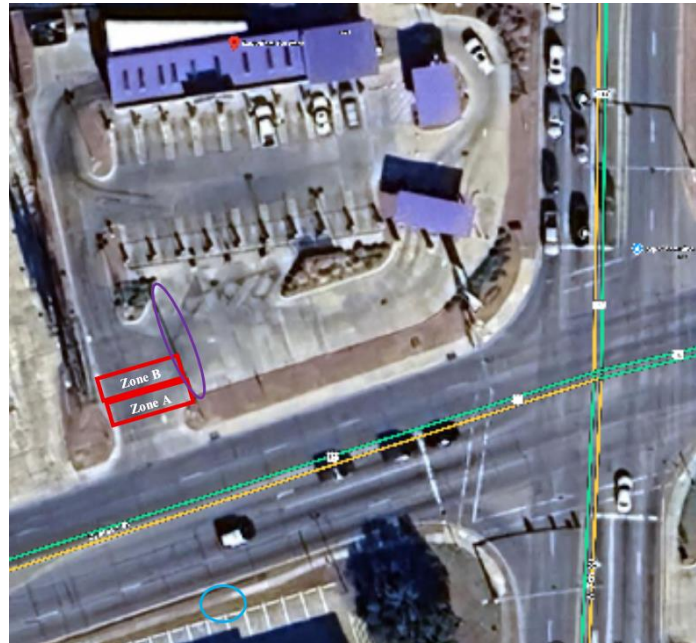
**Figure 102. Rocketfast Carwash, West Monroe**

Rocketfast Carwash in West Monroe is located at 2900 Cypress Street in West Monroe, at the intersection with North 7<sup>th</sup> Street. It is shown in Figure 102.

There are no available utility poles opposite the entrance and exit, so it will require the LTRC trailer to be used and positioned in the Entergy parking lot, if possible, where the blue circle is shown in Figure 102. The best location for the CountCAM4 camera is on the utility pole circled in purple, which is right beside the entrance and exit. The counting zones are shown as Zone A and Zone B.

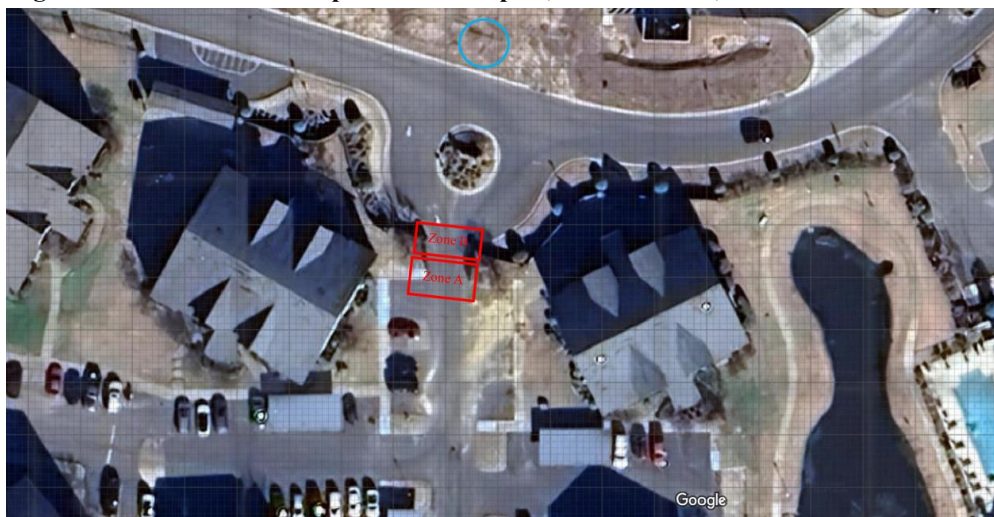
**Figure 104. Ashford Place Apartment Complex, West Monroe, Ashford Drive entrance**

There are no utility poles near the entrance from Ashford Drive. This entrance should be measured using the LTRC trailer positioned across from it, as shown in the blue circle in Figure 103. The video camera will need to be co-located with the SMATS radar, because there are no usable poles in this vicinity. The counting zones should be set up as shown in Figure 103, with Zone A for entering vehicles and Zone B for exiting vehicles.

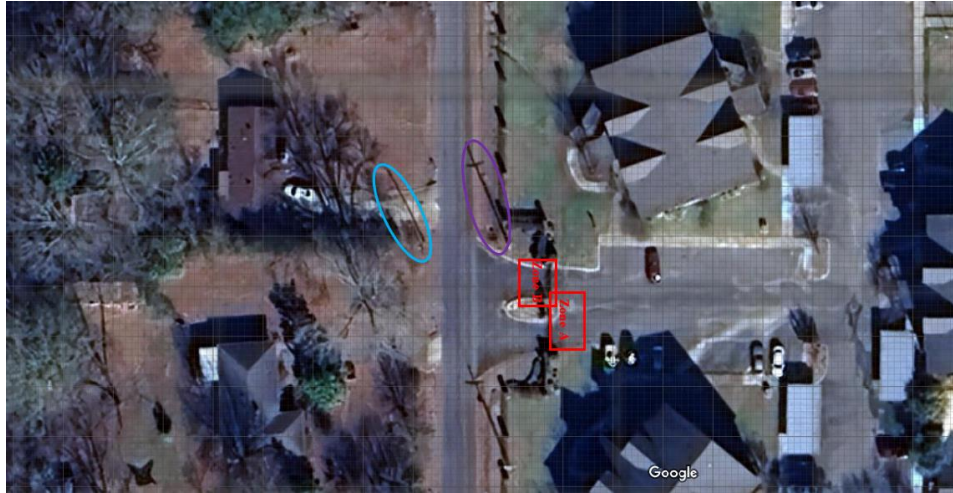
**Figure 105. Ashford Place Apartment Complex, West Monroe, Netherlands Street entrance**

For the Netherlands Street location, there is a utility pole that is ideally located directly across from the entrance to the apartment complex, as shown in Figure 104. The SMATS radar should be mounted on the utility pole on the opposite side of Netherlands Street, as shown circled in blue. This is 64 feet from the entrance. The counting zones should be set up as shown, with Zone A for entering traffic and Zone B for exiting traffic. The video camera should be located on the utility pole circled in purple. It is located just 32 feet from the center of the entrance.

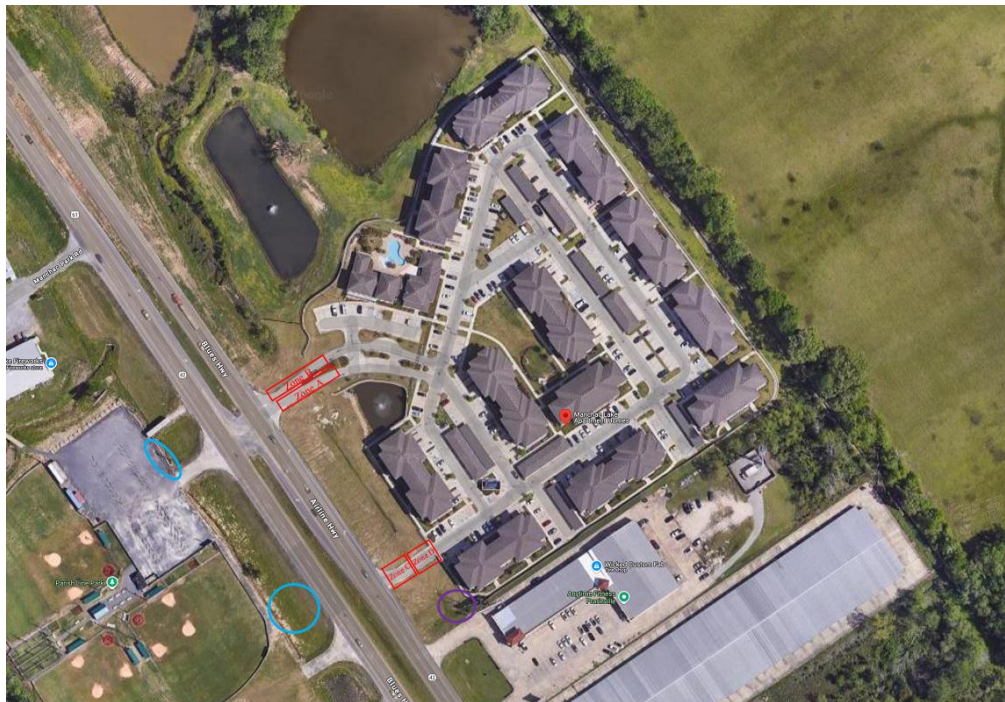
**Figure 106. Manchac Lake Apartment Complex, Prairieville**

There are no utility poles near the south entrance from Airline Highway. This entrance would be measured best by using the LTRC trailer positioned across from the entrance, as shown in the blue circle in Figure 105. This location is approximately 200 feet from the entrance/exit. The radar should be mounted at six meters because of the traffic on Airline Highway. The video camera for this location can be mounted on the utility pole circled in purple. The counting zones should be set up as shown in Figure 105, with Zone C for entering vehicles and Zone D for exiting vehicles.

Placing the trailer in the median would have been preferable, but the median is a drainage ditch and does not appear to offer a level surface for the trailer.

For the north entrance, there is a utility pole opposite the entrance, circled in blue in Figure 105. This pole is approximately 220 feet from the entrance to the driveway and approximately 305 feet from the center of the measurement zones. The radar should be mounted at six meters because of the traffic on Airline Highway, or as high as feasible on the utility pole in question. The measurement zones for this location are Zone A for entering vehicles and Zone B for exiting vehicles. It is important that these zones are between Airline Highway and the entrance to the parking area on the north side of this driveway. The CountCAM4 camera will need to be co-located with the radar because no poles are available near this entrance.

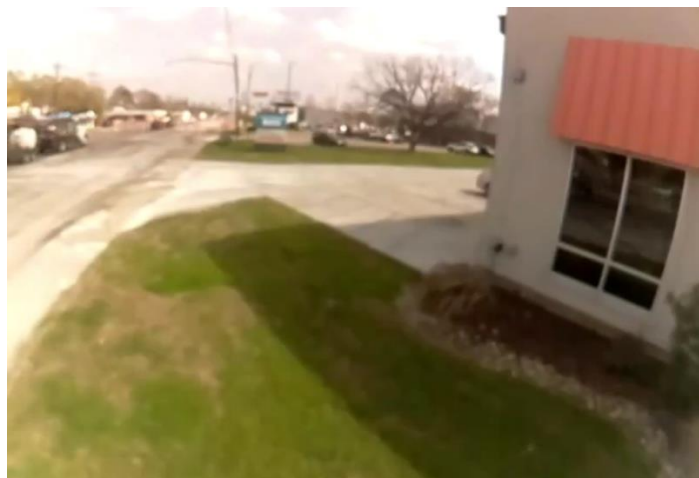
**Figure 109. Camera view at Plank Rd entrance/exit (S1)**

Figure 108 shows the camera view, which was installed at eye level. This camera was used to record the entering and exiting vehicles. Six hours were selected for verification: two in the morning, two in the afternoon, and two in the evening. An automated counting tool using YOLO was developed for vehicle counts. Table 74 provides further details on the visual and automated counts for each period. The accuracy for entering counts is 100%, and for exiting counts, it is 97%.

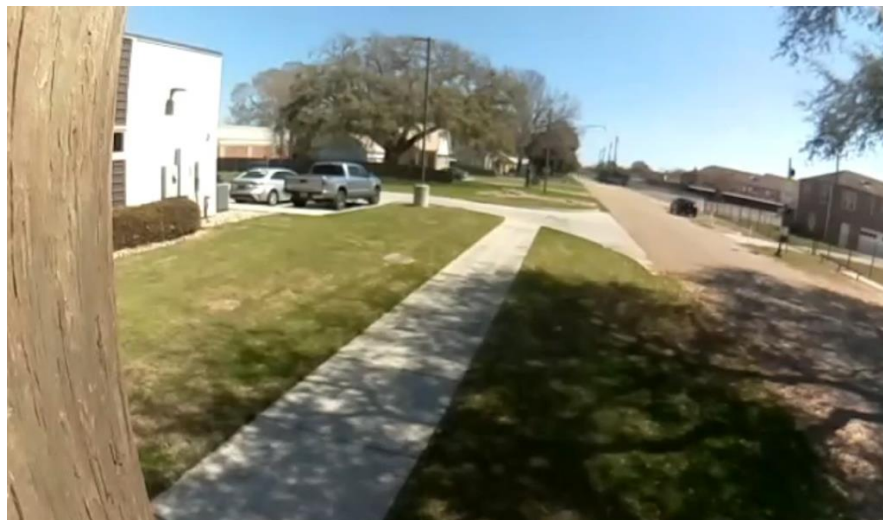
**Figure 110. Camera view at St Katherine Ave entrance/exit (S2)**

Figure 109 shows the camera view, which was installed at eye level. This camera was used to record the entering and exiting vehicles. Six hours were selected for verification: two in the morning, two in the afternoon, and two in the evening. YOLO was used for vehicle counts. Table 75 provides further details on the visual and automated counts for each period. The accuracy for entering counts is 92%, and for exiting counts, it is 91%.

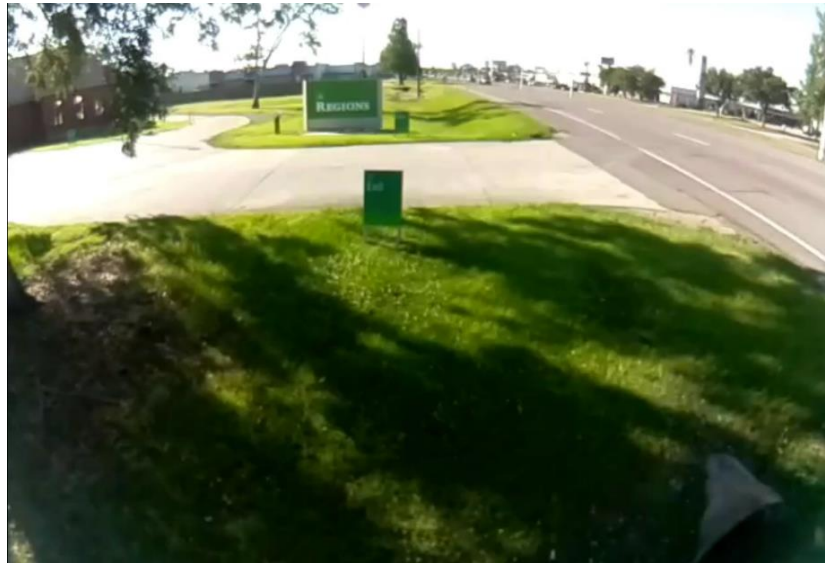
**Figure 120. Camera view at North Airline Hwy entrance/exit (S1)**

Figure 119 shows the camera view, which was installed at eye level. This camera was used to record the entering and exiting vehicles. Six hours were selected for verification: two in the morning, two in the afternoon, and two in the evening. An automated counting tool using YOLO was developed for vehicle counts. Table 85 provides further details on the visual and automated counts for each period. The accuracy for entering counts is 112%, and for exiting counts, it is 105%.

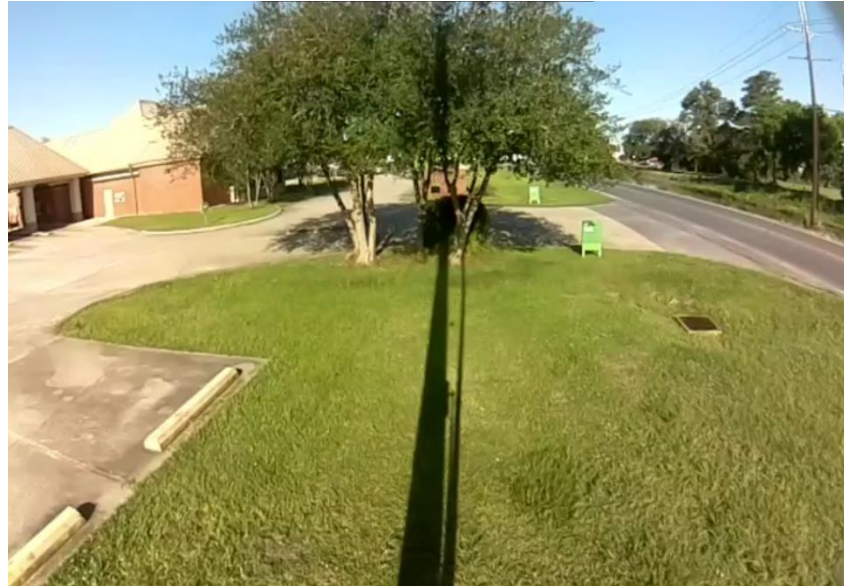
**Figure 121. Camera view at East Weber City St entrance/exit (S2)**

86 provides further details on the visual and automated counts for each period. The accuracy for entering counts is 95%, and for exiting counts, it is 111%.

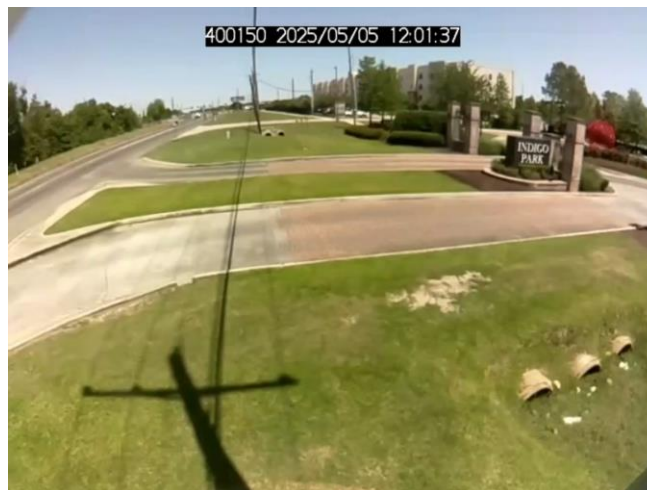
**Figure 124. Camera view at Nicholson Dr entrance/exit**

This site has two entrances/exits, but at the time of recording, the gate on Gardere Lane was closed. Therefore, the counts were only taken from the gate on Nicholson Drive. Figure 123 shows the camera view, which was installed at eye level. This camera was used to record the entering and exiting vehicles. Six hours were selected for verification: two in the morning, two in the afternoon, and two in the evening. YOLO was used for vehicle counts. Table 90 provides further details on the visual and automated counts for each period. The accuracy for entering counts is 104%, and for exiting counts, it is 102%. Overall, the accuracy for both entering and exiting counts is accepted.

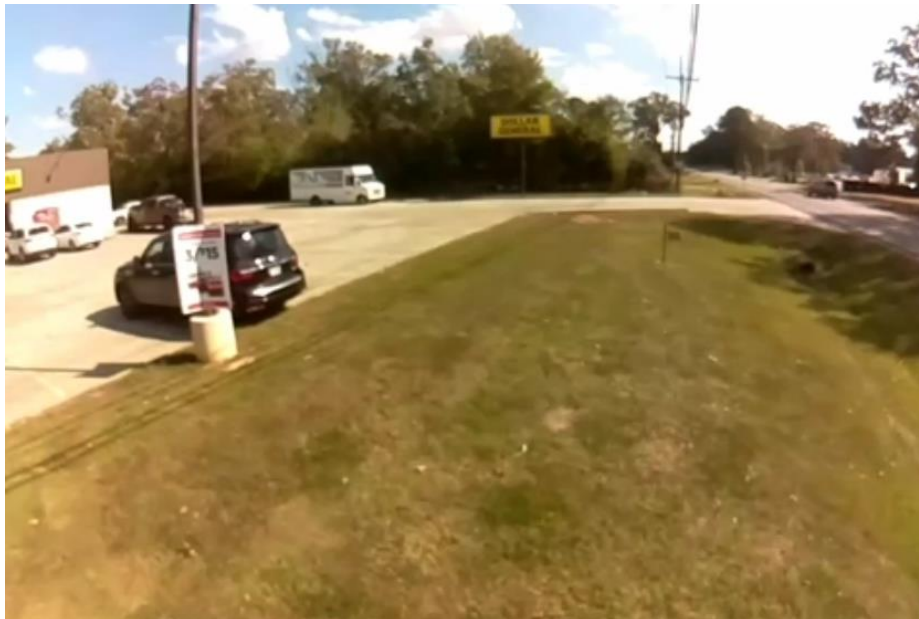
**Figure 127. Camera view at Dollar General, Sterlington, LA 2 entrance/exit**

Figure 126 shows the camera view, which was installed at eye level. This camera was used to record the entering and exiting vehicles. Six hours were selected for verification: two in the morning, two in the afternoon, and two in the evening. YOLO was used for vehicle counts in this remeasurement. Table 93 provides further details on the visual and automated counts for each period. The accuracy for entering counts is 92%, and for exiting counts, it is 92%. Overall, the accuracy for both entering and exiting counts is accepted.

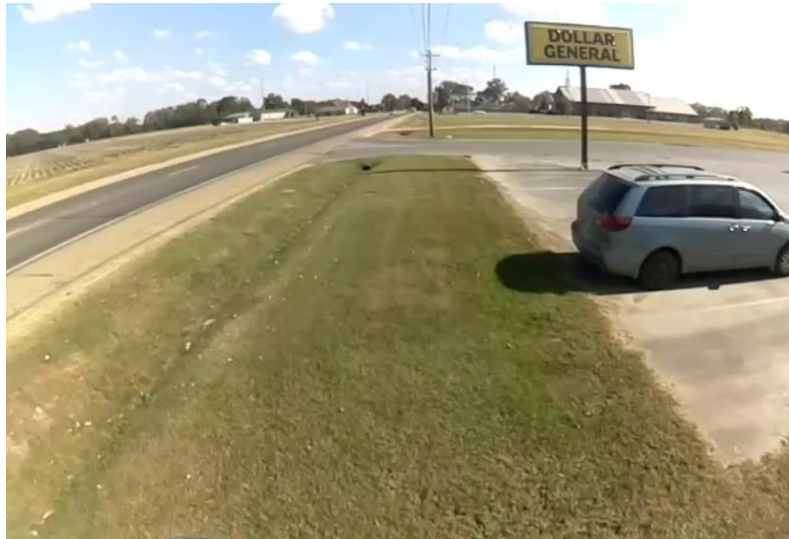
**Figure 128. Camera view at Dollar General, West Monroe, Whites Ferry Rd entrance/exit**

Figure 127 shows the camera view, which was installed at eye level. This camera was used to record the entering and exiting vehicles. Six hours were selected for verification: two in the morning, two in the afternoon, and two in the evening. YOLO was used for remeasuring the vehicle counts. Table 94 provides further details on the visual and automated counts for each period. The accuracy for entering counts is 92%, and for exiting counts, it is 92%. Overall, the accuracy for both entering and exiting counts is accepted.

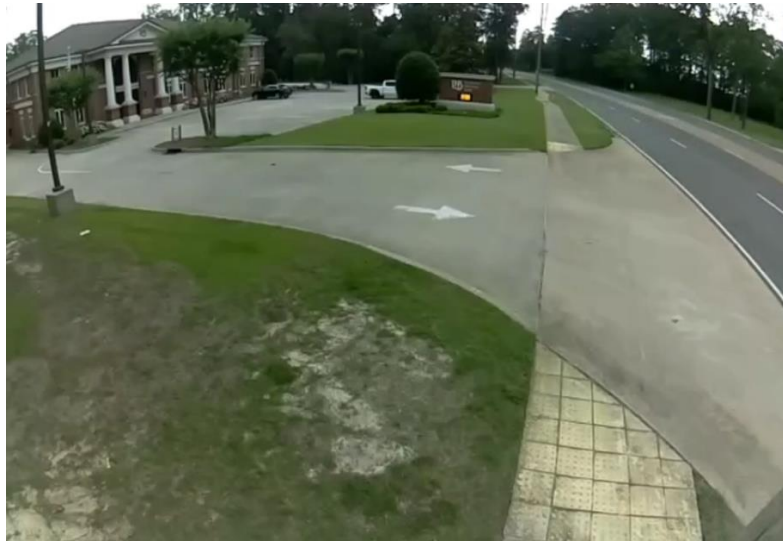
**Figure 131. Camera view at North Trenton St entrance/exit (S1)**

Figure 130 shows the camera view, which was installed at eye level. This camera was used to record the entering and exiting vehicles. Six hours were selected for verification: two in the morning, two in the afternoon, and two in the evening. YOLO was used for vehicle counts. Table 97 provides further details on the visual and automated counts for each period. The accuracy for entering counts is 103%, and for exiting counts, it is 107%.

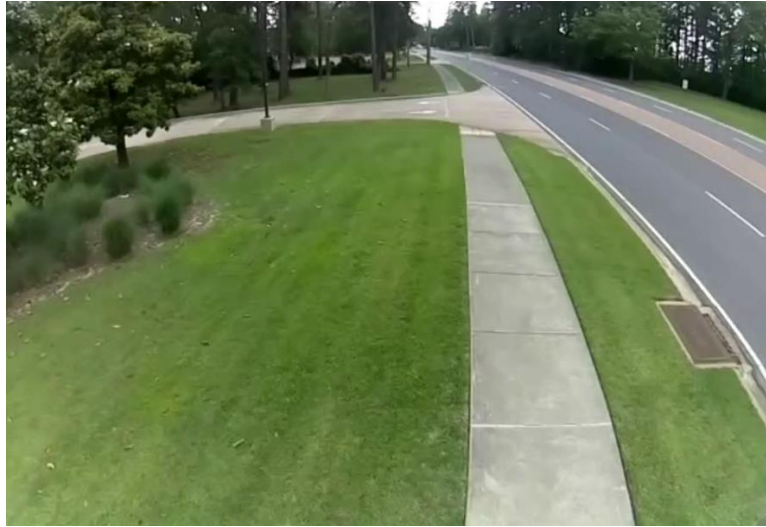
**Figure 132. Camera view at North Trenton St entrance/exit (S2)**

Figure 131 shows the camera view, which was installed at eye level. This camera was used to record the entering and exiting vehicles. Six hours were selected for verification: two in the morning, two in the afternoon, and two in the evening. YOLO was used for vehicle counts. Table 98 provides further details on the visual and automated counts for each period. The accuracy for entering counts is 118%, and for exiting counts, it is 125%.

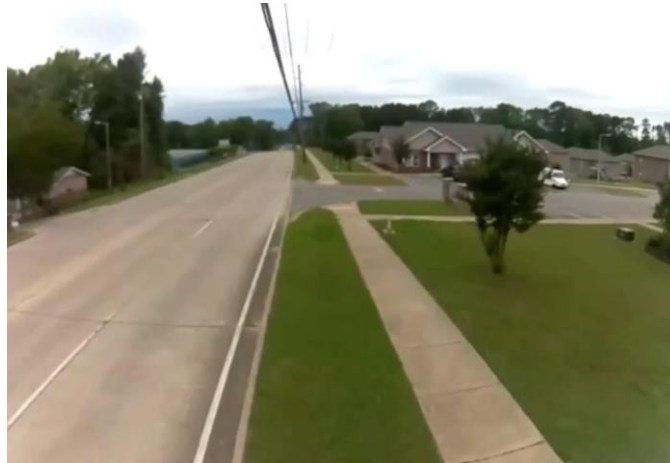
**Figure 133. Camera view at Alabama Ave entrance/exit**

Figure 132 shows the camera view, which was installed at eye level. This camera was used to record the entering and exiting vehicles. Six hours were selected for verification: two in the morning, two in the afternoon, and two in the evening. YOLO was used for vehicle counts. Table 100 provides details on the visual and automated counts for each period. The accuracy for entering counts is 103%, and for exiting counts, it is 101%.

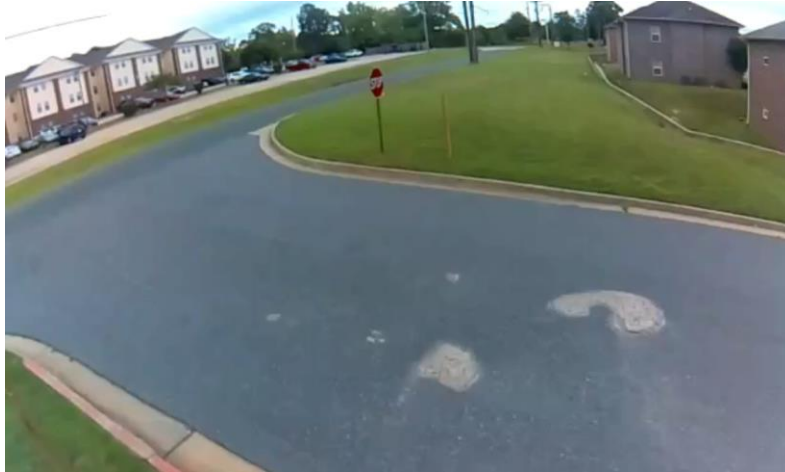
**Figure 134. Camera view at Goyne St entrance/exit**

Figure 133 shows the camera view, which was installed at eye level. This camera was used to record the entering and exiting vehicles. Six hours were selected for verification: two in the morning, two in the afternoon, and two in the evening. YOLO was used for vehicle counts. Table 101 provides details on the visual and automated counts for each period. The accuracy for entering counts is 96%, and for exiting counts, it is 97%.

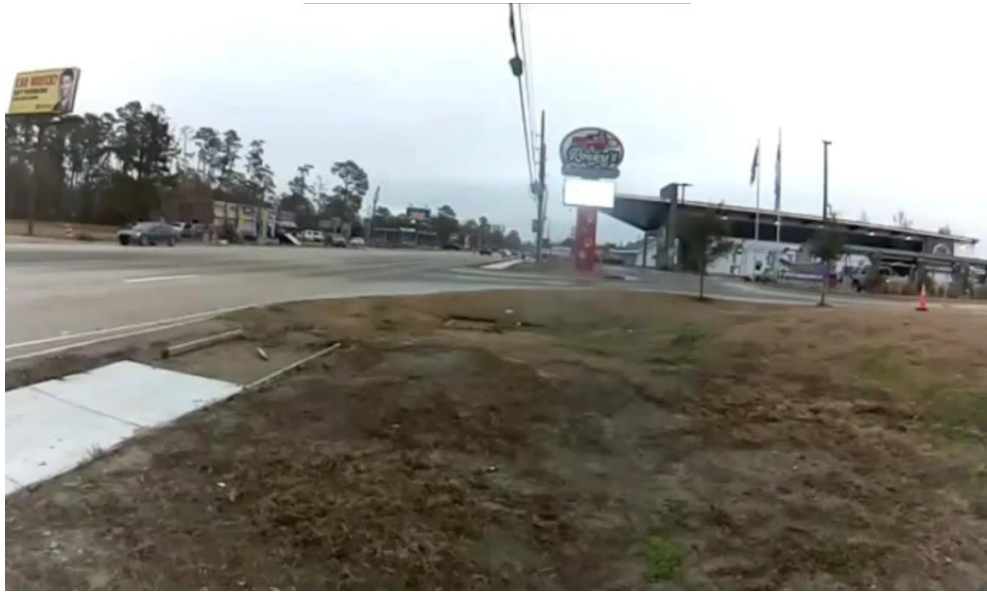
**Figure 135. Camera view at West University Ave entrance/exit**

Figure 134 shows the camera view, which was installed at eye level. This camera was used to record the entering and exiting vehicles. Six hours were selected for verification: two in the morning, two in the afternoon, and two in the evening. YOLO was used for vehicle counts. Table 103 provides further details on the visual and automated counts for each period. The accuracy for entering counts is 104%, and for exiting counts, it is 99%. Overall, the accuracy for both entering and exiting counts is accepted.

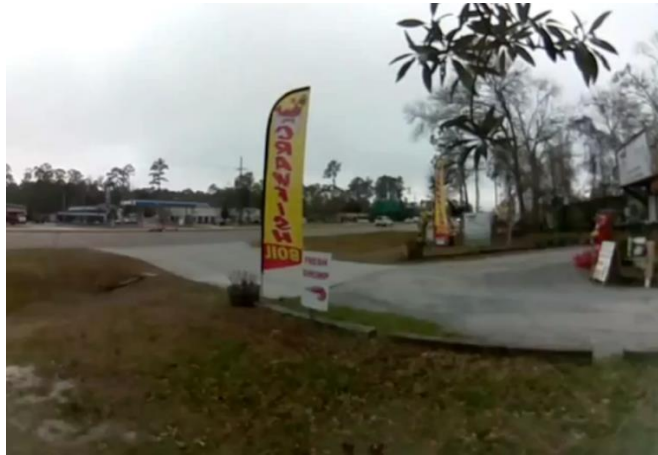
**Figure 136. Camera view at North Hwy 190 entrance/exit**

Figure 135 shows the camera view, which was installed at eye level. This camera was used to record the entering and exiting vehicles. Six hours were selected for verification: two in the morning, two in the afternoon, and two in the evening. YOLO was used for vehicle counts. Table 104 provides further details on the visual and automated counts for each period. The accuracy for entering counts is 100%, and for exiting counts, it is 100%. Overall, the accuracy for both entering and exiting counts is accepted.

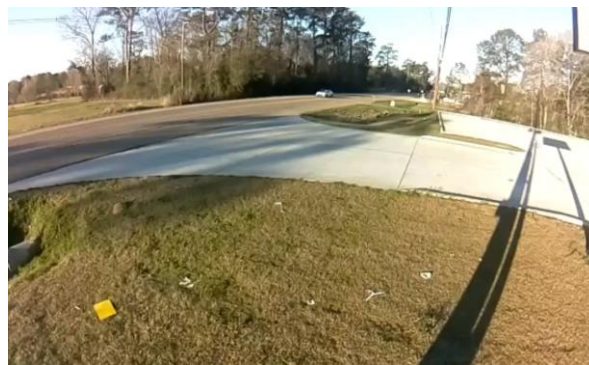
**Figure 137. Camera view at U.S. Hwy 190 East entrance/exit**

Figure 136 shows the camera view, which was installed at eye level. This camera was used to record the entering and exiting vehicles. Six hours were selected for verification: two in the morning, two in the afternoon, and two in the evening. YOLO was used for vehicle counts. Table 105 provides further details on the visual and automated counts for each period. The accuracy for entering counts is 101%, and for exiting counts, it is 99%. Overall, the accuracy for both entering and exiting counts is accepted.

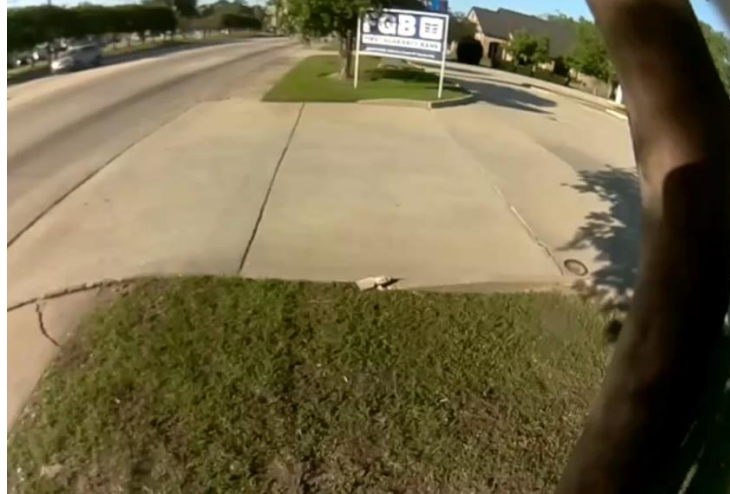
**Figure 148. Camera view at Walker South Rd entrance/exit (S2)**

Figure 148 shows the camera view, which was installed at eye level. This camera was used to record the entering and exiting vehicles. Six hours were selected for verification: two in the morning, two in the afternoon, and two in the evening. YOLO was used for vehicle counts. Table 119 provides further details on the visual and automated counts for each period. The accuracy for entering counts is 95%, and for exiting counts, it is 93%. Overall, the accuracy for both entering and exiting counts is accepted.

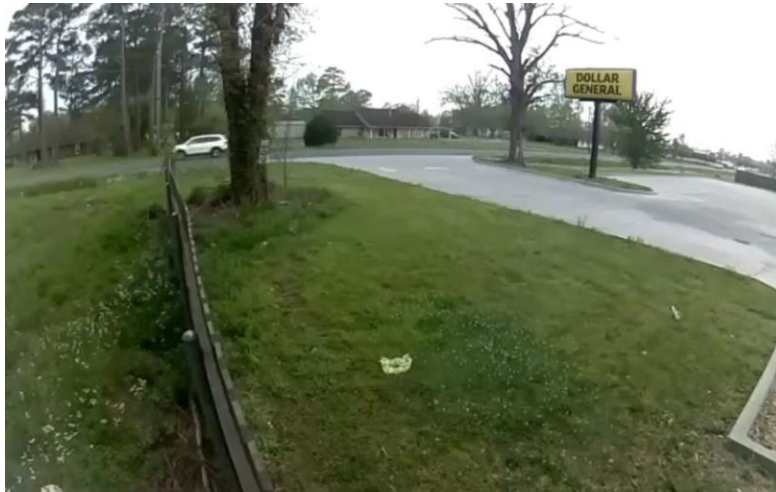
**Figure 149. Camera view at LA-44 entrance/exit**

Figure 149 shows the camera view, which was installed at eye level. This camera was used to record the entering and exiting vehicles. Six hours were selected for verification: two in the morning, two in the afternoon, and two in the evening. YOLO was used for vehicle counts. Table 120 provides further details on the visual and automated counts for each period. The accuracy for entering counts is 95%, and for exiting counts, it is 95%. Overall, the accuracy for both entering and exiting counts is accepted.

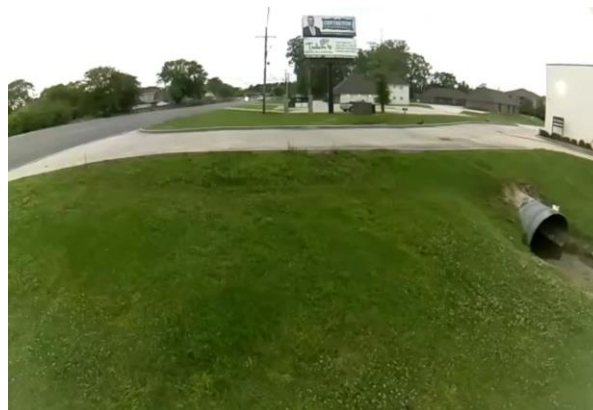
**Figure 150. Camera view at Vincent Rd entrance/exit**

Figure 150 shows the camera view, which was installed at eye level. This camera was used to record the entering and exiting vehicles. Six hours were selected for verification: two in the morning, two in the afternoon, and two in the evening. YOLO was used for vehicle counts. Table 121 provides further details on the visual and automated counts for each period. The accuracy for entering counts is 118%, and for exiting counts, it is 111%.

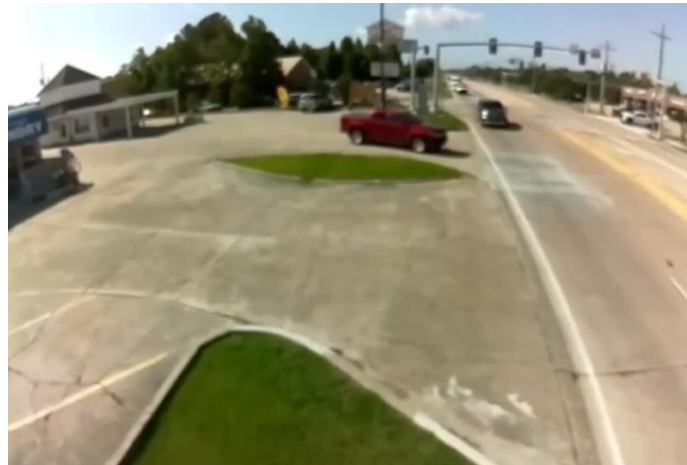
**Figure 151. Camera view at South Range Ave entrance/exit (S1)**

Figure 151 shows the camera view, which was installed at eye level. This camera was used to record the entering and exiting vehicles. Six hours were selected for verification: two in the morning, two in the afternoon, and two in the evening. YOLO was used for vehicle counts. Table 122 provides further details on the visual and automated counts for each period. The accuracy for entering counts is 108%, and for exiting counts, it is 97%.

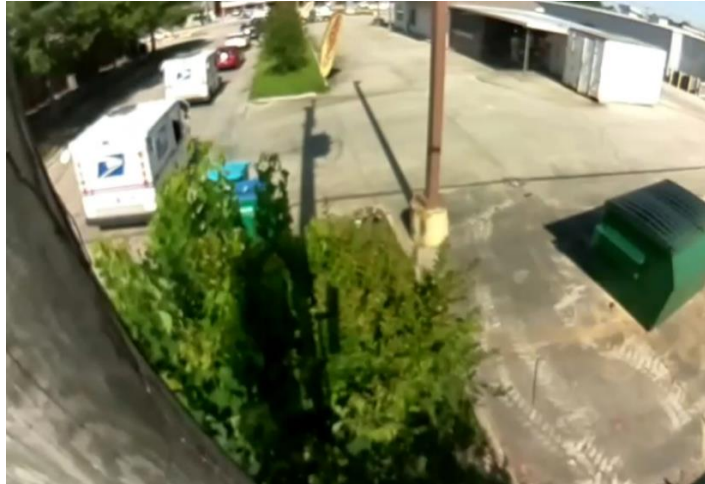
**Figure 152. Camera view at Del Orleans Ave entrance/exit (S2)**

Figure 152 shows the camera view, which was installed at eye level. This camera was used to record the entering and exiting vehicles. Six hours were selected for verification: two in the morning, two in the afternoon, and two in the evening. YOLO was used for vehicle counts. Table 124 provides further details on the visual and automated counts for each period. The accuracy for entering counts is 115%, and for exiting counts, it is 95%.

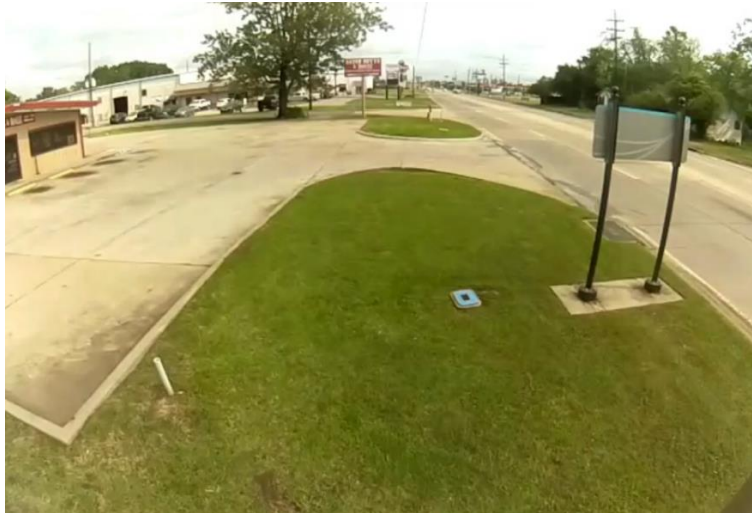
**Figure 153. Camera view at Thomas Rd entrance/exit (S1)**

Figure 153 shows the camera view, which was installed at eye level. This camera was used to record the entering and exiting vehicles. Six hours were selected for verification: two in the morning, two in the afternoon, and two in the evening. An automated counting tool using YOLO was developed for vehicle counts. Table 125 provides further details on the visual and automated counts for each period. The accuracy for entering counts is 103%, and for exiting counts, it is 111%.

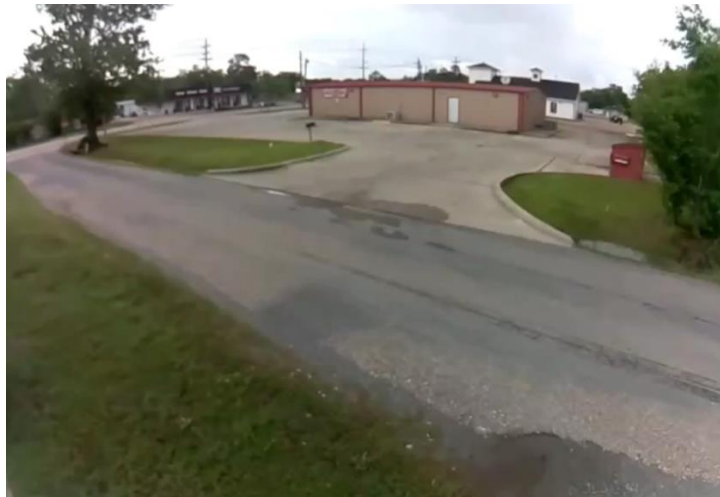
**Figure 154. Camera view at Dawn Ln entrance/exit (S2)**

Figure 154 shows the camera view, which was installed at eye level. This camera was used to record the entering and exiting vehicles. Six hours were selected for verification: two in the morning, two in the afternoon, and two in the evening. YOLO was used for vehicle counts. Table 127 provides further details on the visual and automated counts for each period. The accuracy for entering counts is 104%, and for exiting counts, it is 99%. Overall, the accuracy for both entering and exiting counts is accepted.

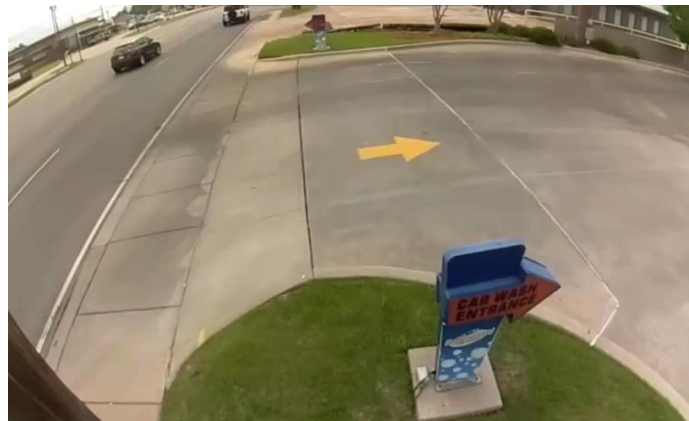
**Figure 155. Camera view at Cypress St entrance/exit**

Figure 155 shows the camera view, which was installed at eye level. This camera was used to record the entering and exiting vehicles. Six hours were selected for verification: two in the morning, two in the afternoon, and two in the evening. YOLO was used for vehicle counts. Table 128 provides further details on the visual and automated counts for each period. The accuracy for entering counts is 105%, and for exiting counts, it is 76%. Overall, the accuracy for entering counts is accepted.

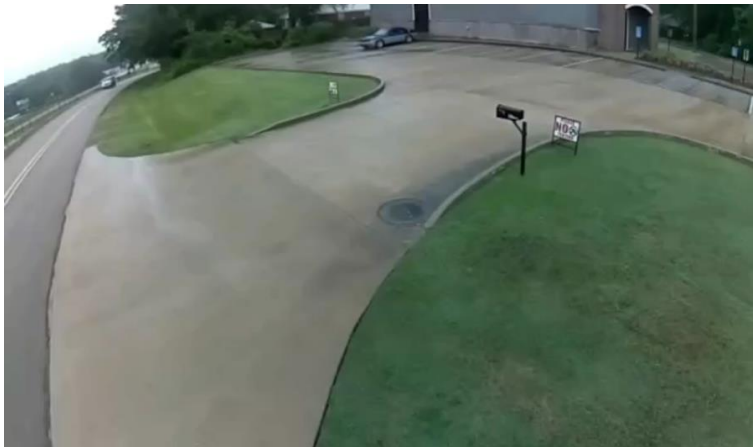
**Figure 156. Camera view at Service Rd West entrance/exit**

This site has two entrances/exits, but at the time of recording, the gate on Netherland St was closed. Therefore, the counts were taken only at the gate on Ashford Drive. Figure 156 shows the camera view, which was installed at eye level. This camera was used to record the entering and exiting vehicles. Six hours were selected for verification: two in the morning, two in the afternoon, and two in the evening. YOLO was used for vehicle counts. Table 129 provides further details on the visual and automated counts for each period. The accuracy for entering counts is 99%, and for exiting counts, it is 100%. Overall, the accuracy for both entering and exiting counts is accepted.

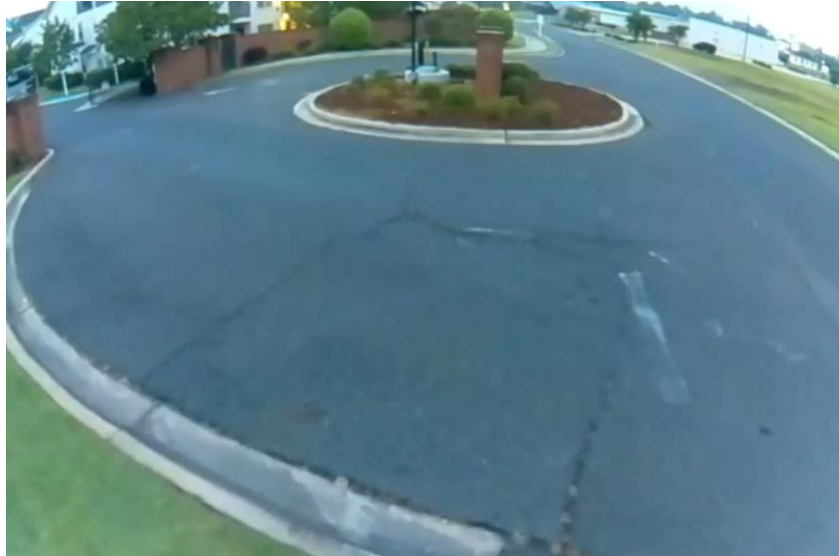
Figure 157. Camera view at Ashford Dr entrance/exit

Figure 157 shows the camera view, which was installed at eye level. This camera was used to record the entering and exiting vehicles. Six hours were selected for verification: two in the morning, two in the afternoon, and two in the evening. YOLO was used for vehicle counts. Table 130 provides further details on the visual and automated counts for each period. The accuracy for entering counts is 100%, and for exiting counts, it is 104%.

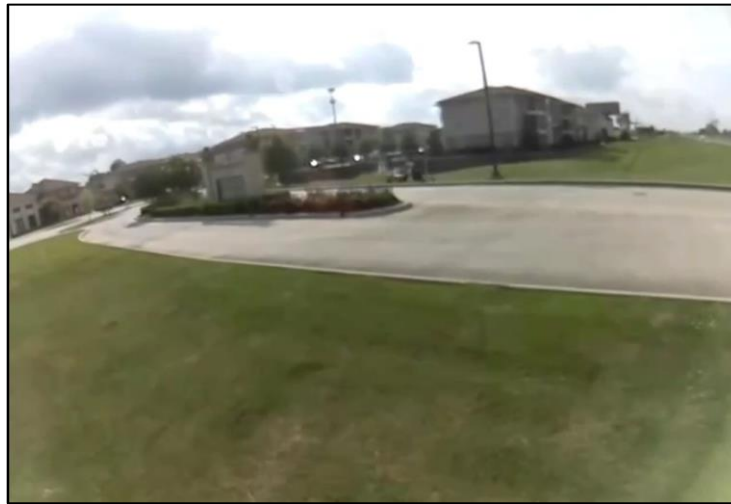
Figure 158. Camera view at Airline Hwy entrance/exit 1

Figure 158 shows the camera view, which was installed at eye level. This camera was used to record the entering and exiting vehicles. Six hours were selected for verification: two in the morning, two in the afternoon, and two in the evening. YOLO was used for vehicle counts. Table 131 provides further details on the visual and automated counts for each period. The accuracy for entering counts is 101%, and for exiting counts, it is 95%.
