**Report No. CDOT-DTD-R-2000-5**

# **PERFORMANCE OF GEOSYNTHETIC- REINFORCED WALLS SUPPORTING THE FOUNDERS/MEADOWS BRIDGE AND APPROACHING ROADWAY STRUCTURES**

**REPORT 1: DESIGN, MATERIALS, CONSTRUCTION,  
INSTRUMENTATION, AND PRELIMINARY RESULTS**

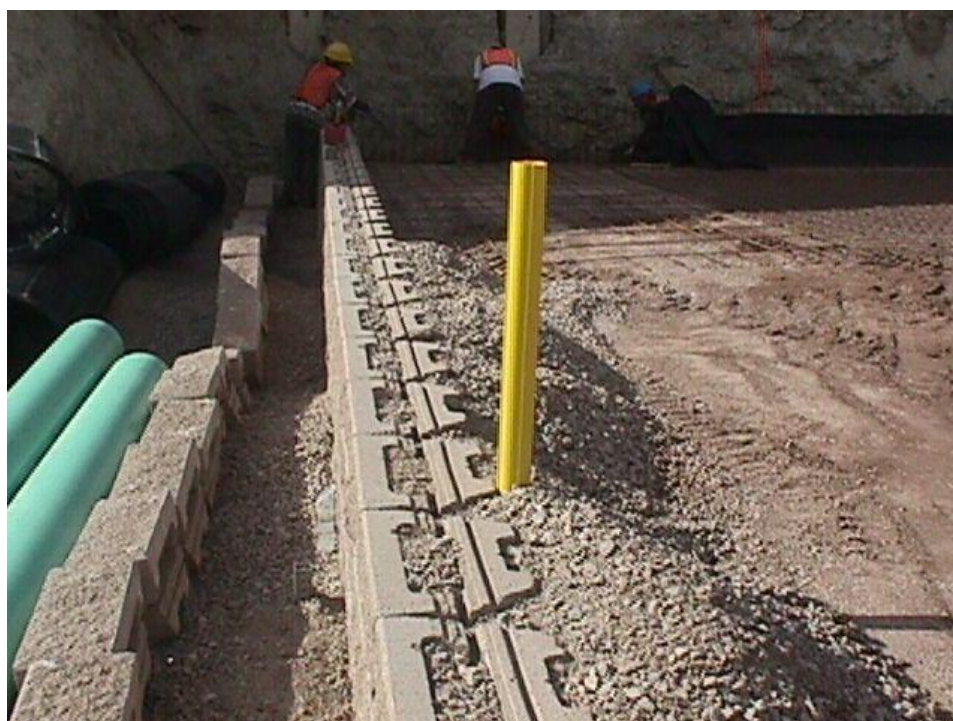
**Figure B-4. Picture showing facing blocks, crushed stone used to fill in and 0.3 m behind the blocks, and the compacted CDOT Class 1 backfill. The yellow inclinometer tube was used to measure lateral movement in the structure along Section 400.**

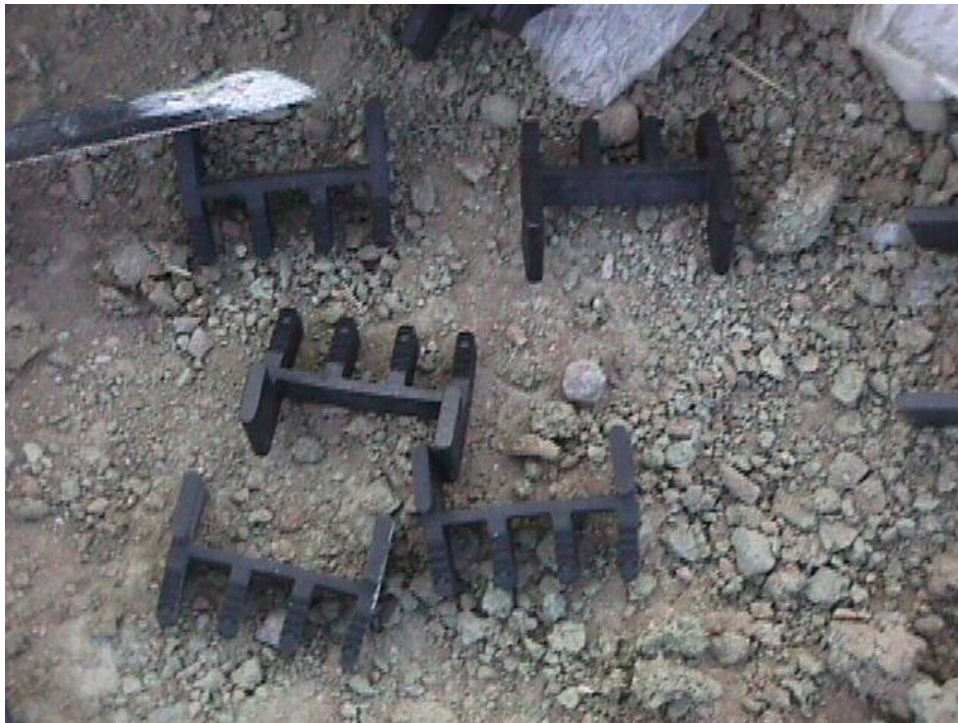
**Figure B-10. The Standard Mesa Connectors which provide the positive mechanical connection strength between blocks and between blocks and geogrid. This connector has four “teeth” that fit down into the groove of the block (Fig 8) and two “flags” where the geogrid is hooked. The rear of the cavity of the next row of blocks rests against the two large flags. This provides connection strength between blocks.**

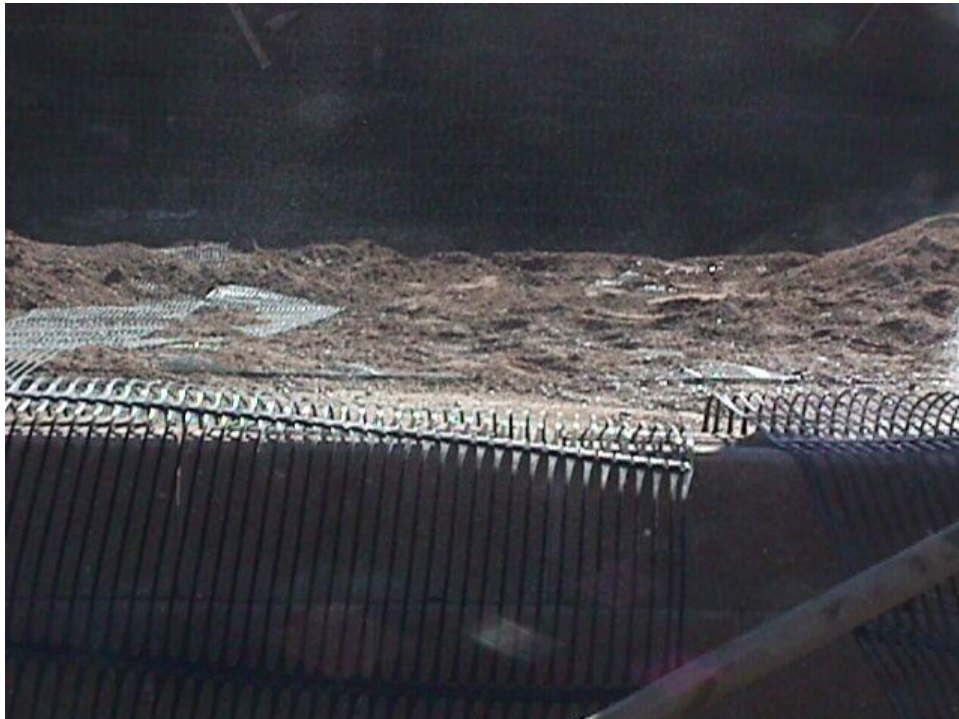
**Figure B-16. Around the corners of the lower MSE walls, where geogrid from the front and side of the structure overlapped, a thin layer of fill material was placed between these geogrid layers to provide friction between them.**

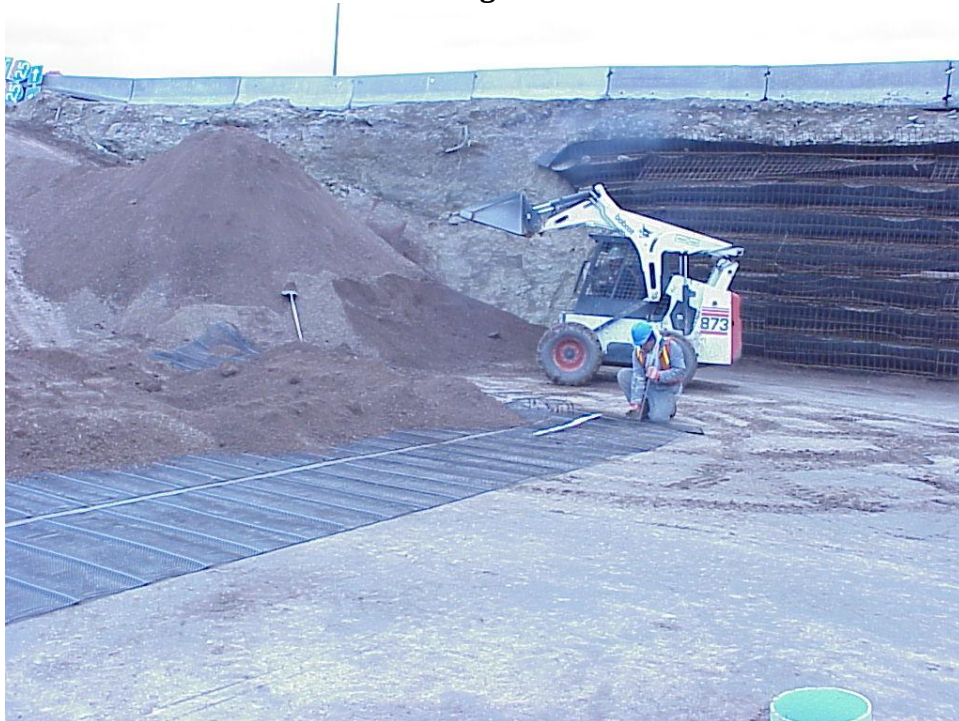
**Figure B-20. The geogrid was connected at the wall end, rolled out, and then stretched by hand. The back end was staked to prevent geogrid movement while the fill was placed using a small loader. In the background is the steel reinforcement used to temporarily support the northern face of the Phase I structure.**

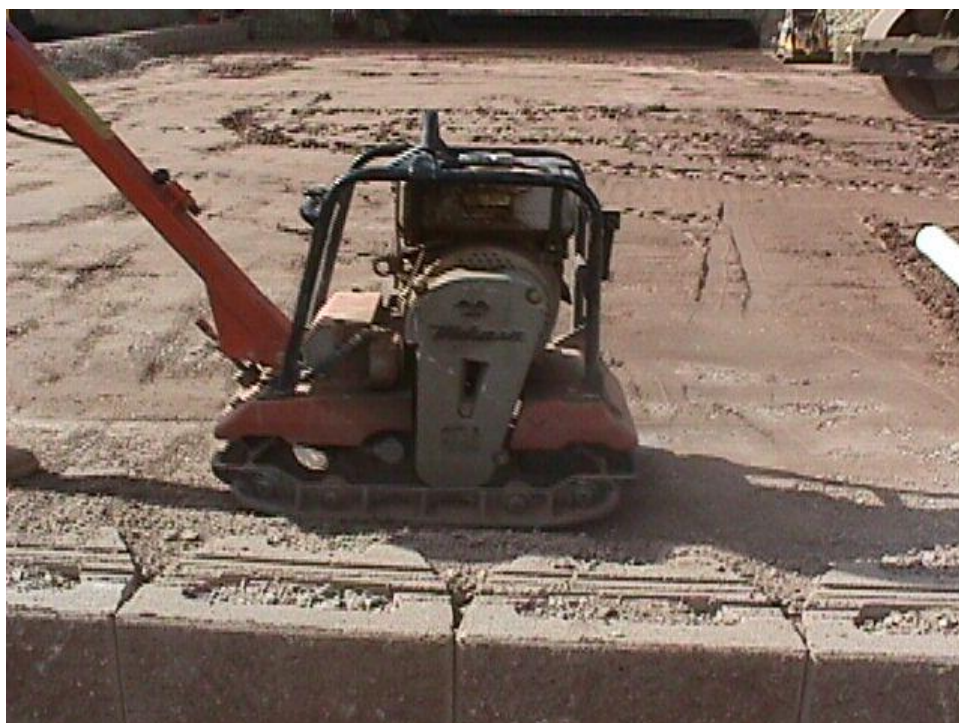
**Figure B-22. Near the block facing, a small walk-behind compactor was used to prevent pushing the blocks out of position.**

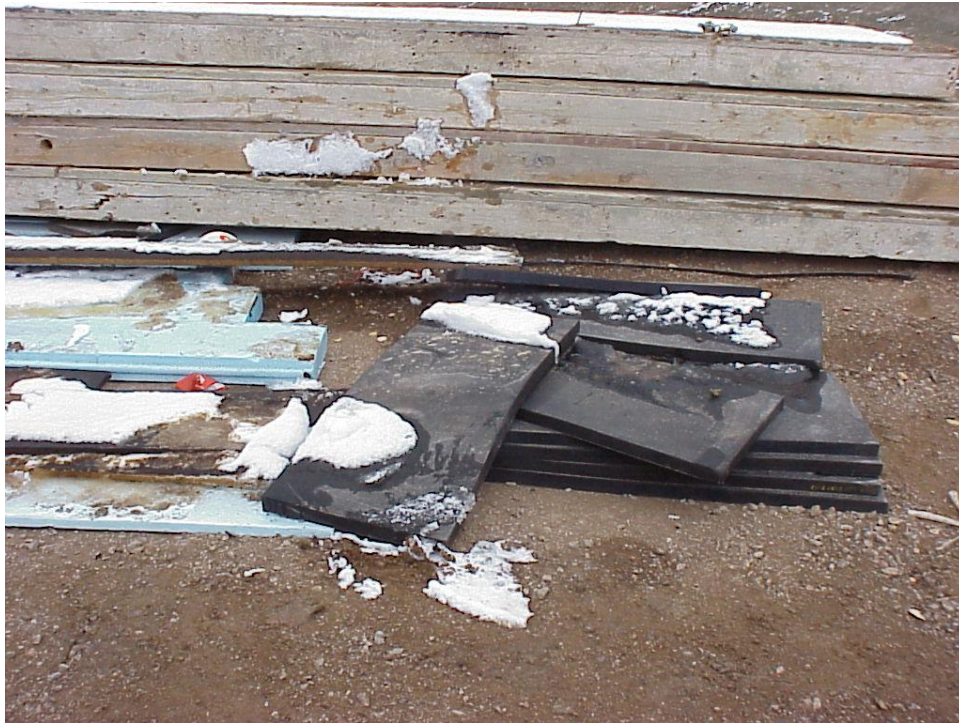
**Figure B-30.** These elastomeric bearing pads were installed on the abutment wall where the bridge girders are seated.

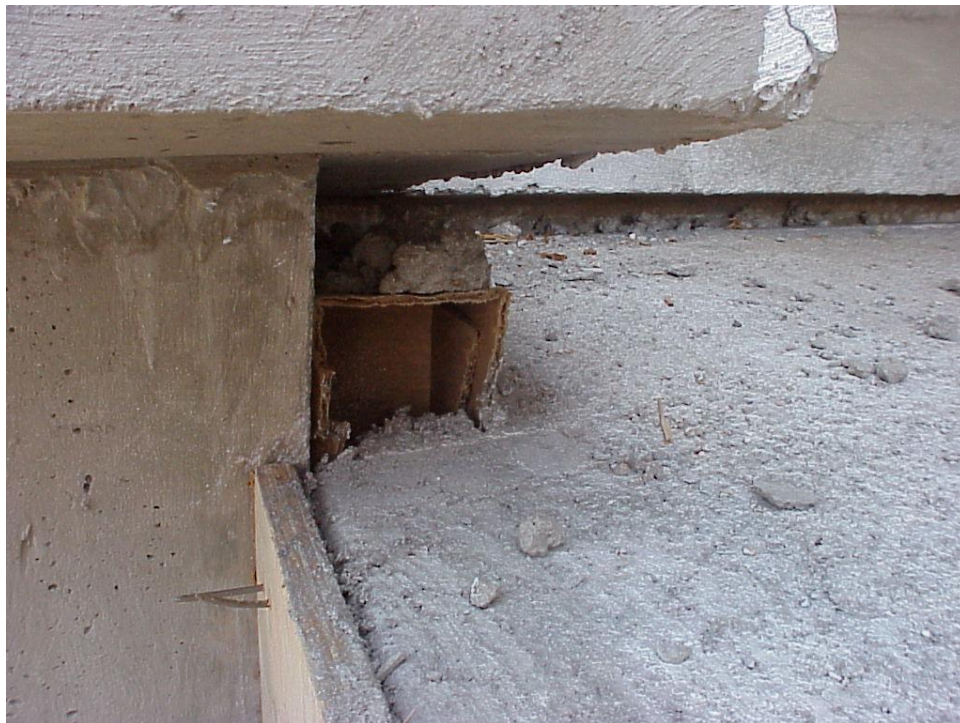
**Figure B-40. Collapsible cardboard was placed in front of the bottom portion of the abutment wall behind slope paving (see figures 29 and 35).**
