DOT/FAA/CT-93/74  
DOT-VNTSC-FAA-93-12

# A Laboratory Study of Multiple Site Damage in Fuselage Lap Splices

December 1993

Final Report

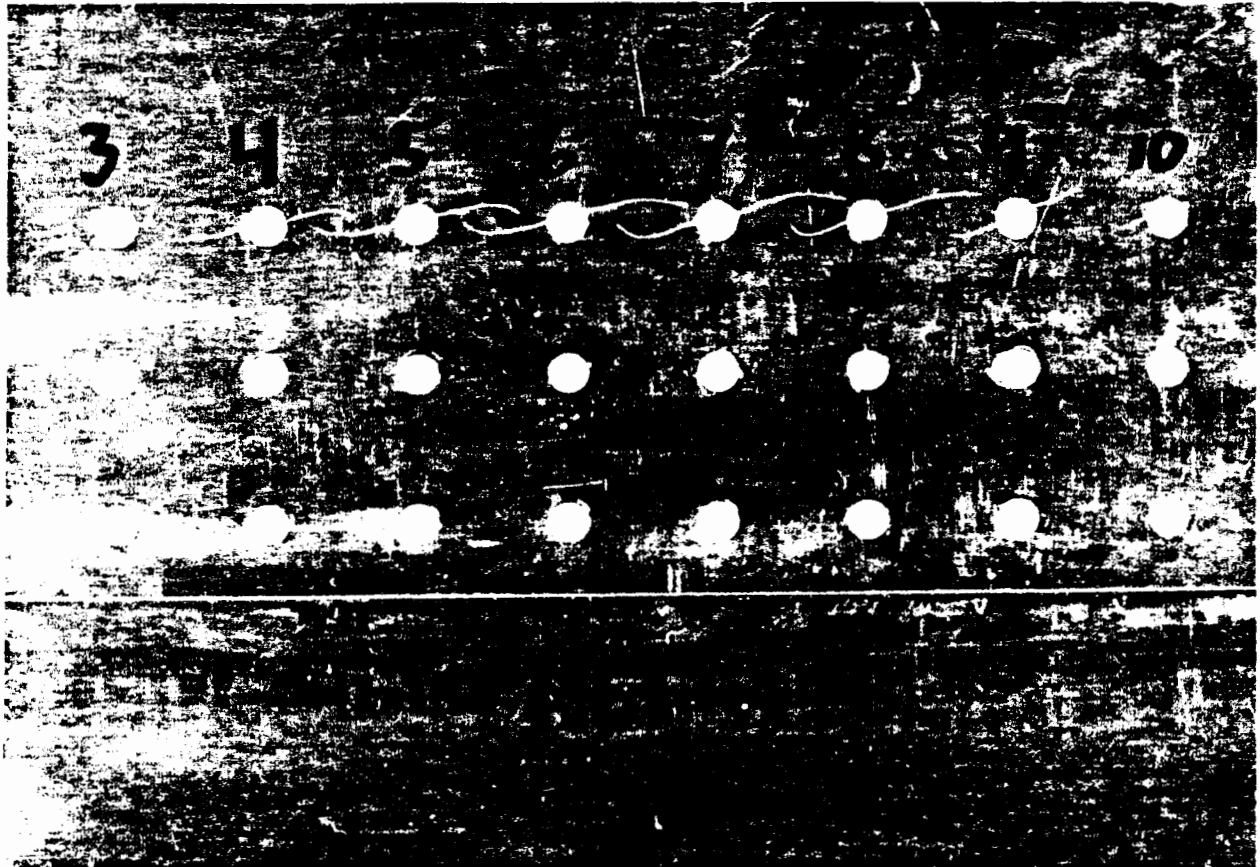
Figure 15: An Example of the Cracking Pattern for a Panel Tested at a Shear-to-Tension Ratio of 0.2

Table 8 lists the results for the shear/tension tests and Figure 14 compares the results of all baseline tests. This figure shows the significant reduction in fatigue life caused by the addition of shear. Figure 15 shows a photograph of the cracks resulting from a test conducted at a shear-to-tension ratio of 0.2 and Figure 16 shows the crack pattern for one of the 0.1 ratio specimens in quantitative terms. Examination of Figure 16 and others like it - Appendix A - suggests that the addition of shear neither diminishes nor exacerbates the formation of MSD. However, there is a reduction in fatigue life which appears to be greater than expected from consideration of principal stress above. (This
