# **Long-Term Performance of Accelerated Rigid Pavements, Project CXMP 13-0006-07**

**Final Report  
October, 1996**

**Long-Term performance of Accelerated Rigid  
Pavements, Project CXMP 13-0006-07**

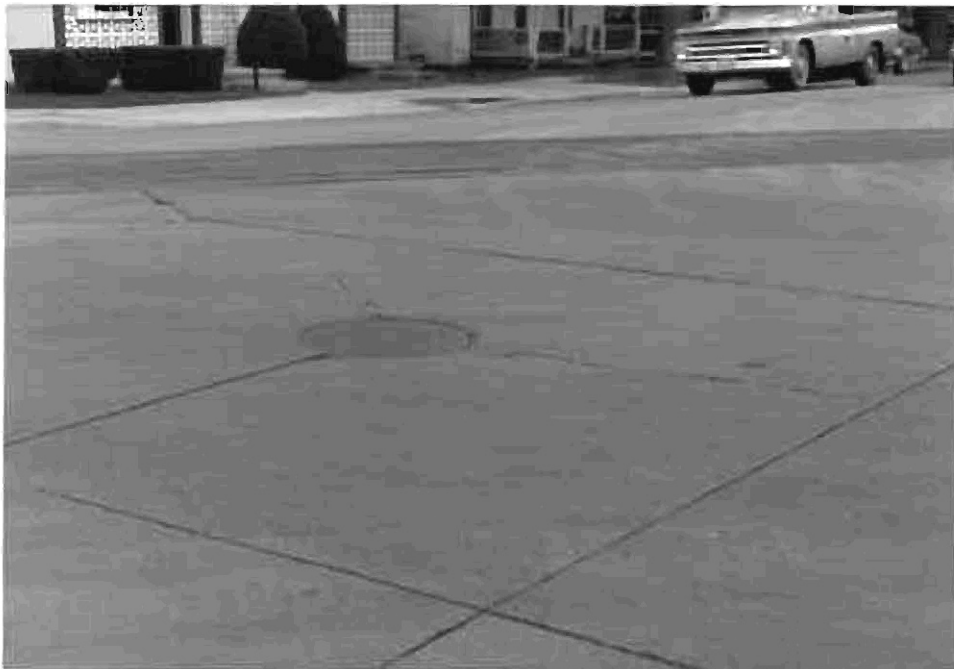
Photograph 4 shows some diagonal cracks which are believed to be caused by the irregular spacing of the joints at the transition between the manhole and the adjacent slabs.

Photo 4: Formation of diagonal cracks due to presence of manhole and/or irregular joint spacing.

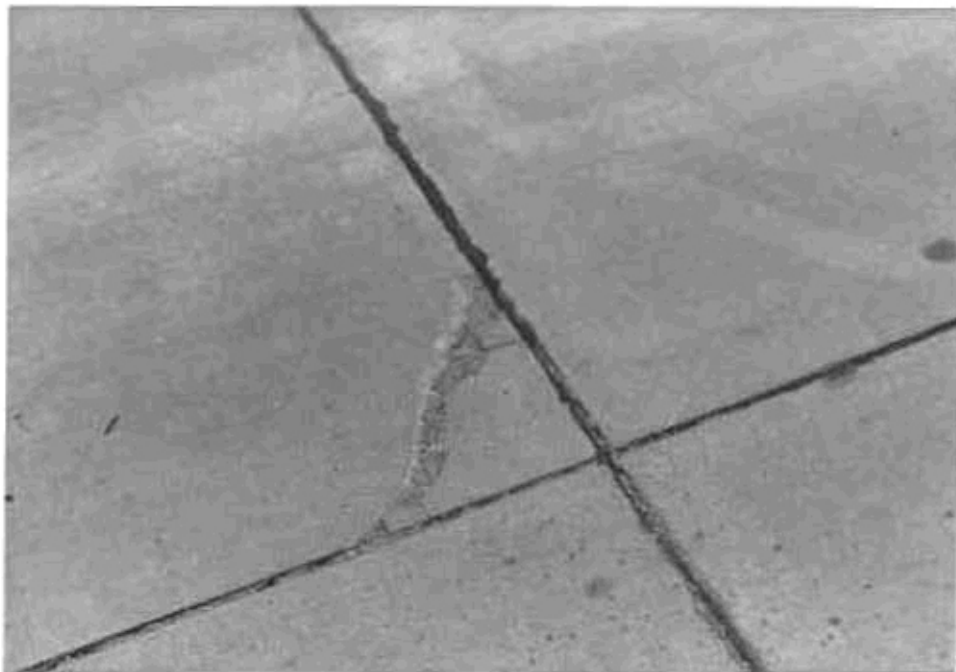
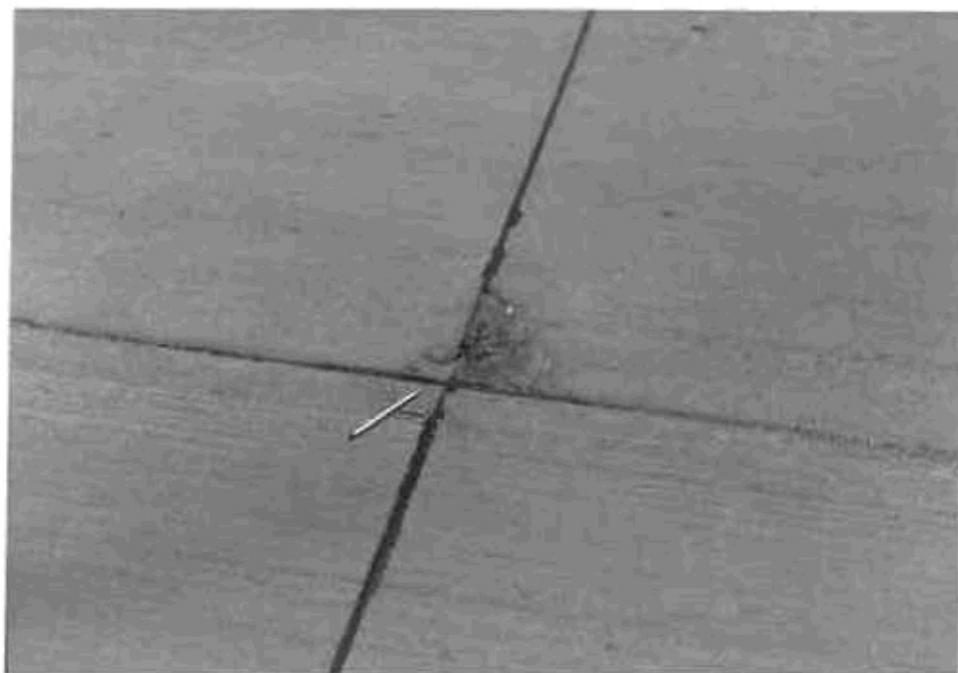
Minor corner breaks were noted at few isolated locations (Photograph 5 and 6). These types of failures are primarily attributed to the lack of support or poor load transfer (non-doweled concrete slabs). It is CDOT's standard practice to not use load transfer devices for facilities with speed limits of less than 45 mph.

Photo 5&6: Minor corner breaks noted at two locations.

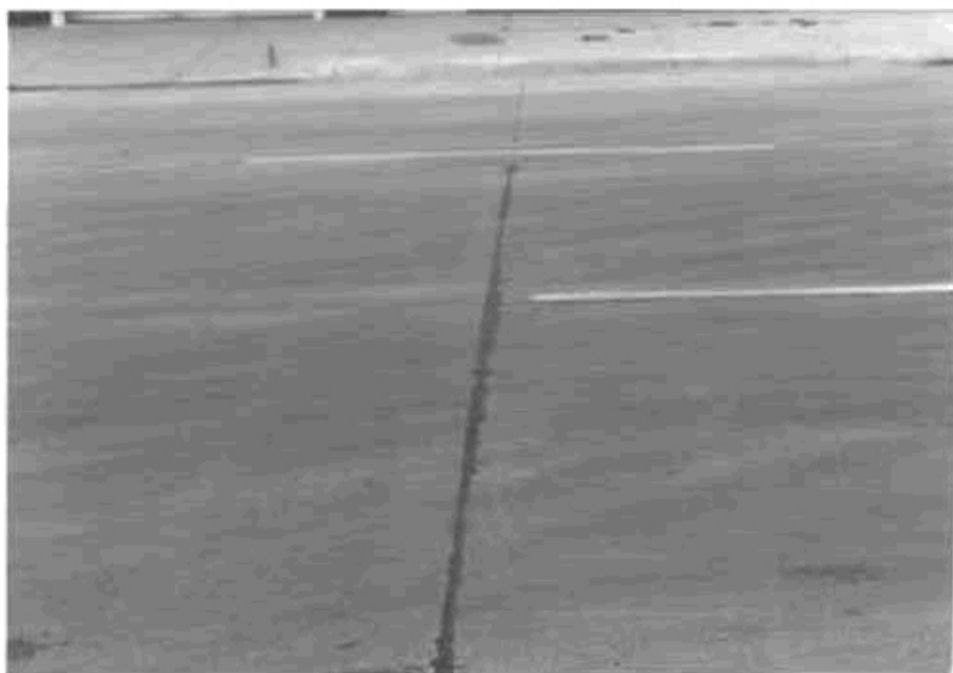
related failures. The joints were overfilled with sealant material in many places (photograph 7). Cohesion, adhesion and extrusion failures were quite evident throughout the project as shown in Photograph 8.

Photo 7: Example of an overfilled joint.
