Guidelines for the Installation, Inspection, Maintenance and Repair of Structural Supports for Highway Signs, Luminaires, and Traffic Signals

1. Report No. FHWA NHI 05-036		2. Government Accession No.		3. Recipient's Catalog No.	
4. Title and Subtitle Guidelines for the Installation, Inspection, Maintenance and Repair of Structural Supports for Highway Signs, Luminaires, and Traffic Signals				4. Report Date March 2005

16. Abstract: This document provides guidance for the installation, inspection, maintenance, and repair of structural supports for highway signs, luminaires and traffic signals. The primary purpose is to provide owners with information that can assist them in managing their inventory, identifying potential problem areas, and ensuring safe and satisfactory performance of these types of ancillary highway structures. The primary reason for compiling this guidance is increasing problems with wind induced vibration, fatigue, and even structural collapse of these support systems. Documented problems with these structures include questionable design and details, poor fabrication practices, and poor installation techniques.

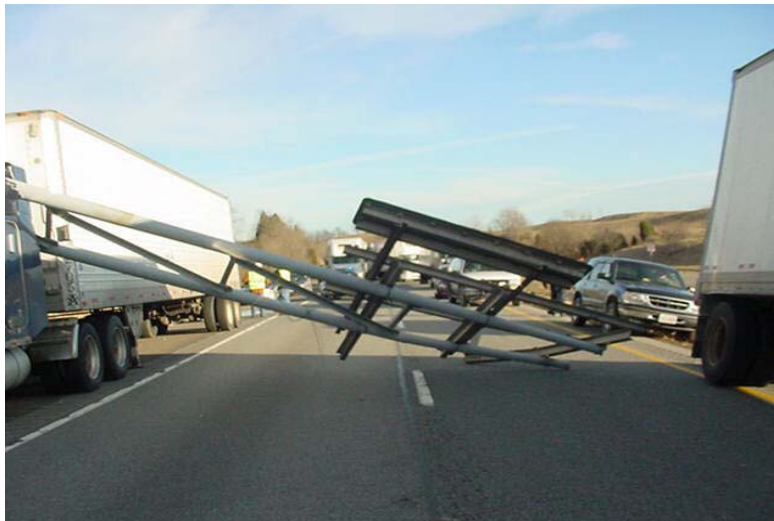
Figure 1. Cantilever Sign Structure Failure.

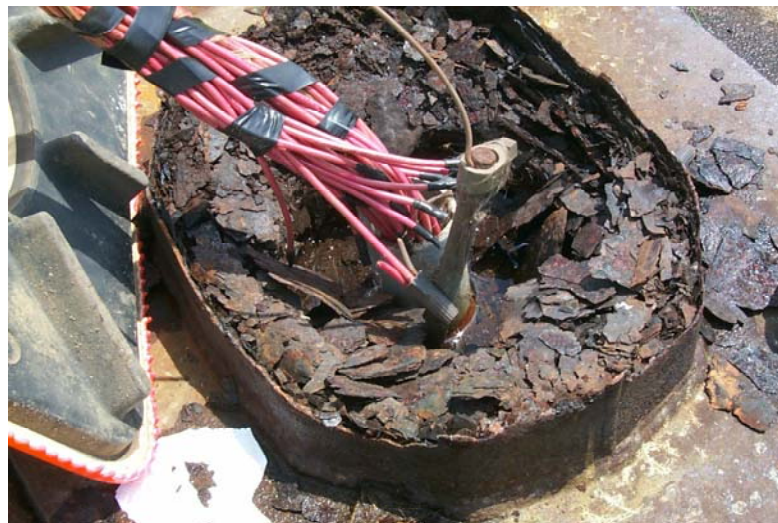
Figure 2. Failure of Weathering Steel Pole. Note the Corrosion Product.

Areas of particular concern for corrosion of weathering steel ancillary structures are the internal corrosion of tubular members, and corrosion in the mating surface of slip joint connections. Tubular members will corrode on the inside if water or an electrolyte is able to continuously contact the surface. Members should contain drain holes and be detailed so that locations are not created where moisture can pool, or debris collect. Figure 2 shows the base of a weathering steel light pole that collapsed due to corrosion at its base. Slip joints draw water into the joint through capillary action. As this area does not dry well, pack rust develops which can generate sufficient force to split the tube vertically, starting at the bottom of the joint. Painting the slip joint surface before assembly, or sealing the bottom edge of the joint are two methods of improving the performance of this area.

Weathering steel bases may also experience premature corrosion when they are buried in soil or covered by vegetation.

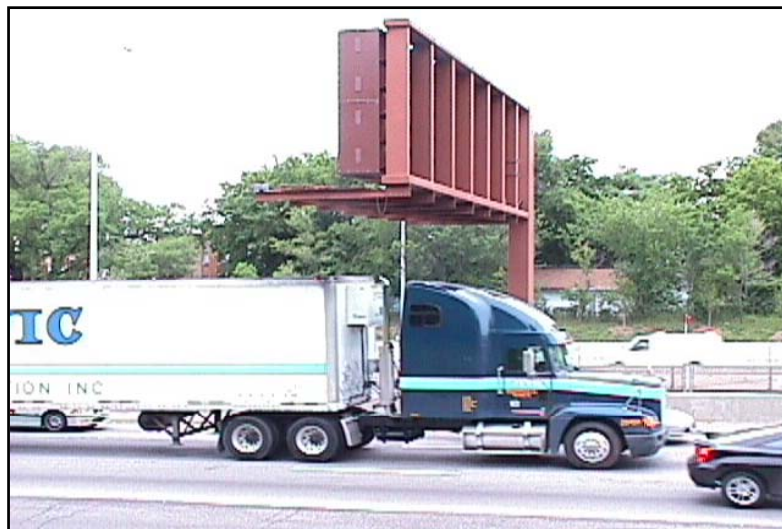
Figure 3. Truck Passing Under VMS.

The passage of trucks beneath support structures induces both horizontal and vertical gust loads on the structure, creating a motion that is primarily vertical but may also include a significant horizontal component as well. The magnitude of the horizontal truck gust is negligible relative to the natural wind gust and is therefore ignored in the specifications. The vertical truck gust load in the specifications is an equivalent static pressure range applied to the underside of the mast arm or truss and any attachments. Due to the large depth of variable-message signs (VMS) in the direction of traffic flow (up to 1.2 m for older signs), the support structures are the most susceptible to truck-induced wind gust fatigue because they present a large area in the horizontal plane, as seen in Figure 3.

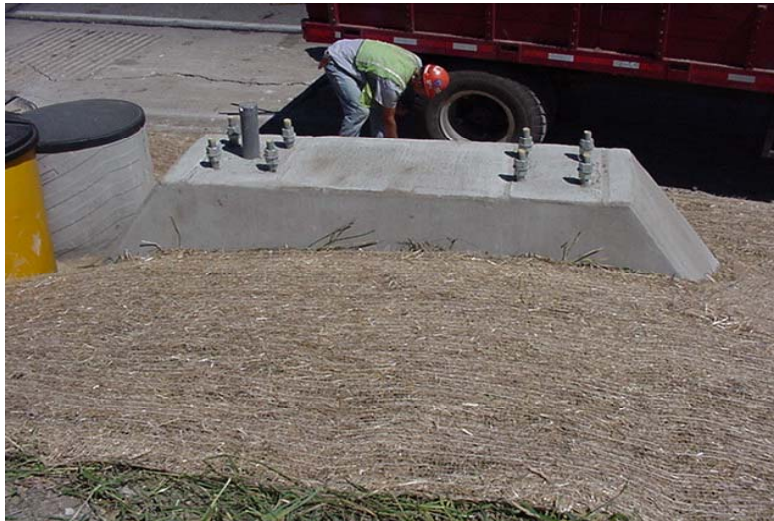
Figure 5. Foundation Ready for Structure Installation.

The erector should verify that the foundations are set to the proper elevation and anchor rods are set in the correct pattern and orientation, are of the correct size, and are plumb with the specified extension and thread length above the top of concrete, as seen in Figure 5.

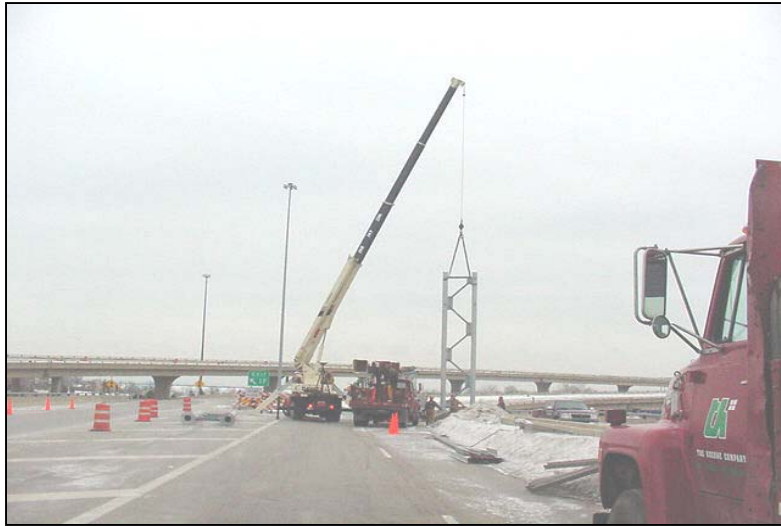
Figure 6. End Frame Being Set Onto Its Foundation.

The actual erection process begins by placing and leveling the leveling nuts. Typically, the bottom of the leveling nuts are set approximately 6 mm (0.25 inches) above the top of the concrete. The posts or end frames are then erected on the anchor rods (Figure 6), being careful not to damage the threads on the anchor rods. The base plate should be leveled by bringing up the leveling nuts on the low sides. To minimize shear and bending in the anchor rods, the bottom of the leveling nuts must not be more than one anchor rod diameter above the

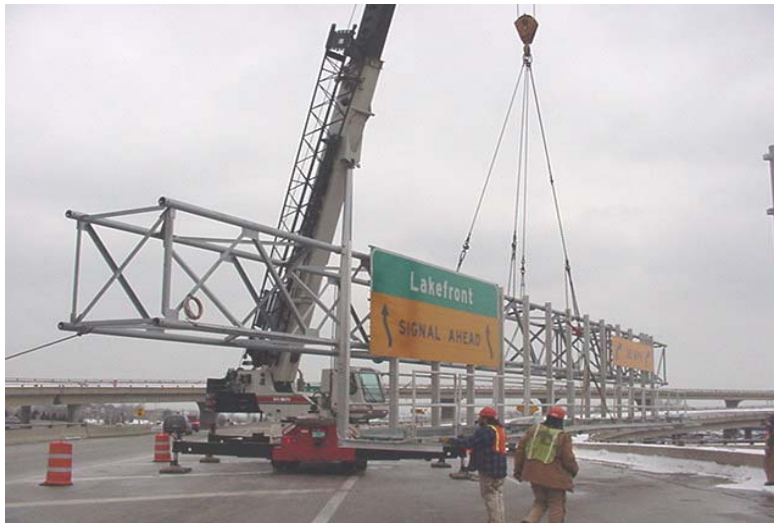
Figure 7. Assembled Truss Being Lifted Into Place.

For sign bridges, the sections (if there are more than one) are normally connected to one another on the ground and set in one lift. Lifting points must be located so that the bridge is not overstressed during lifting, (Figure 7). With the bridge set on the end supports, alignment should be verified and connections brought up to final tightness. With the cantilever arm, or bridge in position, a check of overhead roadway clearance should be performed and documented.

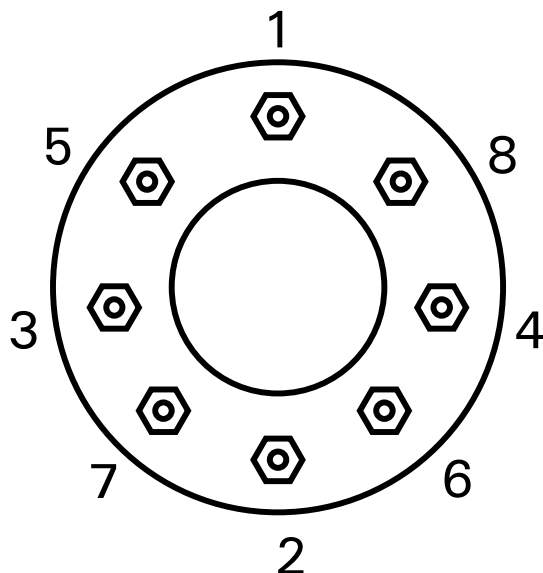
Figure 8. Star Pattern Tightening Sequence.

sheets of other metals) should not be placed between these flanges, even to try to achieve better contact. Tightening of bolts should be performed in a manner that brings the faying surfaces up “evenly.” For flange type connections, a star tightening pattern as shown in Figure 8 is recommended.

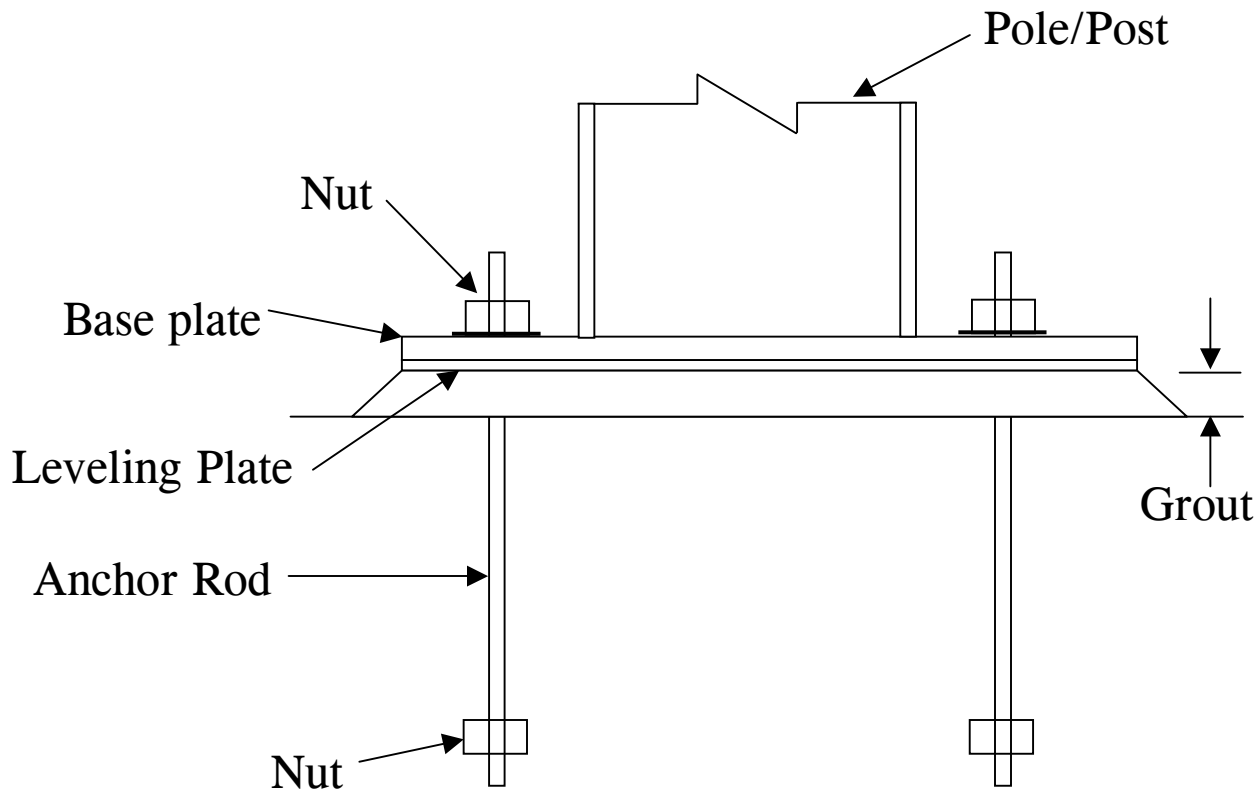
Figure 11. Threaded-Shear-and-Uplift Joint.

The threaded-shear-and-uplift joint rests directly on the concrete or on a grout pad (Figure 11). The base plate is held down by nuts atop the base plate. Single nuts are most common, but double nuts are sometimes used. For proper joint performance, the base plate must be in direct contact with the grout and not be supported by leveling nuts or shim packs. One technique to achieve full grout support is to set the base on shim packs to proper elevation, grout the base and then remove the shims and grout the resulting voids. Only then can the anchor rods be fully pretensioned. Use of proprietary prepackaged grout mixes, so called “non-shrink grout” is recommended and should be carefully installed to manufacturers’ recommendations. The threaded-shear-and-uplift joints can develop some resistance to bending moment as a couple between compressive bearing force on the grout and tensile forces in the anchor rods. It may be difficult to retain the pretension in the anchor rods under cyclic loads as the base plate wears the grout. For these reasons, this type of joint is not recommended by NCHRP Report 469 for large cantilevered support structures, although it is still commonly used for many luminaires and small traffic signal supports. This type of joint is suitable for bridge support structures where there are multiple posts.

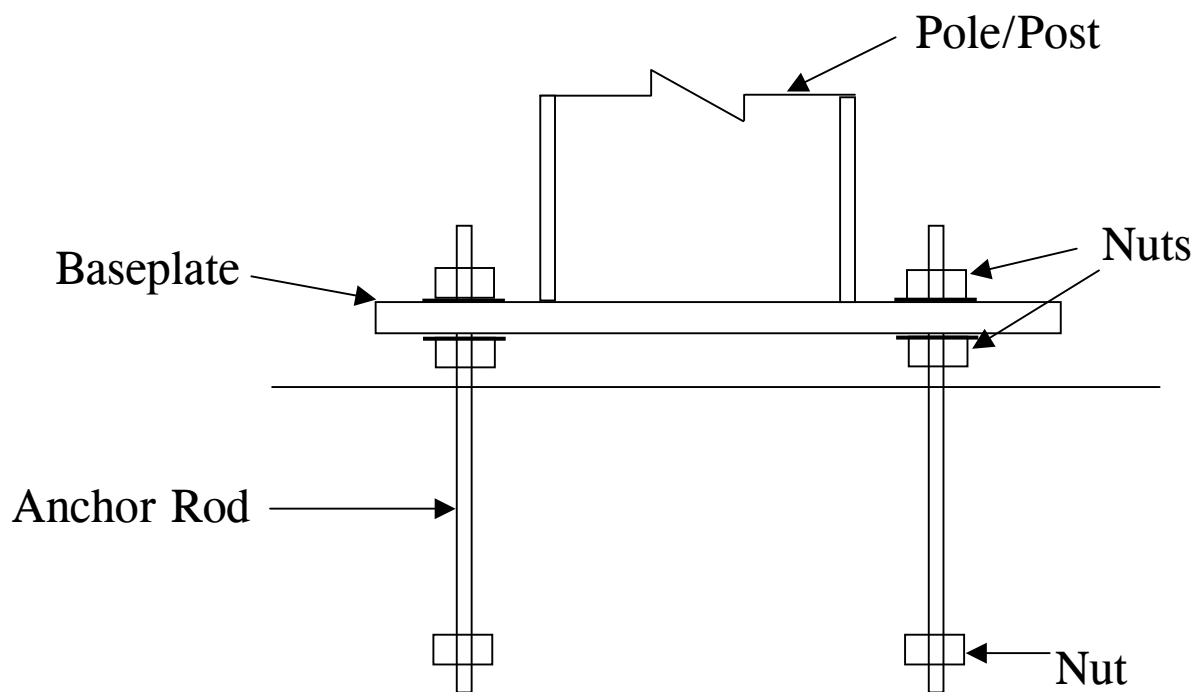
Figure 12. Double-Nut-Moment Joint.

In double-nut-moment joints, the base plate stands off from the concrete foundation and bears on leveling nuts (Figure 12). Thus, the base plate is attached to anchor rods through double nuts: the leveling nut and a top nut (or nuts). This type of joint may be suitable for any type of support structure and is required for cantilevered support structures designed by the 2001 Specifications. Washers should be used under both nuts, and beveled washers should be used if the misalignment exceeds 1:40 for the double-nut-moment joints. Double-nut-moment joints are easy to level and plumb and are also very reliable for transmitting moment to the foundation; therefore, they are satisfactory for non-redundant structures and seismic or fatigue-loaded structures such as highway sign, signal, and light supports.

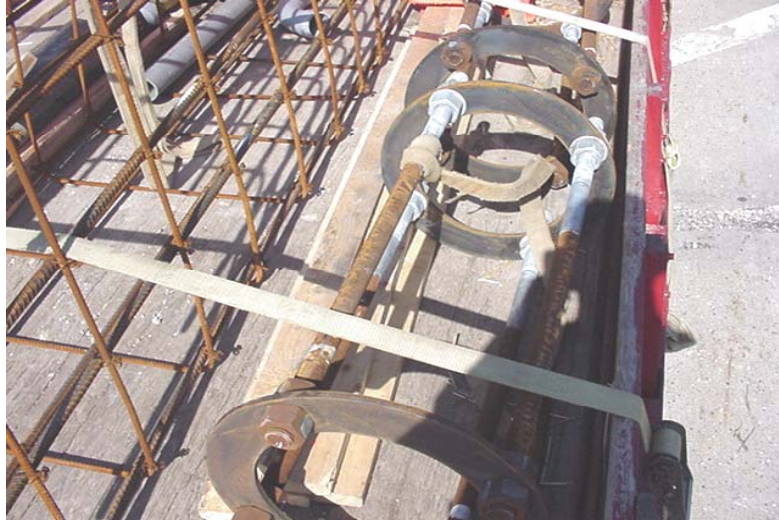
**Figure 13. Four Anchor Rod Group in a Template.
Note Top is Galvanized.**

1. Anchor rods should be installed as a group and should be secured against relative movement and misalignment, such as with a template set composed of rings with nuts on both sides at two locations along the length of the anchor rods. One of the plates or rings is usually above the top of concrete and is reused as a template, see Figures 13 and 14.

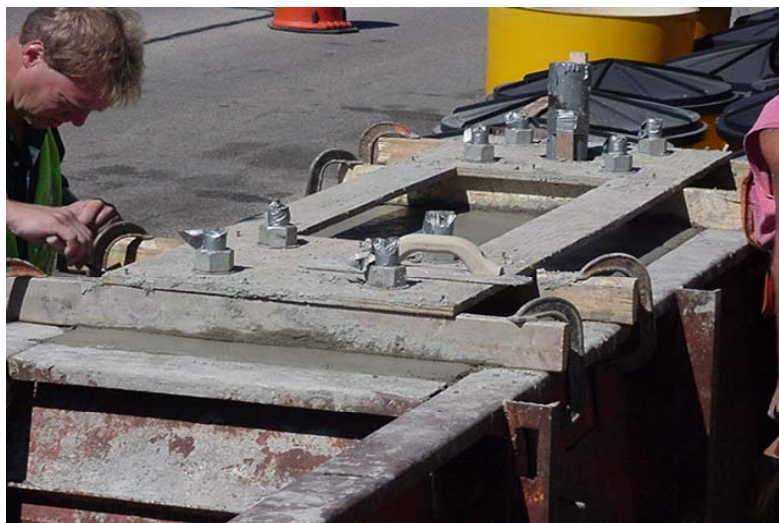
**Figure 14. Template Secured to the Forms to Ensure Proper Alignment.
Note Anchor Rod Threads Taped to Prevent Contamination by Concrete.**

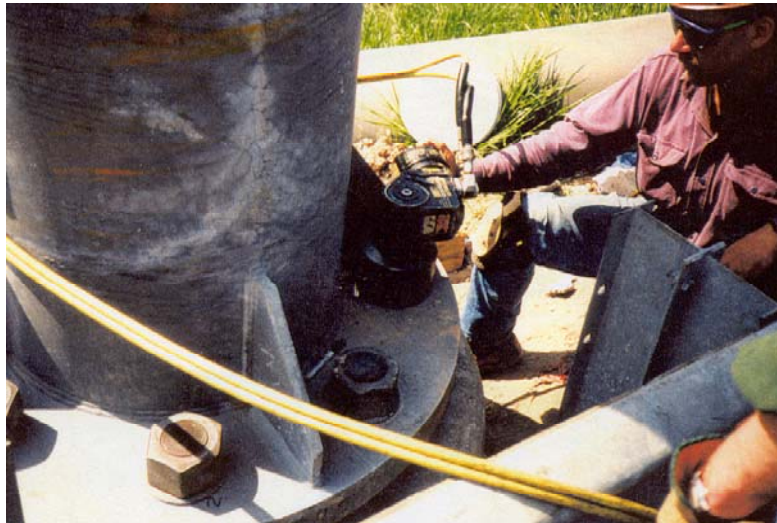
Figure 15. A Hydraulic Torque Wrench Tightening Anchor Rod Nuts to Achieve Needed Rotation.

- ◆ A hydraulic torque wrench (Figure 15) or
- ◆ A box end "slug" or "knocker" wrench with a 3 meter (10-ft), long pipe or extension handle.

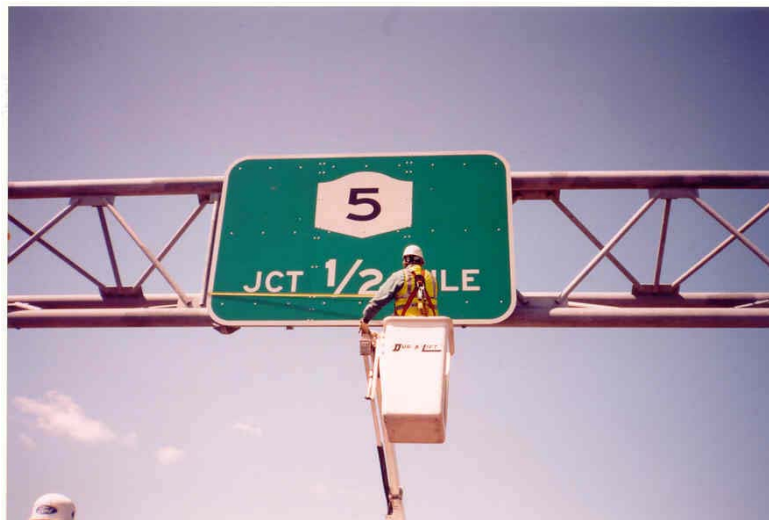
Figure 16. Inspector Measures Sign Panel During Inventory/Inspection Operation.

For these reasons the initial collection of inventory information on ancillary structures is critical. Key pieces of information include route, milepost, GPS coordinates, route association (if not on mainline), county, town, etc. Photos and sign measurements are important to help identify structures, as seen in Figure 16. The following section on database development gives a complete listing that has been used in New Jersey for inventory purposes.

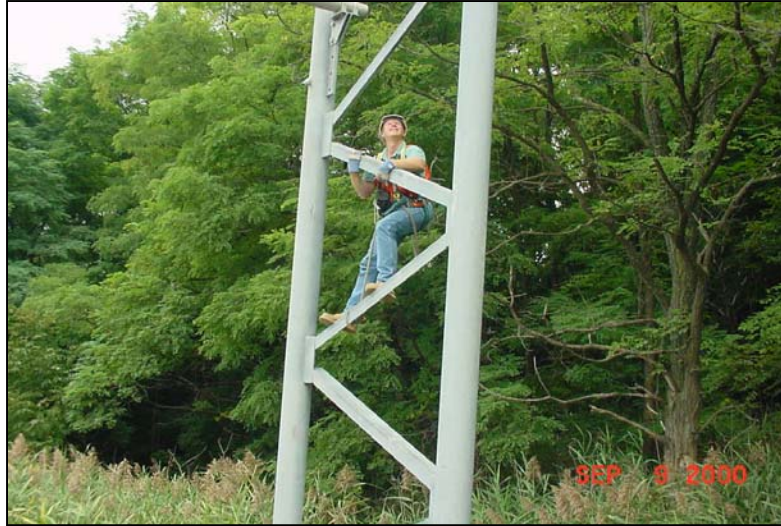
Figure 17. Inspector Climbing Structure.

While free climbing from the shoulder or with ladders, Figure 17, can access many sign structures, the most typical way the sign structure is accessed is by use of a vehicle mounted access bucket, Figure 18. These vehicles are commonly used by cable and telephone companies and are readily available for rent. For most ancillary structures a 30' boom is sufficient. Access vehicles must be operated in accordance with required safety procedures.

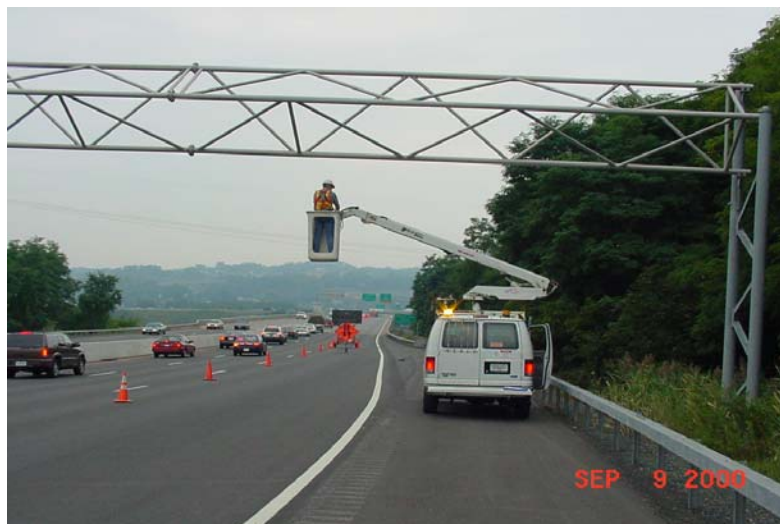
Figure 18. Bucket Truck-Most Common Way to Access Sign Structure.

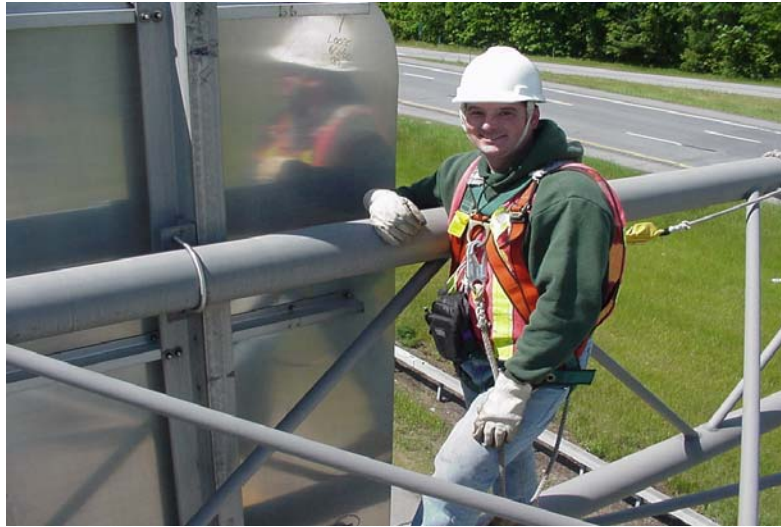
Figure 19. Inspector Uses Double Lanyard System.

When climbing a sign or other ancillary structure a two lanyard system offers the best protection with one lanyard always secured to the structure, see Figure 19. Good gripping boots similar to ones a mountain climber would use are recommended. To perform a climbing inspection everything worn or carried by the inspector must be securely attached to him/her so nothing can drop or hang below the bottom of the structure. The reporting of inspection findings may be handled by use of a radio attached to the inspector through which findings are relayed to a notetaker on the ground. Since the traveling public may be concerned when observing someone climbing a sign structure, some states place a variable message sign stating "Workers Overhead" as informational aid.

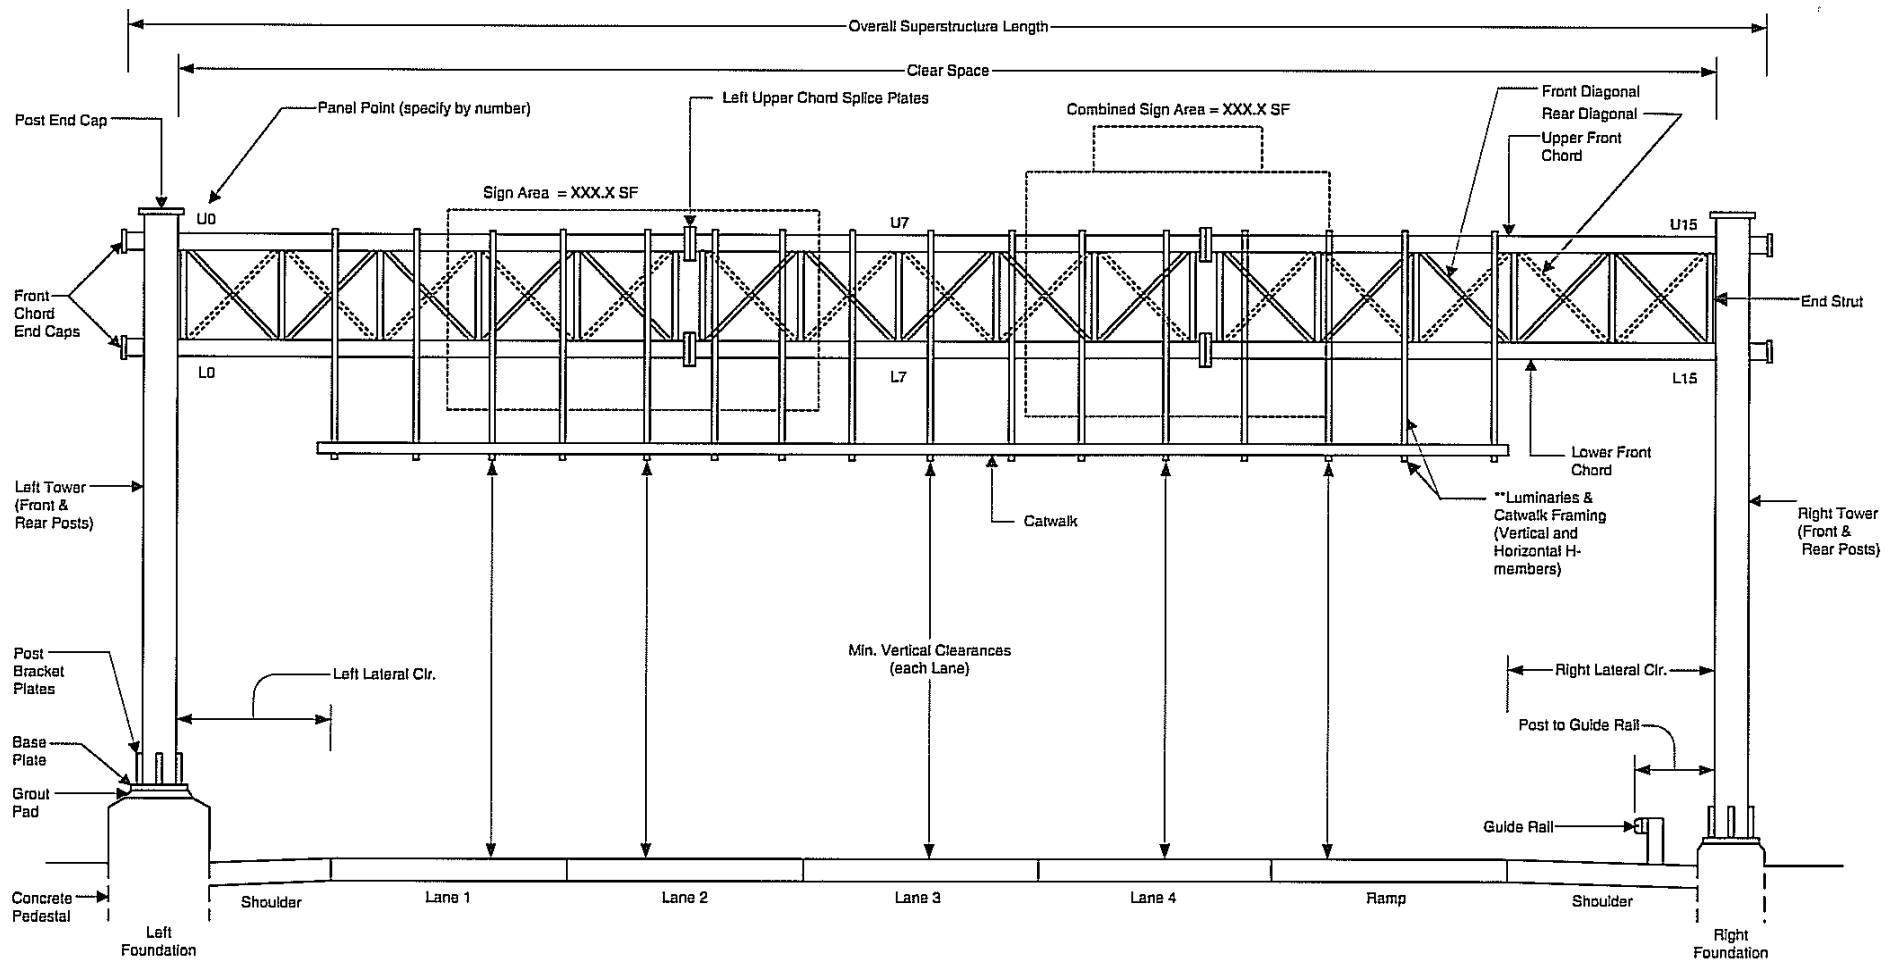
Figure 20. Nomenclature Associated with Sign Bridge.

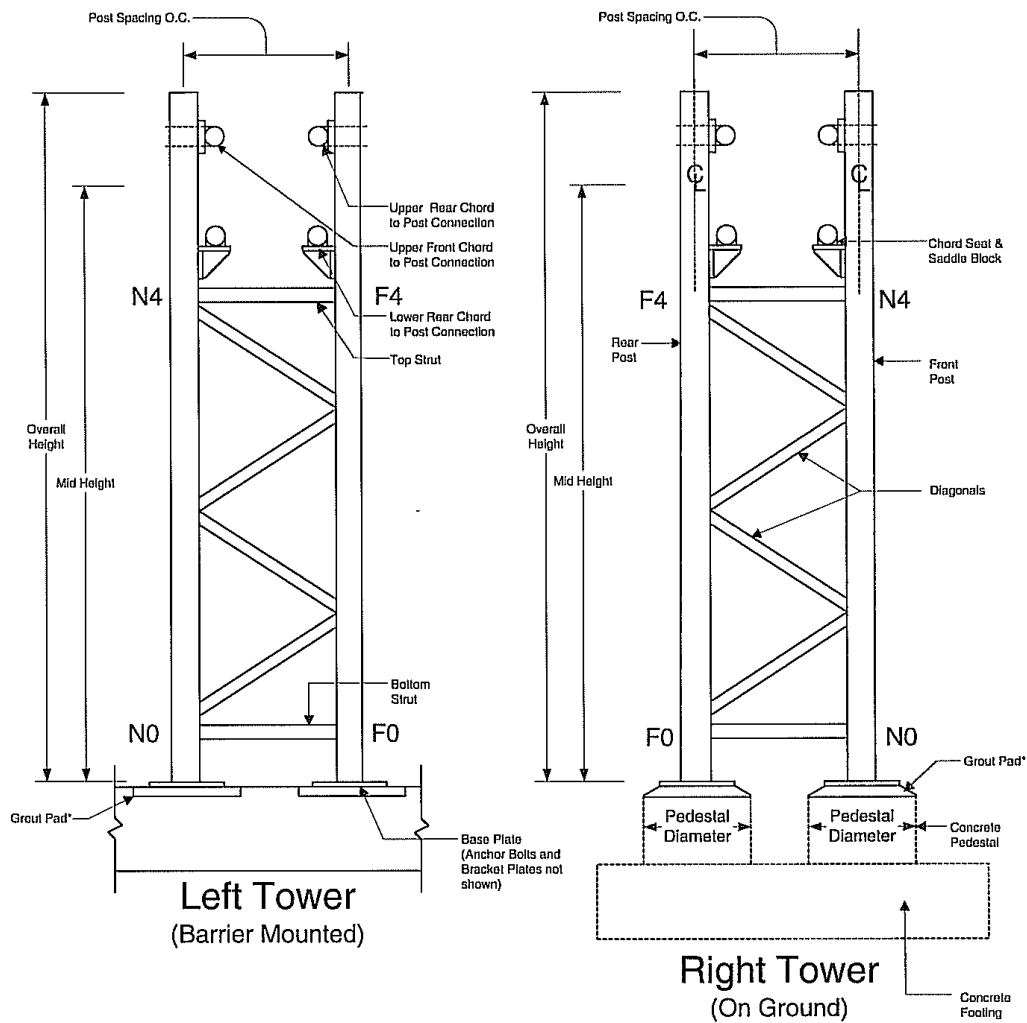
Note: Use of grout pad is optional.

Figure 21. Nomenclature for Ancillary Structure Tower Supports.

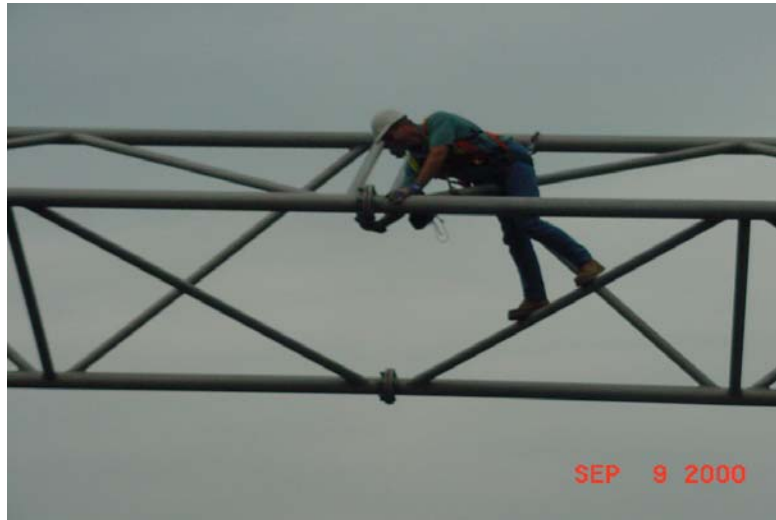
Figure 25. Hands on Inspection of Overhead Signs.

The inspection of ancillary structures requires a 'hands on' approach. To check for structural deficiencies it is necessary for the inspector to access all critical locations, often by climbing. The inspector wears a safety harness with two lanyards so that he/she is tied off to the structure at all times. The inspector carries many tools such as electronic and tape measuring devices, wrenches to tighten loose hardware, marking tools and mirrors to see the underside of welds. Nondestructive testing (NDT) equipment may or may not be required. Figure 25 shows a visual inspection of a chord splice connection for an overhead sign truss.

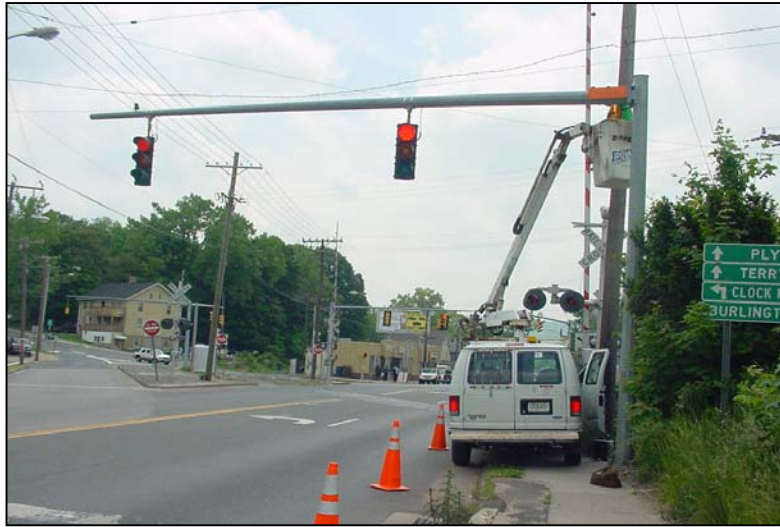
Figure 26. Inspection of a Mast Arm Structure.

The inspection of mast arm structures and signal supports proceeds generally the same as for a sign structure, working from the base on up, see Figure 26. For many of the mast arm and signal supports, the anchor rod nuts are covered by a cap. These must be removed to examine the top nuts, even if removal results in damage. Damaged caps should be reported for future replacement, or the inspection team may be supplied with spares for installation.

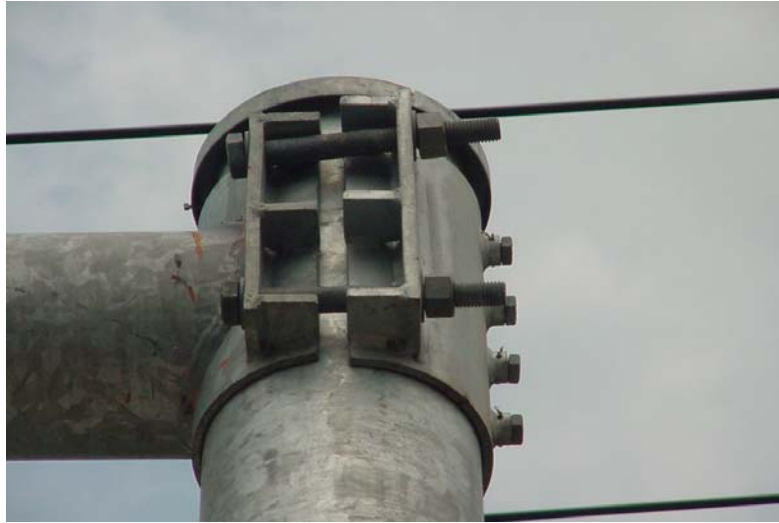
Figure 27. Post to Arm Connection Showing Poor Fit-Up Due to Use of Incorrect Components.

The mast arm to pole connection should be carefully examined. A wide variety of post to arm connections are used. Loose and missing bolts, misaligned fasteners, and weld cracks are often found (Figure 27). Mast arm to post connections where the post connection consists simply of two side plates welded to the pole with a face plate that accepts the bolted arm connection have been found especially susceptible to cracks at the plate to post welds.

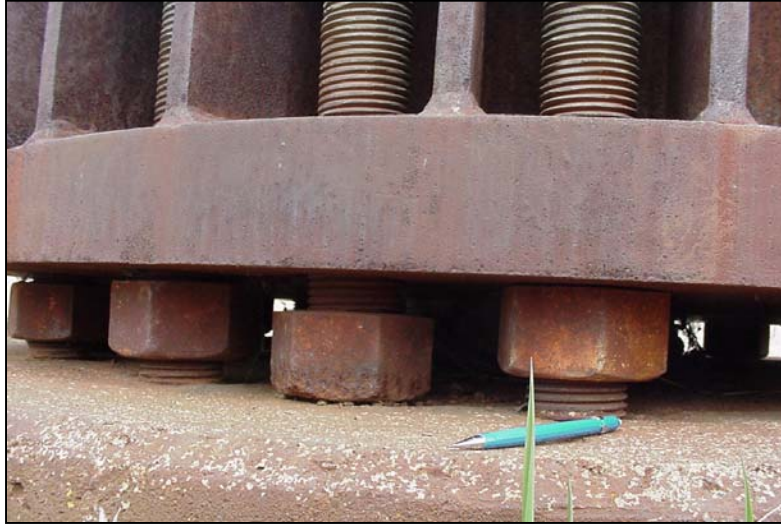
**Figure 28. Loose Leveling Nuts on a High Mast Structure.
(Note: Top Nuts on Chairs Out of Photo)**

For luminaire supports of modest height, say under 40 feet, anchor bolt inspection may require removal of bolt covers. Because these poles may oscillate however slightly in even modest winds, it is recommended that anchor bolt nuts be checked at both the beginning and end of the inspection. Leveling nuts should also be checked if accessible. Figure 28 shows loose leveling nuts on a high mast structure.

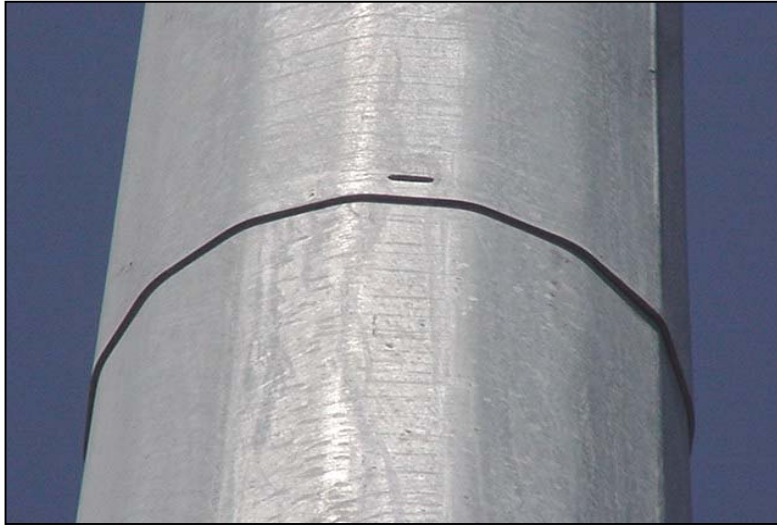
Figure 29. High Mast Pole Slip Joint.

High poles may consist of more than one section. These are “spliced” by use of a slip joint, as shown in Figure 29, in which the upper segment simply slips over the lower segment. The condition of this joint should be examined for cracks, deformation along the base of the connection, and rust stains. Slip joints, partly because of the tendency of water to be drawn into them by capillary action, sometimes experience corrosion between the two segments. This can lead to the build up of pack rust, particularly in weathering steel poles, that may lead to a vertical crack emanating from the bottom of the upper pole segment.

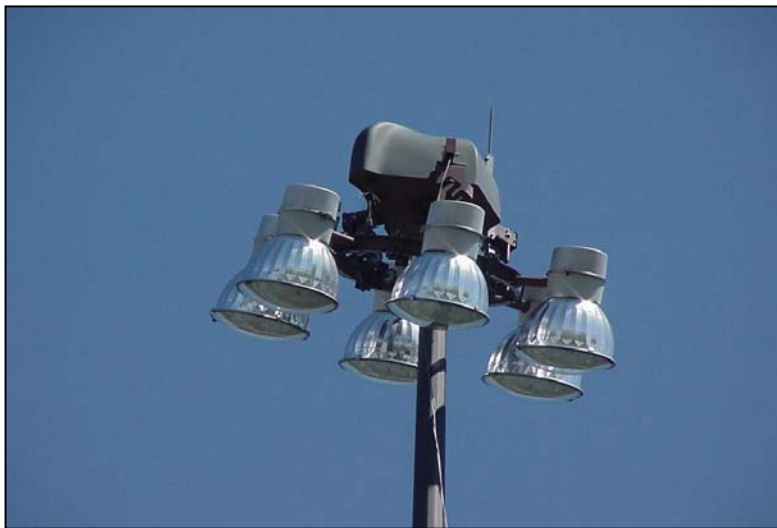
Figure 30. Misaligned Luminaire Ring.

Inspection of the luminaire ring is not usually part of the structural inspection. However, visual observation of any defects should be recorded for future inspection by appropriate personnel. Some defects noted in the luminaire ring may relate to mechanical or structural components and should be examined further. Figure 30 shows a misaligned luminaire ring which was found to be the result of a broken support cable.

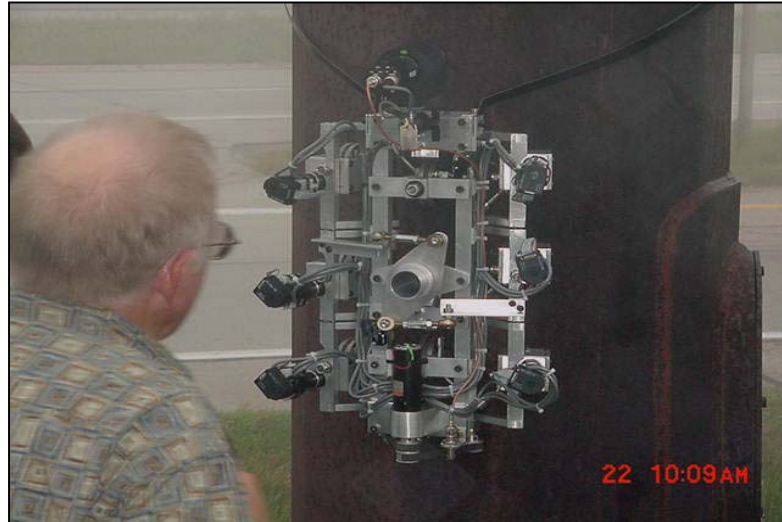
Figure 31. Remotely Operated Inspection Device.

while carrying a video camera and possibly other inspection equipment. Figure 31 shows one such device, developed by the Virginia Transportation Research Council. At present, these devices are difficult to maneuver and position and require increased inspection time. With continued development; however, they may become a tool for routine inspections, particularly of slip joints.

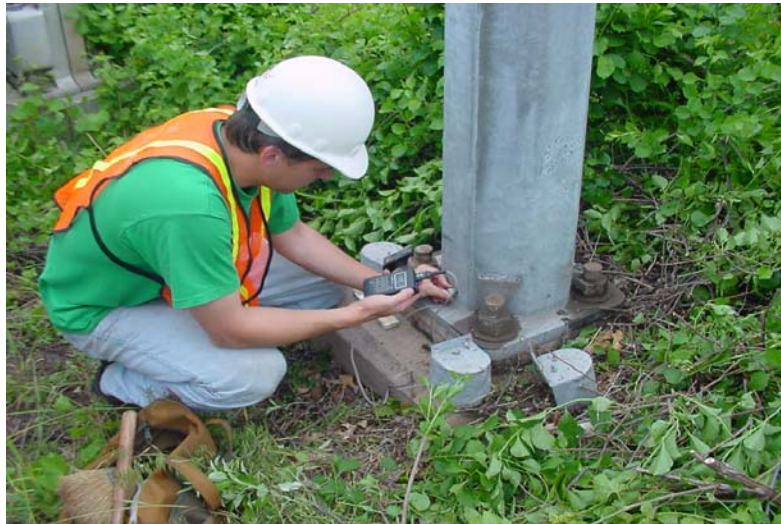
Figure 32. Thickness Measurement at Critical Location of Structure Post.

- ◆ Ultrasonic thickness 'D meter' measurements – Probably the most critical NDT for ancillary structures since failures have been attributed to interior element corrosion that cannot be visually detected (Figure 32). A simple ultrasonic thickness gauge can also be used to check anchor rod lengths and for possible fractures. More sophisticated ultrasonic flaw detection equipment can be used to examine anchor rods for possible cracks or other flaws. A test procedure for anchor rods is contained in Appendix B (Figure 33).
- ◆ Dye Penetrant Test – Excellent test for exposed welds in non-ferrous materials such as aluminum, as well as steel structures. It is usually used to confirm visual observation of a crack. Dye penetrant can help distinguish between cracks and surface defects such as galvanizing flaws which are crack like in appearance. Dye penetrant can only detect surface cracks.

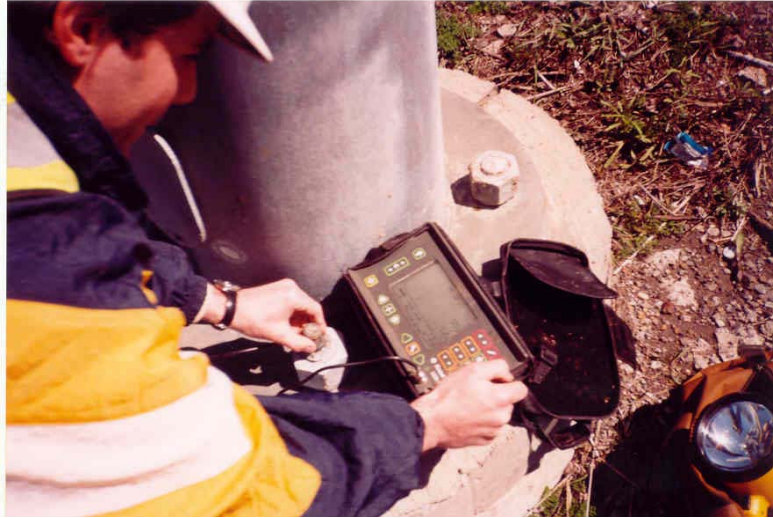
Figure 33. Ultrasonic Testing of Anchor Rods.

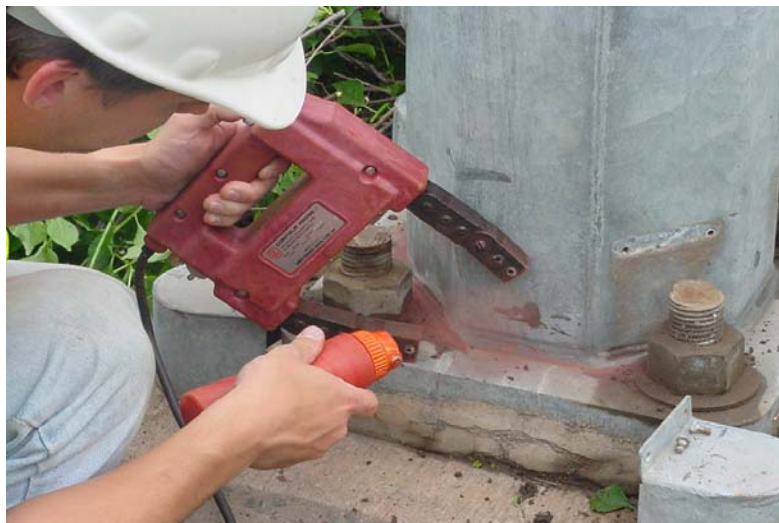
Figure 34. Magnetic Particle Inspection of Weld at Post to Base Plate Connection.

- ♦ Magnetic Particle Test – Excellent test of exposed welds in metallic materials such as steel, Figure 34. This technique can reveal “near surface” cracks as well as surface cracks.
- ♦ Eddy Current Test – Used for painted sign structures or aluminum structures to detect weld cracks where magnetic particle testing does not function due to lack of magnetic attraction.

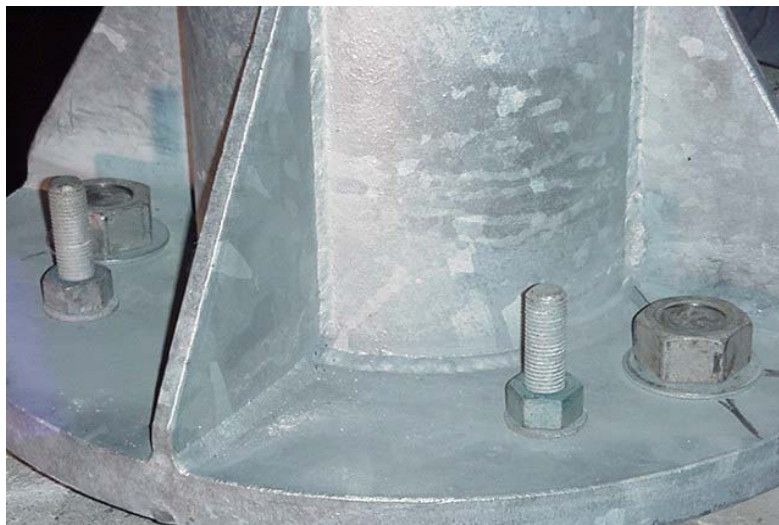
Figure 35. Base plate with Added Anchor Rods.

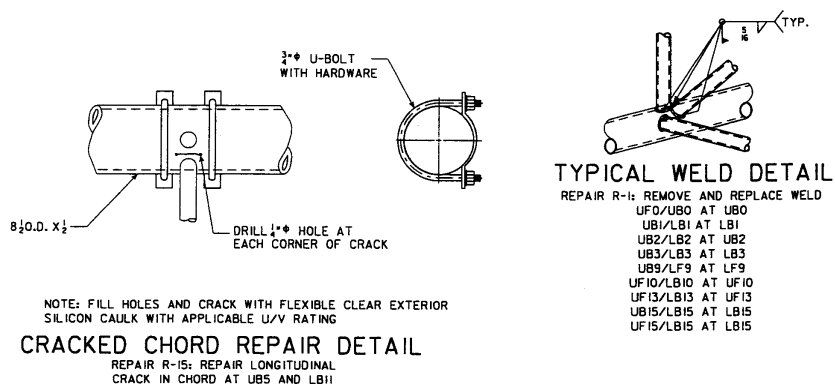
Figure 36. Repair Detail for Overhead Sign Truss Chord Crack.

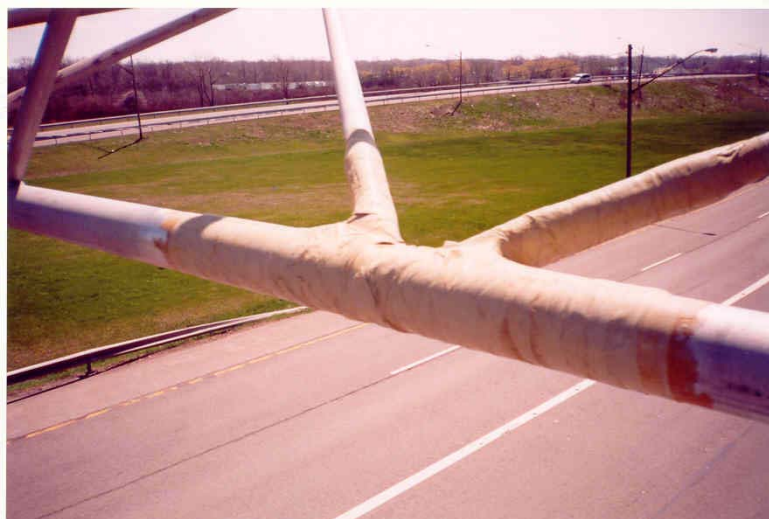
Figure 37. Repair of Truss Members Using FRP.

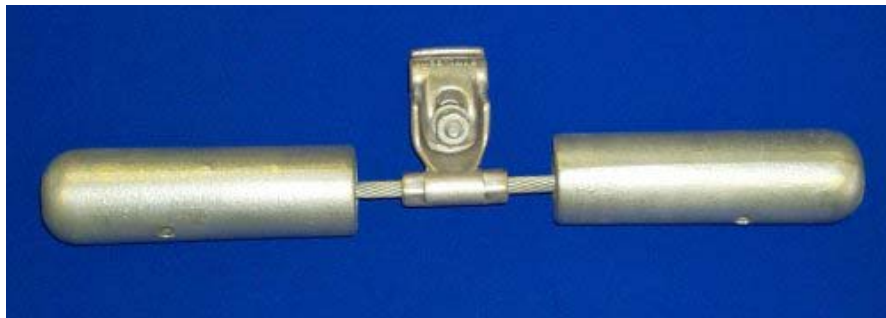
Figure 38. Stockbridge Damper.

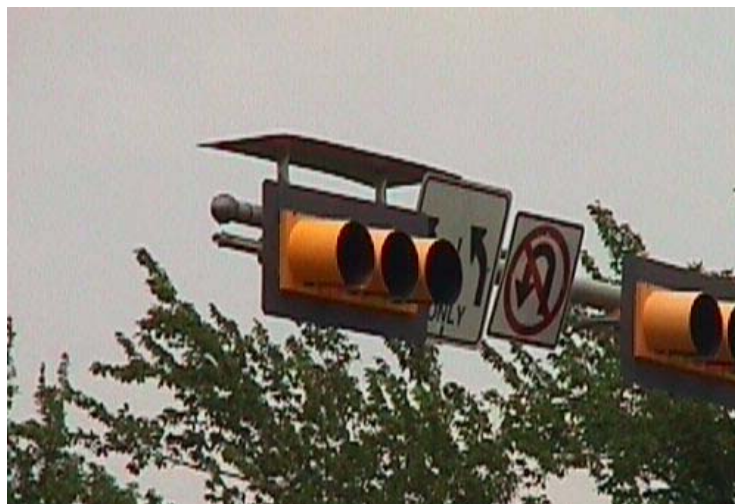
Figure 39. Texas Flat Panel Damper.

To counteract galloping of signal arms a flat panel called a sign blank can be installed horizontally directly over the signal head acting as a drag against the up and down motion. The sign blank must be correctly placed over the signal head to break the airflow. This type of dampener has been used in Texas, see Figure 39. Other dampeners developed include the Florida impact damper and the Wyoming strand damper.

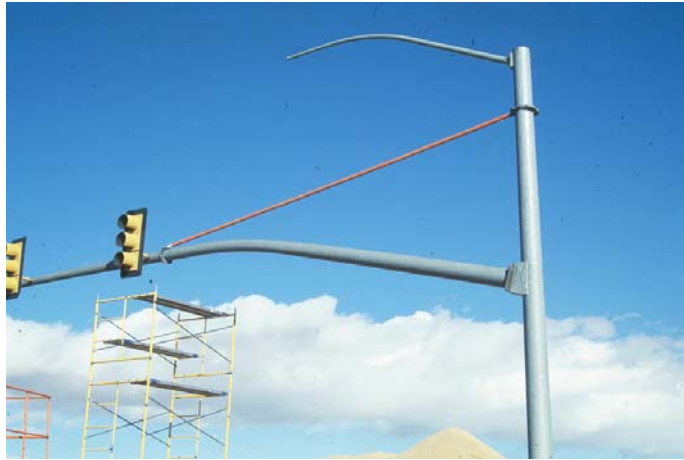
Figure 40. Wyoming Strand Damper.

For natural horizontal wind gusts the Wyoming strand damper, Figure 40, is also helpful as is any kind of horizontal strut that can reduce out of plane bending.

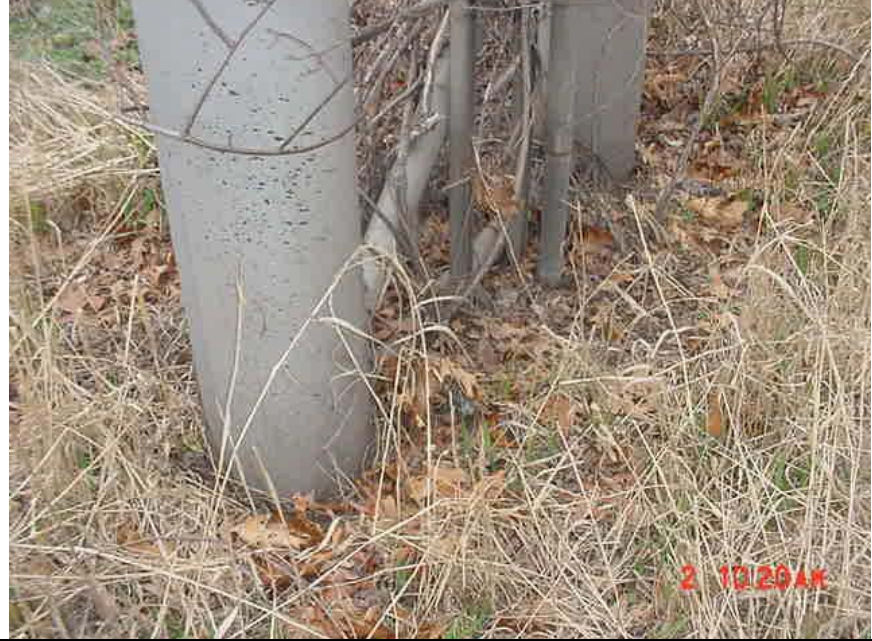
<p>Figure A1</p> <p>Buried Foundation S.01 rate as '0', Not Applicable. However, if opposite tower foundation is exposed, rate S.01 for that foundation, state in notes buried foundation and recommend as Priority 3 to expose.</p>

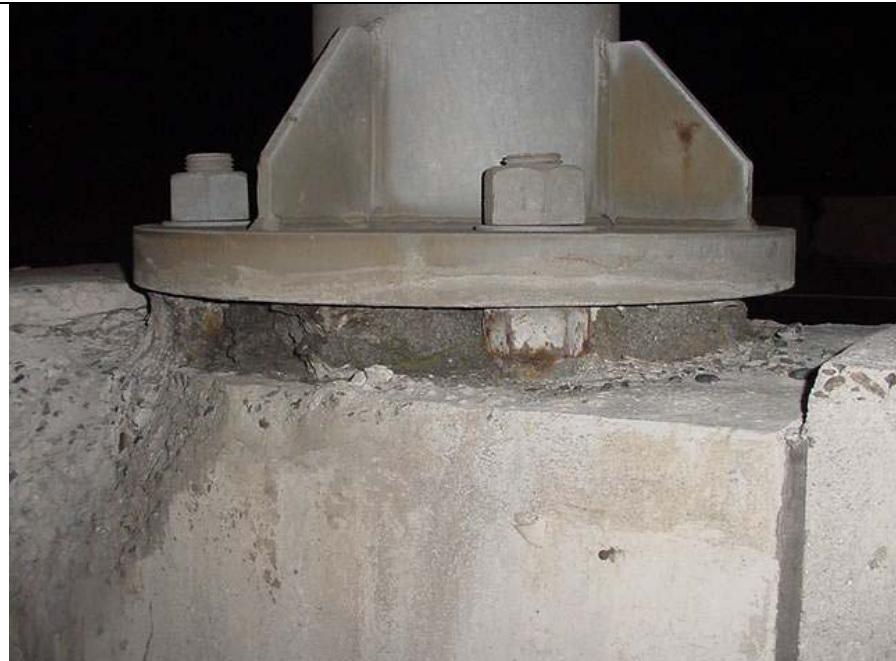
<p>Figure A2</p> <p>Deteriorated Grout Pad S.01 rate as 3, Priority 2 repair. Note also leveling nut corrosion (S.02 Item).</p>

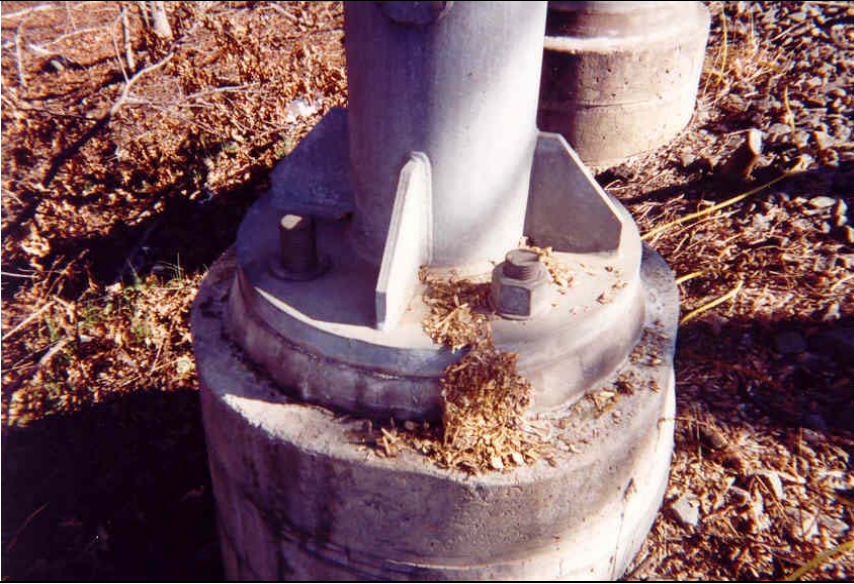
<p>Figure A3 Missing Anchor Nut. If Span structure, rate as 2, Priority Repair 2. If Cantilever structure, rate as 3, Priority Repair 1.</p>
