Guidelines for the Installation, Inspection, Maintenance and Repair of Structural Supports for Highway Signs, Luminaires, and Traffic Signals

1. Report No. FHWA NHI 05-036		2. Government Accession No.		3. Recipient's Catalog No.	
4. Title and Subtitle Guidelines for the Installation, Inspection, Maintenance and Repair of Structural Supports for Highway Signs, Luminaires, and Traffic Signals				4. Report Date March 2005

16. Abstract: This document provides guidance for the installation, inspection, maintenance, and repair of structural supports for highway signs, luminaires and traffic signals. The primary purpose is to provide owners with information that can assist them in managing their inventory, identifying potential problem areas, and ensuring safe and satisfactory performance of these types of ancillary highway structures. The primary reason for compiling this guidance is increasing problems with wind induced vibration, fatigue, and even structural collapse of these support systems. Documented problems with these structures include questionable design and details, poor fabrication practices, and poor installation techniques.

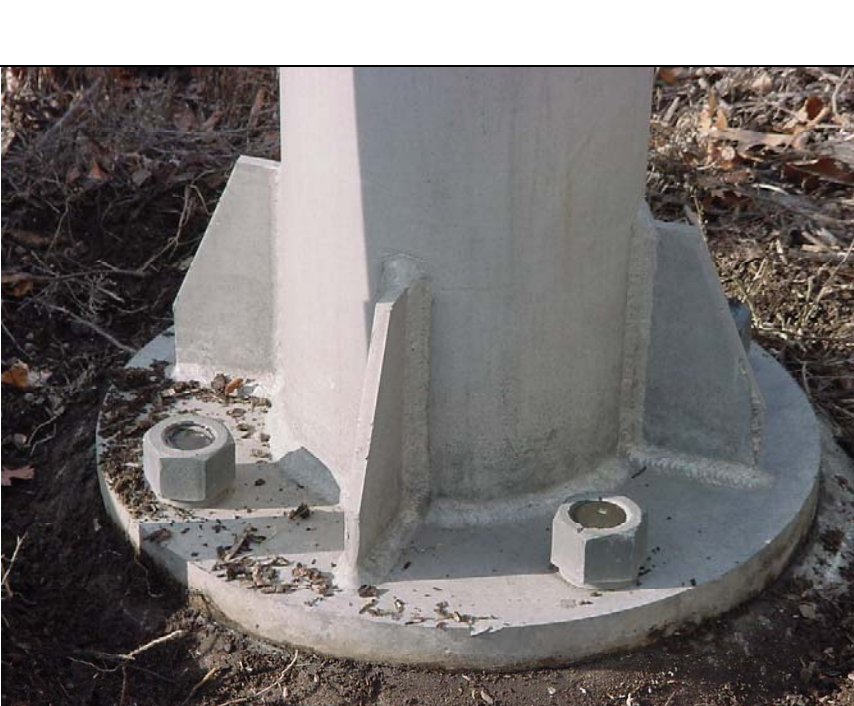
<p>Figure A4 Anchor rods not fully engaged. If 80% threaded, note on report, rate S.02 as '1', no repair.</p> <p>Loose Nuts (Washers Slip) Less than 50% slip, rate S.02 as '2', Priority Repair 2. More than 50% slip, rate S.02 as '2', Priority Repair 1.</p>

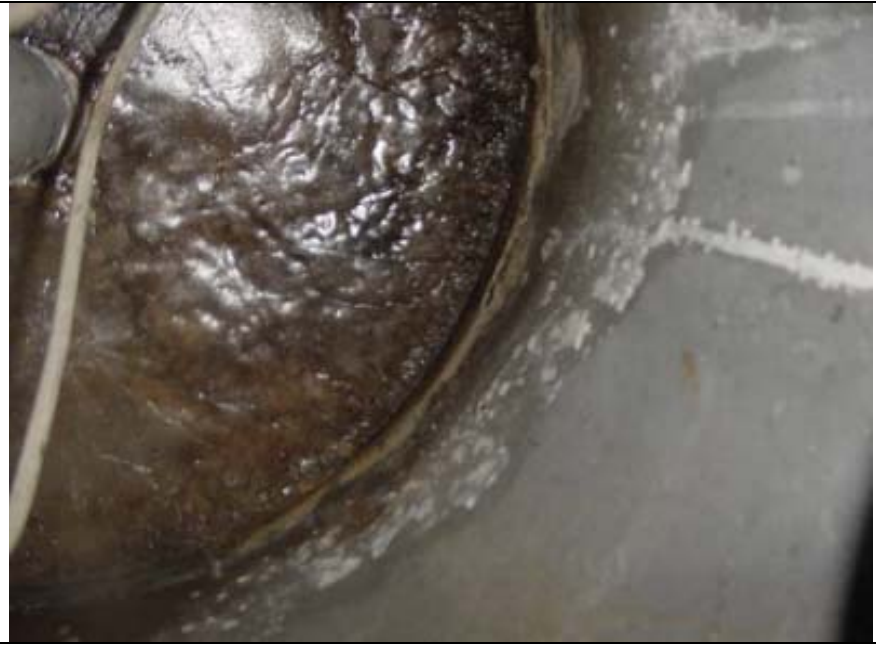
<p>Figure A7</p> <p>1" to 2" Band of surface corrosion at base of post. D-meter results indicate no overall section loss. Rate 2, Small reduction of reliability.</p> <p>However, if overall section loss in cantilever > 25%, rate 4, repair priority 1.</p>

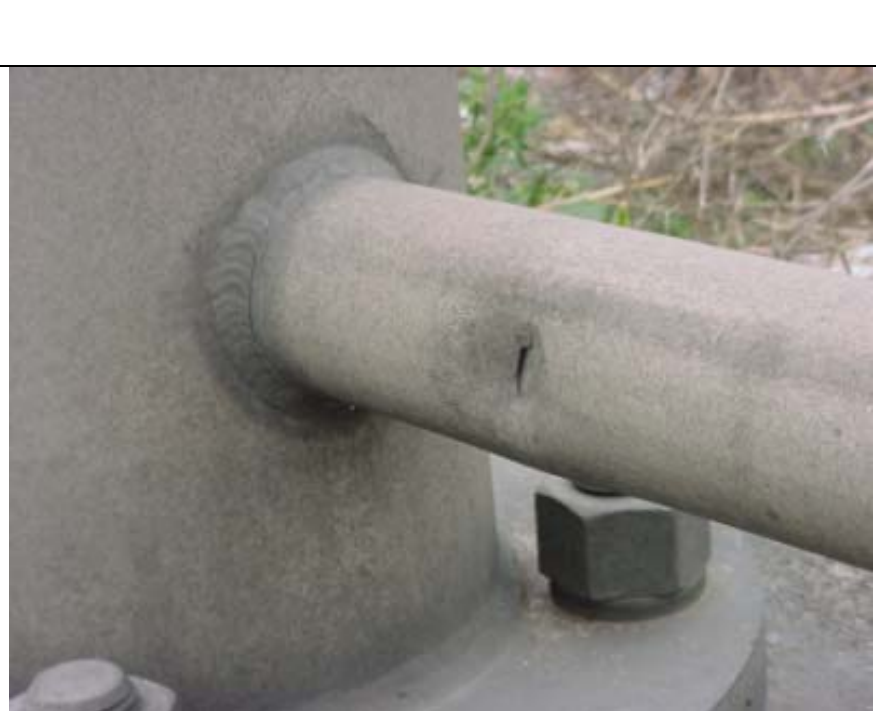
<p>Figure A8</p> <p>Dent, tear, and weld crack in first strut on tower.</p> <p>Rate as 2, Repair on Priority 3 basis.</p>

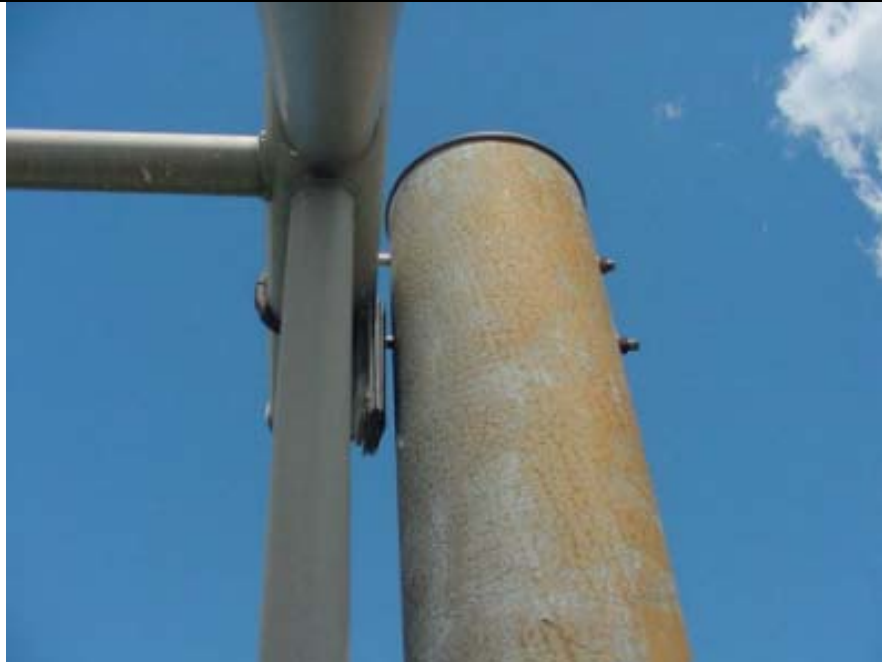
<p>Figure A9</p> <p>Gap between upper chord and shim pack and inadequate shim plate placement. Rate 2, Repair priority 3. Repair recommendation would be to properly place and add shim plates as necessary.</p>

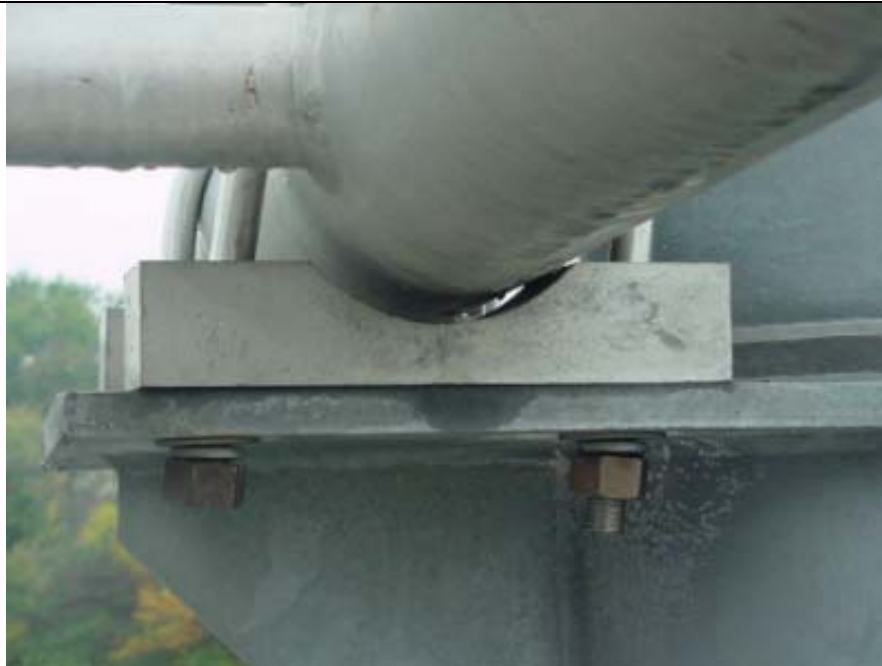
<p>Figure A10</p> <p>Gap between lower chord and saddle block, loose u-bolt. Rate 2, Repair as priority 3. Repair recommendation would be to add shims under saddle block to close gap at chord. The inspector would tighten the u-bolt during inspection.</p>

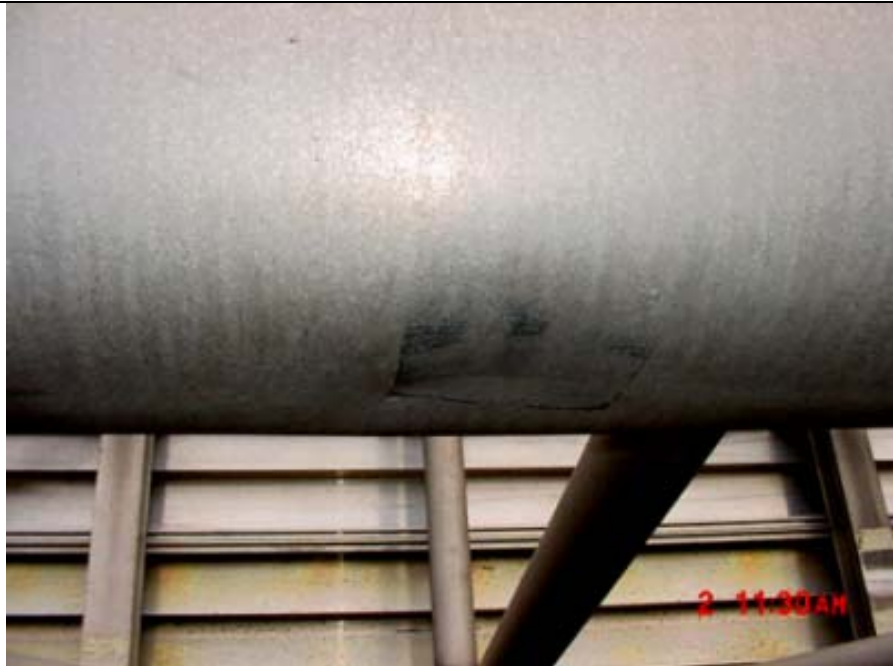
<p>Figure A12</p> <p>Minor 4" diameter ding in lower chord. Right rear end cap missing.</p> <p>Rate 2, Repair priority 3</p>

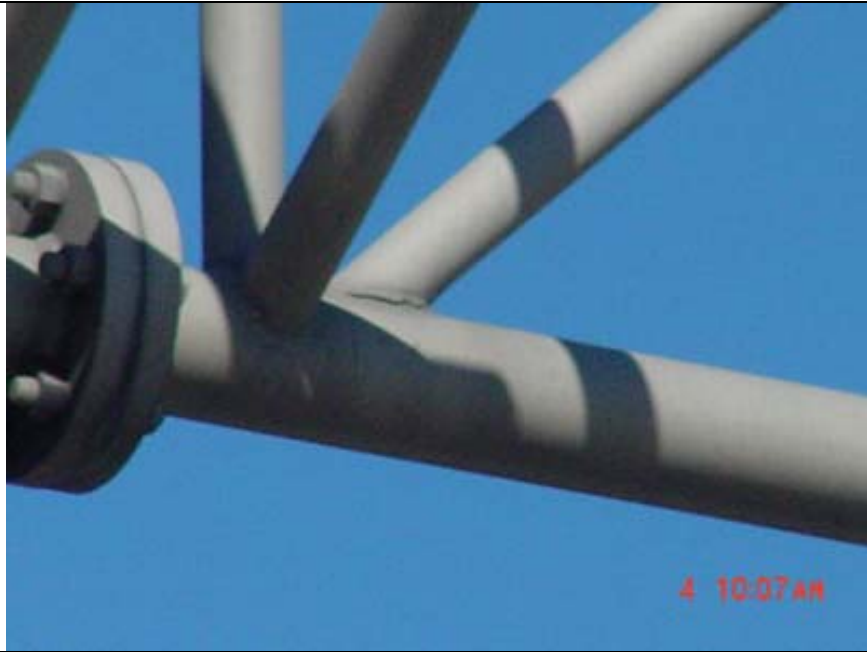
<p>Figure A15</p> <p>Weld crack in member U14 - L15 at L15. The weld crack is approximately 4" long x 1/8" wide and is propagating into the diagonal 1/2".</p> <p>Rate 4, Repair priority 1</p>

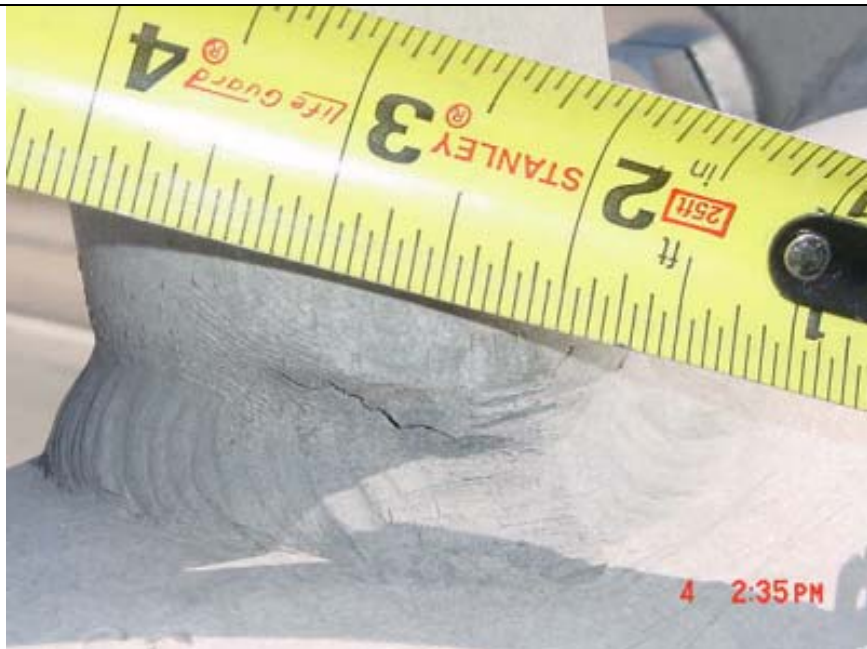
<p>Figure A16</p> <p>1" long weld crack at lower chord.</p> <p>Rate as 3, Repair priority 1</p>

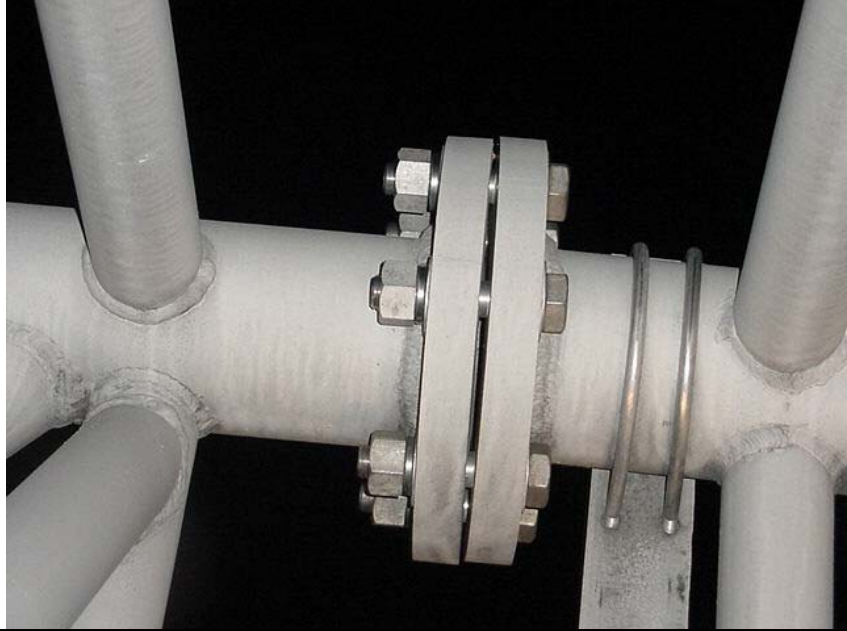
<p>Figure A17</p> <p>Three loose fasteners that could not be tightened by the inspector. Gap in chord splice.</p> <p>Rate 3, Repair priority 2</p>

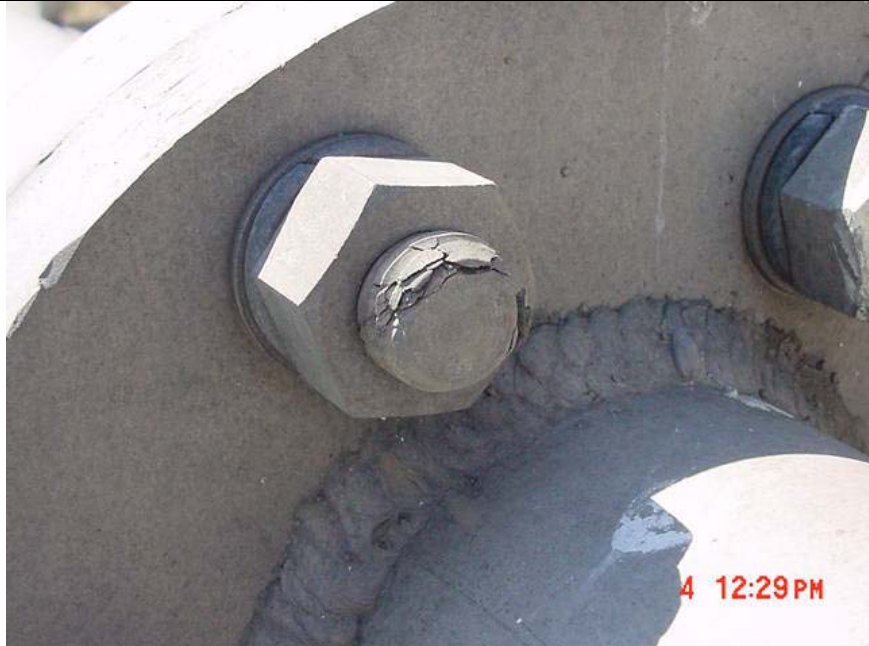
<p>Figure A18</p> <p>One of several severely deteriorated splice bolts.</p> <p>Rate 4, Repair priority 1</p>

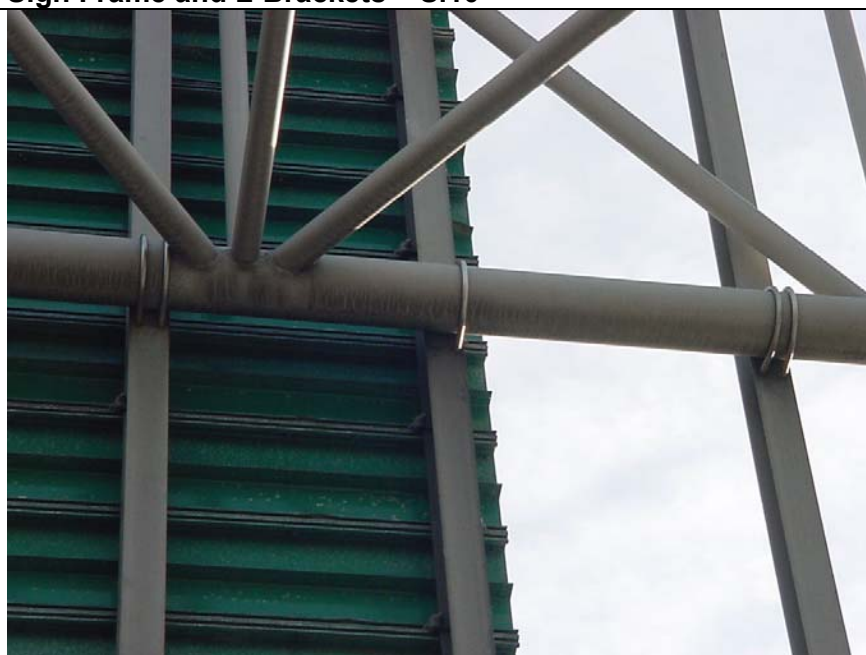
<p>Figure A19</p> <p>Missing one U-bolt at the lower chord to vertical sign member.</p> <p>Rate 1, Repair priority 3</p>

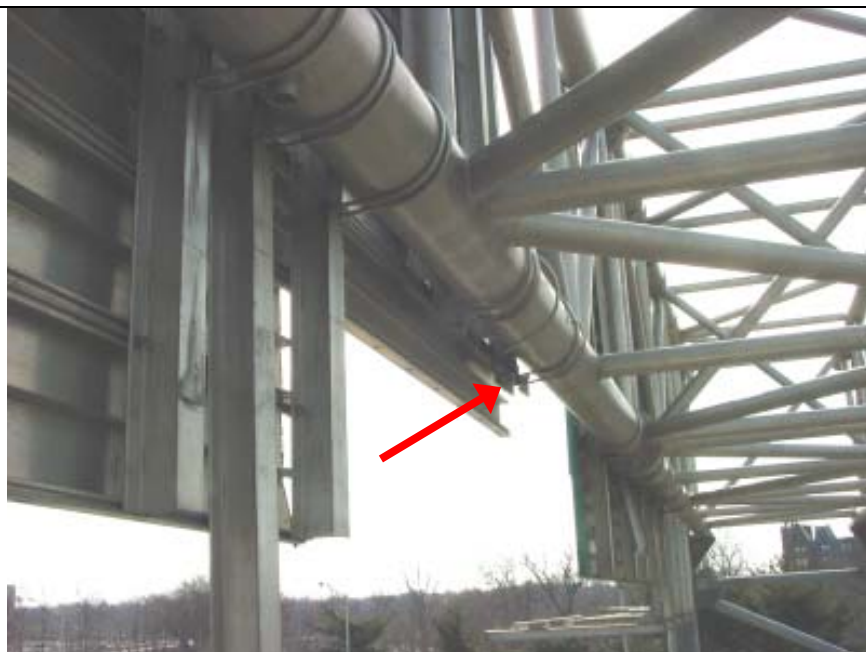
<p>Figure A20</p> <p>Sign 5 exhibits severe impact damage with missing members and hardware. Arrow shows broken bracket.</p> <p>Rate 3, Repair priority 2</p>

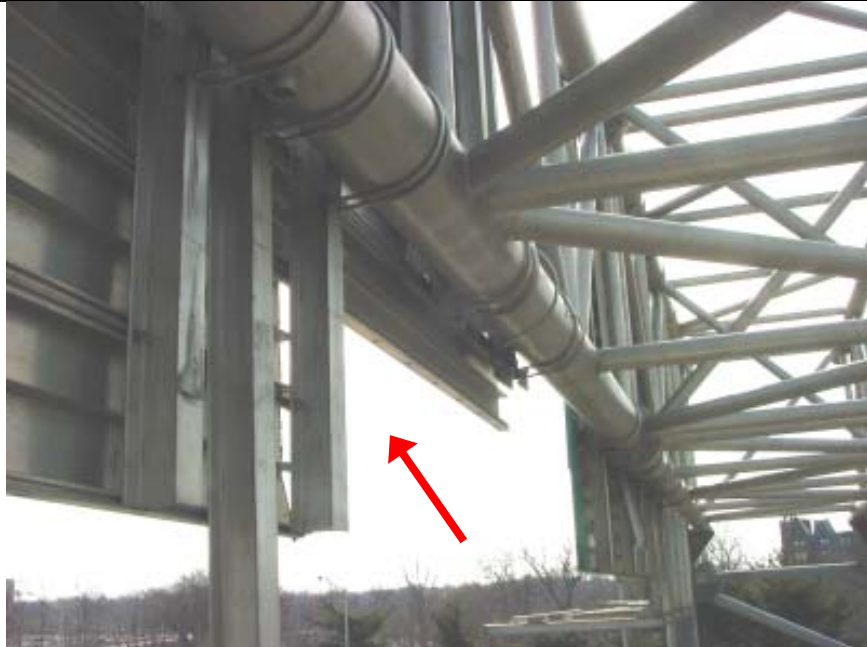
<p>Figure A21</p> <p>Sign 5 exhibits severe impact damage with approx. 1/2 the lower section of the sign panel missing, see arrow.</p> <p>Rate 3, Repair priority 2</p>

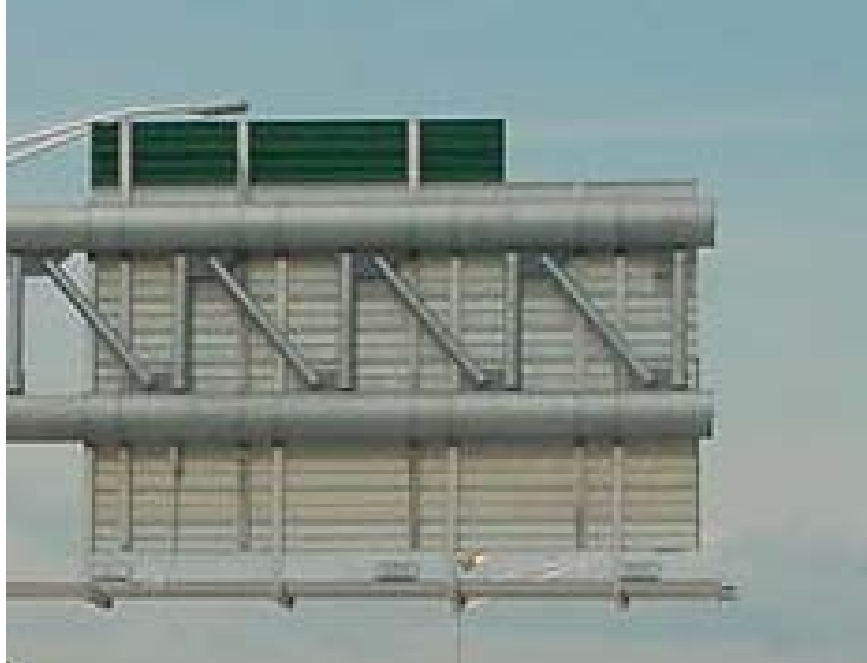
<p>Figure A22</p> <p>Sign panel No. 2 was reused from old sign structure and is in fair condition.</p> <p>Rate 1</p>

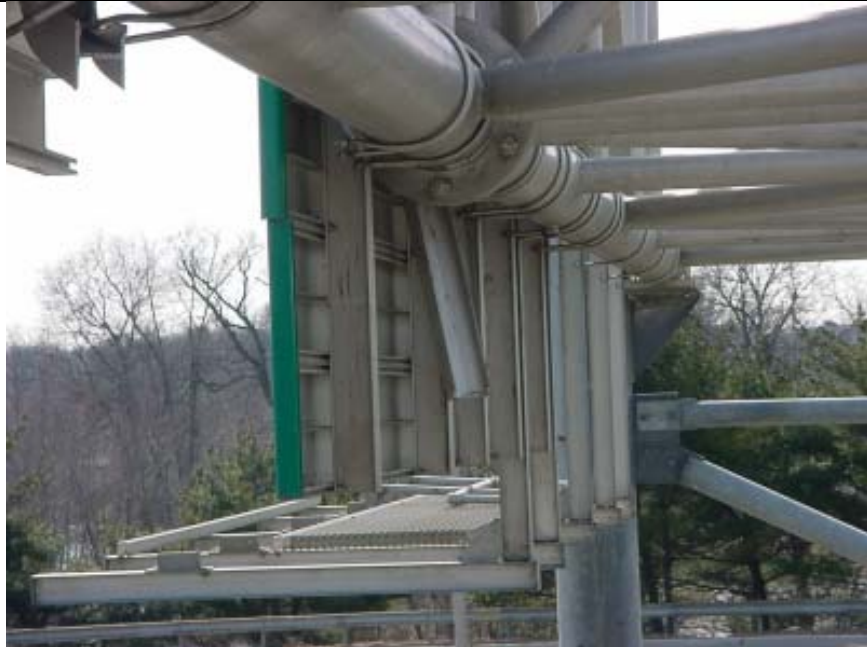
<p>Figure A23</p> <p>Portion of catwalk over main line above lanes 1,2 and 3 exhibits severe impact damage, and has apparently been removed from this section.</p> <p>Rate 4, Repair priority 3</p>

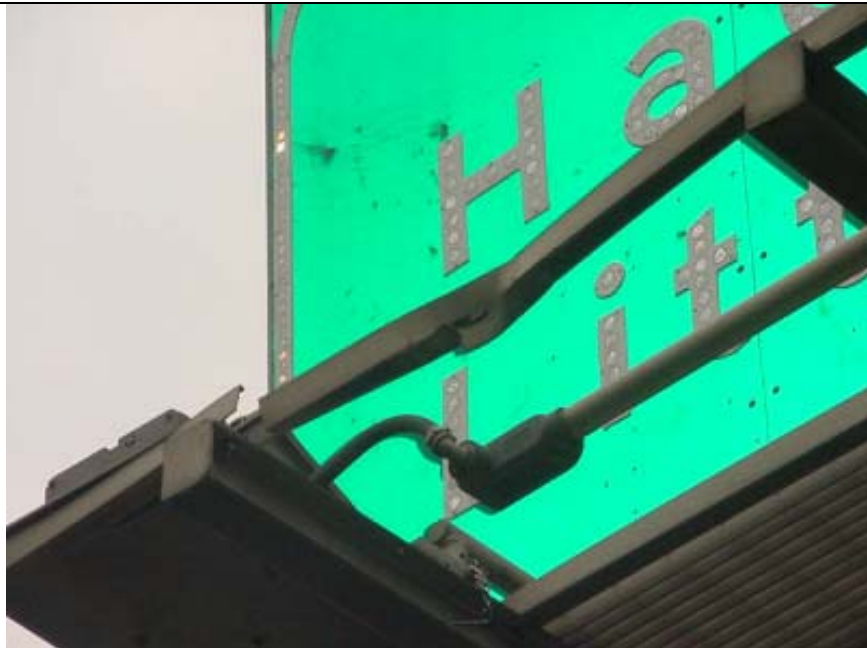
<p>Figure A24</p> <p>The catwalk nosing exhibits moderate impact damage between the left most and middle light fixtures.</p> <p>Rate 2, Repair priority 3</p>

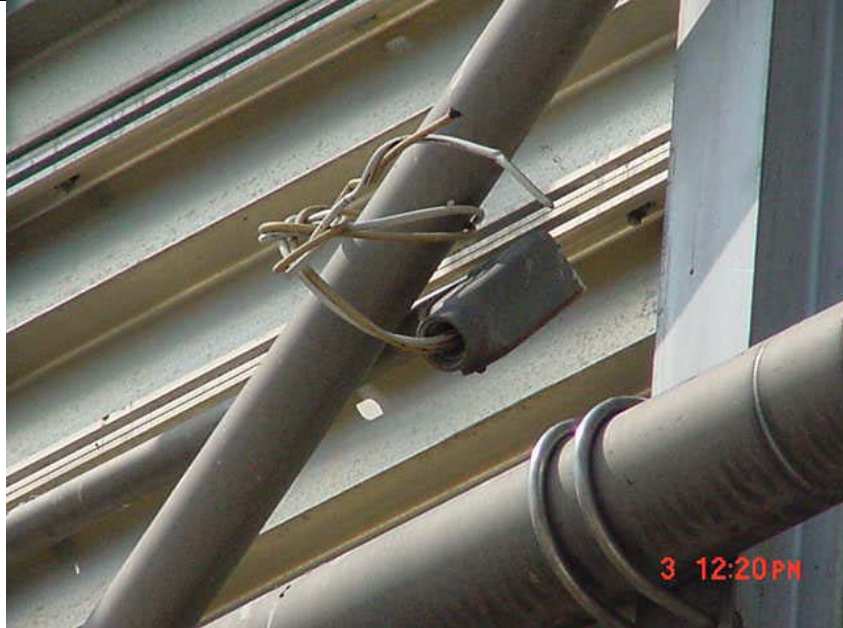
<p>Figure A25</p> <p>Lighting and framework has been removed. A section of abandoned conduit at the center of the truss is held in place by electrical wires on one end and one u-clamp at the other.</p> <p>Rate 0, Repair priority 2 Repair priority 2 due to the inadequate attachment of the abandoned conduit.</p>

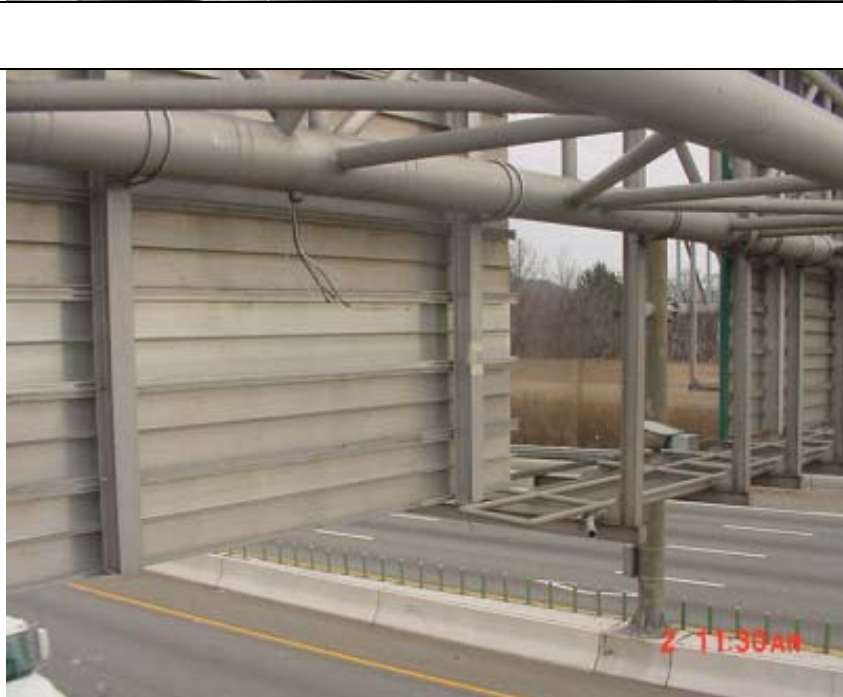
<p>Figure A26</p> <p>Lighting for sign #1 is missing due to impact damage. Exposed wires present.</p> <p>Rate 4, Repair priority 2</p>

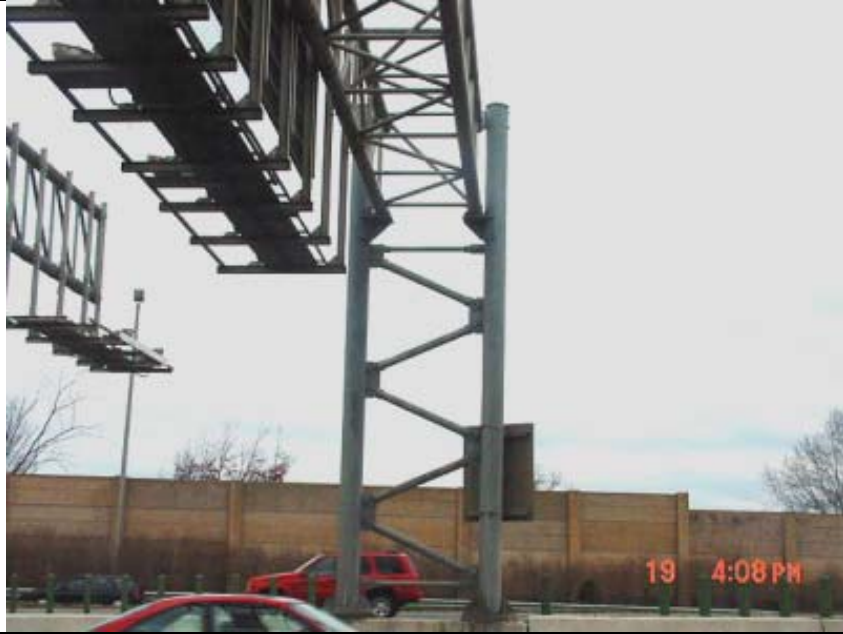
<p>Figure A27</p> <p>Left rear post "No trucks in left lane" sign u-bolts are too large and sign is free to rotate.</p> <p>Rate 2, Repair priority 3</p>

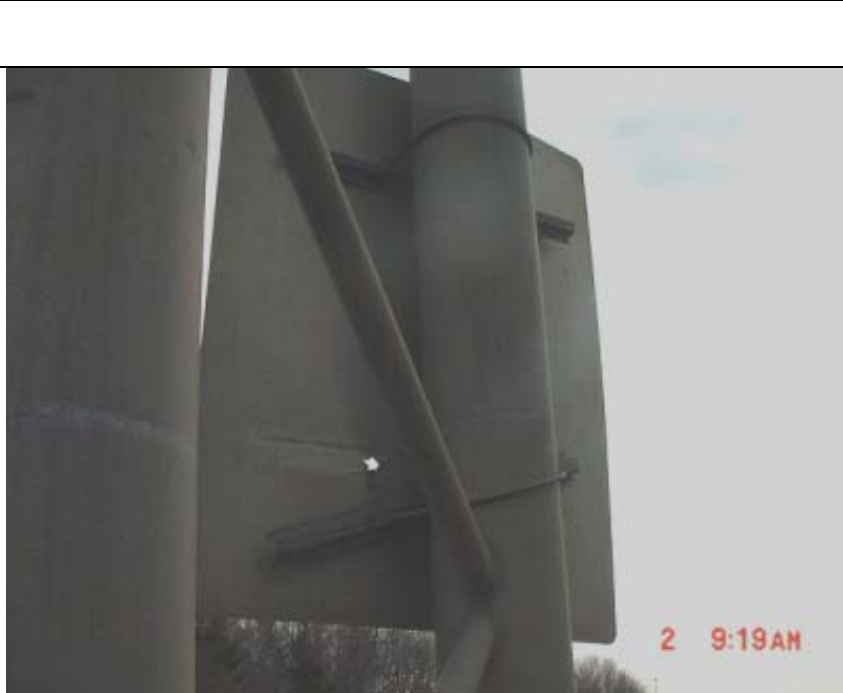
<p>Figure A28</p> <p>"No Trucks In Left Lane" (4' x 5') sign attached to the left rear post (facing the westbound traffic) exhibits moderate impact damage.</p> <p>Rate 3, Repair priority 3</p>

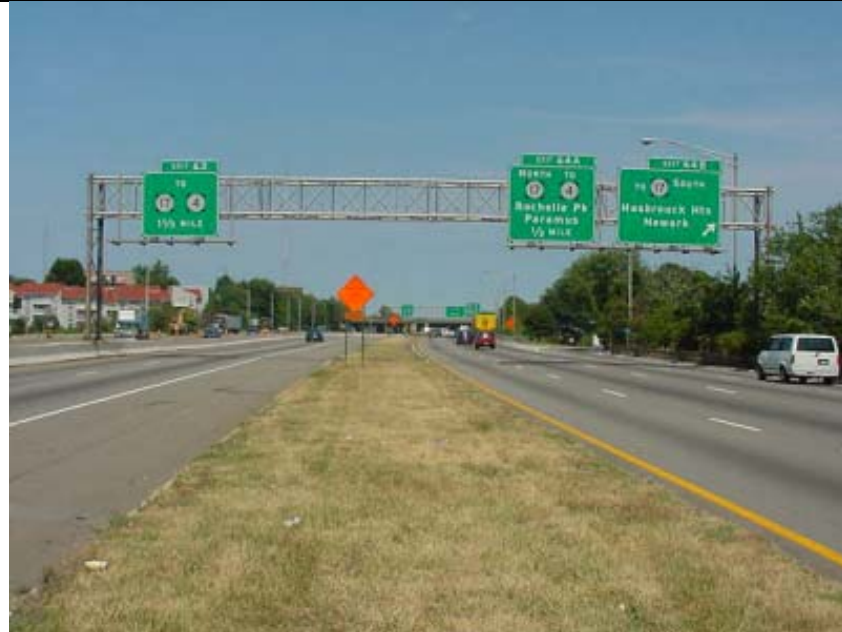
Figure A29

Adequate camber, alignment and vertical clearance over all lanes under span.

Rate 1

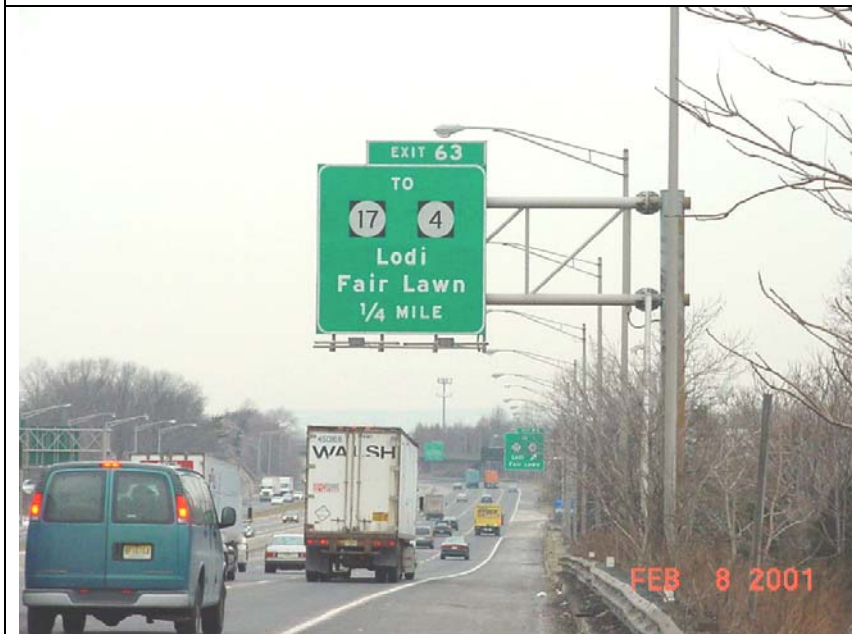
Figure A30

Adequate camber, alignment and vertical clearance over all lanes under the cantilever.

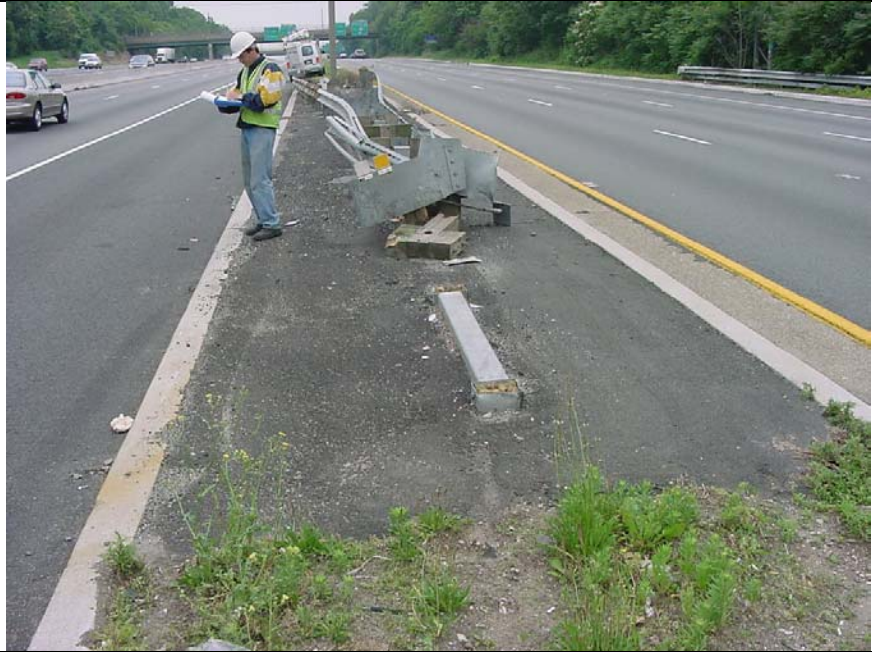
<p>Figure A31</p> <p>Severe impact damage to guide rail. Damage to guide rail directly effects the protection of sign structure and motorist.</p> <p>Rate 4, Repair priority 1</p> <p>Note: This guide rail has since been replaced.</p>

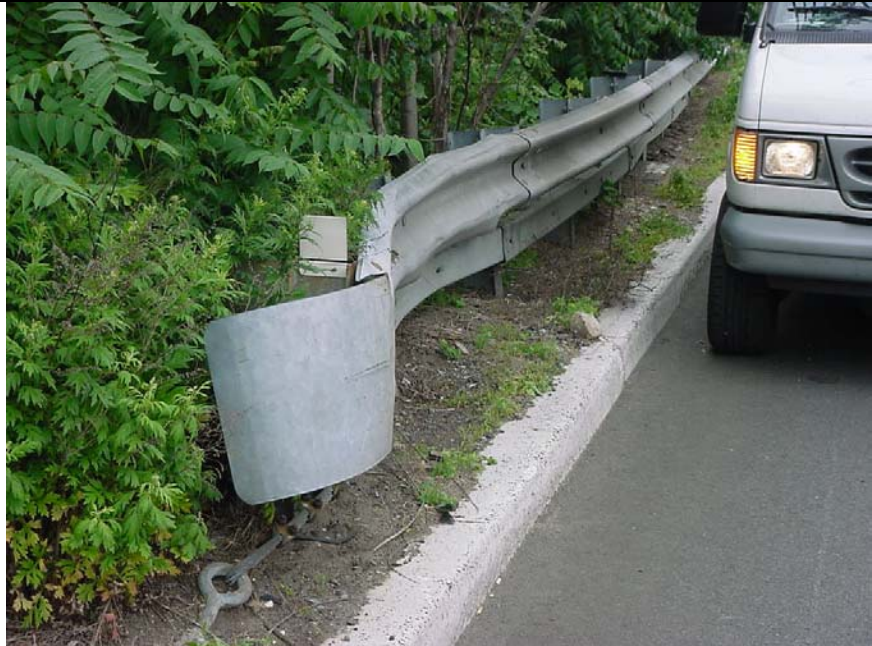
<p>Figure A32</p> <p>Eastbound Loc. Rt Side: Impact damage to guide rail 3yds east of tower. Damage doesn't significantly impact protection of structure or motorist.</p> <p>Rate 2</p>

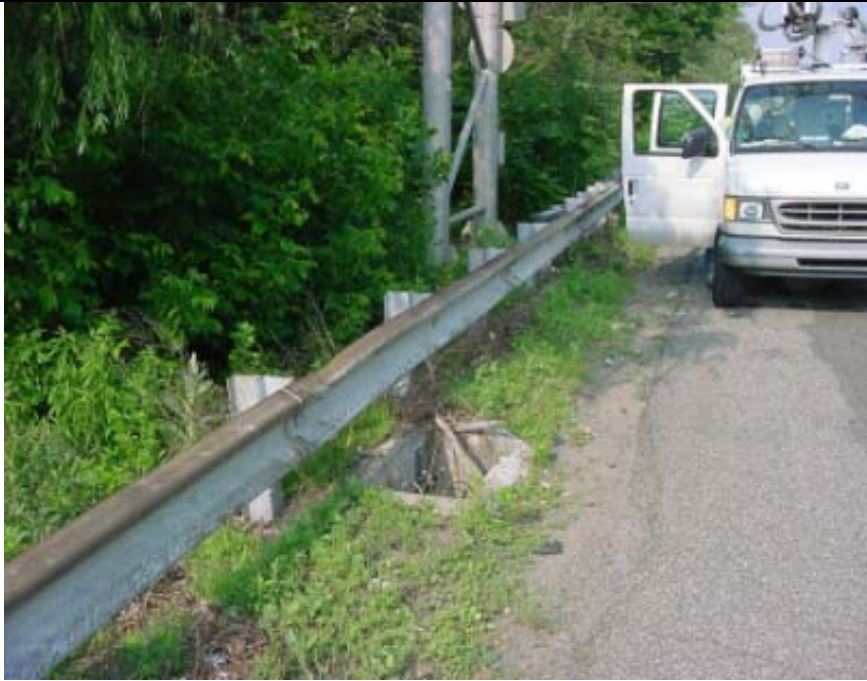
<p>Figure A33</p> <p>24 feet east of sign structure is an abandoned service pit with no cover.</p> <p>Rate 4, Repair priority 2</p> <p>The service pit/vault should be closed to protect the motorists.</p>

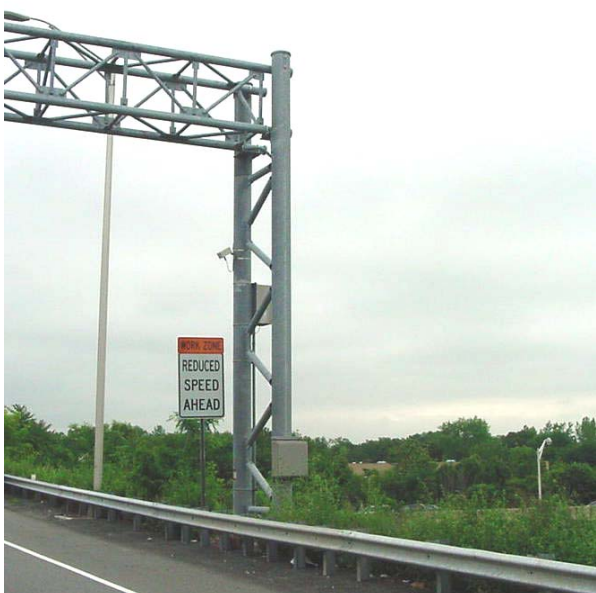
<p>Figure A34</p> <p>RTMS traffic device attached to right rear post.</p> <p>Rate 1</p>

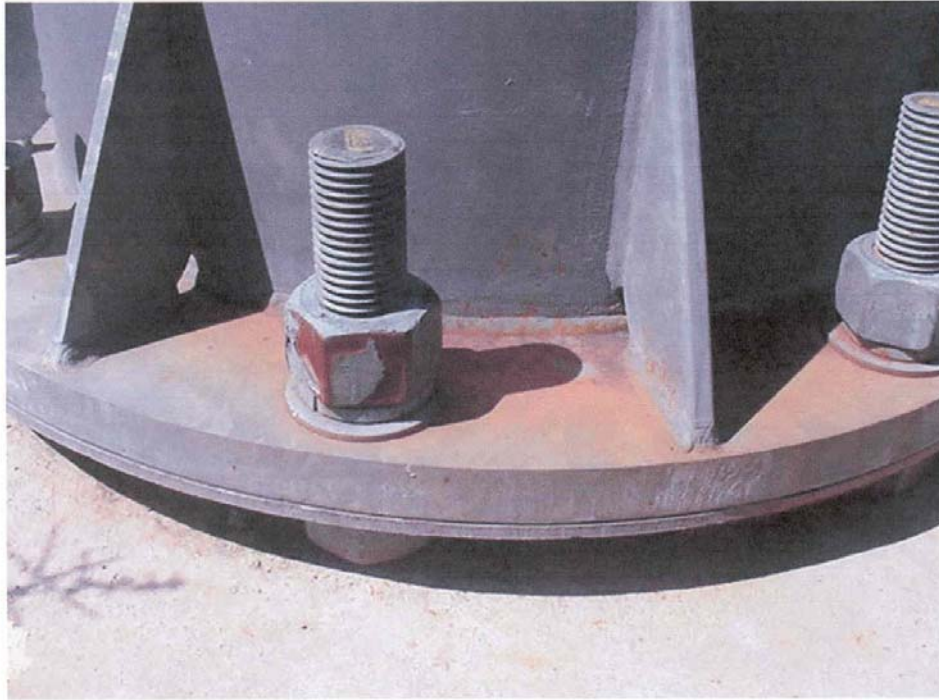
PHOTOGRAPH 5: LIGHT CORROSION ON BASE PLATE

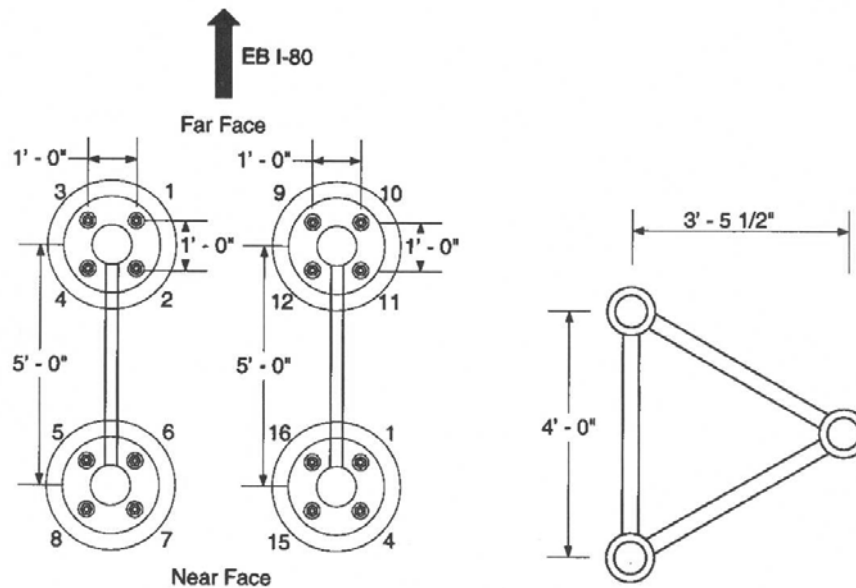
Typical Tower To Foundation Connection
Diameter = 1 1/2"
Bolt Length = 70"
Base Plate Thickness = 1 1/2"

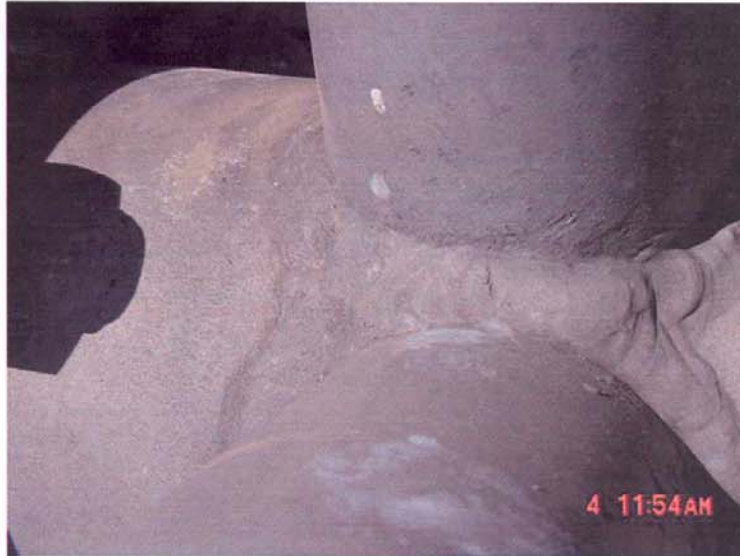
Image No.: 10	Type: jpg	Date: 20020403	Path: c:\njsignimages\1414203_20020403_10bdu.jpg
Description: Lower Chord Splices at L13 - One bolt head is deteriorated.
