**“Analyzing Pre-and Post-Coastal Hazard Pavement Conditions to Optimize  
Response Strategies for Coastal Infrastructure Resilience”**

August 21, 2026

**Final Research Report**

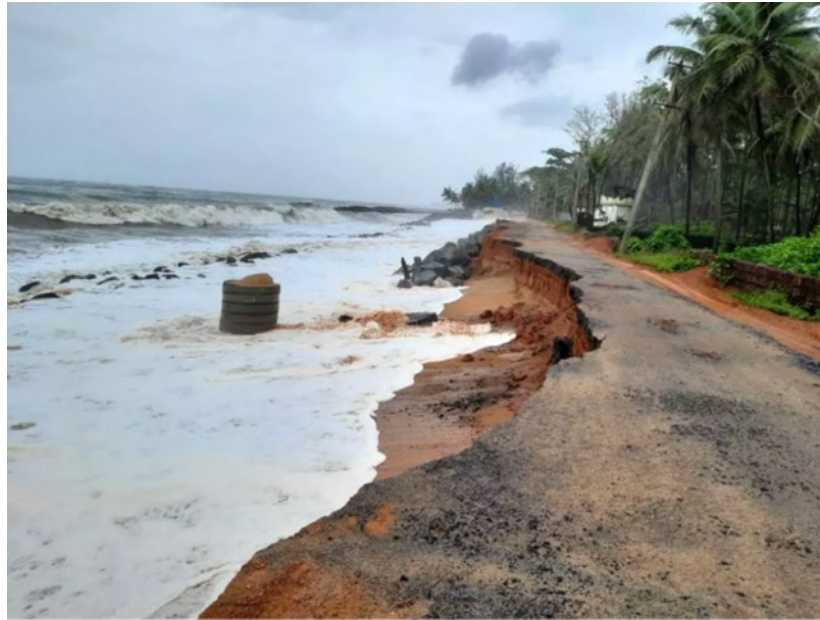
Figure 2. Severe coastal erosion causing partial roadway collapse along the shoreline

interventions (Bryant, 2005). For the pavements located in a coastal area, the coastal erosion may lead to the loss of roadbed materials and undermine the embankment's leading to structural failure. Between 1984 and 2015, approximately 28,000 km<sup>2</sup> of the world's coastline experienced erosion which is nearly double the area formed by sediment accumulation (Abbas et al., 2021). These erosions place coastal highways at an elevated risk of damage, potentially disrupting vital connections between coastal cities and affecting regional economies.

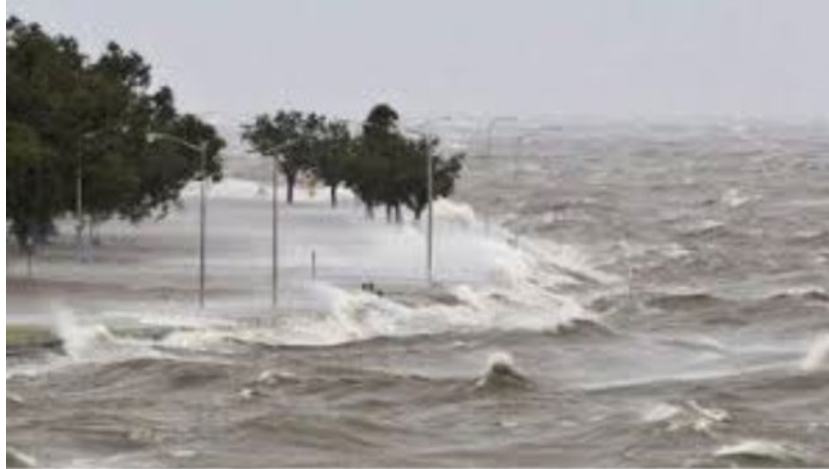
Storm surges are one of the most potent coastal hazards which is caused by the interaction of winds, waves and rising sea levels. Its intensity is dependent on various factors like atmospheric pressure, wind speed, wave height, sea surface temperature, etc. (Harris, 1963; Betts et al., 2004). Pavements in the low-lying area are highly susceptible to inundation and washout during the storm surge, which often results to pavement saturation and loss of subgrade support. Prolonged inundation during storm surges can significantly accelerate pavement deterioration, increase maintenance costs, and reduce pavement lifespan. In Bangladesh, strategic roads vulnerable to storm surges were upgraded with raised subgrades and gabion walls to mitigate damage and improve resilience (Amin et al., 2018).

Figure 3. Storm induced coastal flooding submerging roadways

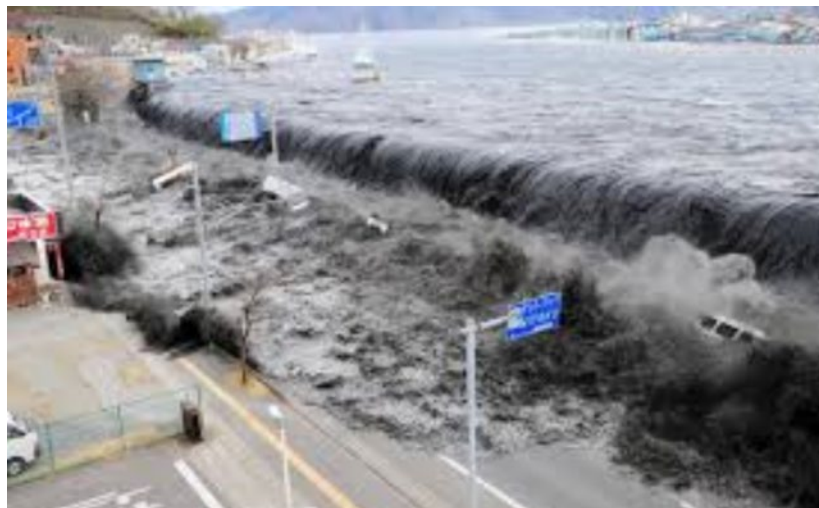
Tsunami is referred to as “the underrated hazard” due to its low frequency of occurrence (Bryant, 2008). They generally occur during earthquakes, volcanic eruptions, and landslides. Tsunami can cause severe scouring and roadbed displacement in pavements and lead to the destruction of bridges and intersections as well. Pavements in tsunami-affected regions not only sustain extensive damage from direct wave impact but also from underlying soil liquefaction. During the Great East Japan Earthquake accompanied by tsunami, it was observed that cavities were formed beneath the road surface even though there were no visible surface deformations (Hashimoto et al., 2012).

Figure 4. Tsunami waves inundating coastal infrastructure and vehicle

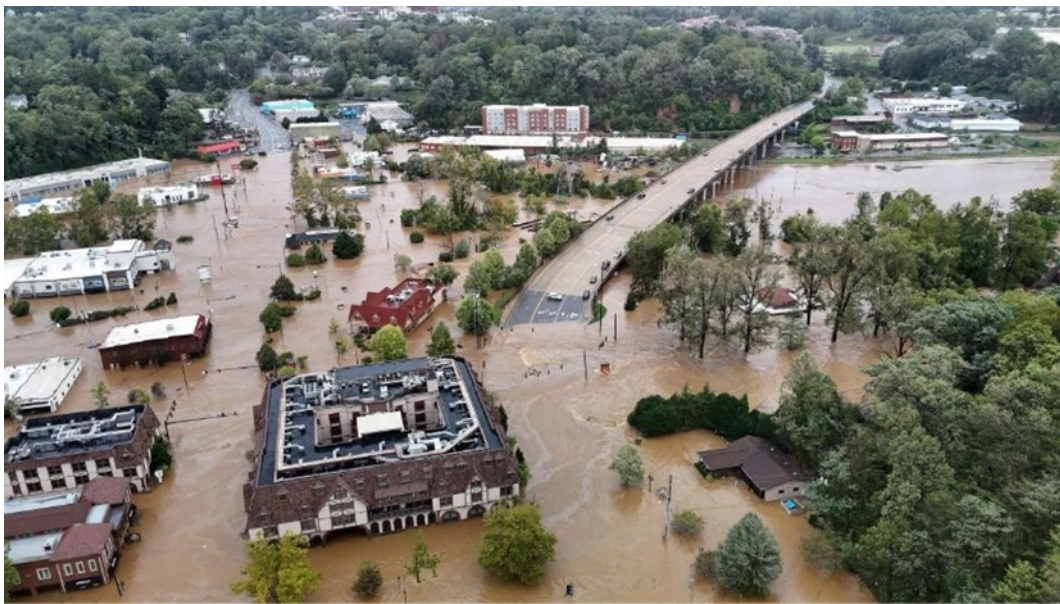
According to Kaiser, (2006) flooding can be categorized into two types: episodic flooding and permanent flooding. Episodic flooding results from cyclones or storm surges and causes more extreme damage to the pavements. It saturates the subgrade, disrupts the drainage system and makes it difficult for critical emergency operations. Permanent flooding causes constant saturation and exposure to extreme precipitation, reducing the bearing capacity of the subgrade. Extreme hydrologic events significantly contribute to changes in the international roughness index (IRI) for extreme events, with the number of event cycles directly correlating with increased damage ratios. The loss of pavement life becomes particularly evident during long-duration and high-cycle flooding events (Lu et al., 2018).

Figure 5. Urban flooding following a major storm event

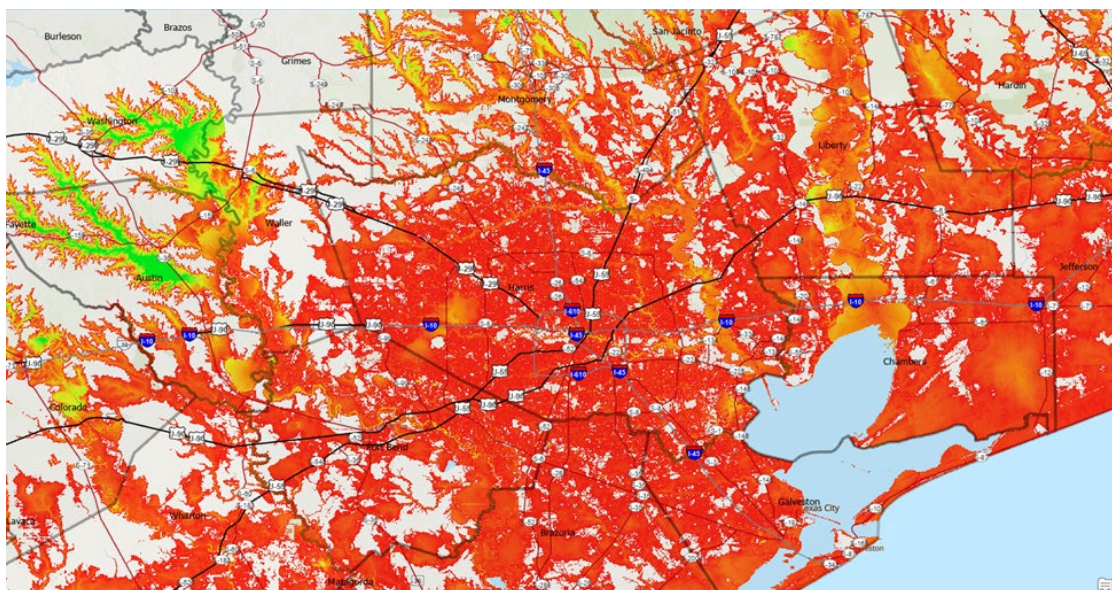
Figure 9. Flood projections during Hurricane Harvey prepared in Arc GIS
