CDOT Office of Applied Research

## I-25 South Gap Wildlife Monitoring Study

August 2025

CDOT-2025-08

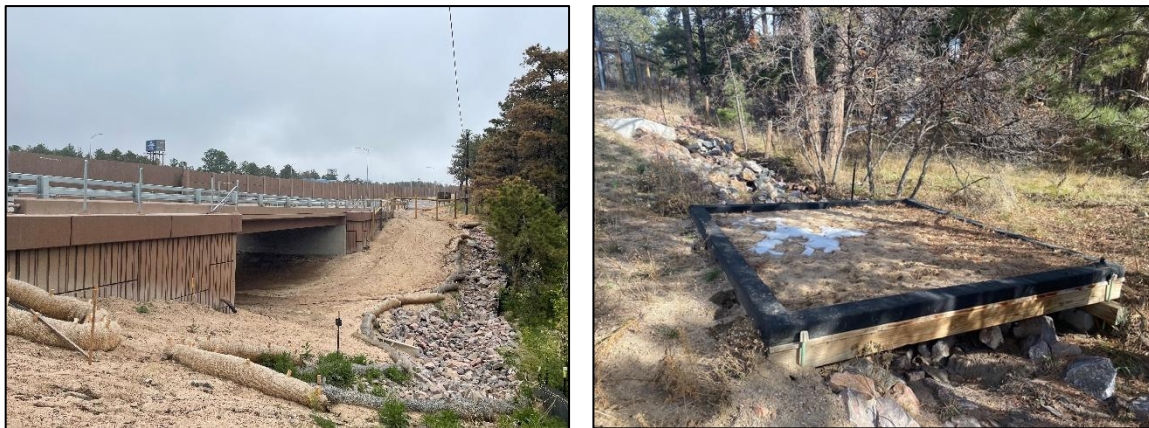
**Figure 2. Riprap drainage running across the east entrance to the Monument Hill Underpass (left) and the natural surface 'deer bridge' installed over the riprap drainage to facilitate wildlife passage (right).**

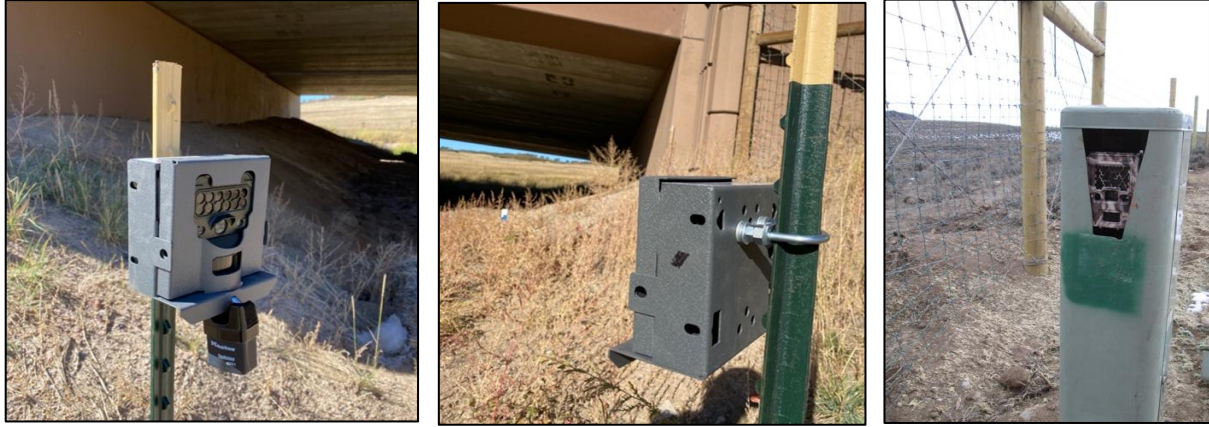
**Figure 3. Camera mounted on T-post (left) with U-bolt mounting and security system (middle), and camera mounted in utility box (right).**

Motion-triggered cameras were deployed to monitor wildlife activity and behavior at wildlife crossing structures, wildlife escape ramps, wildlife guards, and the northern terminus of the wildlife fence. Reconyx HyperFire2 Professional Covert Infrared long-range cameras were mounted on T-posts using a U-bolt system and Reconyx security enclosures. In areas with human activity or that were visible from the roadside, the cameras were mounted inside metal utility boxes to disguise them. All cameras were code-locked and secured with padlocks and/or cable locks (Fig. 3). The cameras took photos day and night with a rapid-fire setting and no down time. Each camera was carefully positioned to optimize capture of wildlife responses to a given mitigation feature.

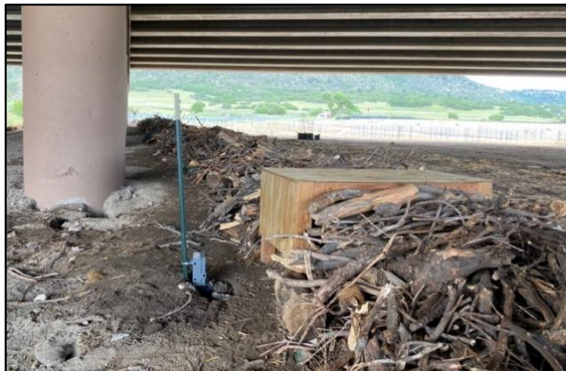
**Figure 5. Small mammal photo booth placed within the habitat cover feature under the Plum Creek Bridge.**

The small fauna cover features, or brush windrow habitat connectivity features, were a unique aspect of the overall mitigation system and a specific focus of the camera monitoring effort. At each large crossing structure, a continuous linear cover feature was constructed from logs and branches salvaged from elsewhere in the project to connect into the habitat on either side of the crossing (Fig. 5).

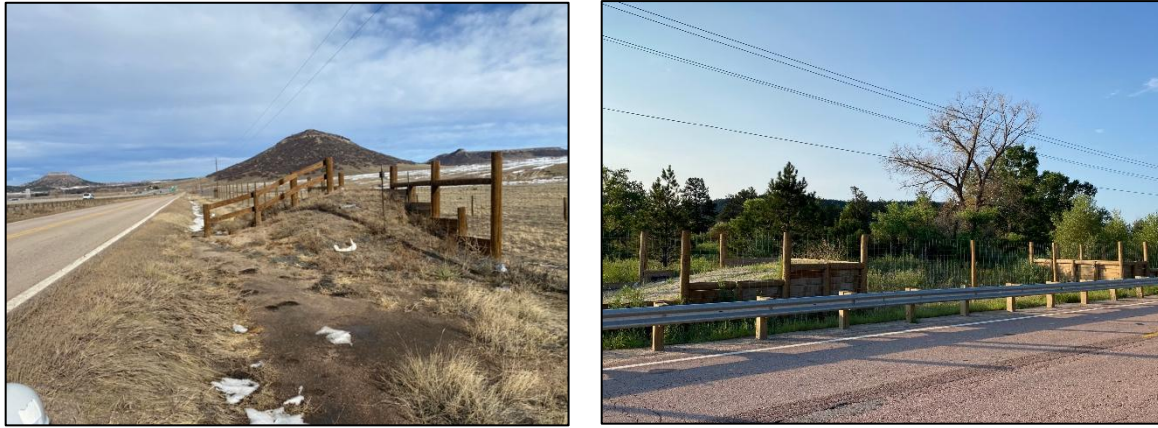
**Figure 6. Example of one-sided escape ramp (left) and two-sided escape ramp (right).**

sided ramps; and a novel 2-sided design that has been successfully employed in Utah (Cramer and Hamlin 2020) (Fig. 6).

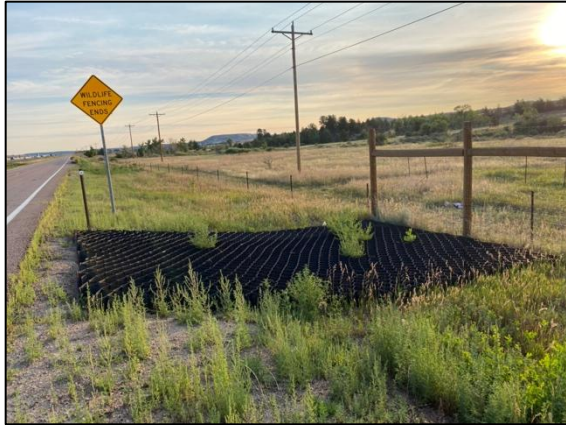
**Figure 7. North fence end Geocell treatment along the east frontage road.**

At the northeast fence end, one camera was positioned to detect wildlife activity near the fence end and, specifically, to capture wildlife responses to the erosion control webbing (Geocell) placed between the pavement edge and the fence (Fig. 7).

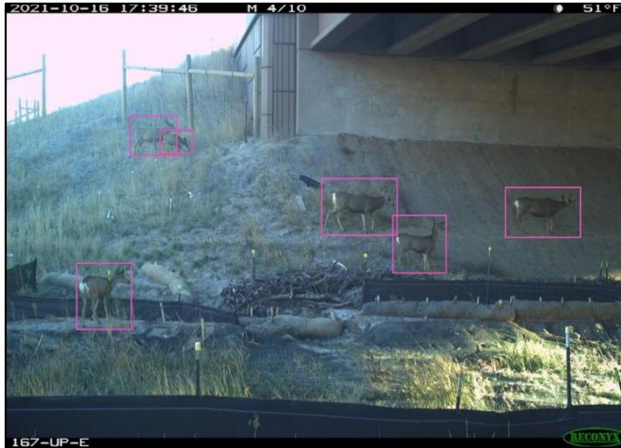
**Figure 8. Automated processing technique to filter photo events triggered by wildlife and assist in species identification.**

To help ease the challenges associated with collecting large volumes of photographic data, the research team developed a custom computer vision model and database system to automatically assist in the processing of photographic data. The computer vision model is a convoluted neural network with a “Faster RCNN” object detection architecture and a ResNet-50 backbone that was trained and deployed using Python. The automated data processing system batch imported and automatically organized photos into the appropriate storage hierarchy for each movement event; captured a photo’s metadata (e.g., date, time, location); automated tasks (e.g., assign event identification number; calculated time of day, season and week of year); and, augmented with machine learning, supported efficient photo processing, including the filtering of false positives (i.e., images not triggered by an animal such as a vehicle or blowing vegetation) (Fig. 8).

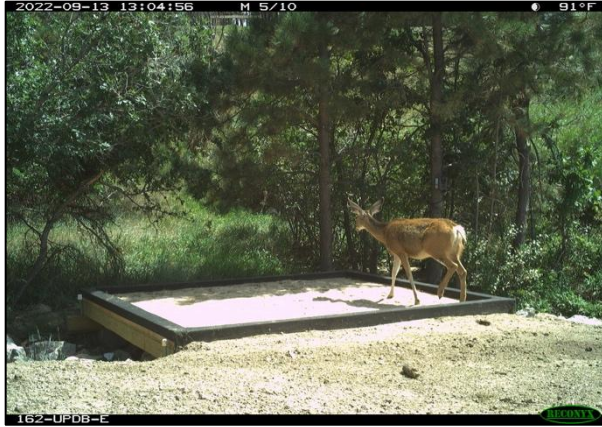
Underpass ('deer bridge') that was installed over the riprap drainage to provide direct access to/from the east entrance of the crossing structure (Fig. 29).

**Figure 29. A mule deer using the deer bridge after crossing through the Monument Hill Underpass.**

During the period this structure was monitored, a total of 2,928 mule deer were documented crossing over the bridge. Of 6,379 successful through passage movements at the Monument Hill Underpass from August of 2022, when the deer bridge was installed, through December of 2024, 2,614 (41%) incorporated the deer bridge.

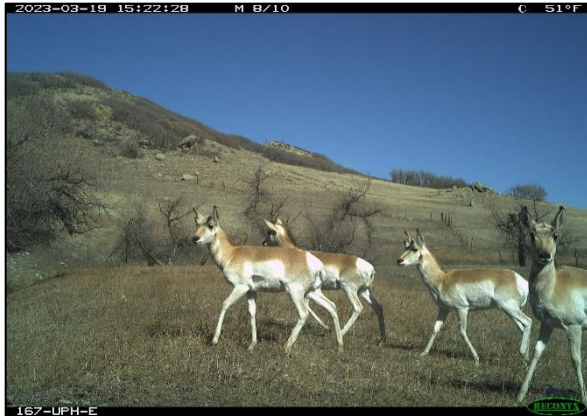
**Figure 30. Image of pronghorn captured on the east side of the Greenland Underpass.**

At all crossing locations, elk was detected with greater frequency on the habitat cameras than successfully using the corresponding crossing structures. Notably, pronghorn was detected on the east side of the highway in the habitat adjacent to both the Dogleg and Greenland Underpasses but was not detected approaching any of the crossing structures (Fig. 30).

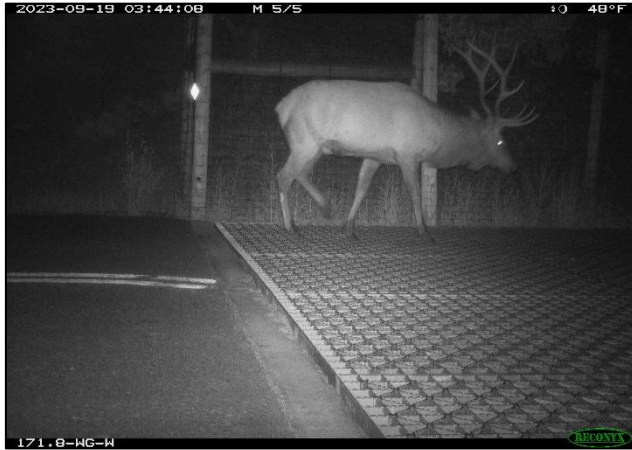
**Figure 39.** Bull elk successfully breaching the Upper Lake Gulch Road - West Wildlife Guard.

Overall ungulate approaches to the wildlife guards decreased in the second year post-construction – from 96 approaches in 2023 to 40 in 2024, a 58% decrease. In 2023, the first year post-construction, the total number of ungulate approaches to the guards peaked and the repel rate was at its lowest (48%) resulting in 50 ungulate breaches over the guards (Fig. 39).

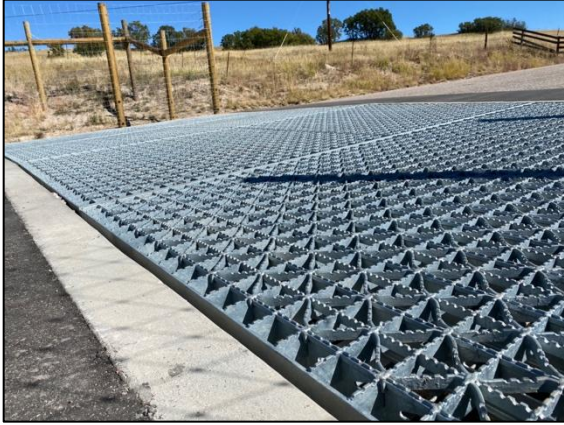
**Figure 41.** Surface of the wildlife guards in the I-25 South Gap Project.

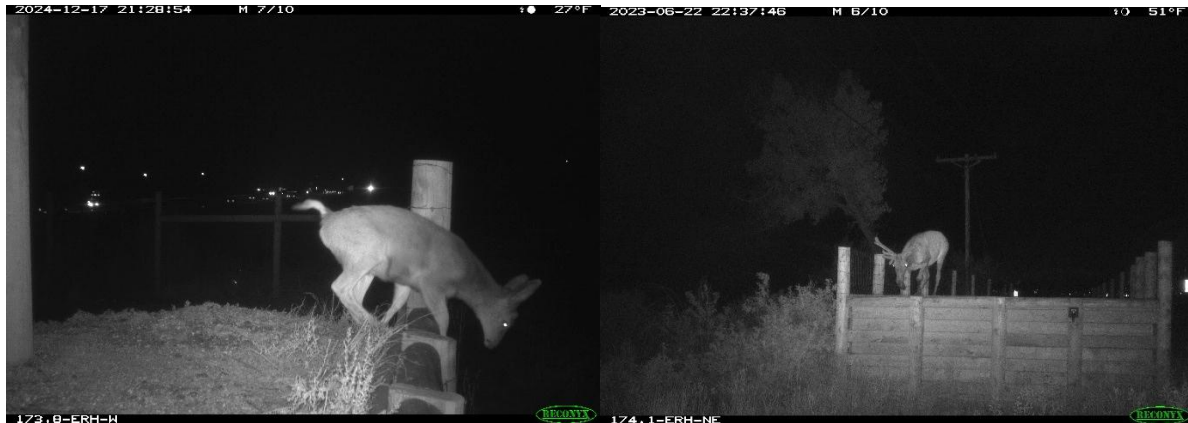
**Figure 42. Young mule deer using standard ramp (right) and buck mule deer using 2-sided ramp (left) to successfully escape to the habitat side of the fencing.**

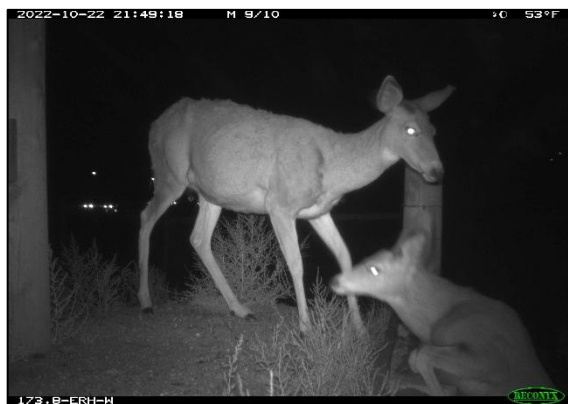
**Figure 43. Mule deer attempting to jump up from the habitat side of the escape ramp.**

Both mule deer ( $n=4,488$ ) and elk ( $n=370$ ) were documented moving parallel along the fence line on the habitat side of the ramps. On a few occasions, elk were recorded looking up at the fence opening at the top of the ramp, but no elk attempted to jump up from the habitat side of a ramp into the fenced right-of-way. The only species documented jumping or climbing up from the backside of the ramp to enter the right-of-way was bobcat ( $n=1$ ). One mule deer attempted to jump up but was not successful (Fig. 43).

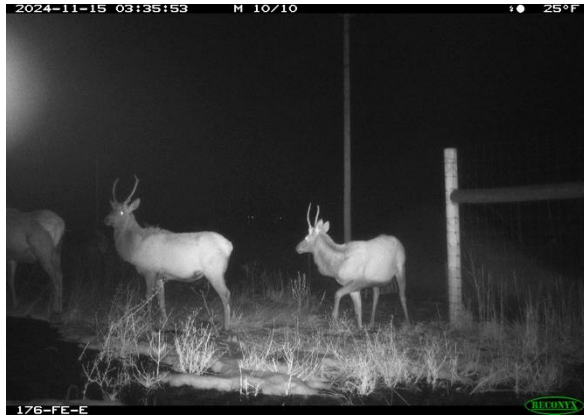
**Figure 45. Bachelor elk herd moving beyond the northeast fence end.**

Small herds of mule deer, white-tailed deer, and elk were documented at the northeast fence end. In total, 251 ungulate movements were documented at the northeast fence end, the majority of which were mule deer (58%). White-tailed deer and elk each comprised 21% of all fence end movements. Across all three years of the study, most wildlife movements at the fence end were made by animals moving beyond the fence end that did not interact with or approach the fence end or Geocell treatment (79%) (Fig. 45).

Anecdotally, some of these animals were observed looking in the direction of the opening between the fence end and the pavement edge, but did not approach.

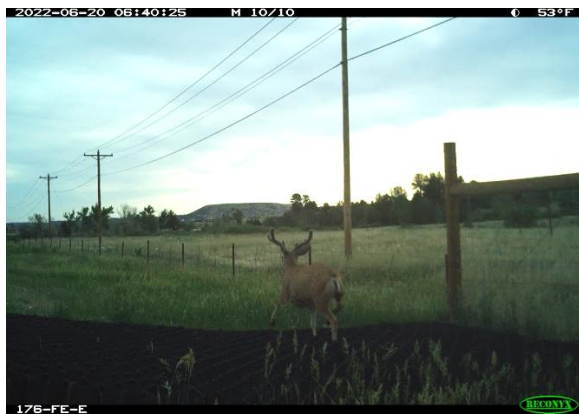
**Figure 48. Mule deer breaching the Geocell to exit the fenced right-of-way.**

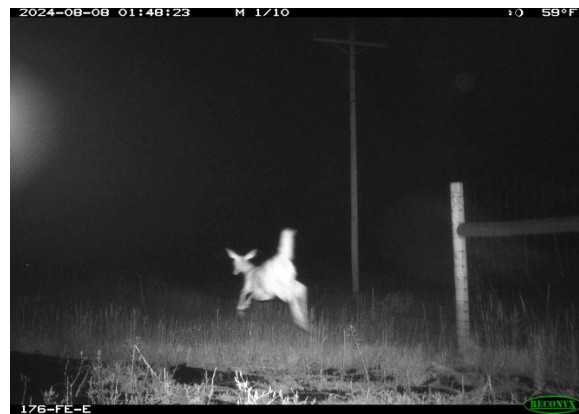
**Figure 48. White-tailed deer jumping over the Geocell fence end treatment.**

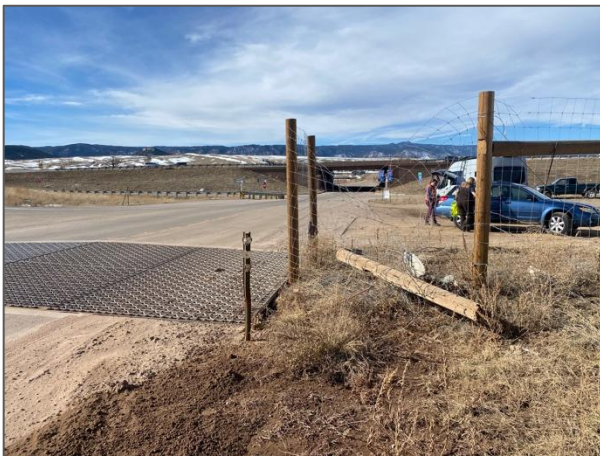
**Figure 53. Broken fence post at the Greenland Rd East Wildlife Guard that was down for several months.**
