## Assessing And Characterizing Geotechnical Soil Strength Parameters For A Systematic Process To Analyze Slope Stability in accordance with LRFD methods.

July 2026  
CDOT-2026-10

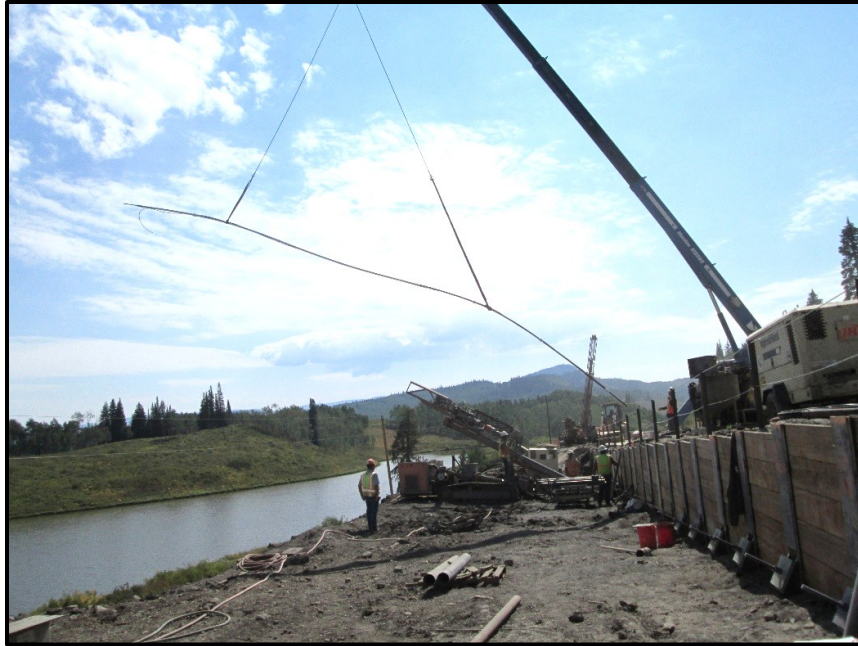
Figure 5. US 40 MP 156.7 depiction of installation of a tieback into the soldier pile lagging wall.

US 40, MP 156.7, Site Area A was a regular maintenance problem for CDOT with pavement cracking resulting from slope instability over decades. Various attempts to avoid the landslide by moving the roadway alignment uphill of the failure were unsuccessful. Groundwater was also relatively high at this location adjacent to a lake. To mitigate the site a soldier pile and tieback wall was designed and constructed to support the two-lane roadway. Figure 5 depicts the partially completed project illustrating the insertion of ground anchor tiebacks into the soldier pile wall.

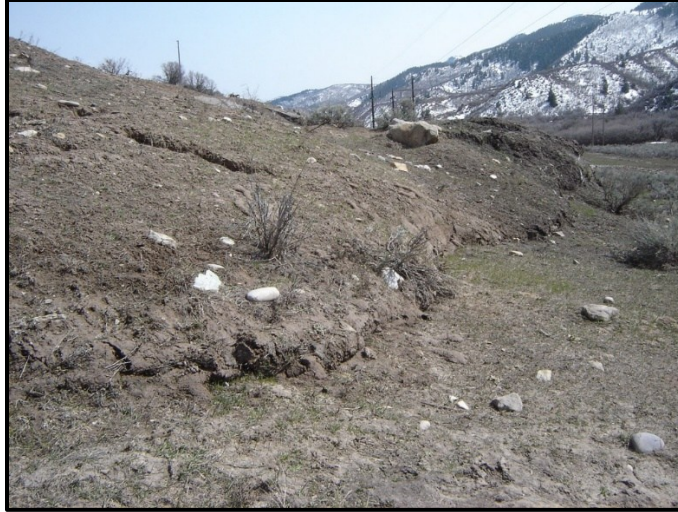
Figure 6. CO 13 MP 15.9 depicts toe of slope which failed as a bearing/slide and over-rode materials.

CO 13, MP 15.9, Site Area B consisted of a site that was a constant embankment fill problem for CDOT maintenance with cracking pavement and slope instability. The roadway stability issue began in 2005 with roadway cracking and vertical movement which accelerated and eventually the entire roadway in this section dropped vertically approximately 4 feet in just a few days. Groundwater was also relatively high. To mitigate the site a geofoam lightweight fill solution was designed and constructed to support the two-lane roadway. Figure 6 depicts the toe of slope which failed as a bearing/slide over-rode surface material below. Figure 7 depicts the vertical movement that occurred in just a few days. Figure 8 depicts the placement of geofoam at the site. These selected geofoam projects have been published in (Arndt, 2016).

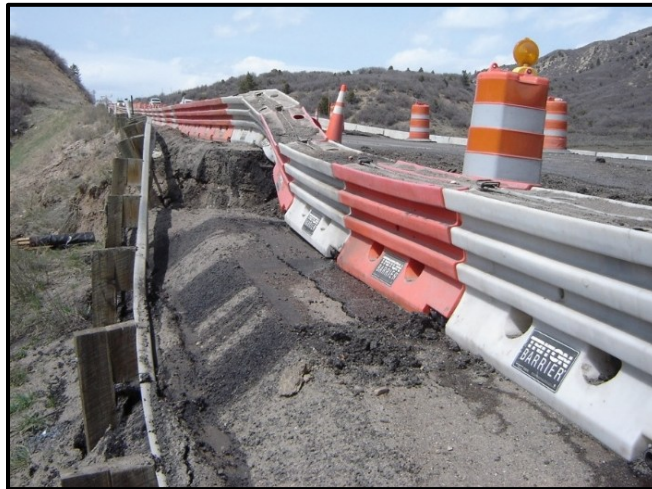
Figure 7. CO 13 MP 15.9 depicts the vertical movement that occurred in just a few days

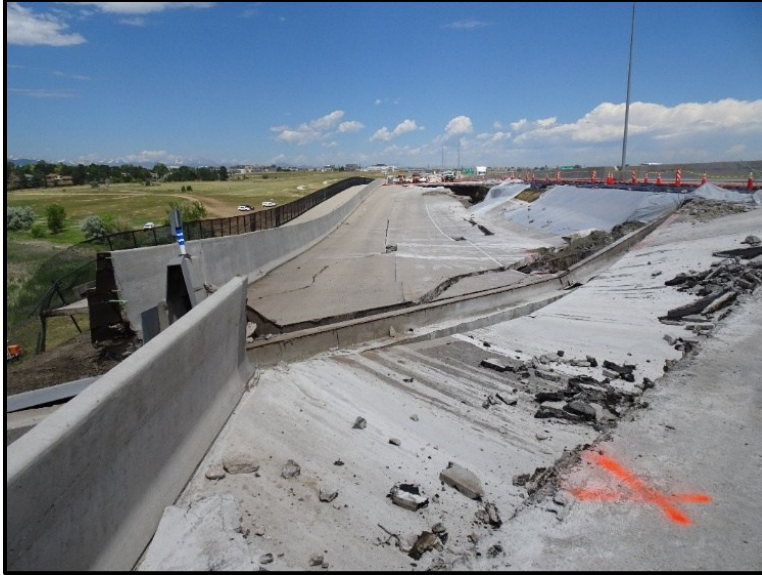
Figure 9 depicts the rigid pavement cracking that occurred in the summer of 2019.

US 36 MP 50.05, Site Area C consisted of a site that was a recently constructed MSE wall on a clay foundation. The stability issue in 2019 began essentially overnight with pavement cracking of a major highway between Denver and Boulder (US 36) and eventually the entire roadway in this section dropped vertically approximately 10 feet in about a week. Figures 9 and 10 depict the rigid pavement cracking that occurred in the summer of 2019. Figure 11 depicts the failure toe materials overriding lower sections of the slope. This project was written up (Arndt, 2021).

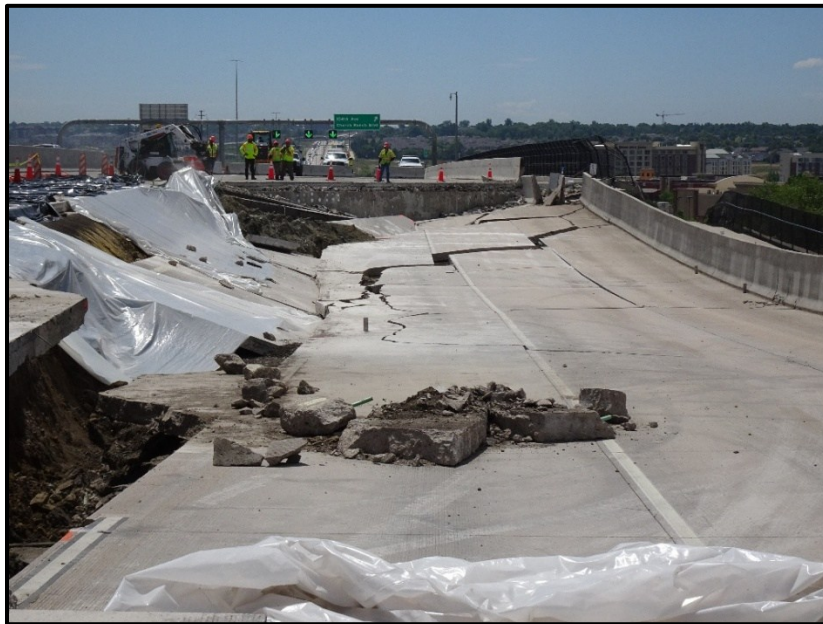
Figure 10. US 36 MP 50.05 depicts the rigid pavement cracking that occurred in the summer of 2019.

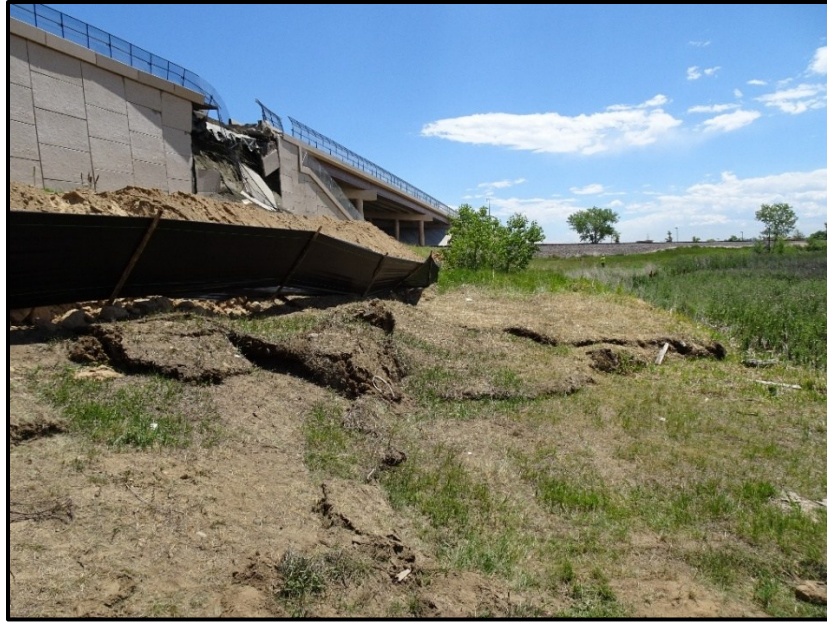
Figure 11 US 36 MP 50.05 depicts the toe of the slope that was failing in bearing/stability, and the toe was overriding the lower surface.

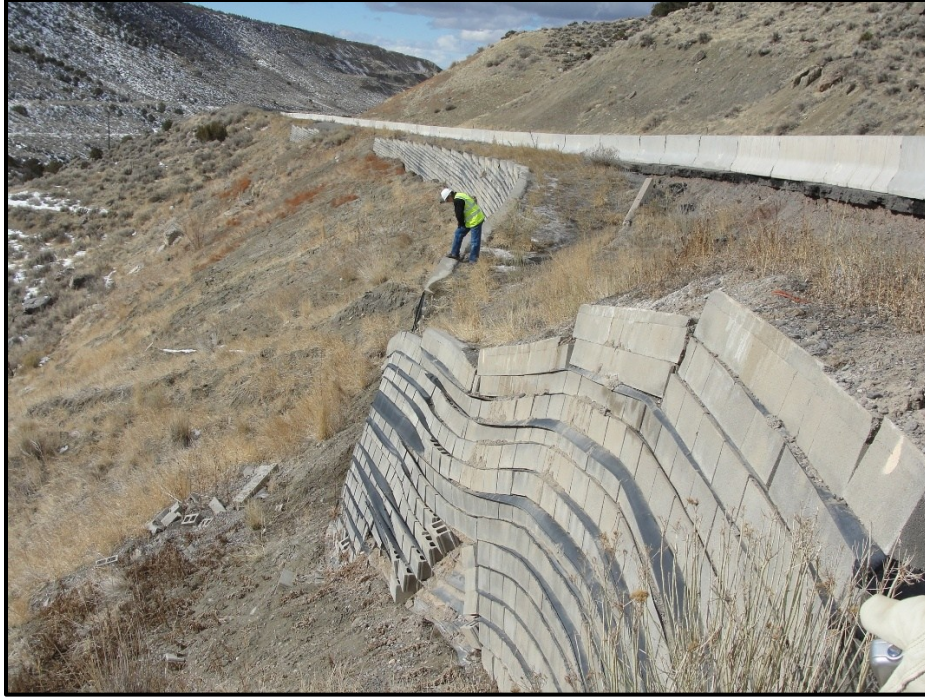
Figure 12. US 50 MP 104.3 depiction of failed block faced wall.

Site Area D consists of six landslide/embankment/wall failure sites along US 50 between MP 103.7 and 121.8. Much of the area is mapped as landslide deposits on USGS maps and is underlain by the Mancos Shale which is a predominate shale in western Colorado. The mitigation options along the corridor consist of geofoam embankment stabilization, micropile foundations for failing block walls and near the eastern end of the corridor a couple shear shaft system that will be mentioned for other locations in this research report. Figures 12 through 15 depict various sections of the roadway corridor that was mitigated. It should be noted that the roadway along US 160 (Site Area E) is very similar to geofoam mitigation repairs to the US 50 (Site Area D) corridor roadway and are essentially very similar. These selected Geofoam projects have been published in (Arndt, 2016).

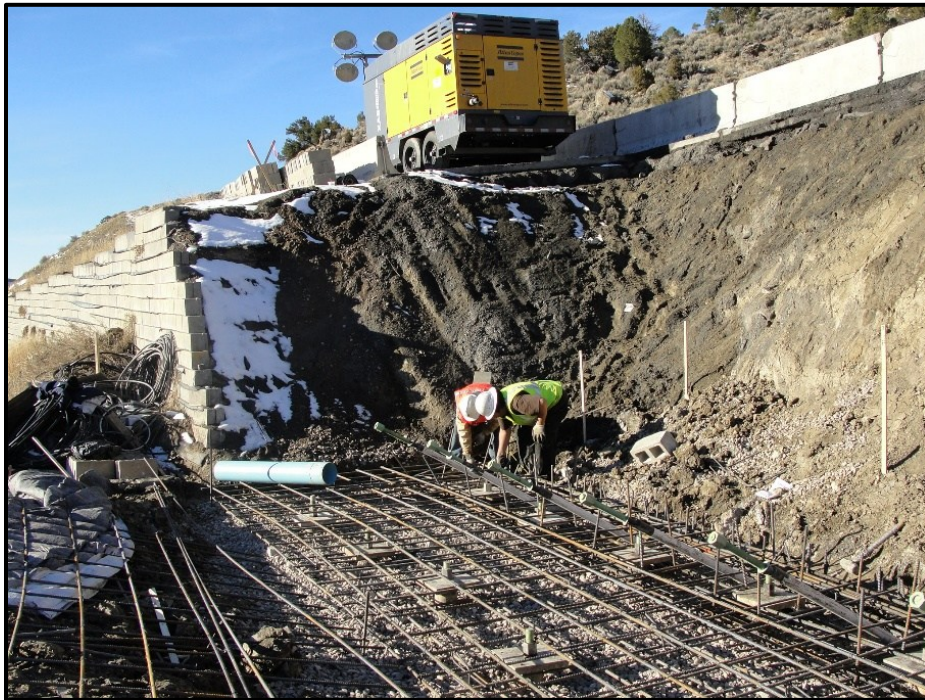
Figure 13. US 50 MP 104.3 depiction of micropiles to support failed block faced wall.

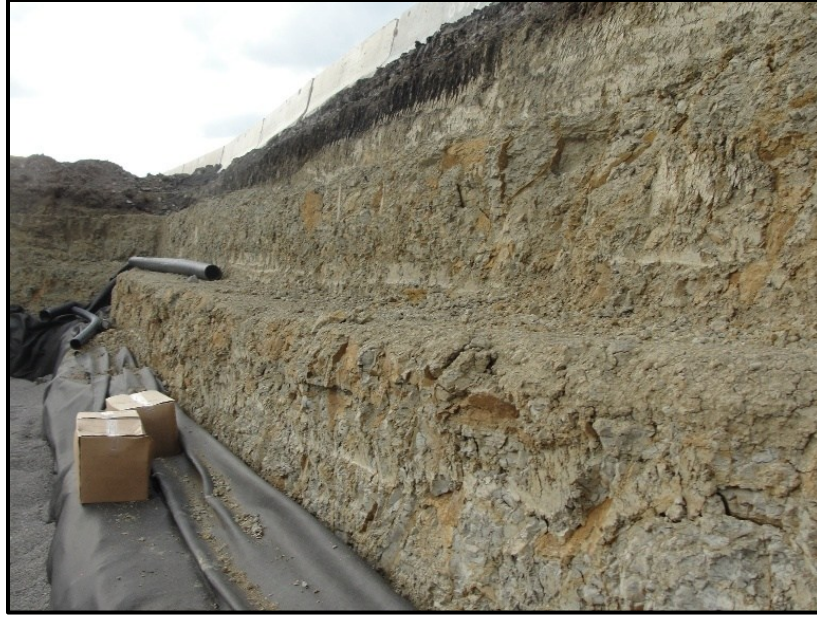
Figure 14. US 50 MP 108 depiction of desiccated clay materials underneath the roadway.

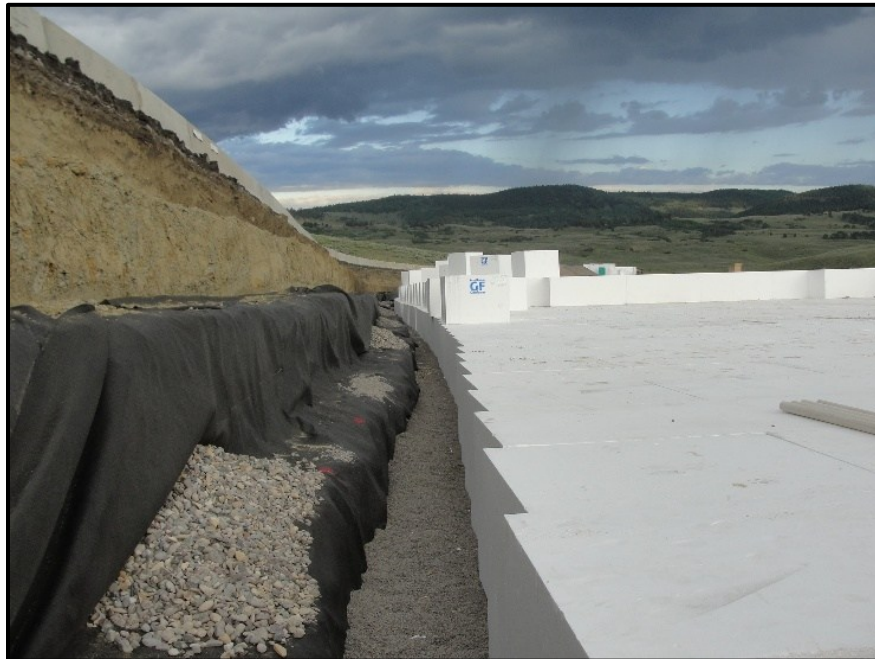
Figure 15. US 50 MP 108 depiction of construction of geofabric mitigation stabilization.

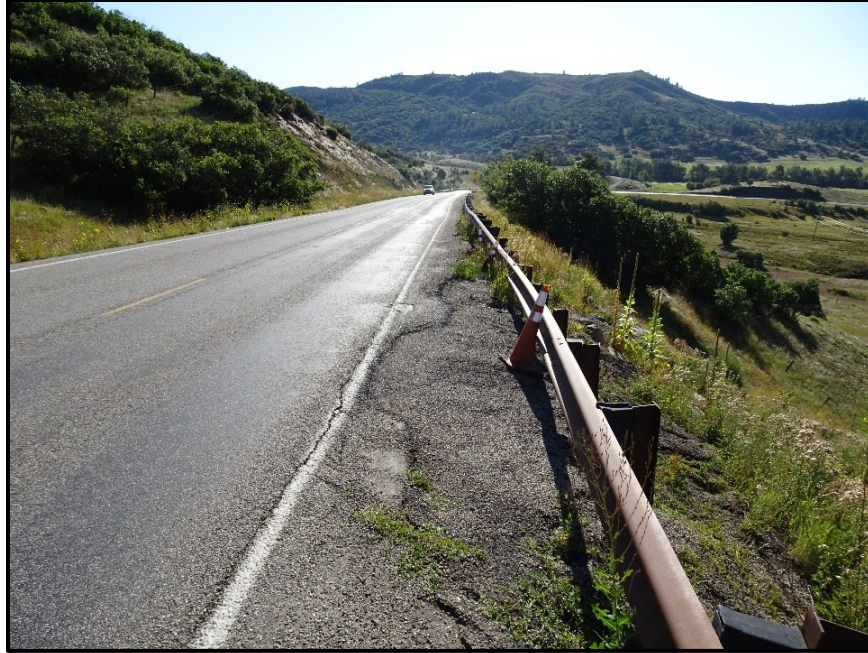
Figure 16. US 84 MP 7.6 depiction of failing roadway shoulder at landslide site.

Site Area F consisted of a landslide/embankment failure along US 84 between MP 7.6. Site Area F consists of a structural mitigation option using paired drilled shafts to mitigate the landslide area. Figures 16 to 17 depict the failing area and construction of the paired drilled shafts.

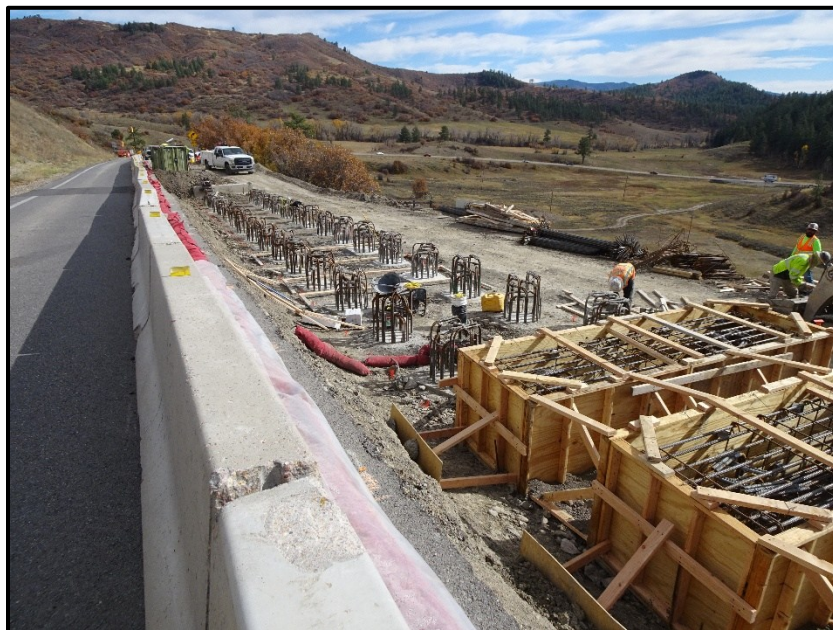
Figure 17. US 84 MP 7.6 depiction drilled shafts to stabilize roadway using shafts that are coupled together in pairs.

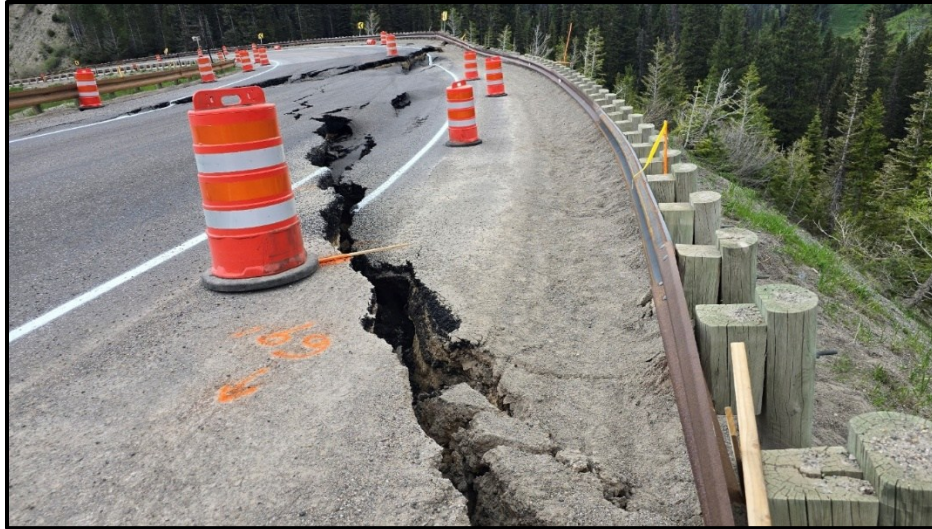
Figure 18. WY 22 MP 12.8 depiction beginning of embankment landslide failure in 2024.

Site Area G depicts the Teton Pass embankment failure that occurred in 2024 due to higher-than-normal groundwater conditions resulting from rapid snowmelt. Figures 18 through 20 depict the failure and the final mitigation photos. The project was written up in an ASCE publication (Arndt, 2026).

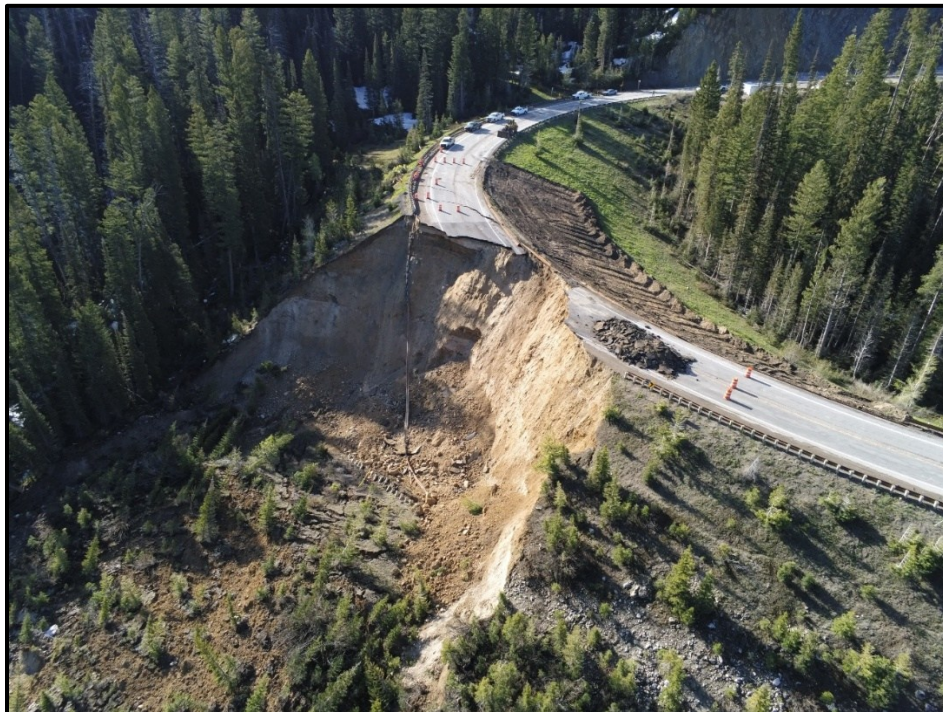
Figure 19. WY 22 MP 12.8 aerial view of embankment landslide failure in 2024.

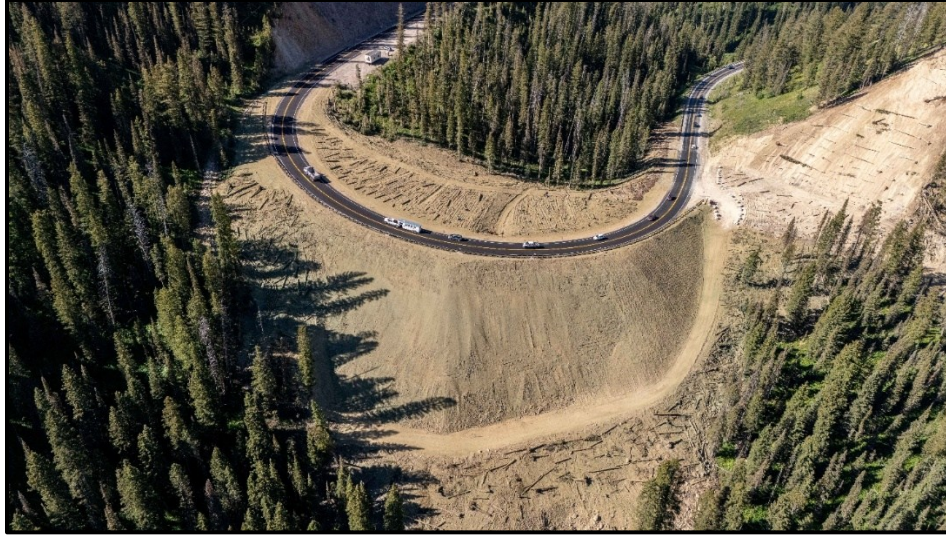
Figure 20. WY 22 MP 12.8 aerial view of embankment stabilization in 2025.

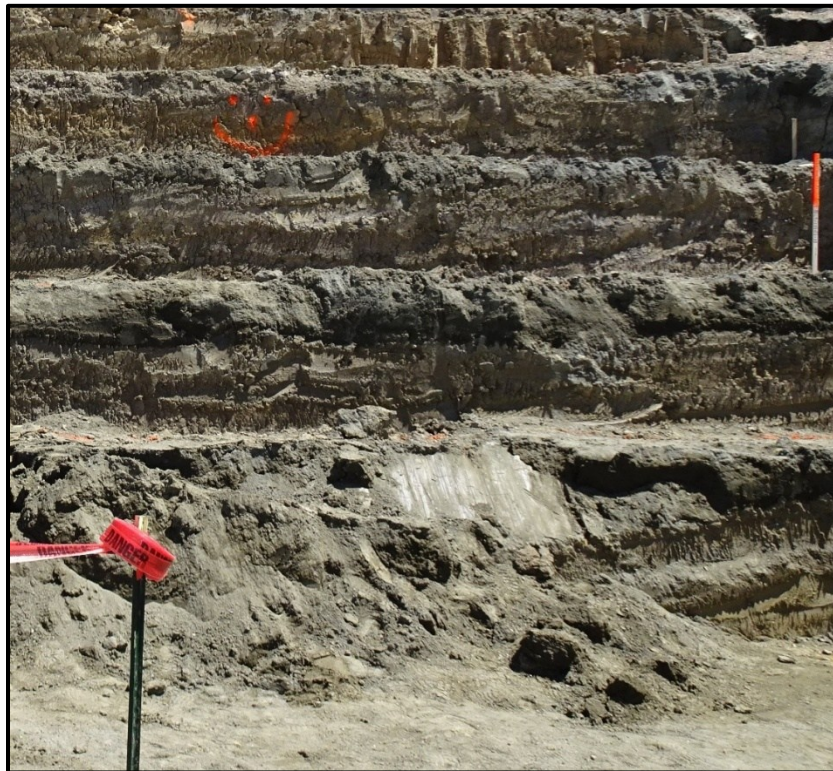
Figure 24. US 36 MP 50.05 Location of Slickensides Donating Failure Plane in Excavation.

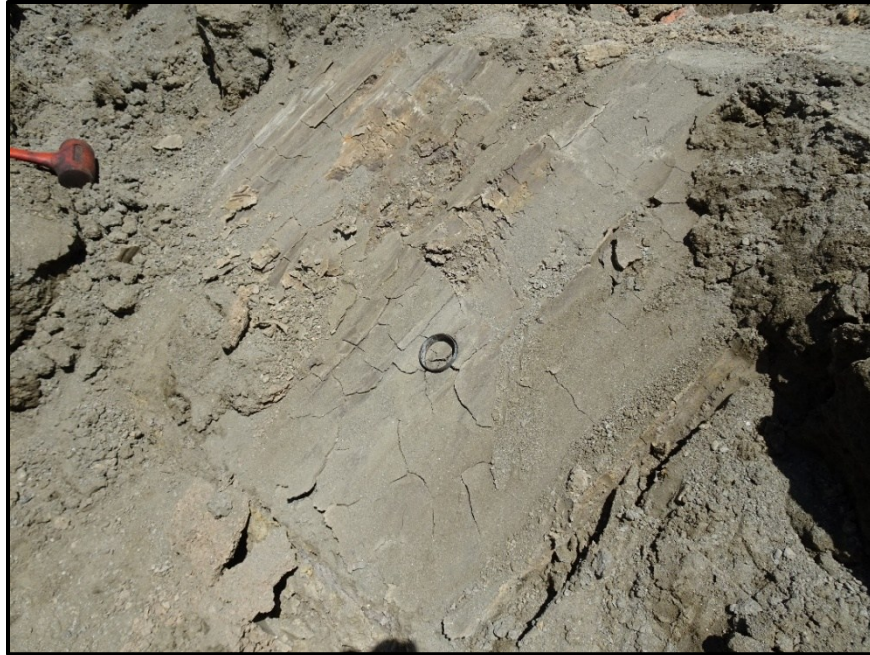
Figure 25. US 36 MP 50.05 Location of Slickensides denoting Failure Plane in Excavation with California Sampler Hand Driven to collect sample for Direct Shear.
