## Long-Term Maintenance Needs and Costs of Green-Colored Pavement Markings and Flexible Post Delineators

**Final Report VTRC 27-R07**

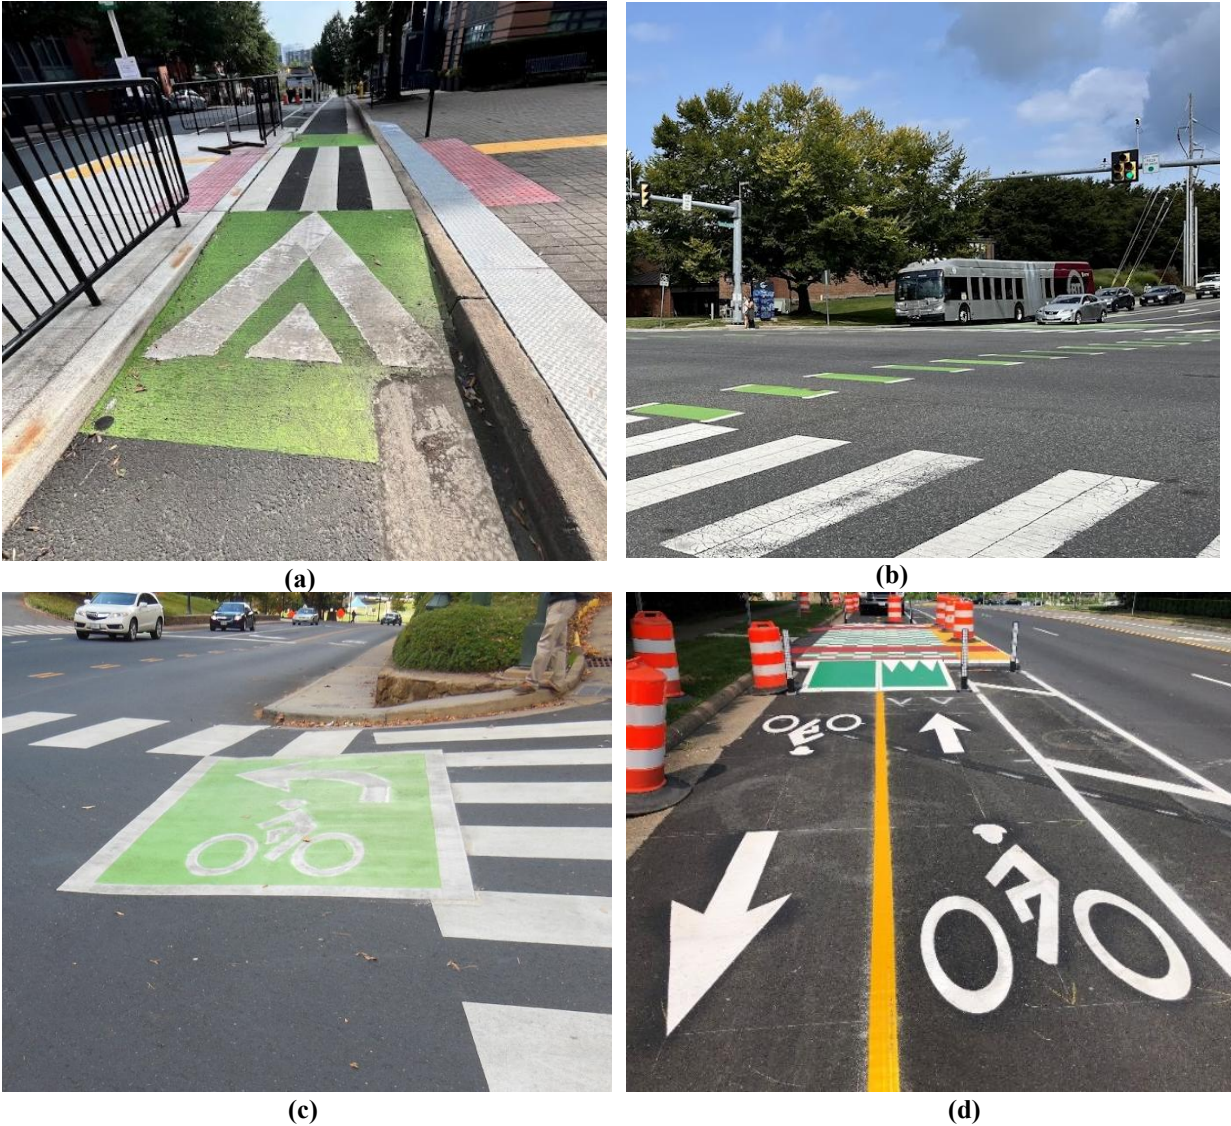
**Figure 1. Green-Colored Pavement Markings in Virginia Take a Variety of Forms: (a) a separated bike lane at a bus boarding island in Arlington; (b) bicycle lane extension markings through an intersection in Blacksburg; (c) green included in the bikeway portion of a modular bus boarding island in Fairfax County; (d) a bicycle turn box in Charlottesville**

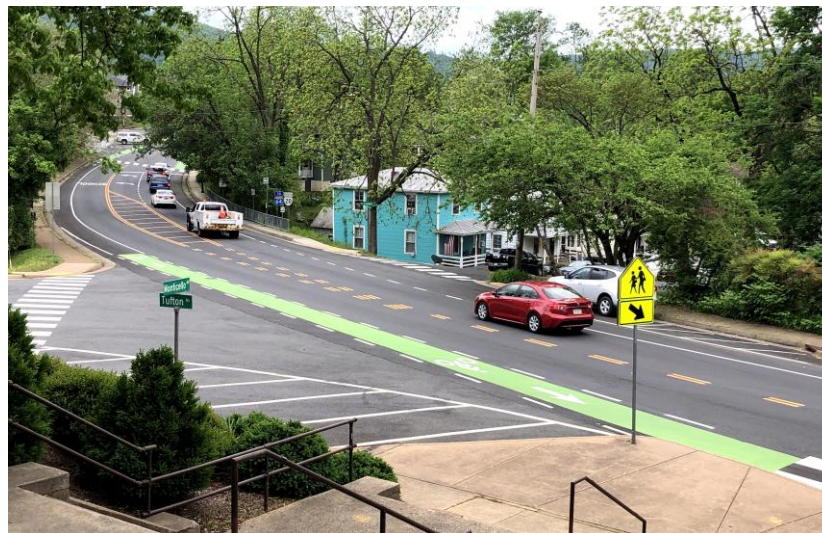
**Figure 3. Solid Green-Colored Pavement Markings in a Bicycle Lane Along Monticello Avenue at Tufton Avenue in Charlottesville, Virginia**

Some localities in Virginia that independently maintain their roads have used these guidelines to implement GCPMs that denote bicycle facilities at conflict points and intersections. Figure 3 shows an example of a solid green bicycle lane at a skewed intersection in Charlottesville.

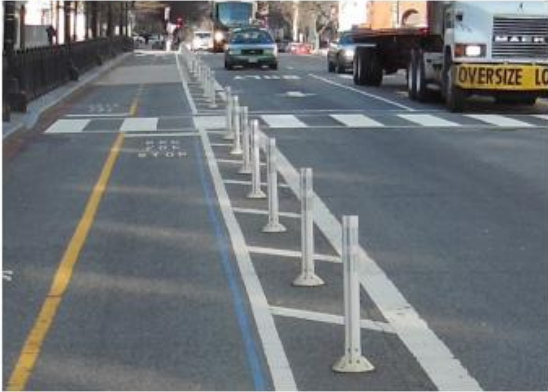
**Figure 4. Flexposts Are One Form of Bicycle Lane Separation (FHWA, 2024b). Reprinted with permission.**

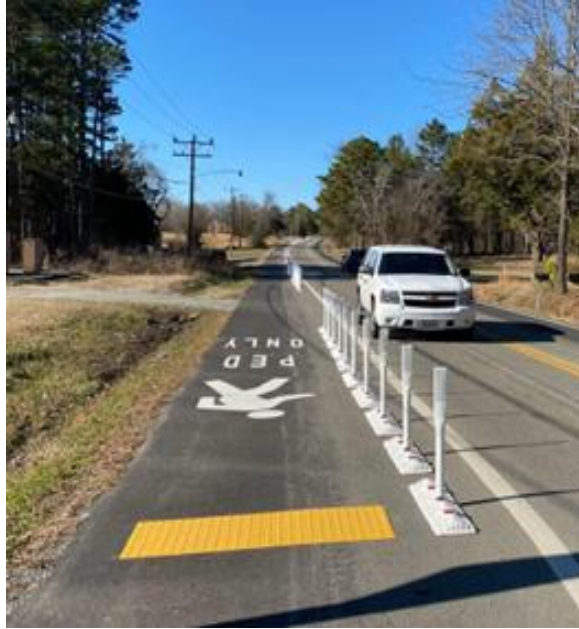
**Figure 5. Flexposts Used for a Pedestrian Lane Along Sinai Road in Halifax County**

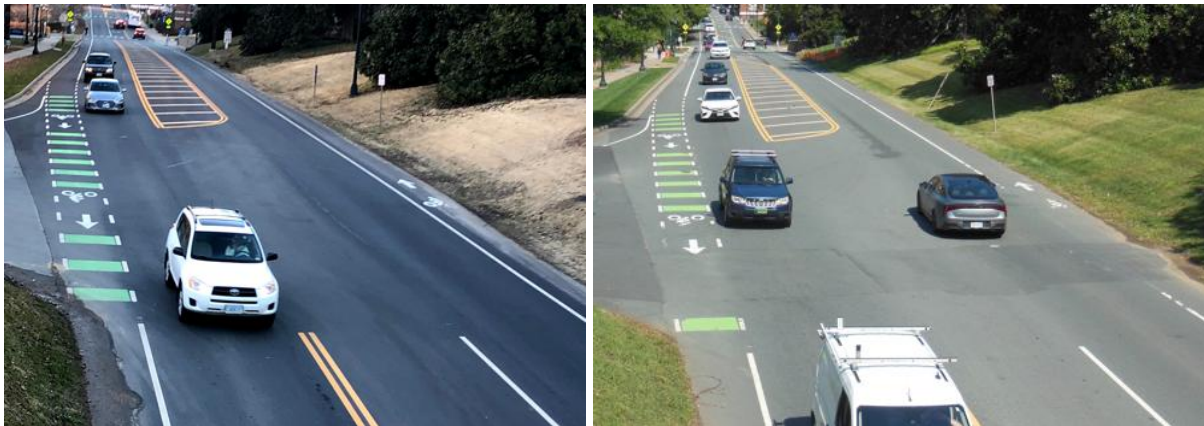
**Figure 7. Example of Utility Work Having Removed a Section of Dashed Green-Colored Pavement Markings Without Replacing Them: (left) before utility work; (right) after utility work.**

For GCPMs, installation questions addressed materials used, the application process, temperature considerations, surface preparation, the curing process, labor, and pavement type and condition. Monitoring questions covered the method and frequency of monitoring, the determination of the need for intervention, skid resistance, and pavement durability surrounding and beneath GCPMs. Maintenance operations questions addressed sweeping and winter maintenance (plowing and de-icing), including any operational differences from bike lanes without GCPMs and any damage resulting from maintenance activities. Questions regarding replacement addressed the frequency, removal, labor, cost, equipment, areas of increased need for replacement, and coordination with other projects, such as utility work (Figure 7).

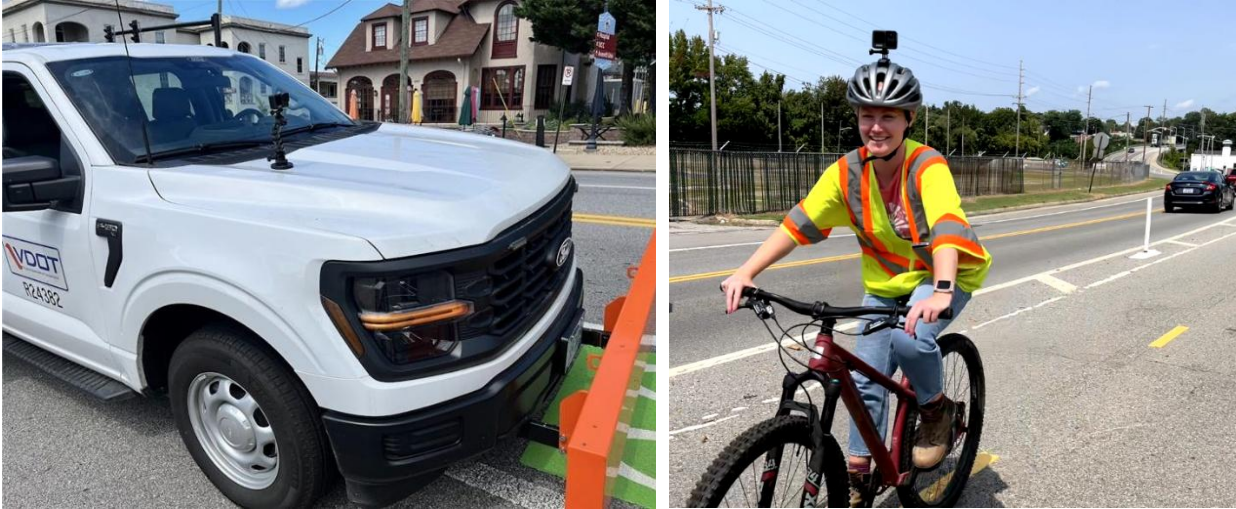
**Figure 8. Collection of Video Recordings of Infrastructure Using an Action Camera: (left) mounted on a VDOT vehicle; (right) mounted on a bicycle helmet**

To document the current condition of the infrastructure at each site, video recordings were made using an action camera mounted on either a vehicle or a bicycle helmet (Figure 8). For sites with GCPMs, observations were made regarding roadway conditions, the condition of markings and marking materials, the presence of friction materials, and the presence of multiple layers of marking. Staff from VDOT's Materials Division evaluated the GCPM color using a colorimeter and surface friction using a British Pendulum Tester (Figure 9). Materials testing was not part of this study's scope, so this report does not include testing methods and results. However, the testing methods and results contributed to the Materials Division's ongoing field evaluations. For sites with flexposts, researchers observed and documented the type of flexpost and base, the connection to the roadway, the general condition of the roadway and flexposts, spacing between flexposts, and the number of missing posts and bases.

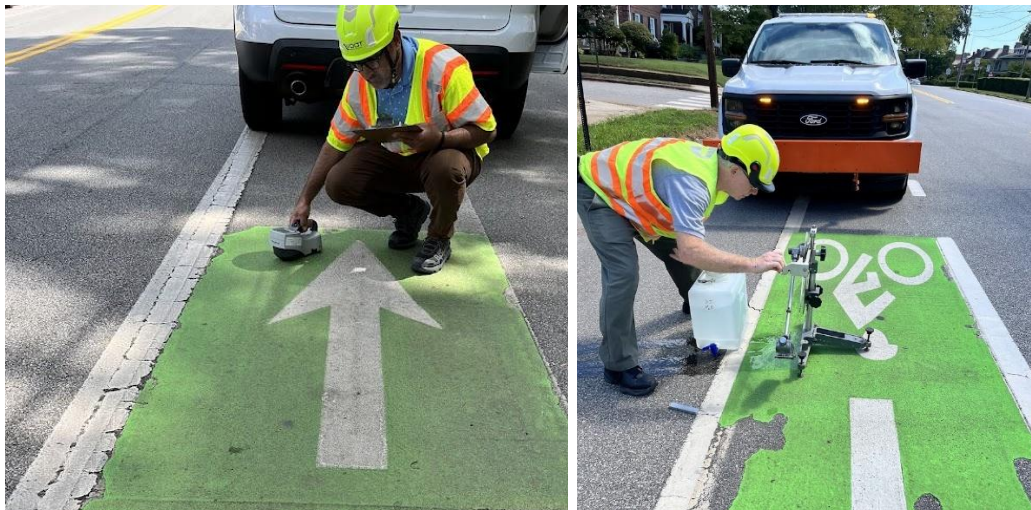
**Figure 9. Collection of Green-Colored Pavement Marking Color Readings Using a Colorimeter (left) and Skid Resistance Data Using the British Pendulum Tester (right)**

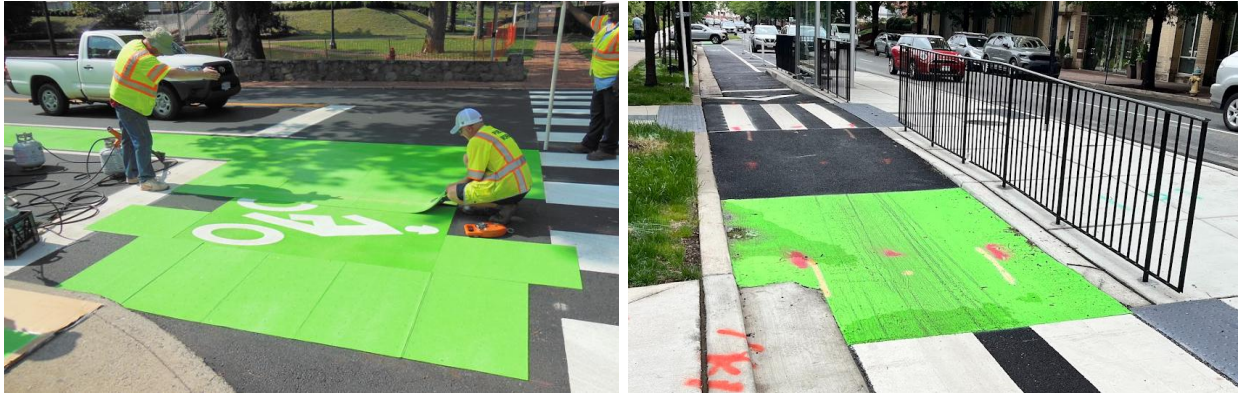
**Figure 10. Thermoplastic and Methyl Methacrylate Green-Colored Pavement Markings: (left) preformed thermoplastic; (right) methyl methacrylate**

Three main GCPM materials were identified in the literature: thermoplastic, methyl methacrylate (MMA), and waterborne paint. Figure 10 shows thermoplastic and MMA. Some state departments of transportation and researchers have performed studies to evaluate the performance and durability of different types of GCPMs (Anderson, 2018; Bao et al., 2024; Fanijo et al., 2022; Kassem et al., 2021; Nyamuhokya and Wilson, 2023). These studies were generally limited in scope regarding the number of sites evaluated and the length of time between GCPM installation and evaluation.

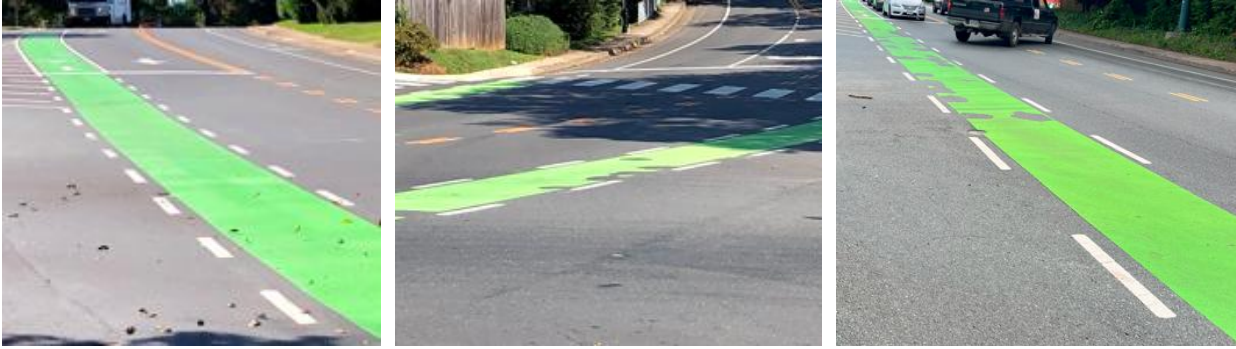
**Figure 12. A Site in Charlottesville with Solid Green Thermoplastic: (left) shortly after installation; (center) from the opposite angle, wear after 1 year; (right) additional wear after 5 years**

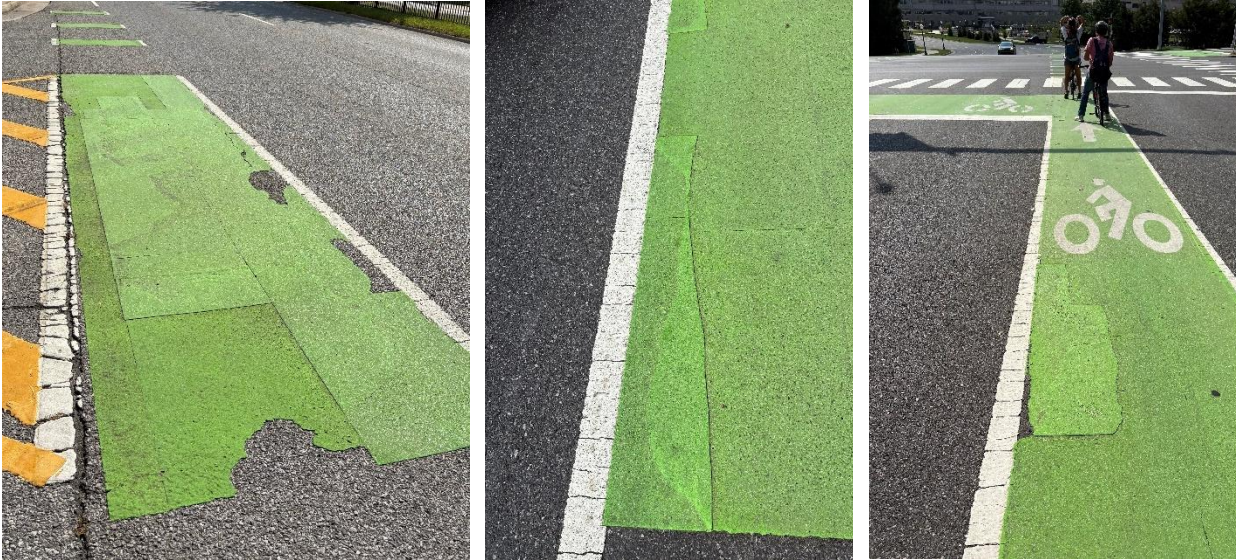
**Figure 13. Examples of Marking “Touch-up” Work in Blacksburg with Preformed Green Thermoplastic Placed on Top of Existing Green-Colored Pavement Markings that Had Deteriorated**

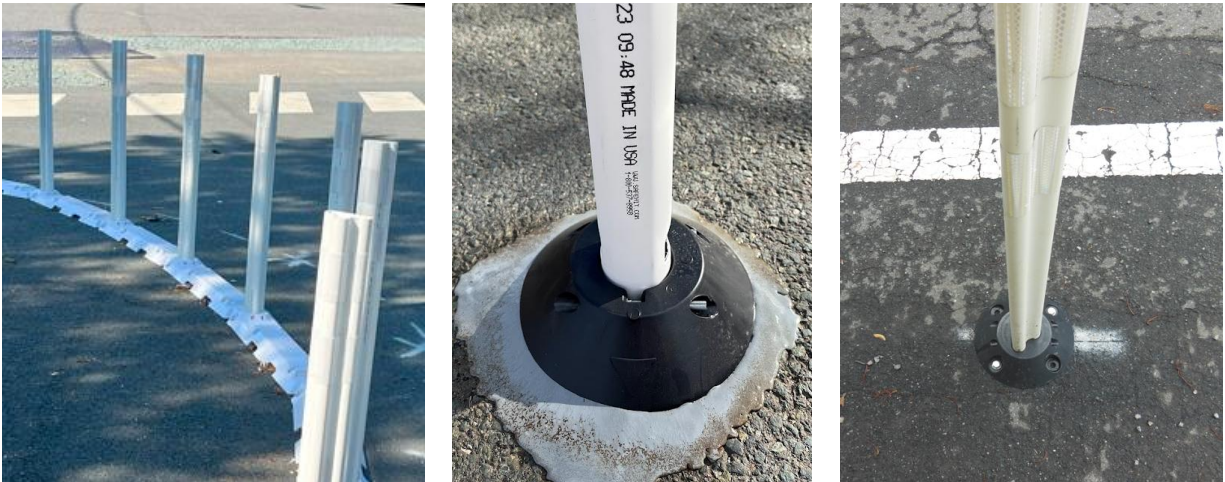
**Figure 14. Examples of Flexpost Installations: (left) on a curb base; (center) individually mounted using epoxy; (right) individually mounted using two of four bolt holes**

have four bolt holes, five agencies reported sometimes using two bolts rather than four to attach flexposts to the pavement. Interviewees who mentioned using this practice typically said it saved time during installation and that two bolts were sufficient for securing the flexpost to the pavement. One agency noted that using only two bolts facilitated reinstallation of a downed flexpost in the same location.

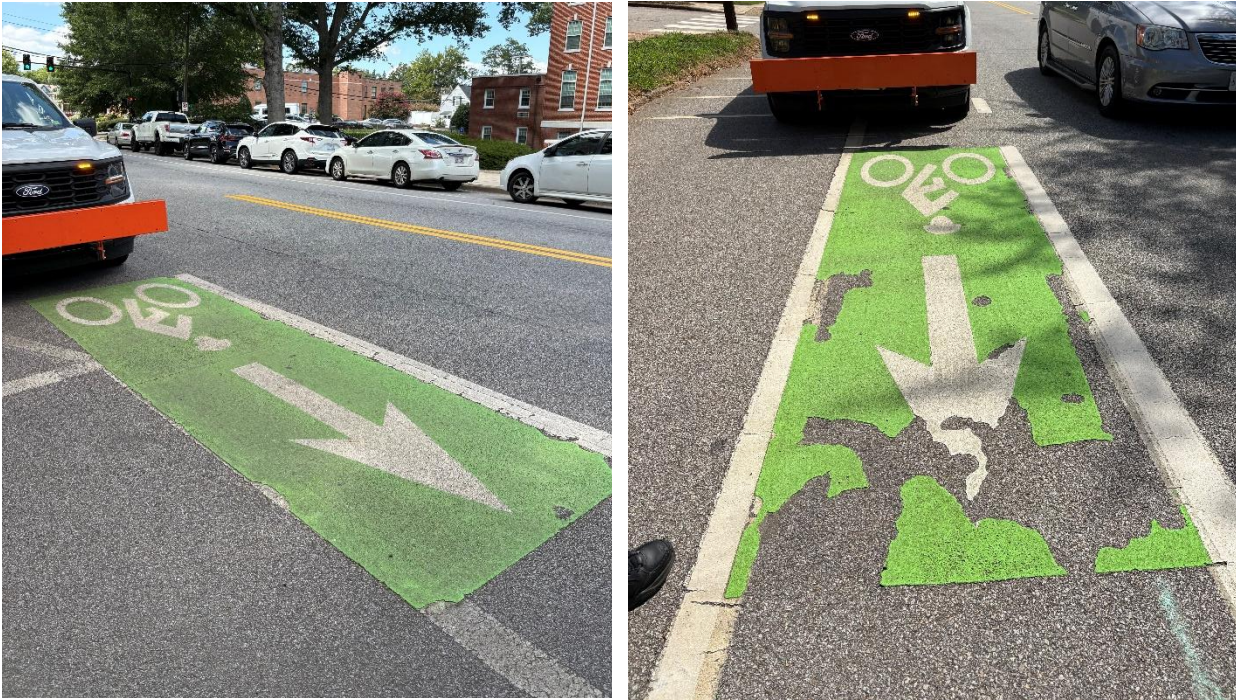
Figure 17. West Main Street Green-Colored Pavement Markings in the City of Danville

ADT of 7,400 vehicles per day. GCPMs were installed between late 2018 and 2020. Each GCPM consists of two preformed thermoplastic sections: the arrow and the bicycle symbol (Figure 17). The markings are not in conflict zones and are not exposed to high volumes of motor vehicle traffic.

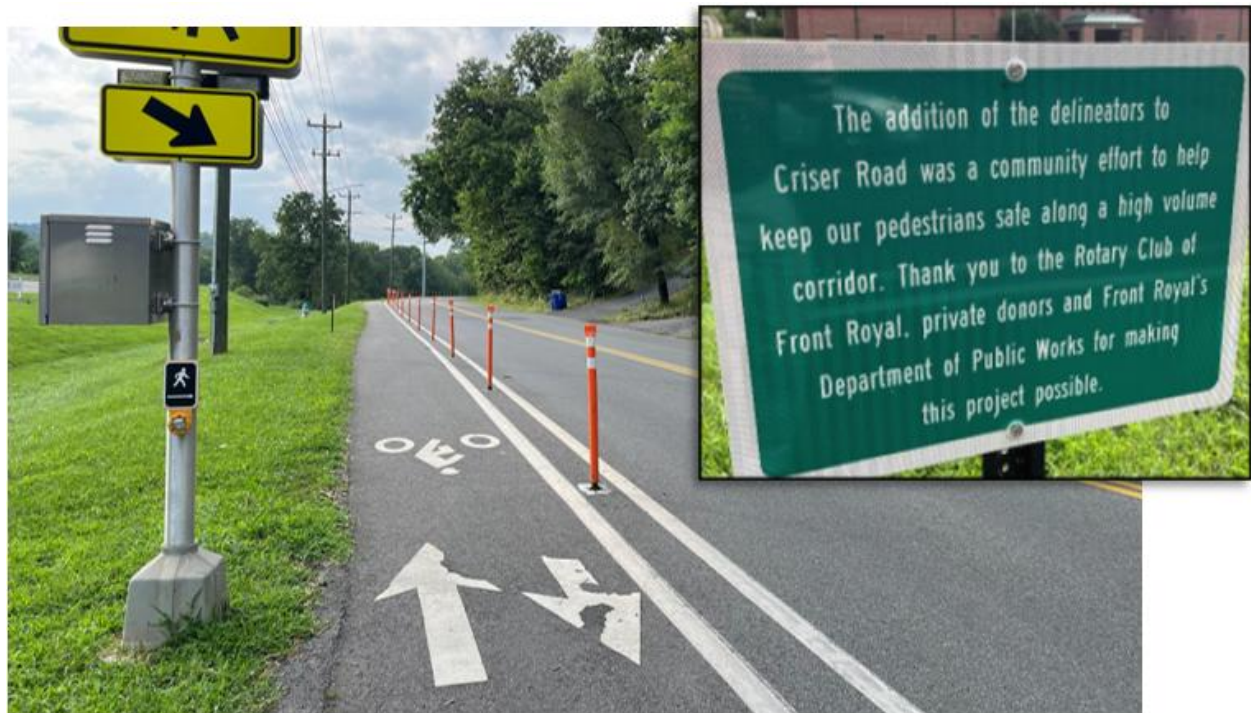
**Figure 19. West Criser Road Bicycle and Pedestrian Lane Separated with Flexposts**

The separated bicycle and pedestrian lane on the south side of West Criser Road from Skyline Vista Drive to Luray Avenue is approximately 1,150 feet long (Figure 19). The lane is within a school zone for Skyline High School and has 56 removable orange flexposts mounted on recessed, plowable bases. West Criser Road is a two-lane major collector with a posted speed limit of 25 mph and ADT of 3,400 vehicles per day. The flexposts and separated lane were installed in 2024 as an interim improvement until a sidewalk with a curb and gutter can be installed as part of a \$3.1 million project anticipated to begin in the fall of 2027 (VDOT, 2026c). Community fundraising via an outside organization covered the cost of the delineators, and the town covered the installation cost. Generally, public feedback on the interim project has been positive. One resident involved in the fundraising process noted that although the project had increased perceived safety overall, the removable nature of the flexposts defeated their purpose to some degree, because they were not in place during the winter months, coinciding with much of the school year when students used the facility (Shotton, 2025).

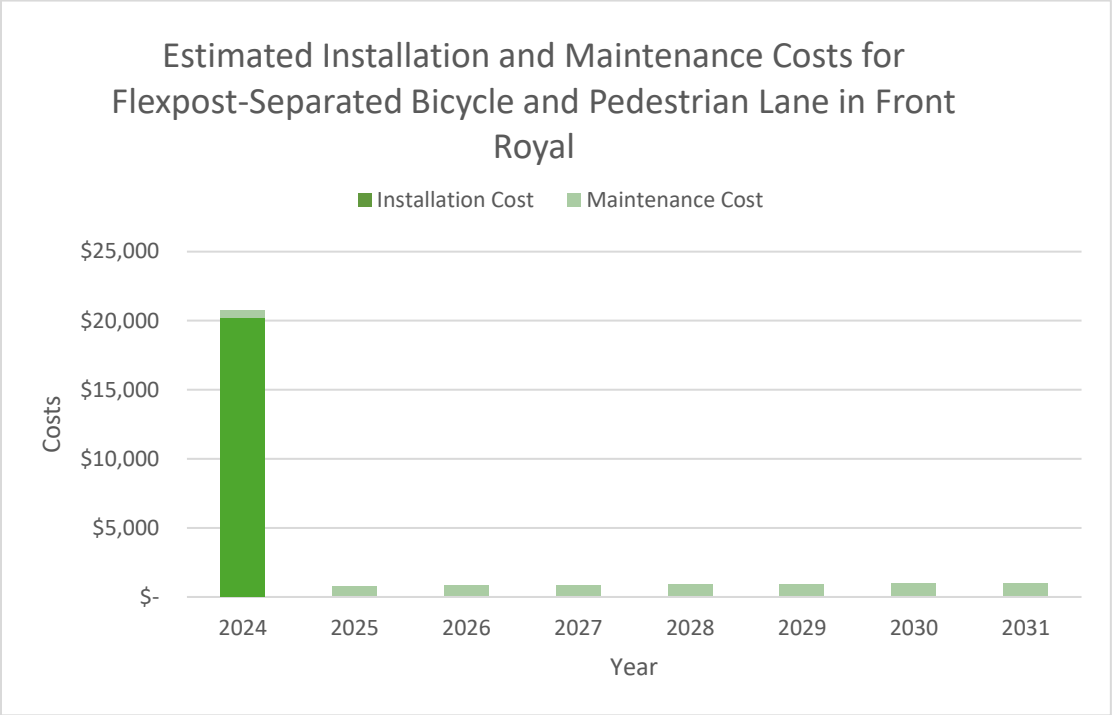
Figure 20. Estimated Installation and Maintenance Costs for Flexpost-Separated Lane in Front Royal

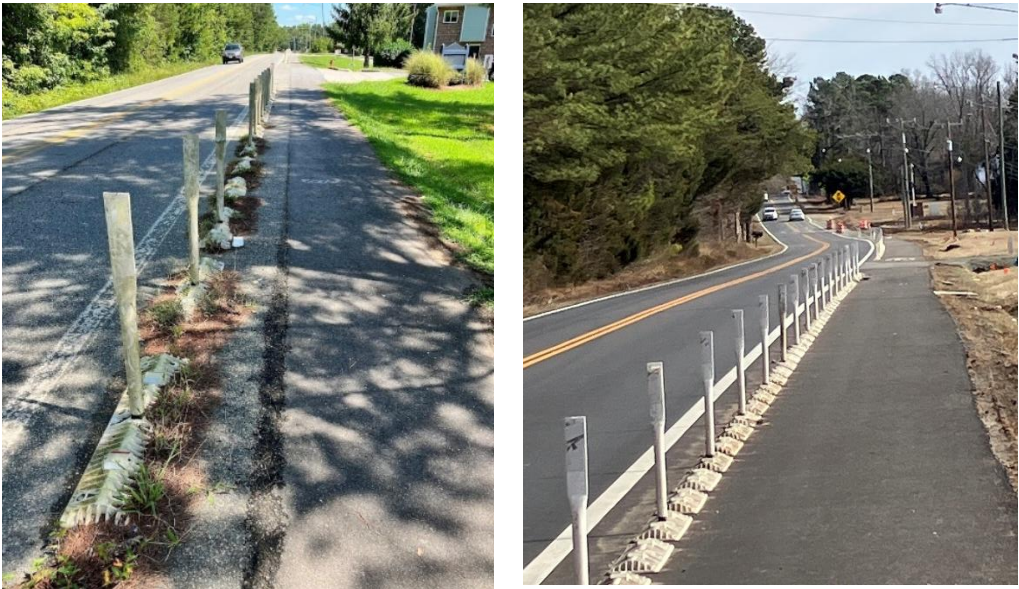
Figure 21. Sinai Road Pedestrian Lane in Halifax County: (left) August 2025; (right, courtesy of Roy Sage) January 2026

lane major collector with a posted speed limit of 35 mph and ADT of 6,300 vehicles per day. The separated lane consists of approximately 350 bases with flexposts that were initially installed in 2020 as a quick-build project via shoulder widening and roadway restriping. The intent was that Halifax County would apply for funding to construct a sidewalk. As of 2025, Sinai Road was in need of repaving, and the county’s funding application had not been approved, so VDOT reinstalled the bases and flexposts in January 2026 (Figure 21).

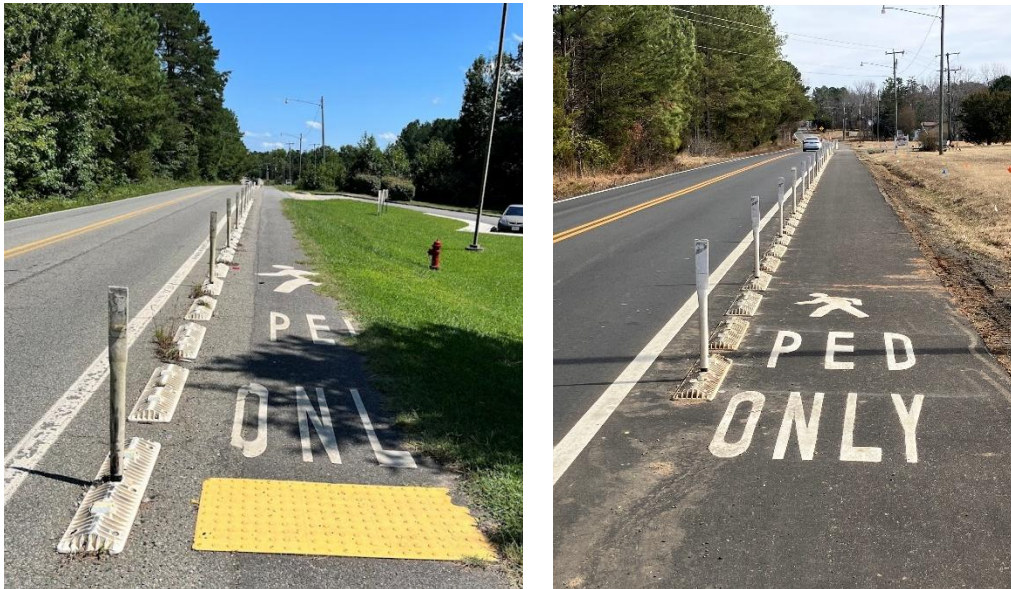
Figure 22. Sinai Road Pedestrian Lane in Halifax County: (left) vegetation overgrowth on shoulder in August 2025; (right, courtesy of Roy Sage) after repaving and reinstallation in January 2026

January 2026 as part of repaving. Halifax Residency staff advised that 49 flexposts were replaced as part of that effort.

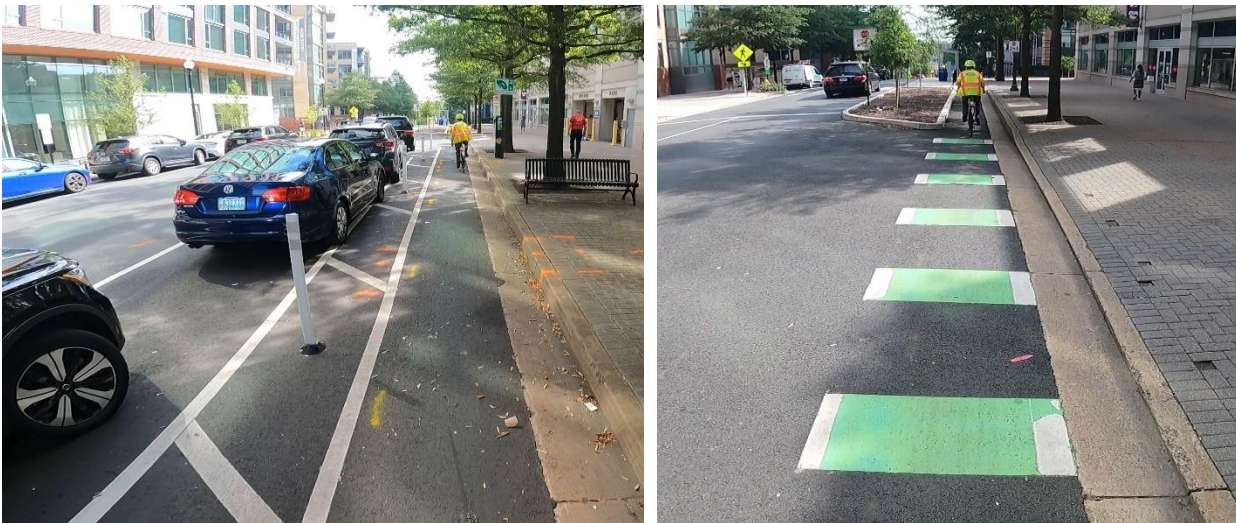
**Figure 24. Clarendon Boulevard Flexpost-Separated Bike Lane: (left) from North Courthouse Road to 1515 Clarendon Boulevard parking garage; (right) thermoplastic green-colored pavement marking skips at 1515 Clarendon Boulevard**

The roadway cross-section changes along the approximately 0.6-mile corridor. East of North Courthouse Road, the roadway includes (from left to right) two vehicle travel lanes, a parking lane, a buffer zone with flexposts, and a separated bicycle lane (Figure 24). At the time of the site visit, eight flexposts were installed along the bicycle lane from North Courthouse Road to the 1515 Clarendon Boulevard parking garage entrance and six GCPM skips at that entrance.

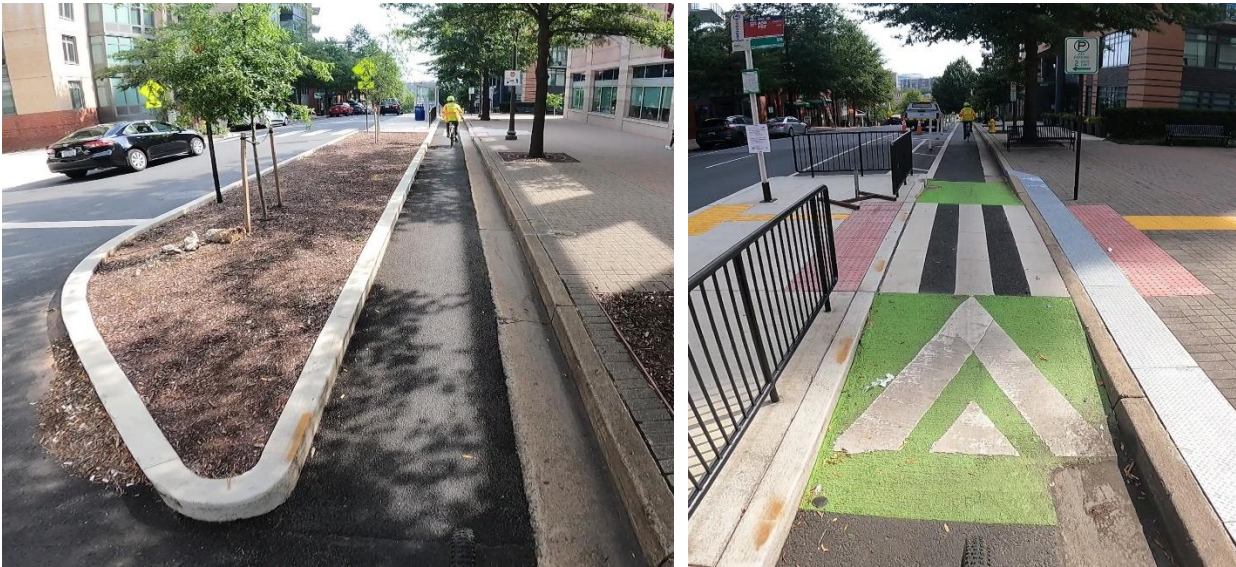
**Figure 25. Clarendon Boulevard Bike Lane: (left) curb-separated lane; (right) methyl methacrylate green-colored pavement markings at bus boarding island**

From 1515 Clarendon Boulevard to the nearby bus boarding island, the bicycle lane is curb-separated and has MMA GCPMs on ramps adjacent to a raised crosswalk (Figure 25).

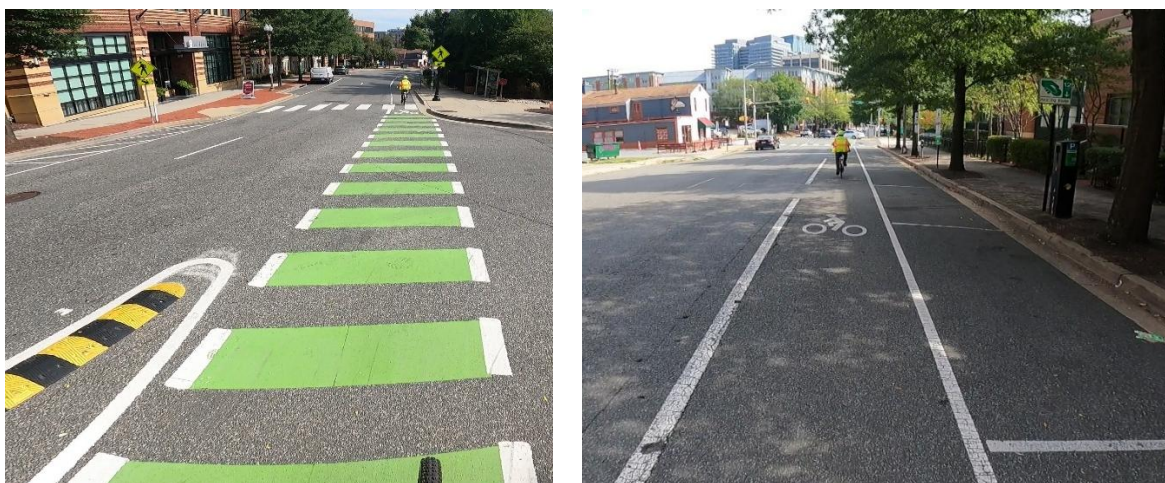
**Figure 26. Clarendon Boulevard Unprotected Bicycle Lane: (left) thermoplastic skips at Clarendon Boulevard and North Scott Street; (right) standard bicycle lane from North Scott Street to North Rhodes Street**

At the intersection of Clarendon Boulevard and North Troy Street, the Clarendon Boulevard bicycle lane is a curb-separated lane, which continues to North Scott Street. Six thermoplastic GCPM skips were present at the Retail Parking entrance, and 13 thermoplastic GCPM skips were present at the North Scott Street intersection (Figure 26).

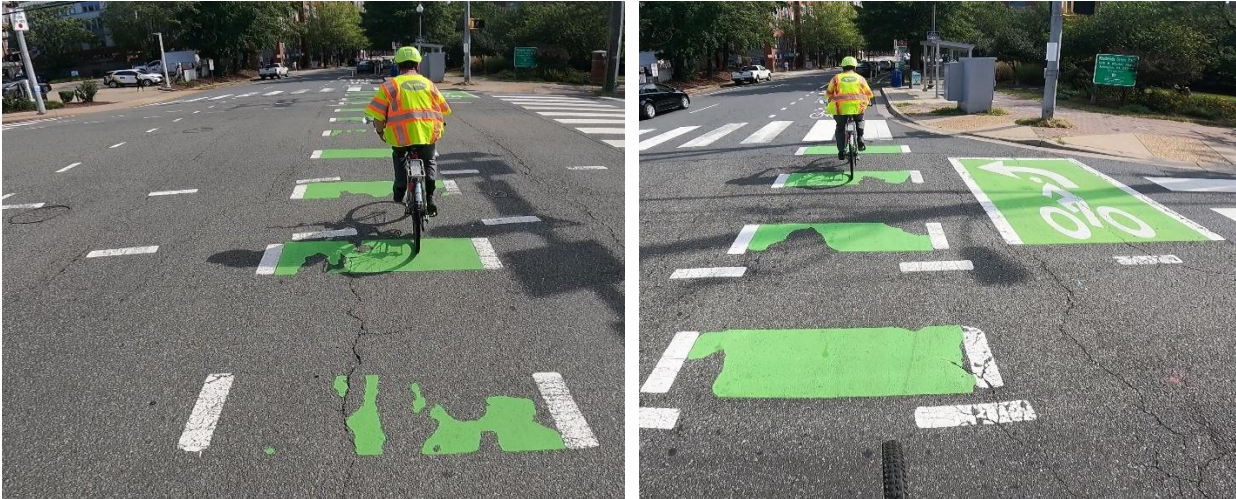
**Figure 27. Clarendon Boulevard and North Rhodes Street: (left) thermoplastic skips; (right) two-stage turn box**

From North Scott Street to North Rhodes Street, the facility is a standard bicycle lane, without separators or buffers, between general-purpose lanes and curbside street parking (Figure 25). Eleven thermoplastic GCPM skips and one two-stage turn box were present in the North Rhodes Street intersection (Figure 27).

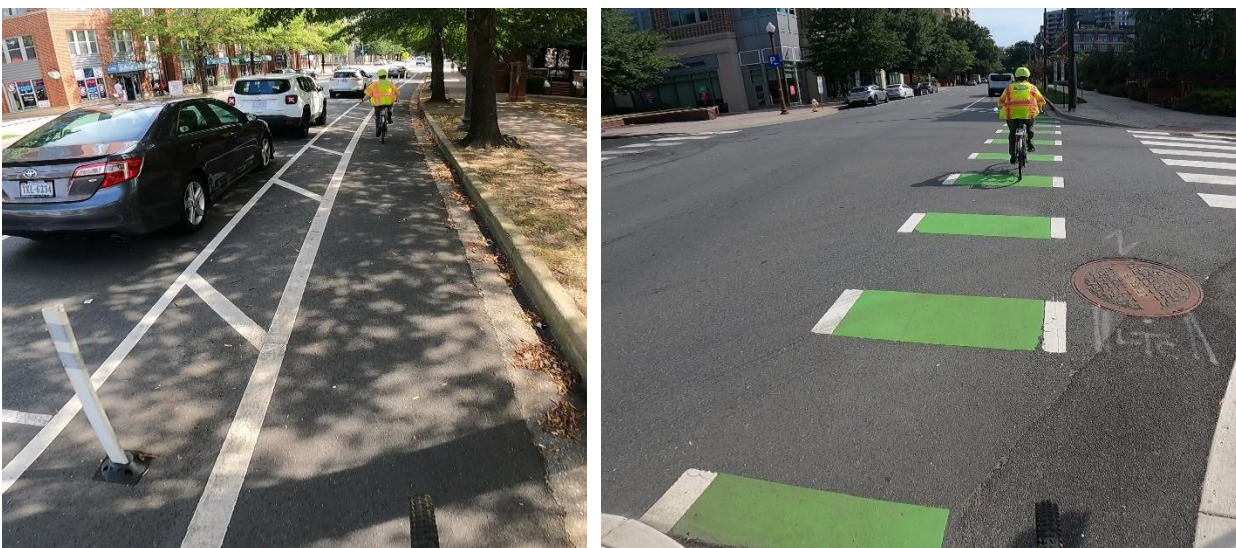
**Figure 28. Clarendon Boulevard Bicycle Lane: (left) flexpost-separated bike lane from North Rhodes Street to North Quinn Street with missing flexposts; (right) thermoplastic skips at Clarendon Boulevard and North Quinn Street intersection**

From North Rhodes Street to North Quinn Street, the facility is a separated bicycle lane to the right of on-street parking, with a buffer zone and flexposts. Seven flexposts were present in this section, and five flexposts appeared to be missing. Ten thermoplastic GCPM skips were observed at the North Quinn Street intersection, one of which appeared to have been partially removed by pavement patching (Figure 28).

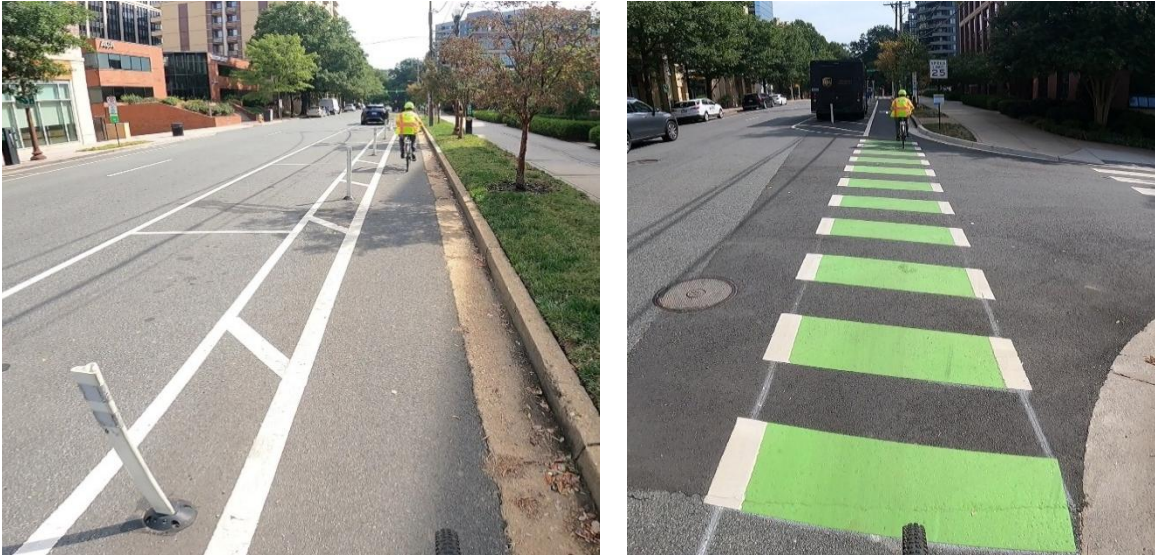
**Figure 29. Clarendon Boulevard Bicycle Lane: (left) flexpost-separated bike lane from North Quinn Street to North Queen Street; (right) thermoplastic skips at Clarendon Boulevard and North Queen Street intersection**

The parking-separated bicycle lane continues from North Quinn Street to North Queen Street. Eight flexposts were present in this section, and one or two flexposts appeared to be missing. Eleven thermoplastic GCPM skips were present at the North Queen Street intersection, which appeared to have been replaced recently following repaving (Figure 29).

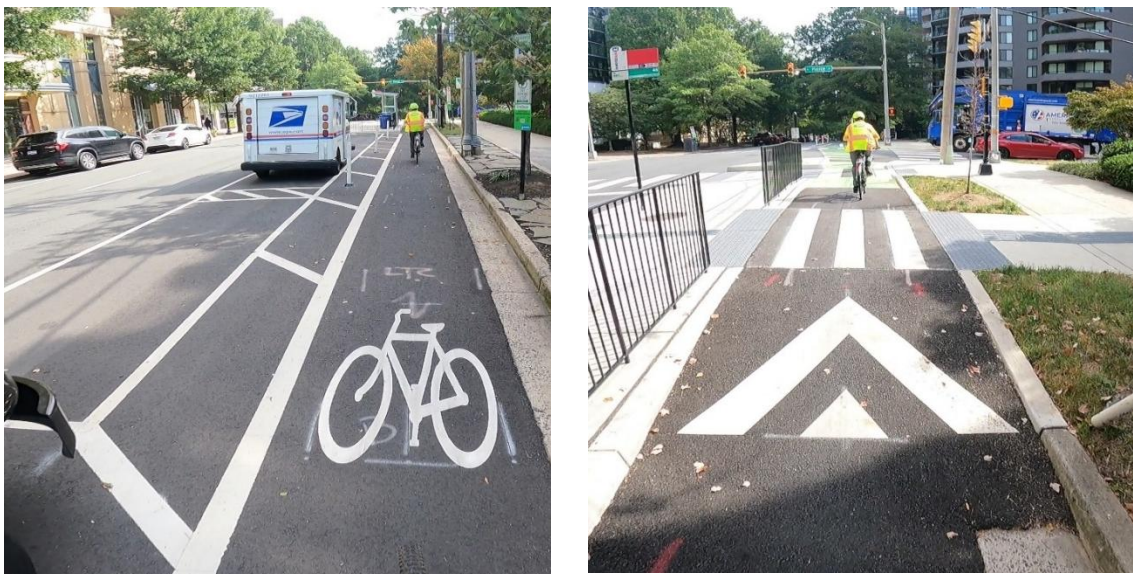
**Figure 30. Clarendon Boulevard Bicycle Lane: (left) flexpost-separated bike lane from North Queen Street to North Pierce Street with missing flexposts; (right) crosswalk to bus boarding island slightly west of North Pierce Street intersection**

From North Queen Street to the bus boarding island slightly west of North Pierce Street, the parking-separated bicycle lane had four flexposts present and two or three missing. At the bus boarding island, the bicycle lane is separated by a curb. MMA GCPMs were adjacent to the intersection crosswalk at the end of the bus platform. A second crosswalk in the center of the bus platform had no GCPMs (Figure 30).

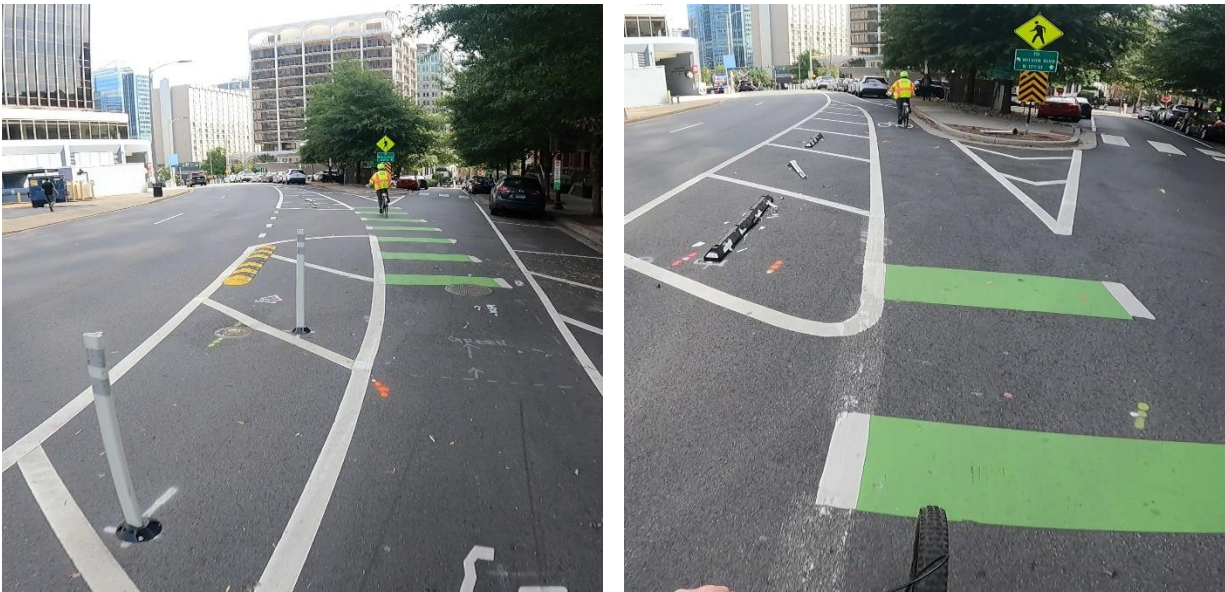
**Figure 34. Clarendon Boulevard and 17th Street North Intersection: (left) flexposts and thermoplastic green-colored pavement marking skips; (right) downed flexpost**

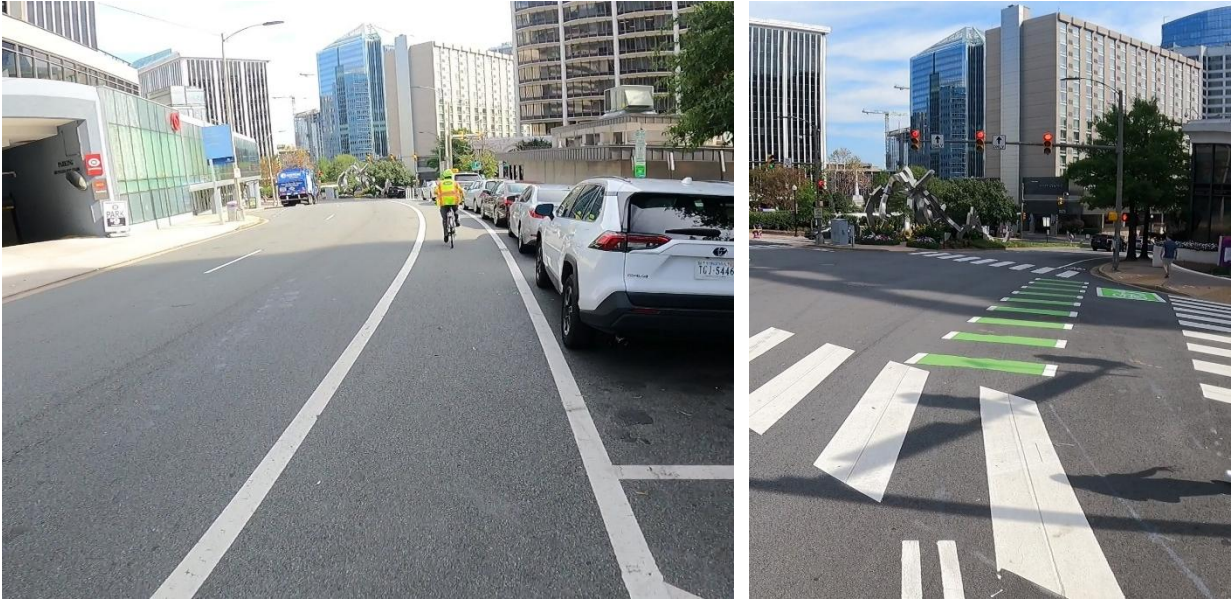
**Figure 35. Clarendon Boulevard Bicycle Lane: (left) standard bicycle lane from 17th Street North to the North Oak Street intersection; (right) thermoplastic green-colored pavement marking skips and a two-stage turn box at the Clarendon Boulevard and North Oak Street intersection**

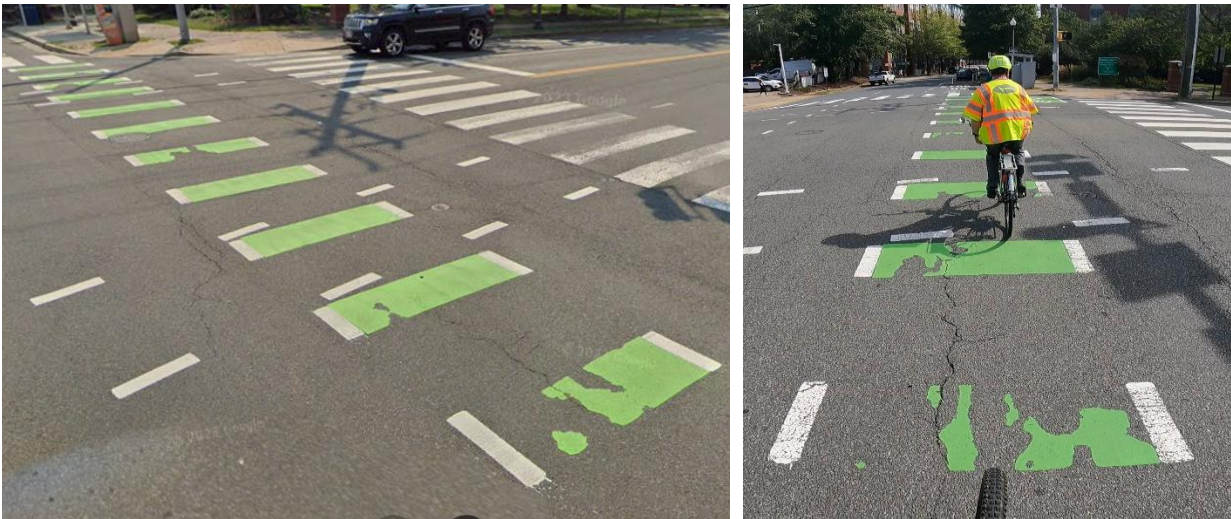
**Figure 36. Thermoplastic Green-Colored Pavement Marking Skips at the Clarendon Boulevard and North Rhodes Street Intersection: (left) visible wear in the earliest available Google Maps imaging after installation (image capture: July 2021 © 2026 Google); (right) visible wear to the same skips from a site visit conducted in September 2025**

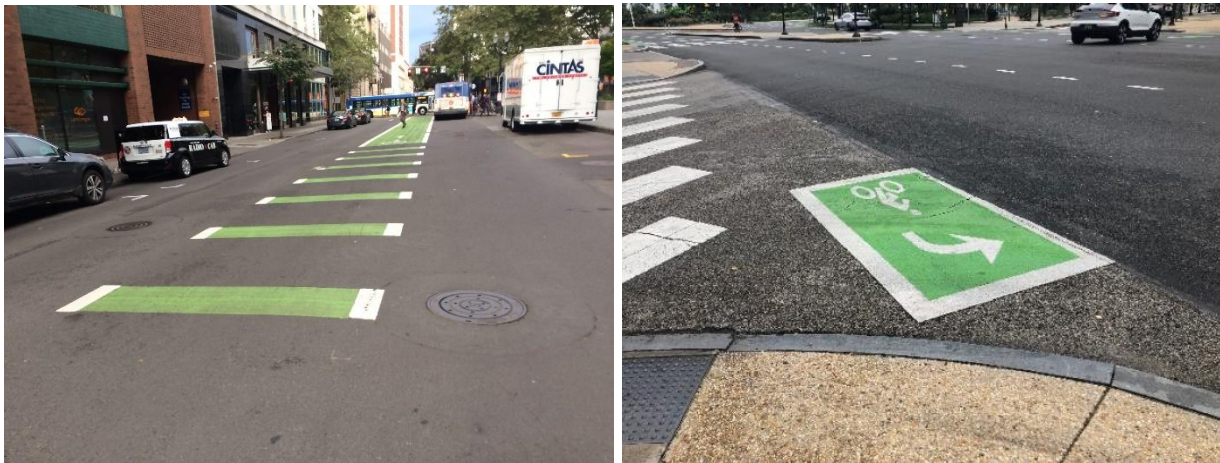
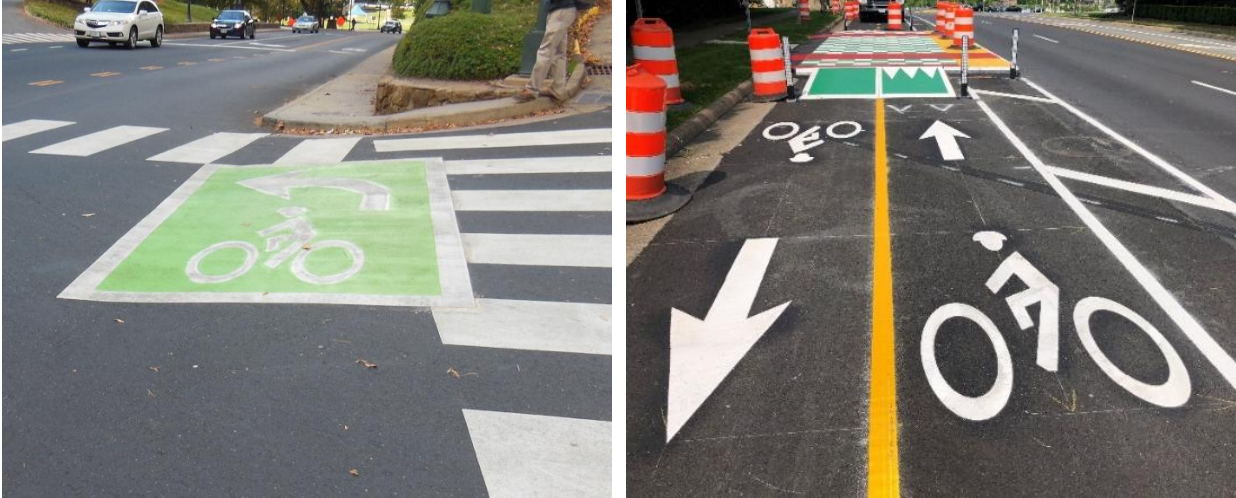
GCPMs are often used to denote the roadway space where bicyclists operate. GCPMs may deter drivers from parking in bike lanes and help decrease obstructions in bicycle facilities. A wide variety of marking types using green-colored materials have been used to designate bicycle facilities. Some examples of GCPM use are shown below.

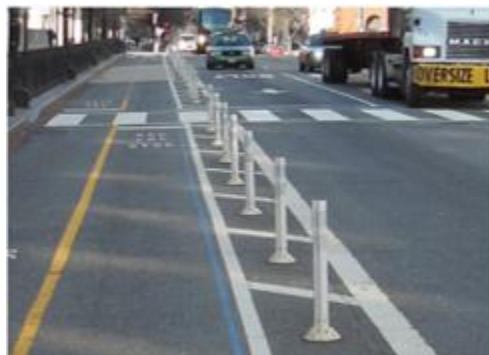
Also known as cycle tracks or protected bike lanes, separated bicycle lanes have some form of vertical physical separation from motor-vehicle traffic, in contrast to standard or buffered bike lanes that utilize striping alone to separate the bicycle lane from the general-purpose lane. An example of flexposts used in a bicycle application is shown below.

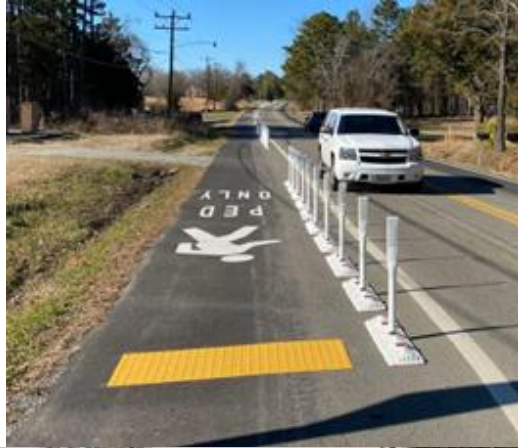
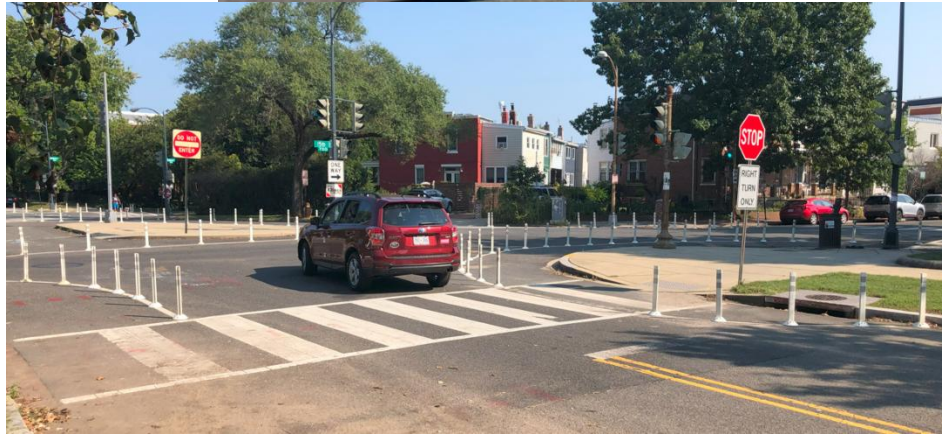
Flexposts have been employed in pedestrian facility applications such as curb extensions and interim pedestrian lane facilities, where they offer a flexible, low-cost solution for enhancing pedestrian visibility and safety in temporary or constrained environments. Examples of flexposts used in pedestrian applications are shown below.
