**EROSION CONTROL  
AND REVEGETATION TECHNIQUES  
USING MECHANICALLY  
STABILIZED EARTH SLOPES**

**COLORADO TRANSPORTATION INSTITUTE**

| REPORT DOCUMENTATION PAGE | | | FORM APPROVED<br>OMB NO. 0704-0188 | |
|---|---|---|---|--|
| 4. TITLE AND SUBTITLE<br>Erosion Control and Revegetation Techniques Using Mechanically Stabilized Earth Slopes | | | 5. FUNDING NUMBERS | |

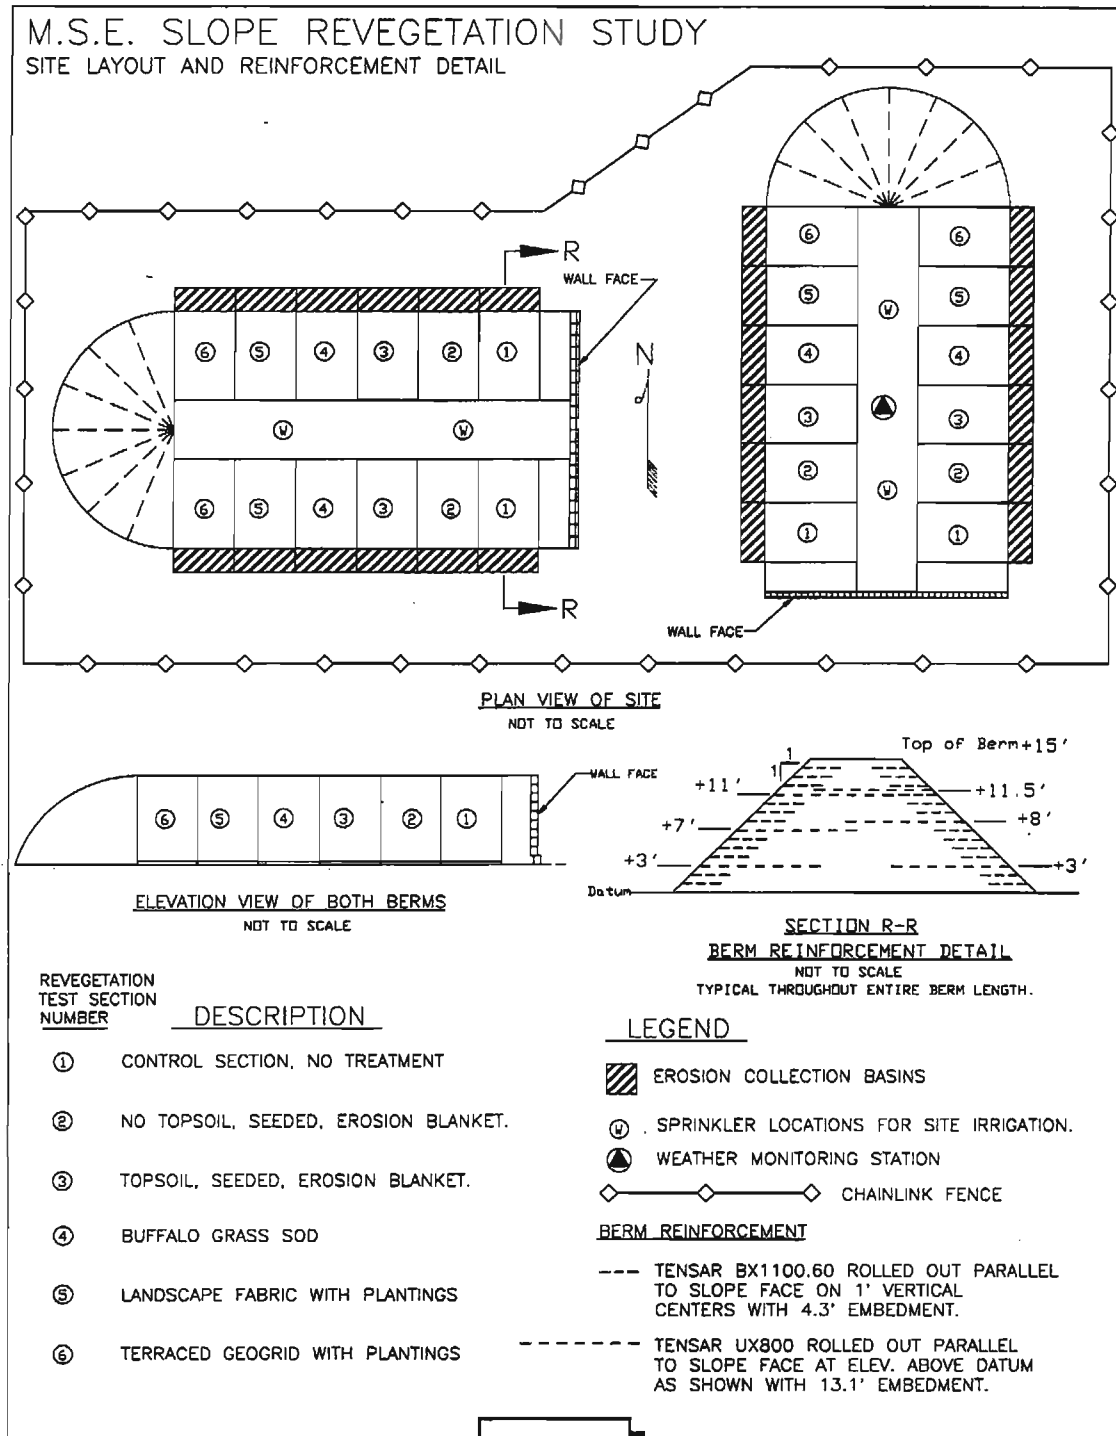
**Figure A**

Two embankments were constructed at the Colorado Department of Transportation's Commerce City Maintenance Yard to study the characteristics of M.S.E. slopes and mechanically stabilized backfill (M.S.B.) walls. The M.S.B. walls are the focus of a separate study and report. The embankments were approximately 65 feet long with a bottom width of 40 feet and a height of 15 feet. M.S.E. slopes were constructed at one-to-one slope so that the berm width at the top was 10 feet. One berm was oriented from the north to the south and the other was oriented from the east to the west. This directed the four test slopes to the four compass directions. Primary and intermediate slope reinforcement was provided by Tensar geogrids. See Figure A.

The revegetation test sections that were built are labeled and described as "Section 1" through "Section 6" in Figure A and Figure B. Each test section was subjected to North, South, East and West exposure.

Erosion collection bins (See Figure A) were constructed of 2" x 6" pine board frames and specially fabricated impermeable 30 mil plastic linings. The collection bins were built to provide each test section with a 10' x 4.5' rectangular bin at it's base to contain all eroded material for measurement.

The six revegetation test sections were constructed on the North, South, East and West facing slopes (See Figure A and B above). Following is the vegetation planted on the individual test sections.

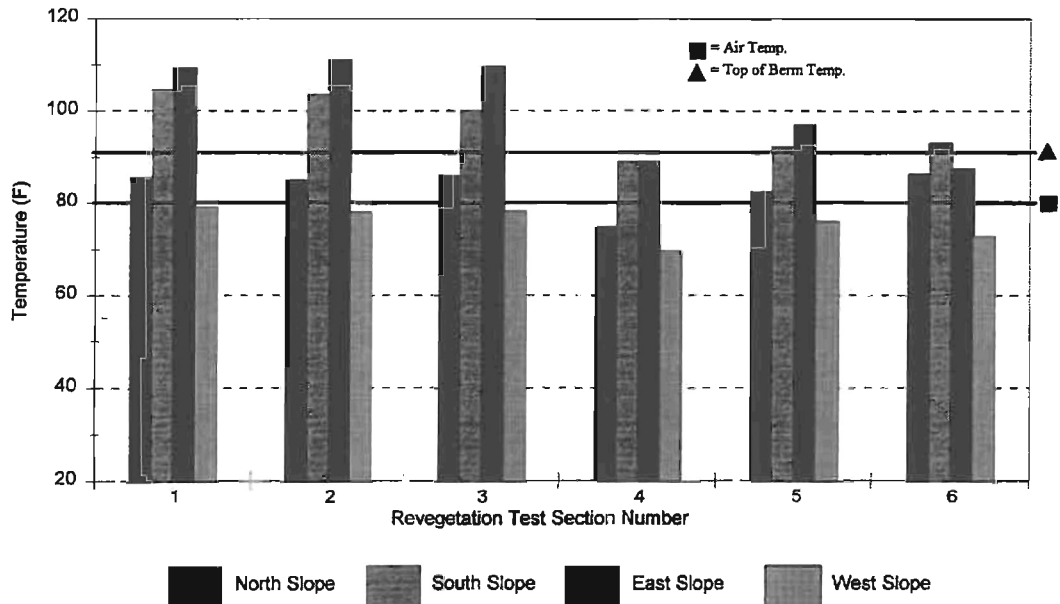
Figure C.1

Soil temperatures were recorded at the top and bottom of each test section as well as on either end of the top of both berms three times during the study period. **Figures C.1, C.2, and C.3** show slope temperature relationships.

**SOIL TEMPERATURES**  
June 20, 1994 10:30 am

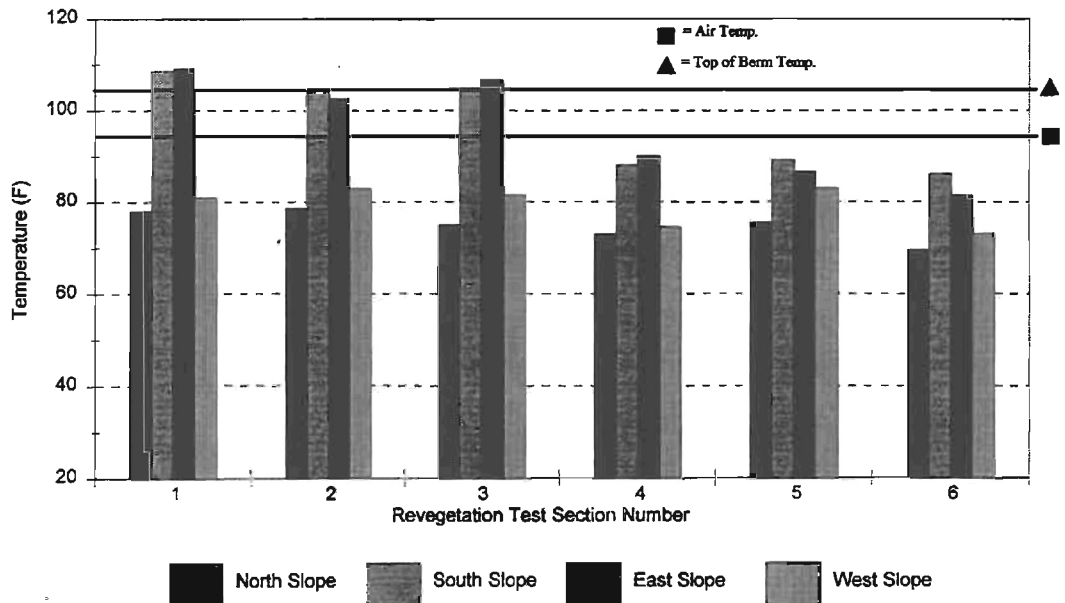
Figure C.2

**SOIL TEMPERATURES**  
Aug. 17, 1994 12:00 noon
