**SMA**  
**(Stone Matrix Asphalt)**  
**Colfax Avenue Viaduct**

**Colorado Department of Transportation  
4340 East Arkansas Avenue  
Denver, Colorado 80222**

**Construction Report  
April, 1996**

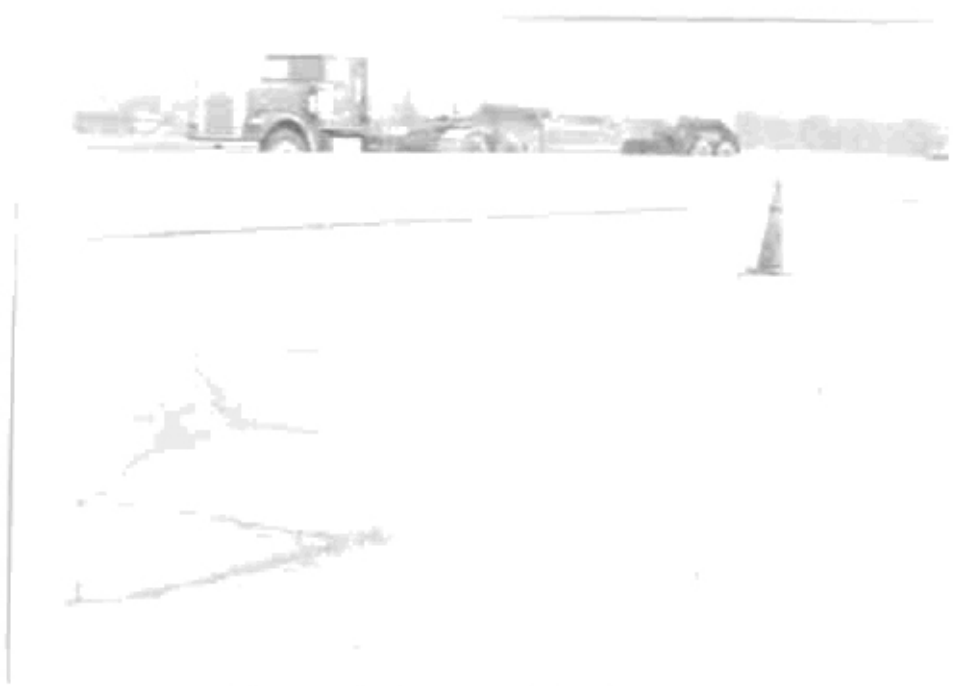
**Figure 3. Typical cracking pattern prior to paving.**

Crack maps were prepared for the evaluation section. Cracking was very extensive so only the transverse cracks were recorded. On the average there were about 14 transverse cracks per 100 foot of pavement. It was observed that on the average there was only 1 transverse crack per 100 foot that ran the entire width of the pavement. This type of cracking does not follow the typical thermal cracking pattern that is found in roadways. Thermal cracking in roadways tend to extend the full width of the pavement.

The cracks had began to deteriorate on the edges and there were a number of areas on the mat where the membrane was exposed. These areas ranged in size from  $25\text{cm}^2(4\text{in}^2)$  to  $0.1\text{m}^2(1\text{ft}^2)$  square. Prior to paving the larger areas were repaired. The membrane was removed and a cold pour material was applied. Typical distress found in the existing overlay on the deck surface is shown in Figures 3 and 4. The removal and repair of the exposed membrane is shown in Figures 5 and 6.

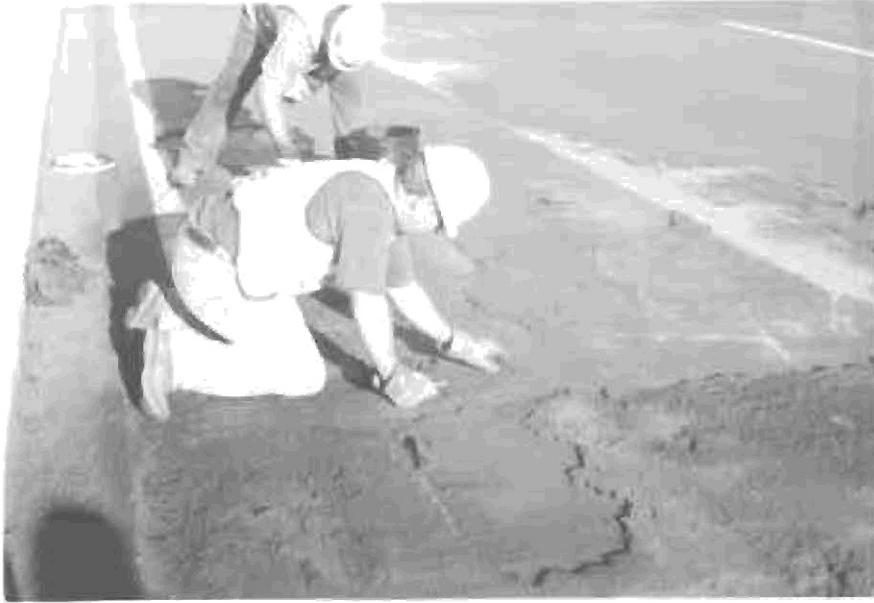
**Figure 5. The exposed membrane was removed.**

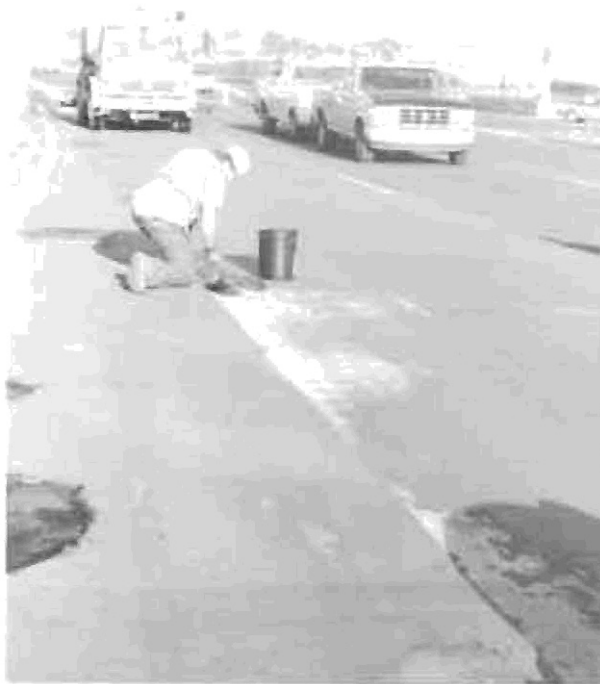
**Figure 6. A cold-pour material was used to cover the area where the membrane was removed.**

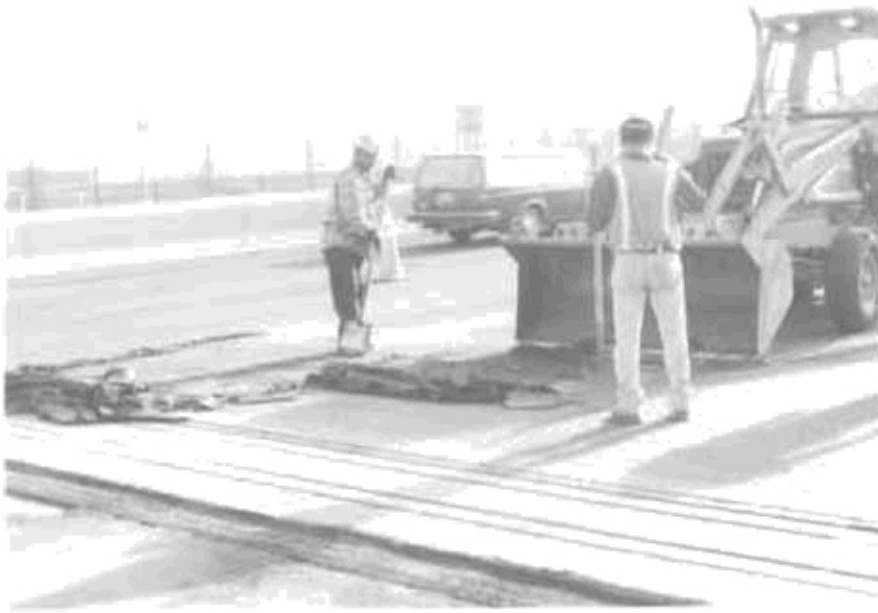
**Figure 7. Removing the taper at the expansion joint.**

Tapers were placed at all expansion joints once the pavement was milled. These tapers were removed prior to placing the SMA pavement. Although hand work is difficult with SMAs the contractor did not have much difficulty working with the SMA material at the expansion joints.

Figures 7 and 8 show the preparation at the expansion joints. Figure 9 shows the required hand work at the expansion joint.

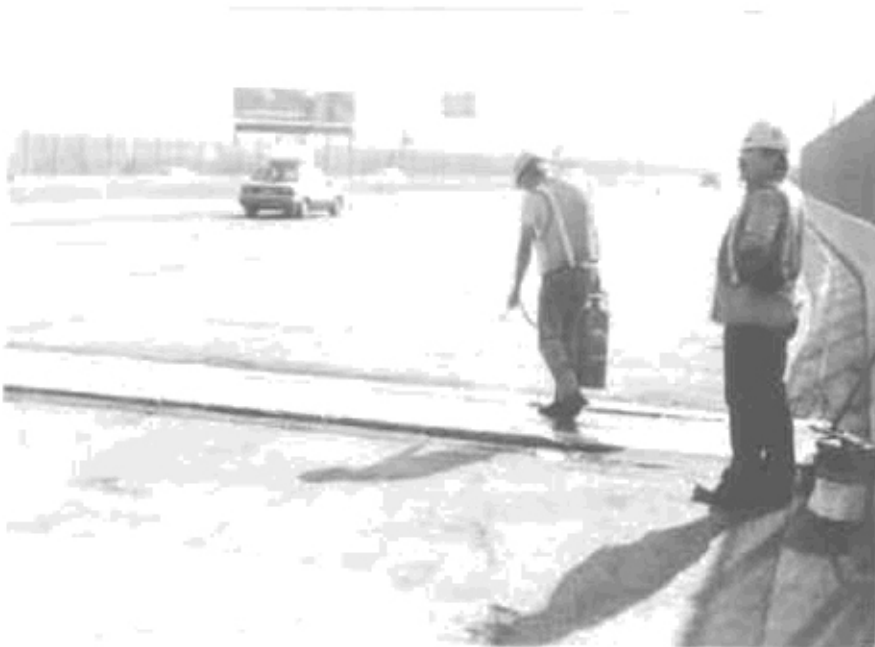
**Figure 8. Preparing the joint prior to SMA placement.**

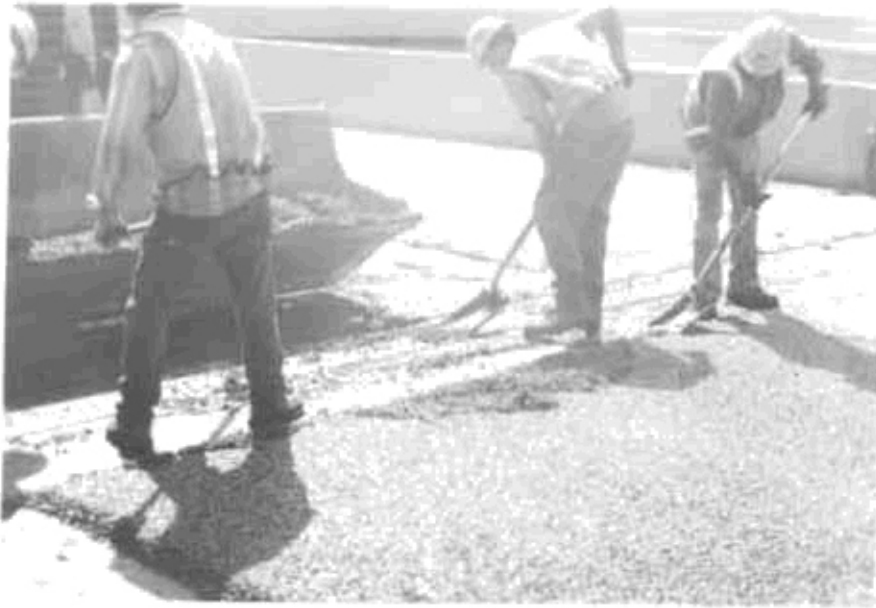
**Figure 9. Hand work is required at the expansion joint.**

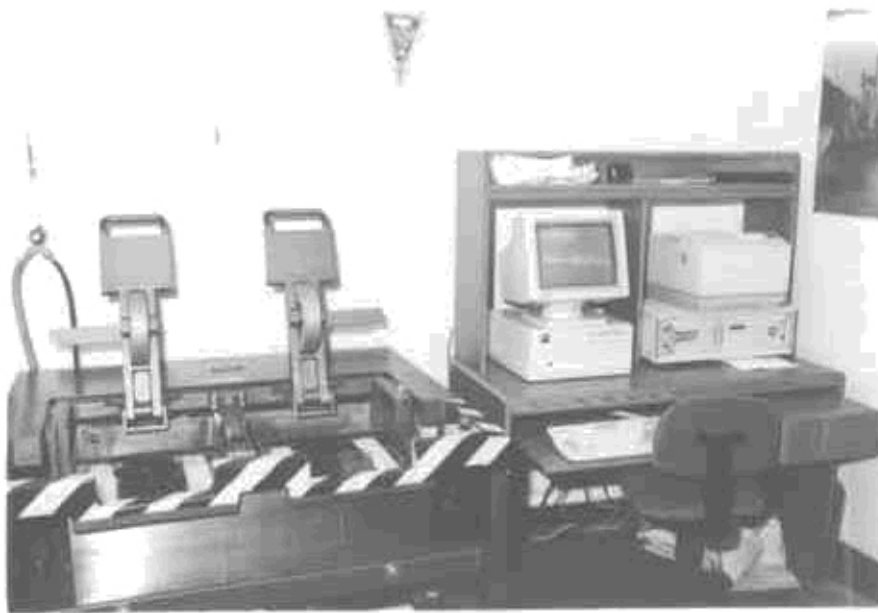
**Figure 10. The Hamburg Wheel-Tracking Device.**

The Hamburg wheel-tracking device is used to evaluate the resistance of the HBP to moisture damage. It is manufactured by Helmut-Wind Inc. in Hamburg, Germany as shown in Figures 10 and 11.

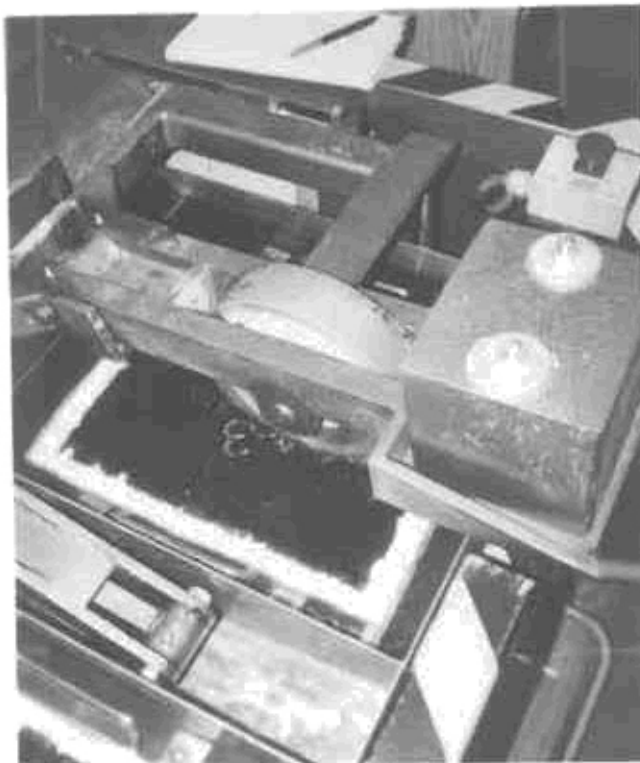
**Figure 11. Close-Up of the Hamburg Wheel-Tracking Device.**
