# The Deep Patch Technique for Landslide Repair

Bassam M. Helwany  
Colorado Transportation Institute  
4201 East Arkansas Avenue  
Denver, CO 80222

Final Report  
October, 1994

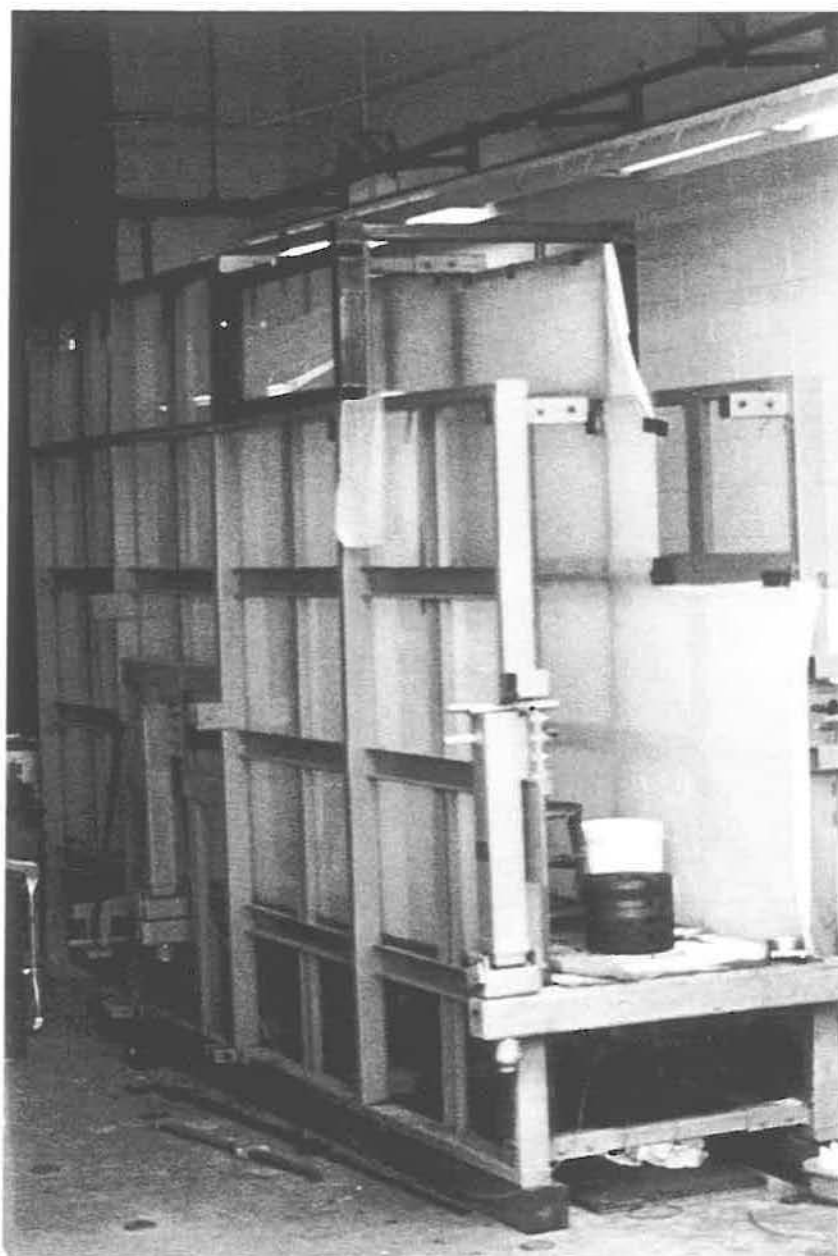
Figure 2.1 The Deep Patch Test Apparatus

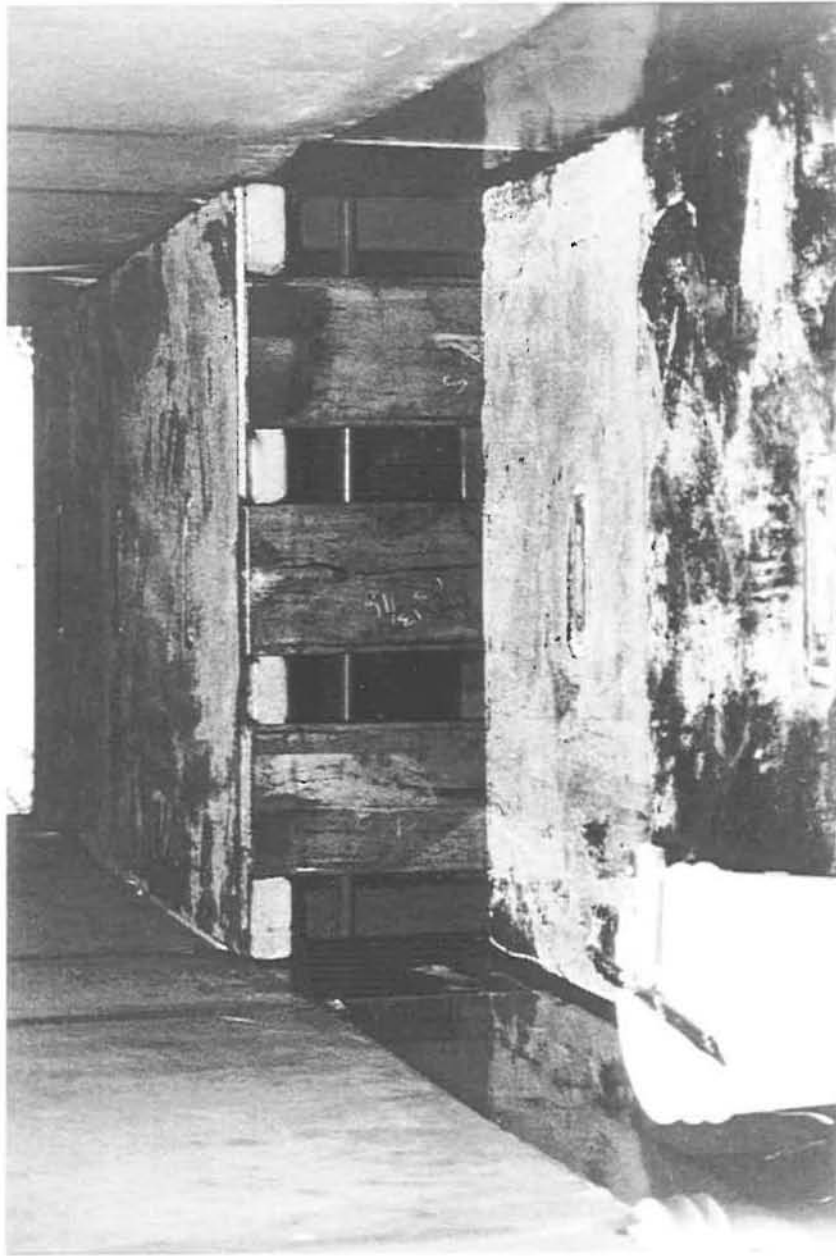
Figure 2.4 The Movable Part of the Bottom Panel at 11 inch Drop

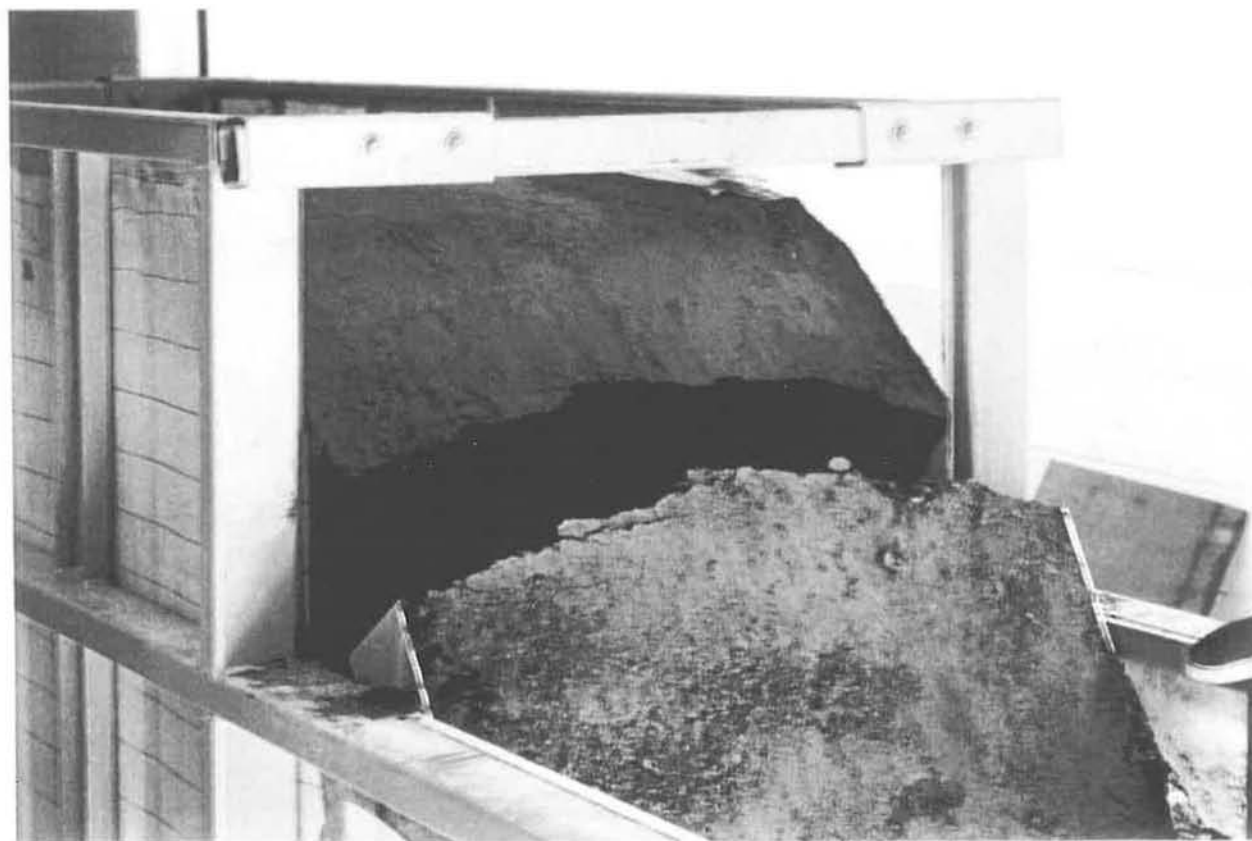
Figure 2.33 The Crack Corresponding to 11 inch-Drop in the Unreinforced USFS Deep Patch Test

The displacement of the slope, the bottom panel, and the top surface in the USFS unreinforced test, as measured by the lubricated latex grid, is shown in Figure 2.32. A near vertical crack emanating from a point on the slope nearly above the inner end of the moveable part of the bottom panel is shown in the figure. The crack started with the first drop of 0.2 inch and propagated throughout the test due to further drops of the moveable part of the bottom panel. The depth of the crack was approximately 70 inches and its width was approximately 12 inches due to the 11 inch drop in the moveable part of the bottom panel (see Figure 2.33).

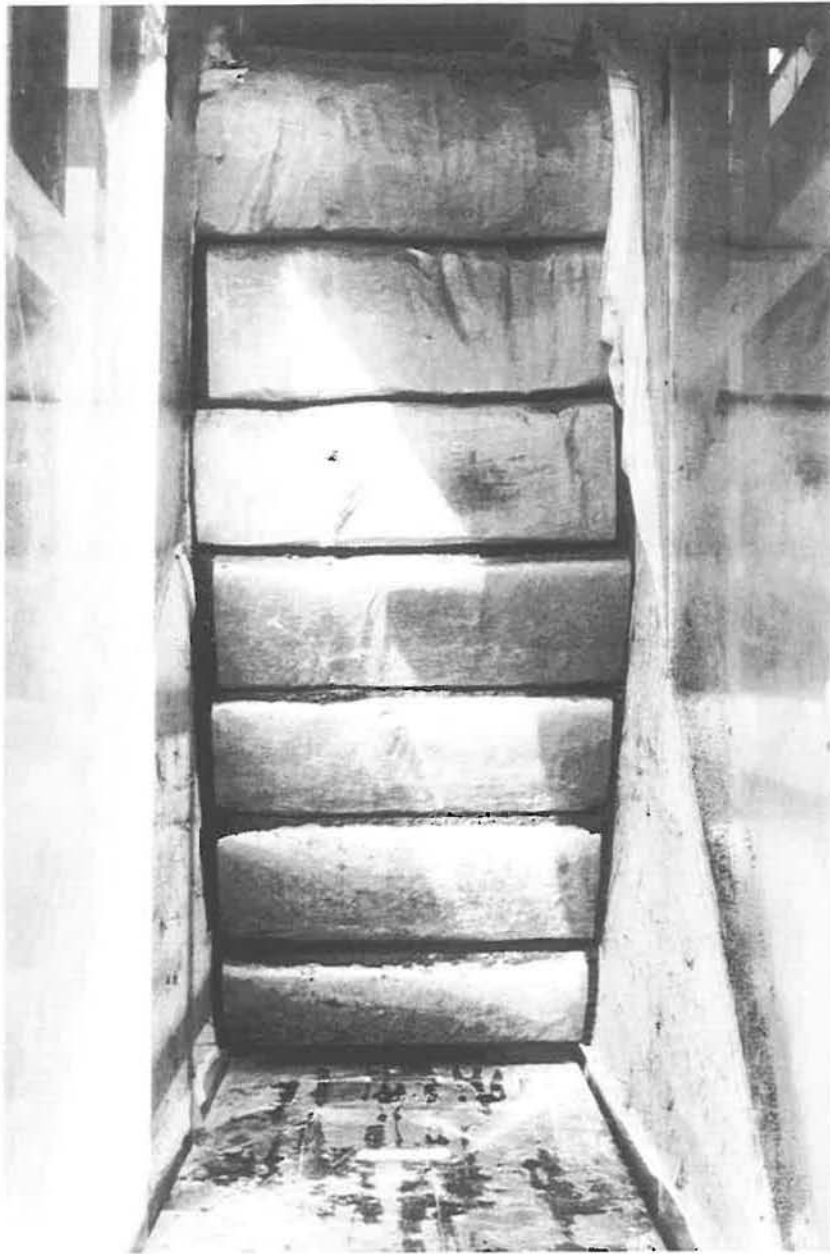
Figure 3.5 The Deformed Face of the CTI Deep Patch Test with Road Base Backfill after Removing the Berm
