FHWA/RD-86/191

**EFFECTS OF CHANGES IN EFFECTIVE RAIL HEIGHT ON BARRIER PERFORMANCE**

**Volume 1: Research Report**

**Prepared for  
Safety Design Division  
FEDERAL HIGHWAY ADMINISTRATION  
U.S. Department of Transportation  
Washington, D.C. 20590**

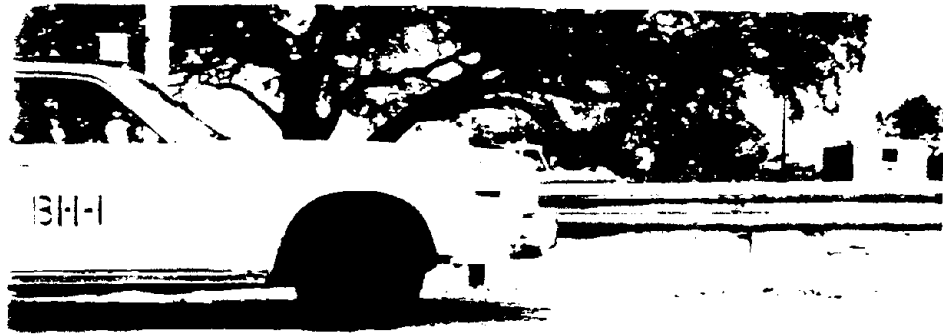
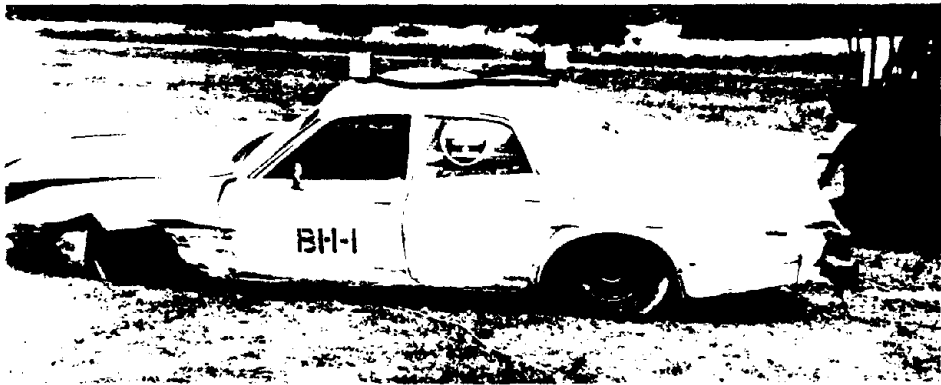
Figure 20. Before and after test photographs, Test BH-1.

Test BH-1. The purpose of this test was to evaluate the G4(1S) guardrail (coupled) for underride with the W-beam mounted at 30 in (76 cm) above grade. The underride height for the test vehicle was 20 in (51 cm) as shown in figure 20. Impact conditions for the 4735-lb (2140-kg) gross weight vehicle were 61.1 mph (98.3 km/h) and 25.9°. The vehicle was redirected as shown in figure 21, although snagging occurred due to wheel contact with posts. The maximum dynamic deflection was 35.2 in (89.4 cm); vehicle and barrier damage are shown in figure 20.

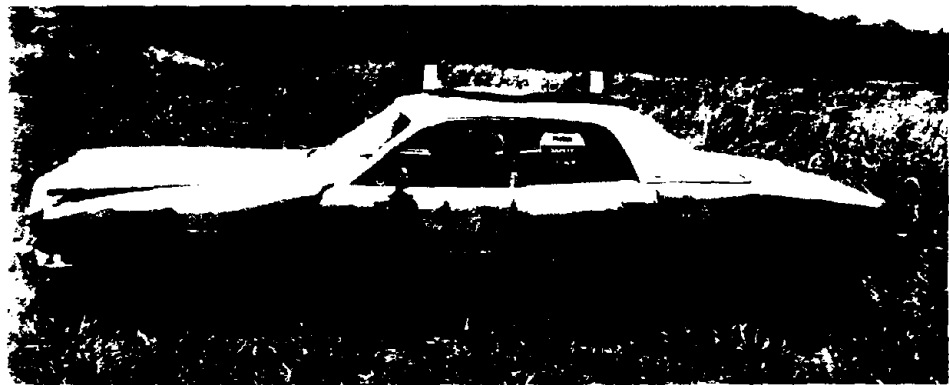
Figure 26. Before and after test photographs, Test BH-4.

Test BH-4. The purpose of this test was to evaluate the G4(1S) guardrail system for underride with the beam mounted at 30 in (76 cm) high as shown in figure 26. Test conditions included a 4699-lb (2131-kg) vehicle with a 20-in (51-cm) underride height impacting at 60.3 mph (97.1 km/h) and angle of 24.4°. As shown in figure 27, the vehicle remained in contact with the barrier for 25 ft (7.6 m) before redirection at a 17.3-degree angle. No significant snagging of the rail or line posts was noted. Damage after the test is shown in figure 26.
