Report No. CDOT-DTD-R-92-4

# **AVALANCHE CHARACTERISTICS AND STRUCTURE RESPONSE**

**EAST RIVERSIDE AVALANCHE SHED  
HIGHWAY 550, OURAY COUNTY, COLORADO**

**Arthur I. Mears, P.E., Inc.  
Gunnison, Colorado**

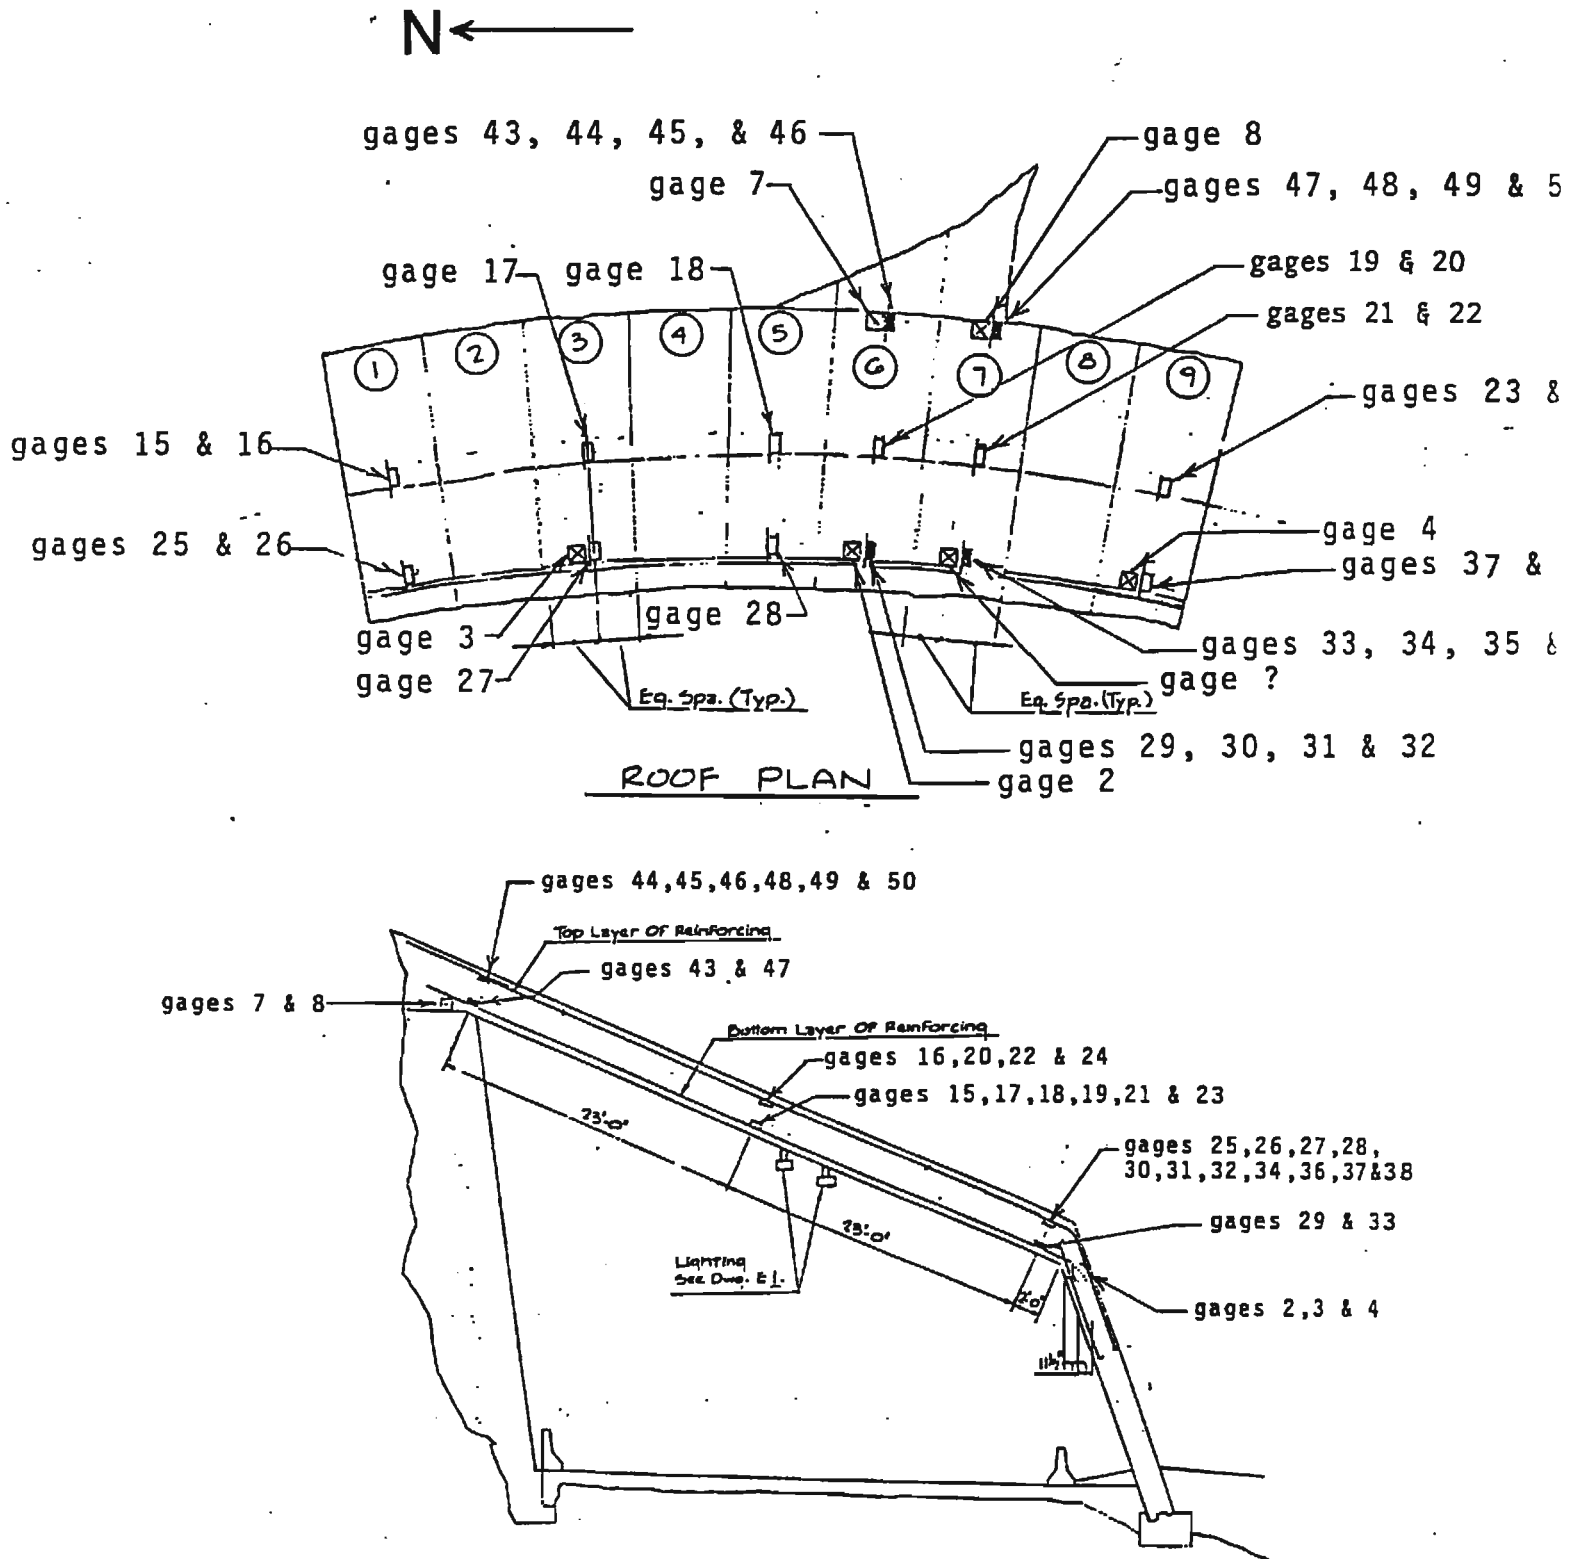
# RIVERSIDE SNOWSHED STRAIN GAGE LOCATIONS

FIGURE 5. Roof plan and cross section of the 180-foot (55m) long East Riverside avalanche shed. Strain gages are shown as small rectangles, load cells as rectangles with an "x", and 20-foot wide shed section numbers are circled. These internal sensors were installed as the shed was being built.

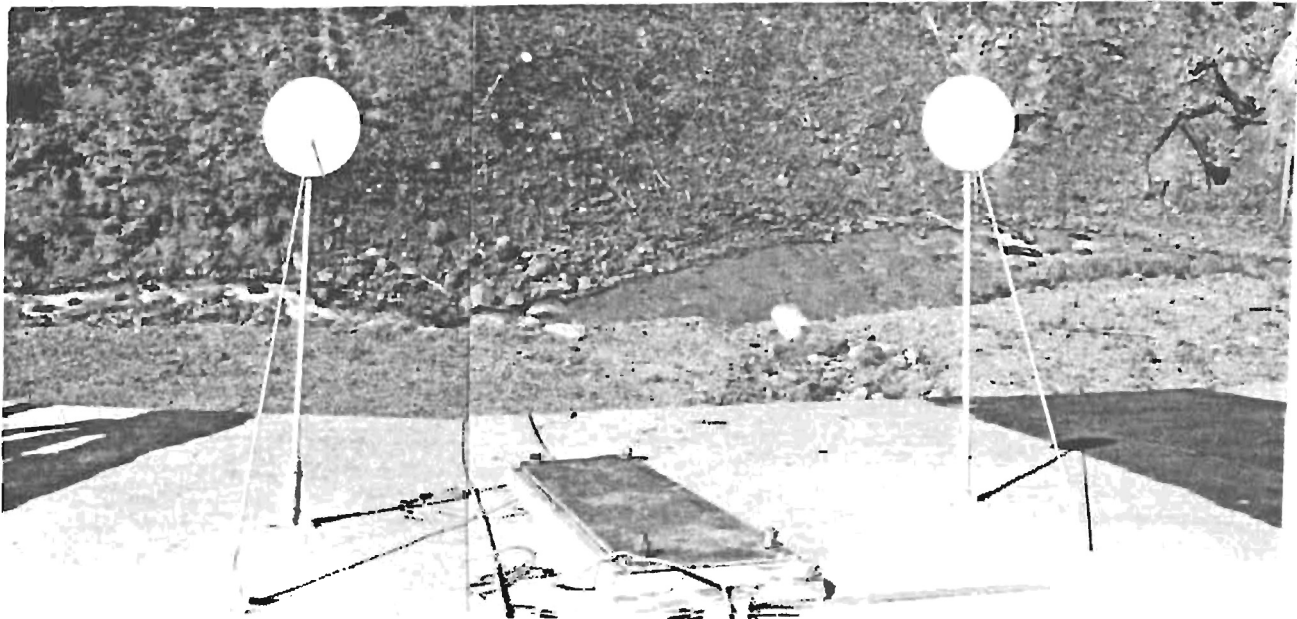
**FIGURE 6.** Photograph of normal-pressure plate and lateral pressure "paddles" taken in November, 1988. The paddles were destroyed by avalanche #8 (12/24/88). The two paddles were replaced with a single paddle with a 1"x2" shaft. This paddle has survived at least 4 avalanche impacts, and data have been recorded. The paddle must be erected after each event.

The load plate was successful in recording avalanche loads, load fluctuations, and duration during several avalanche events. Minor damage to this system was sustained when the entire avalanche deposit slid off the roof during a thaw period in March, 1989, but the system was easily repaired. The lateral pressure-plate system, however, became inoperable after impact with each avalanche. The sensor is clearly underdesigned even with respect to small avalanches, however, a larger, stiffer system could not be anchored to the reinforced concrete roof. Therefore, each impact event bent the rods, flattened the paddles to the roof, or torn the hinges off the roof. Although periodic repairs were necessary, important data about avalanche structure was obtained (Section 4).

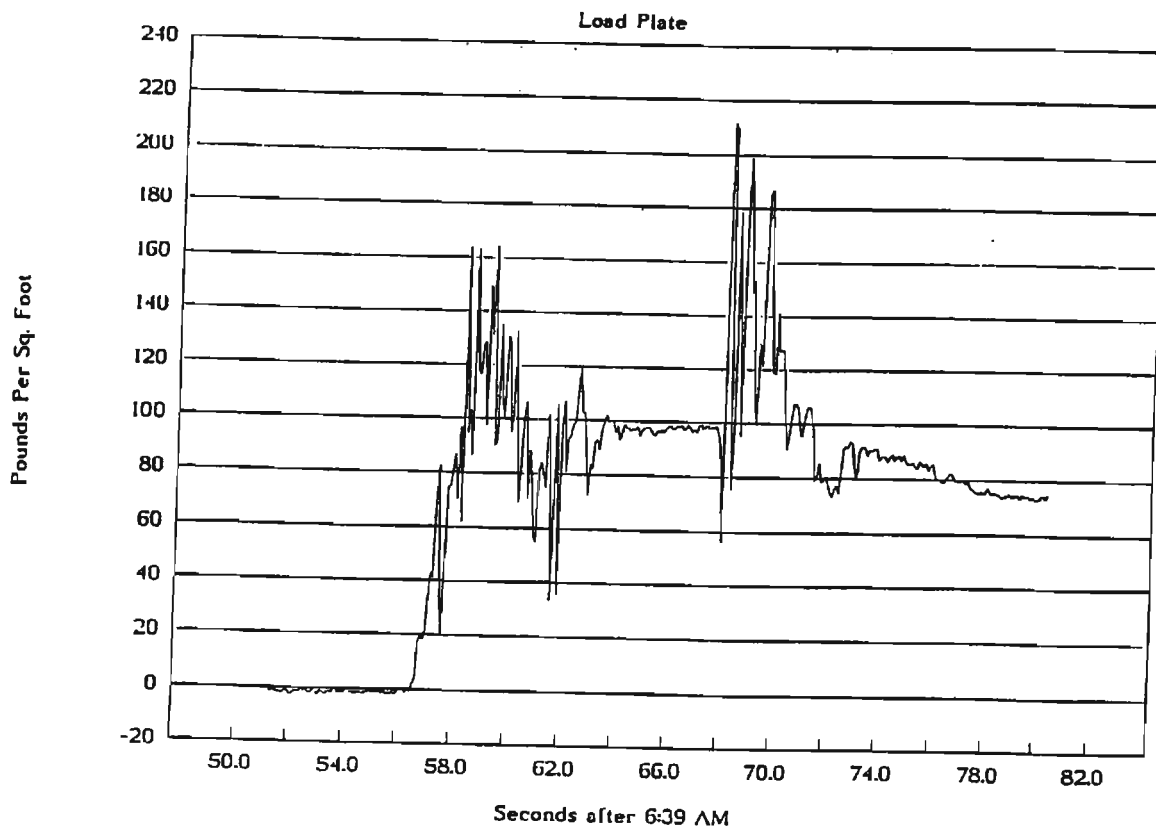
## Avalanche 2/17/91 6:40 AM

FIGURE 8. Time history of strains (equivalent static loads), on lateral-pressure paddle (top) and normal-pressure plate (bottom) from avalanche of 2/17/91. The paddle failed at 56.0 seconds, approximately 1.0 to 1.5 seconds before the main flowing mass began to produce significant loads on the normal-pressure plate. This is similar to the sequence shown in Figure 7, and also suggests the powder-blast component arrived at the shed prior to the main flowing core.

a. Avalanche sequence. The powder-avalanche blast reached the lateral-force plate at 56.0 seconds, approximately 1.0 to 1.5 seconds before the main flowing mass began to produce significant loads on the normal load plate. The lateral-force plate failed, therefore peak loads were not accurately measured.

d. Internal strains. Strains at the top of section 7 were located near the area where the avalanche impacted the shed. These strains began at 55.5 seconds (0.5 seconds before the lateral-force plate failed), and increased rapidly from 57 to 58.5 seconds (Figure 9). This period of rapid strain increase is simultaneous with the load-plate deformation increase. Therefore, the largest strain rates occurred when the avalanche mass was beginning to encounter the load plate. Peak strains of  $10^{-5}$  occurred at 66 and 69 seconds, about 1-2 seconds before peak load on the load plate.

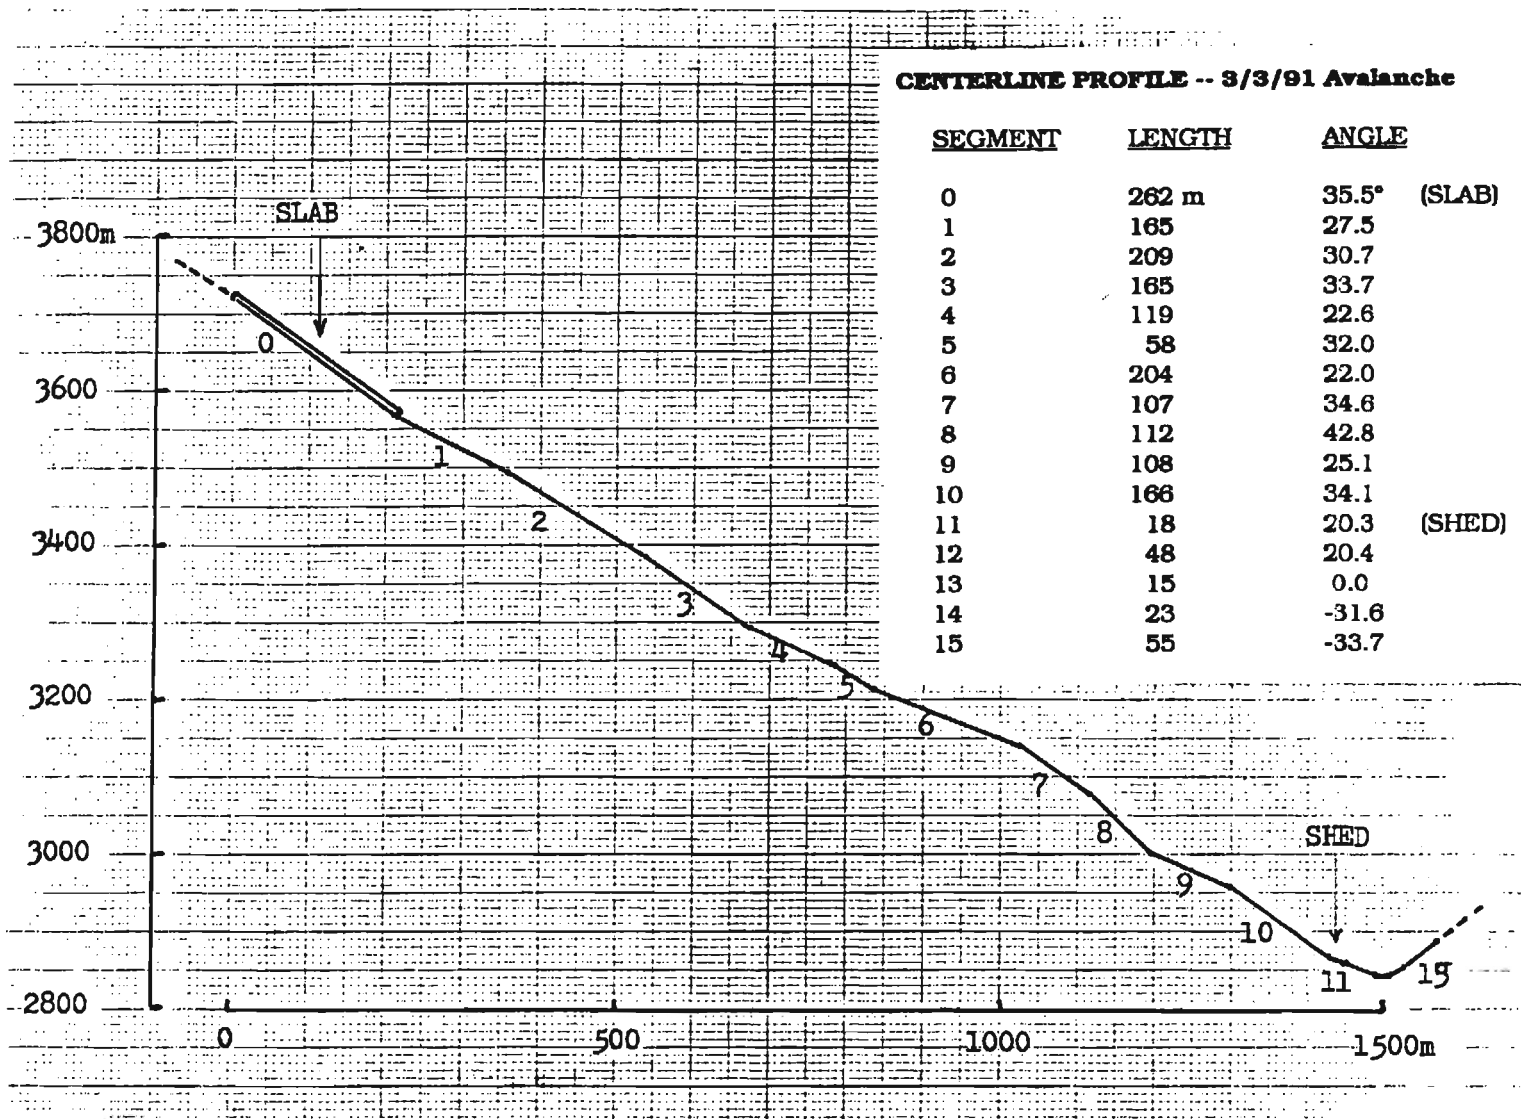
FIGURE 10. Centerline profile of the East Riverside showing segments used in application of stochastic particle model of avalanche movement (Perla, et. al., 1984). Model was applied by matching the observed starting and stopping position of the avalanche and estimating starting-zone volume and mass. Results of velocity modeling of 2/17/91 and 3/3/91 avalanches are given in Table 3 and 4.

The model was forced, by iteration, therefore, to run between the observed starting and stopping positions and to simulate avalanche duration. The iteration was done by varying the dynamic-drag coefficient ( $M/D$ ) until the model simulated observations. Velocity and velocity distribution is provided as computer output along the path profile. Avalanche mass, momentum, and momentum distribution are modeled by setting the initial number of particles equal to the visually-determined estimate of starting zone volume (and mass), calculating a mass per particle in the simulation, and deriving the momentum at the shed from model output.

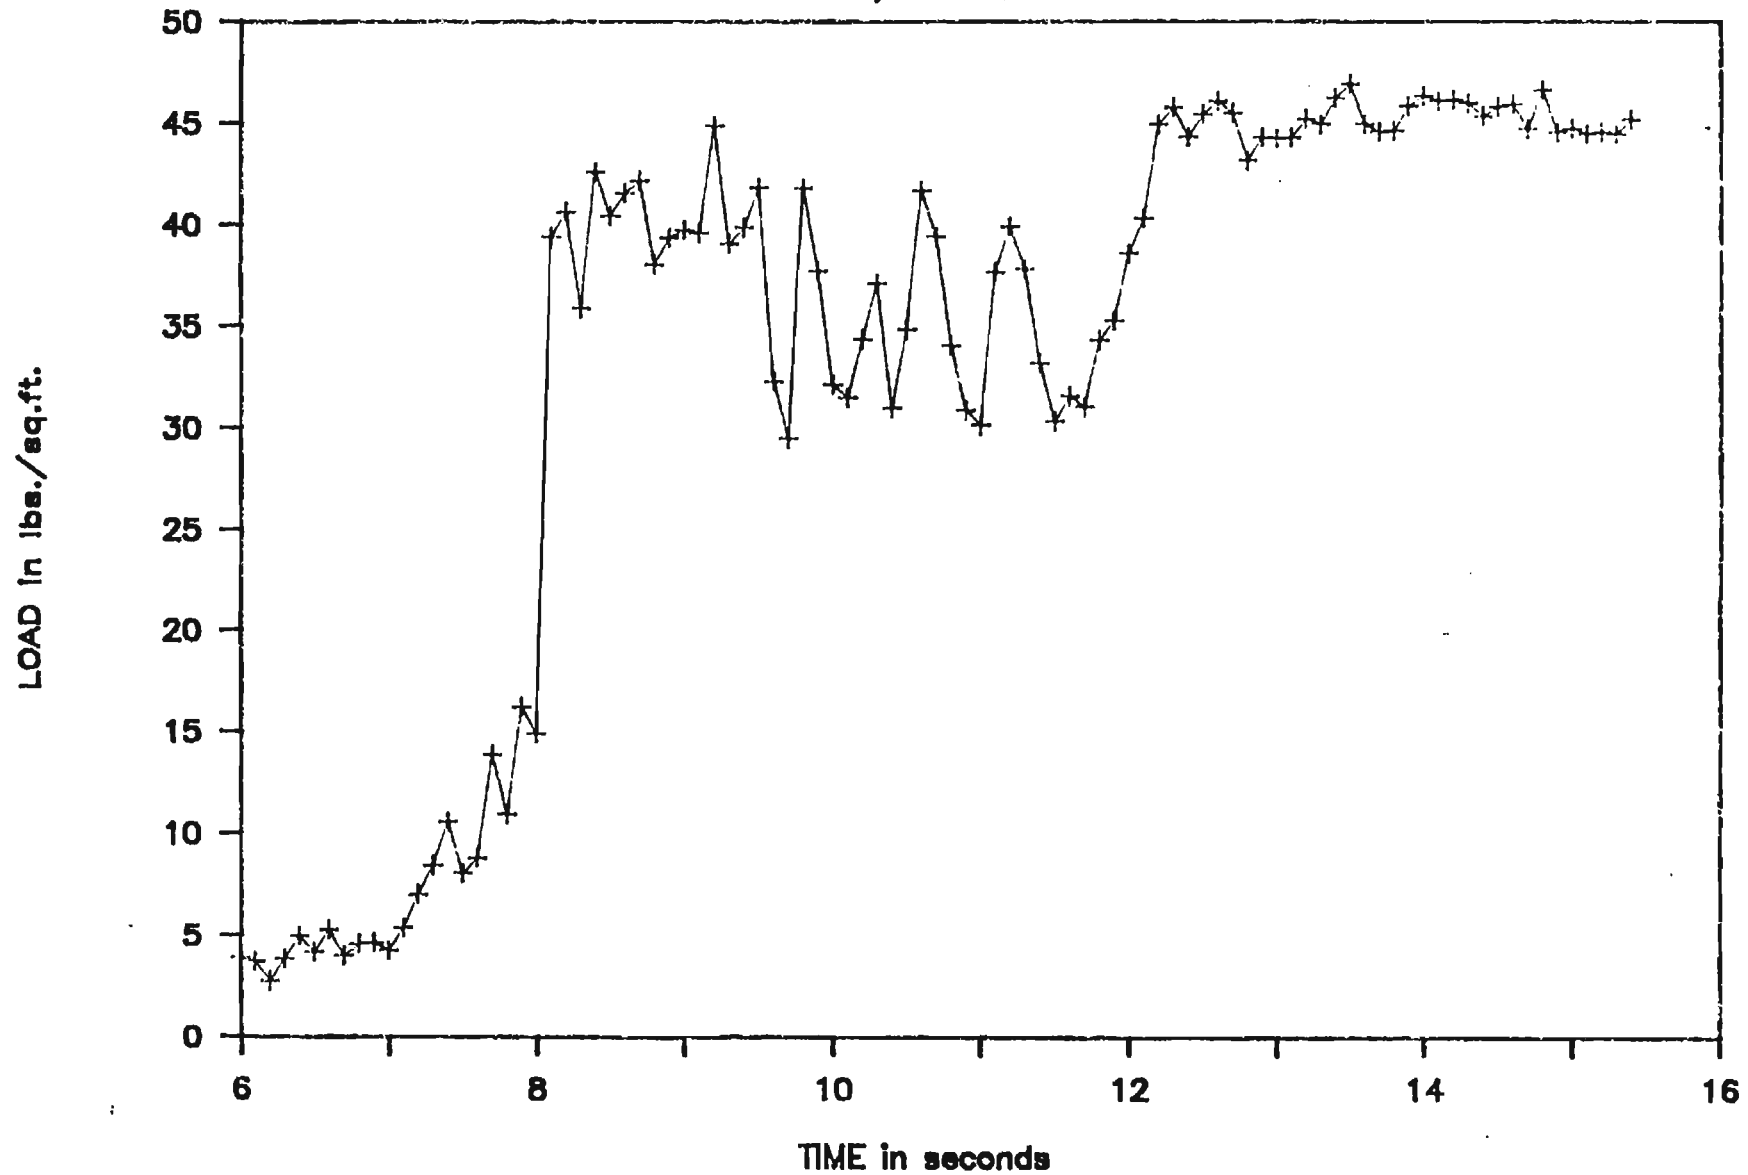
# LOAD PLATE LOAD CHANNEL 30

This was a small, dry-snow avalanche that probably involved little mass and stopped on the shed roof. Load plate data were obtained, but internal shed strains were not. Load increased quickly to approximately 40-45 lbs/ft<sup>2</sup>, then remained at 45 lbs/ft<sup>2</sup> static load. This corresponds to the avalanche deposit on the plate.

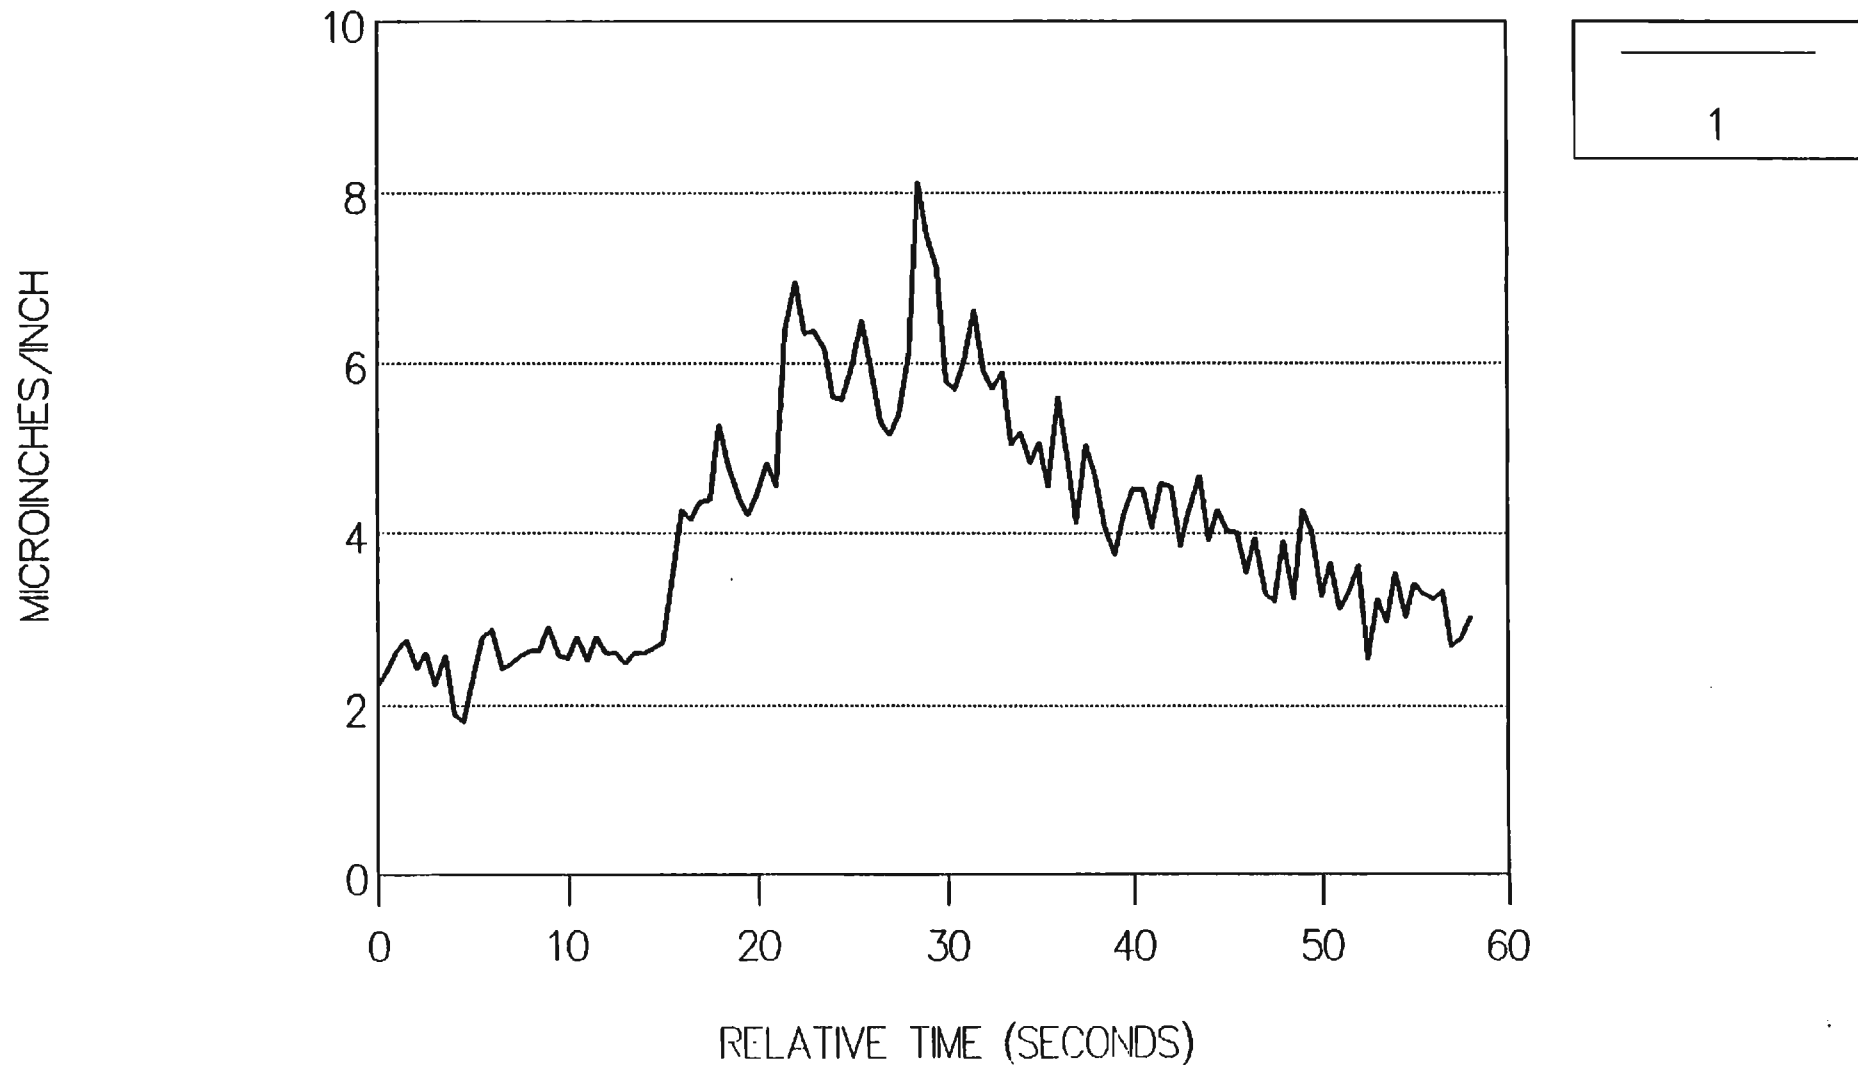
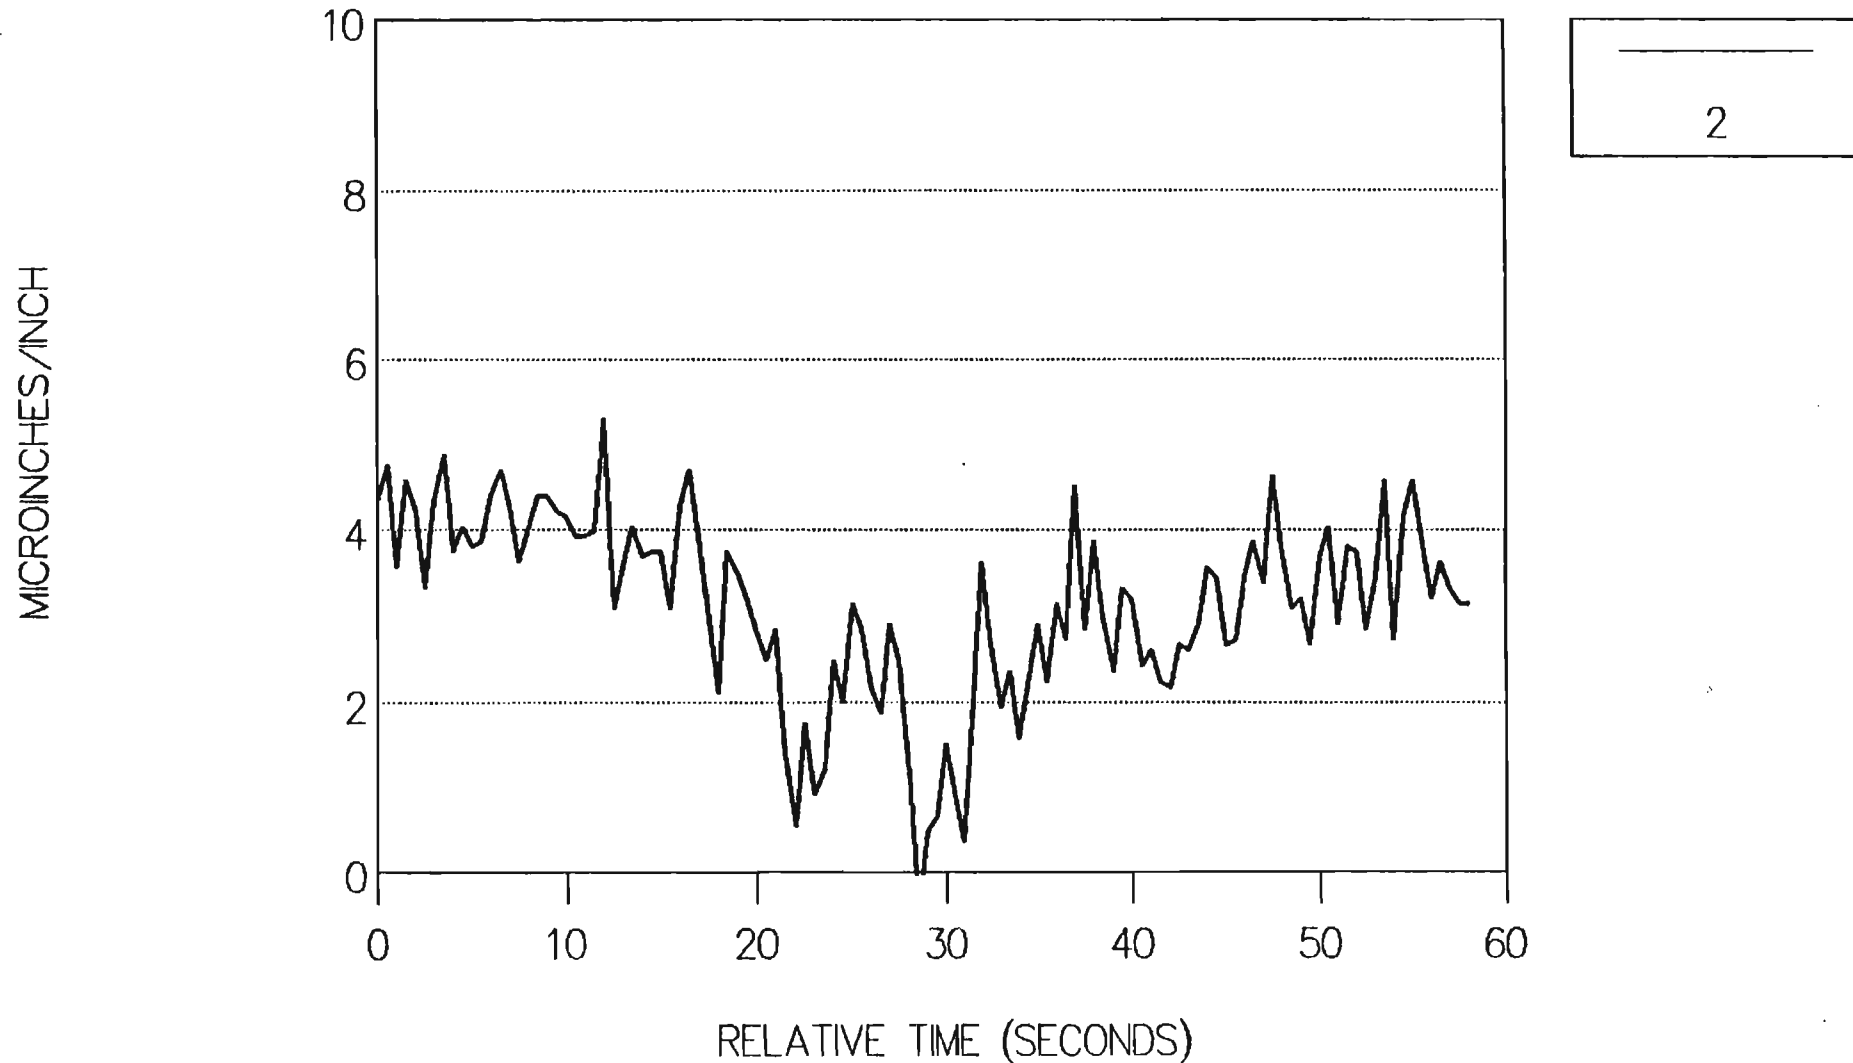
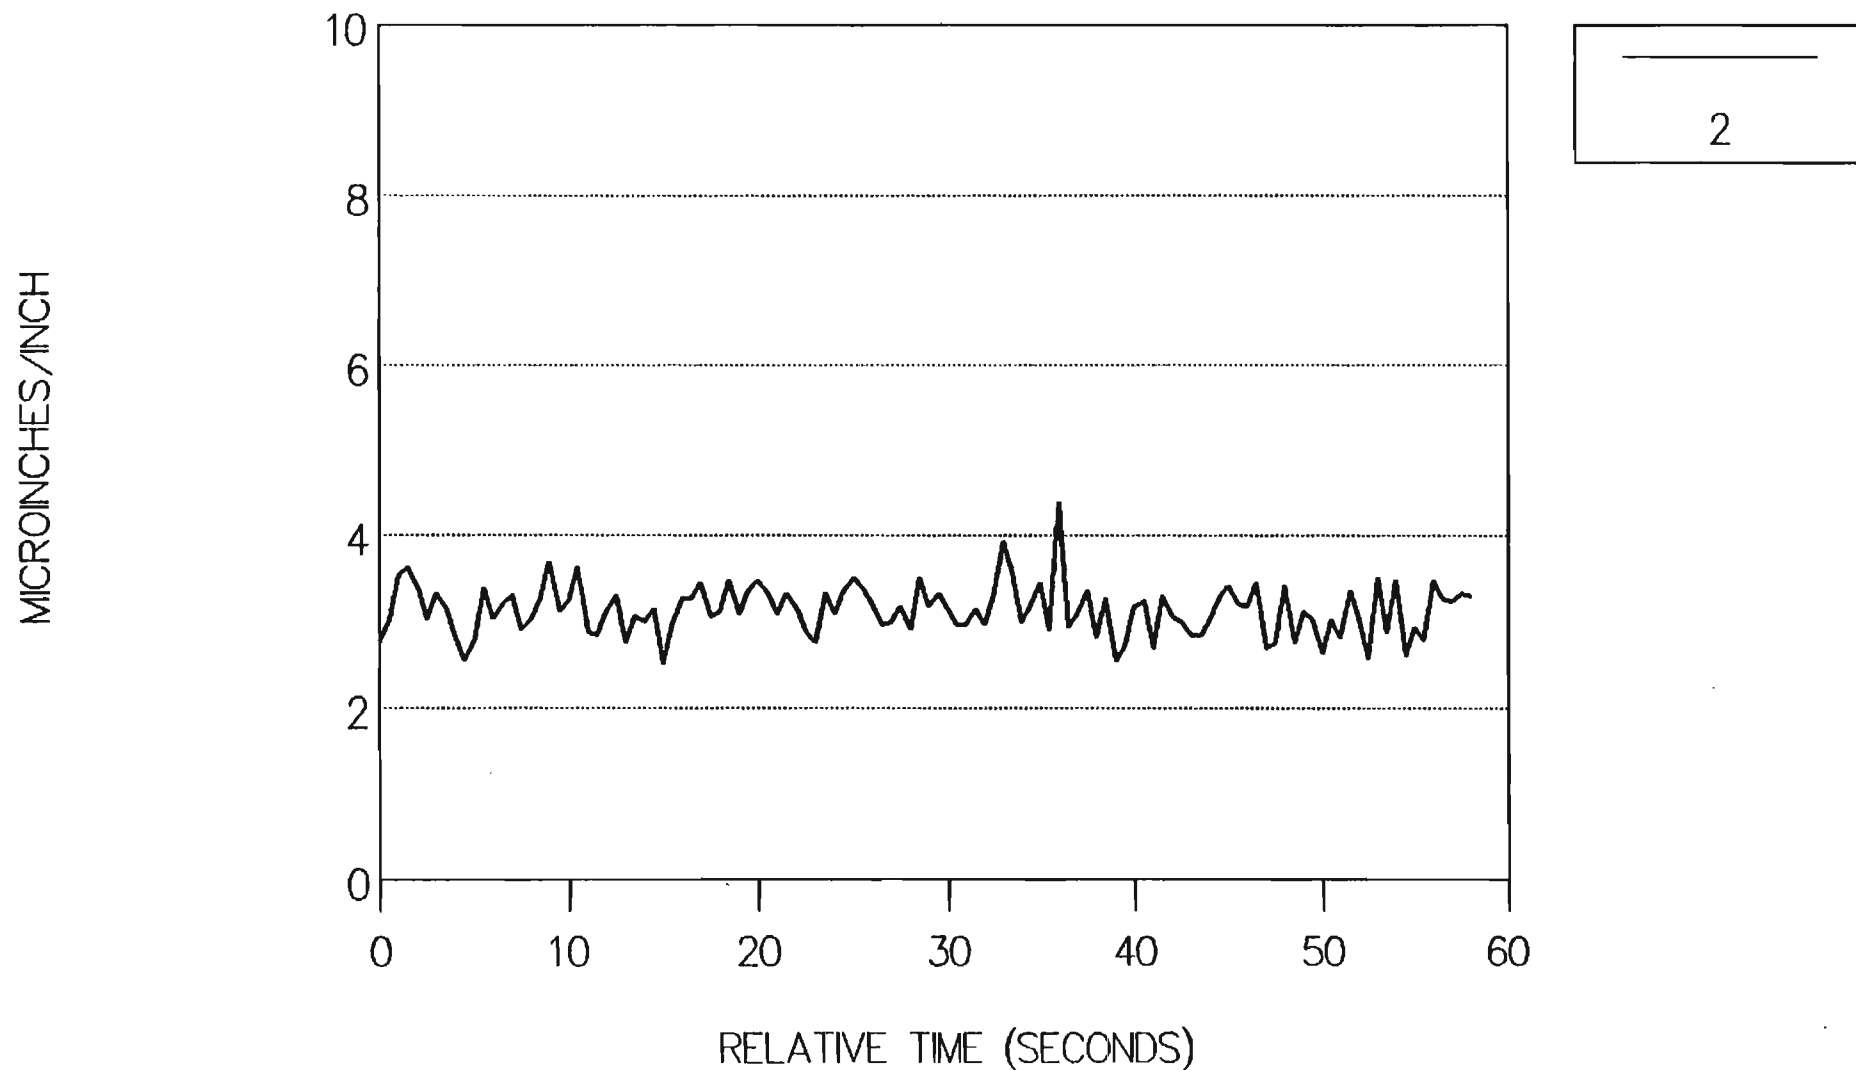
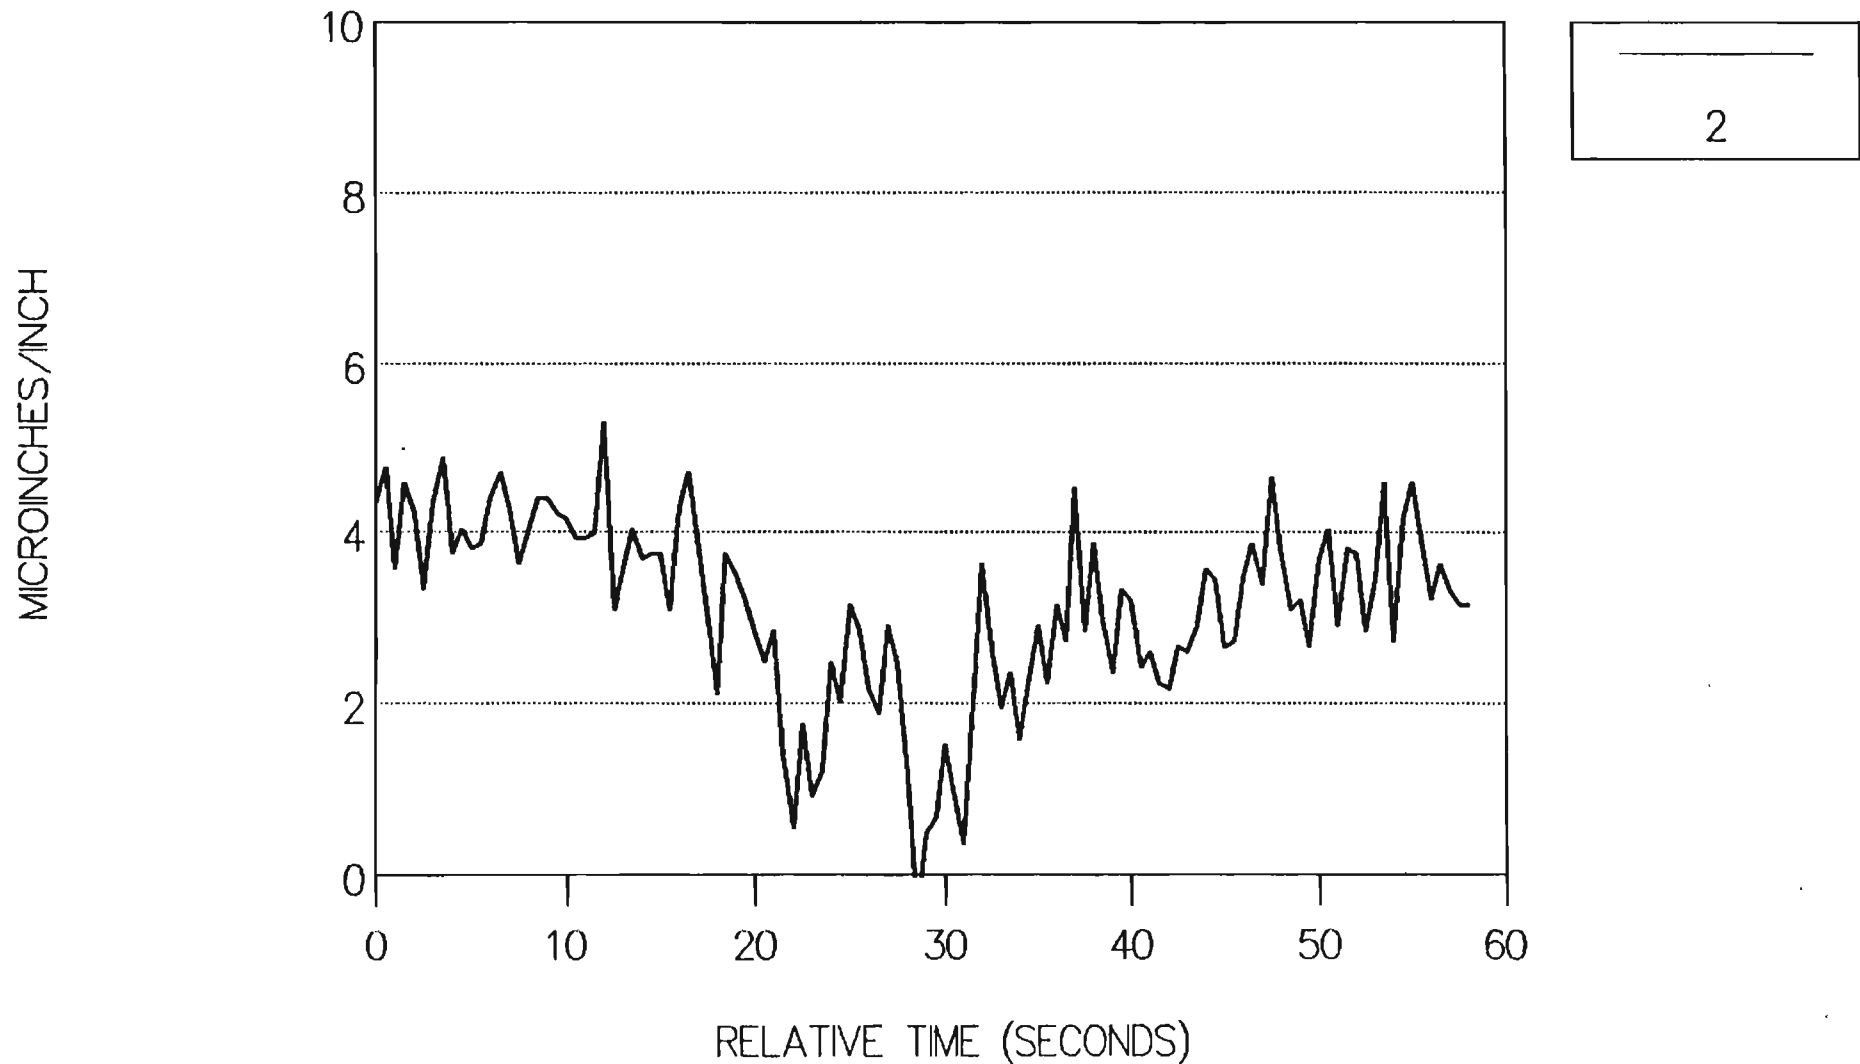
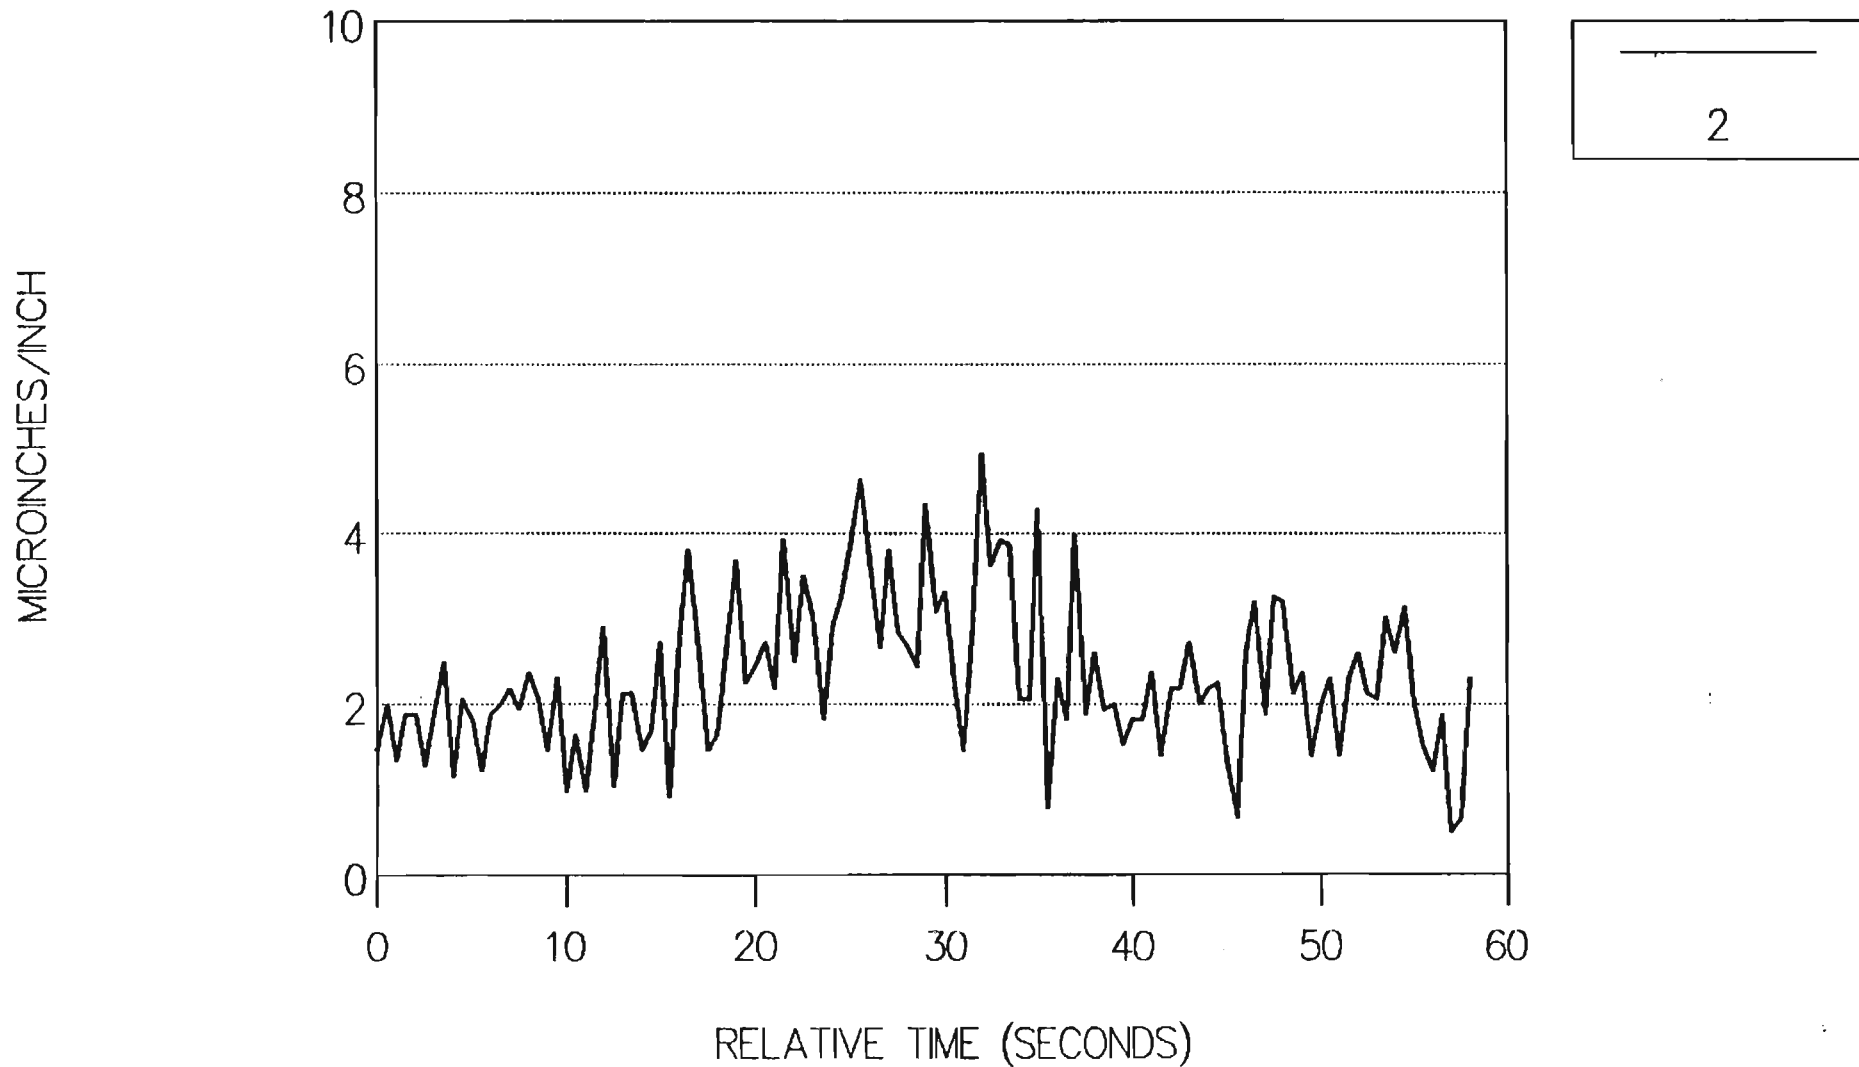
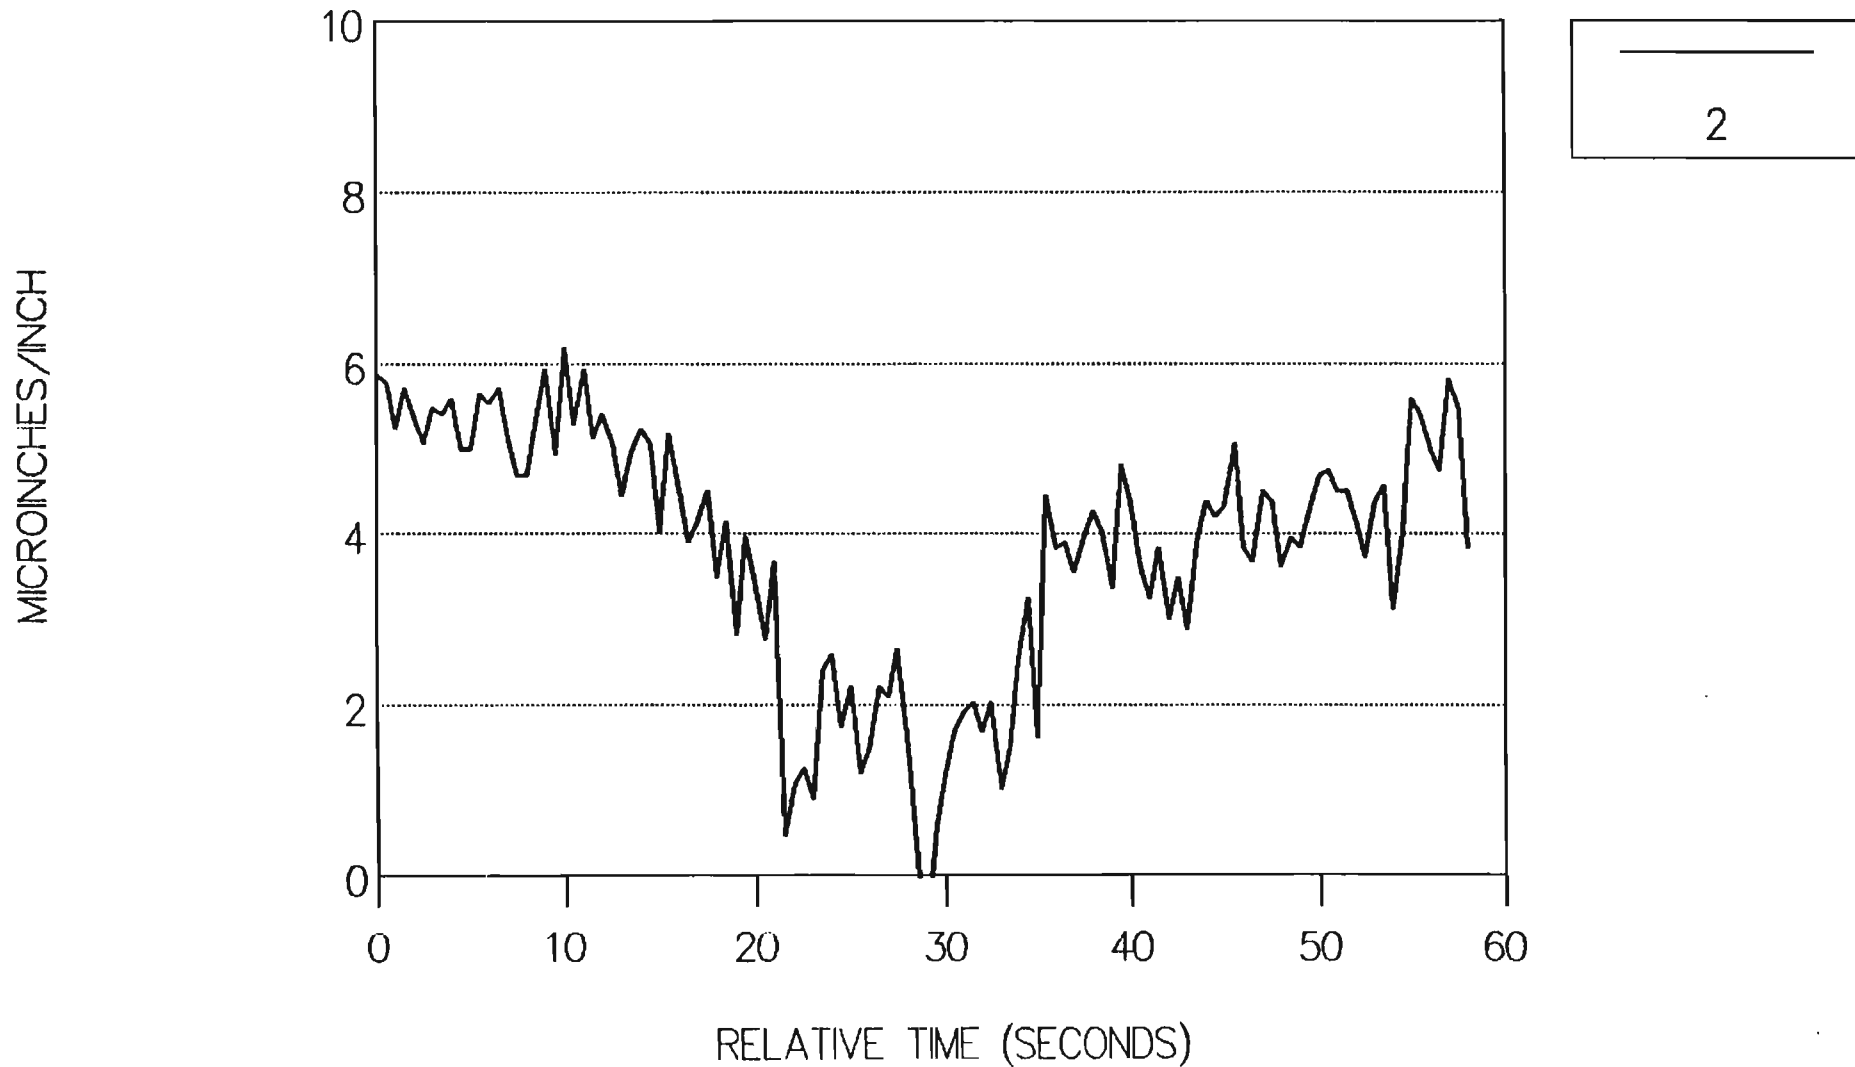
Internal strains are as shown on the attached figures. Maximum values were at east end of section 7. Top and bottom strains were approximate "mirror images" of each other. Maximum strain values were approximately 10 microstrains ( $10^{-5}$ ). Smaller strains were recorded at other locations within the structure.
