# MDOT State Study 312 — Recycling PCC Pavements using Rubblization

## Final Report

Athar Saeed, PhD, PE  
Fawaz A. Akhtar  
Saeed & Associates Consultants, Inc.  
dba Saeed Consultants  
8700 Stonebrook Pkwy, #2796, Frisco, Texas 75034-9998

Report Date: 27 July 2026

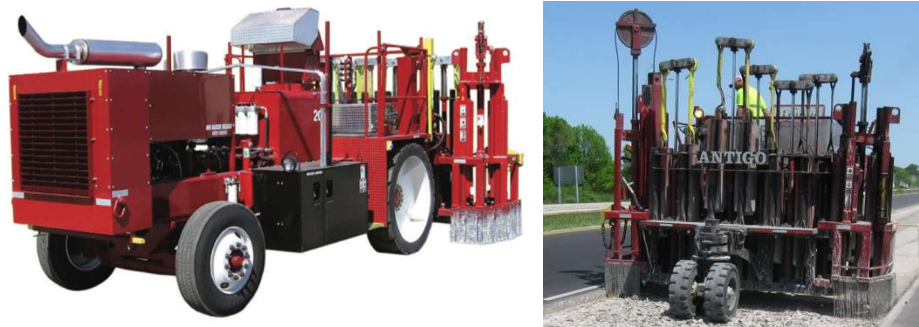
Figure 5. Variations of MHB equipment created by Antigo Construction, Inc. <sup>(21)</sup>.

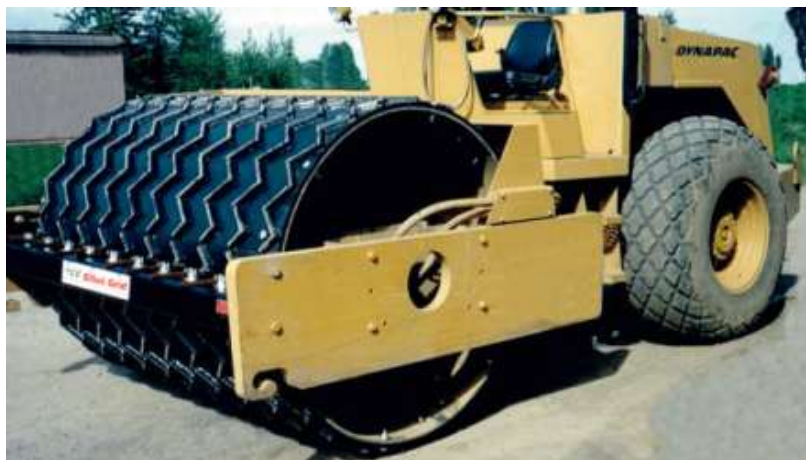
Figure 6. Vibratory roller with Z-patterned or Elliott grid attachment ([www.elliottattach.com](http://www.elliottattach.com)).

Seating presses FCP fragments downward to ensure firm contact with the supporting layers <sup>(25, 26, 27)</sup>. FCP is seated by rolling to maintain a stable foundation (enhance support with base/subbase) using pneumatic-tired, steel drum, vibratory, and Z-pattern rollers. Pneumatic rollers are most effective for seating, as steel drum and vibratory rollers tend to bridge over FCP. Over rolling of FCP tends to increase the measured FCP surface deflection <sup>(24)</sup>.

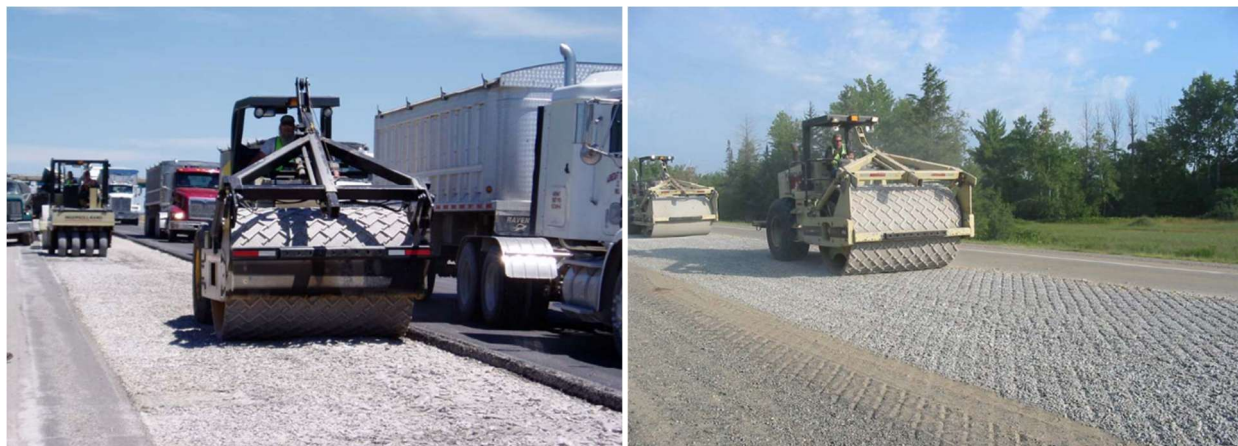
Figure 7. Frequently the Z-grid roller is followed by a steel-wheeled or pneumatic tire roller <sup>(29, 30)</sup>.

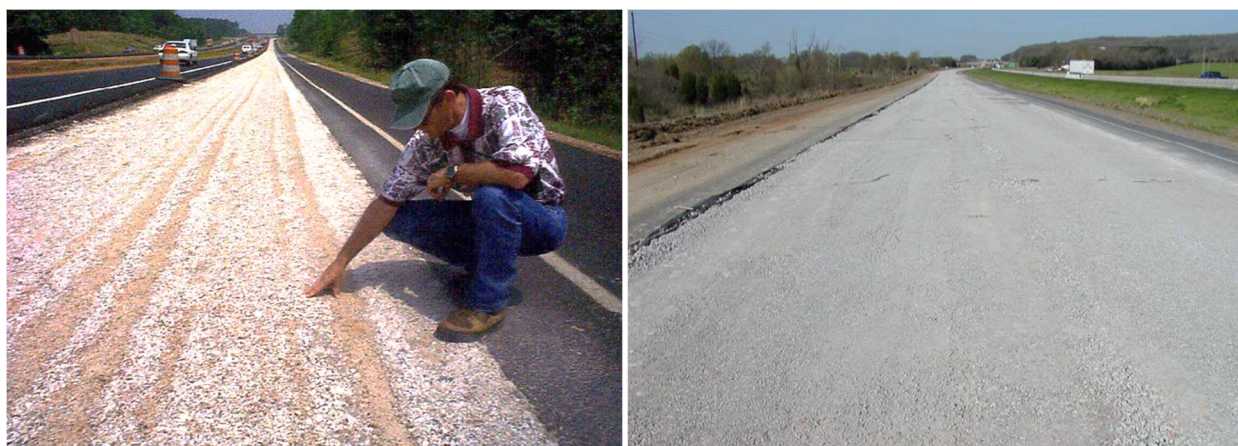
Figure 8. RFB-rubblized PCC before and after seating <sup>(31)</sup>.

RCP produced using different equipment (e.g., multi-head breakers (MHB) versus resonant frequency breakers (RFB)) has different seating needs <sup>(28)</sup>. RFB-produced RCP is seated using a 10-ton tandem vibratory roller, in low amplitude and high frequency mode, very similar to a thin HMA lift ( $\approx$  2-inch). MHB-produced RCP is seated using a Z-patterned or Elliott grid vibratory roller, as shown in Figure 6 <sup>(29, 30)</sup>. Figure 8 shows RFB-produced RCP before and after rolling to seat the rubblized PCC <sup>(31)</sup>. Guillotine or hammer-produced C&S FCP is seated using several passes of a 30-to-50-ton rubber-tired roller. An 8- to 10-ton pneumatic roller smooths up the RCP surface before HMA overlay placement (Figure 7). In areas with subgrade drainage problems, characterized by weak or wet subgrades, the vibratory amplitude should be reduced to prevent subgrade damage. It is effective to use water during FCP seating, and usually, there is no need to apply a prime coat on FCP before the HMA overlay <sup>(22)</sup>.

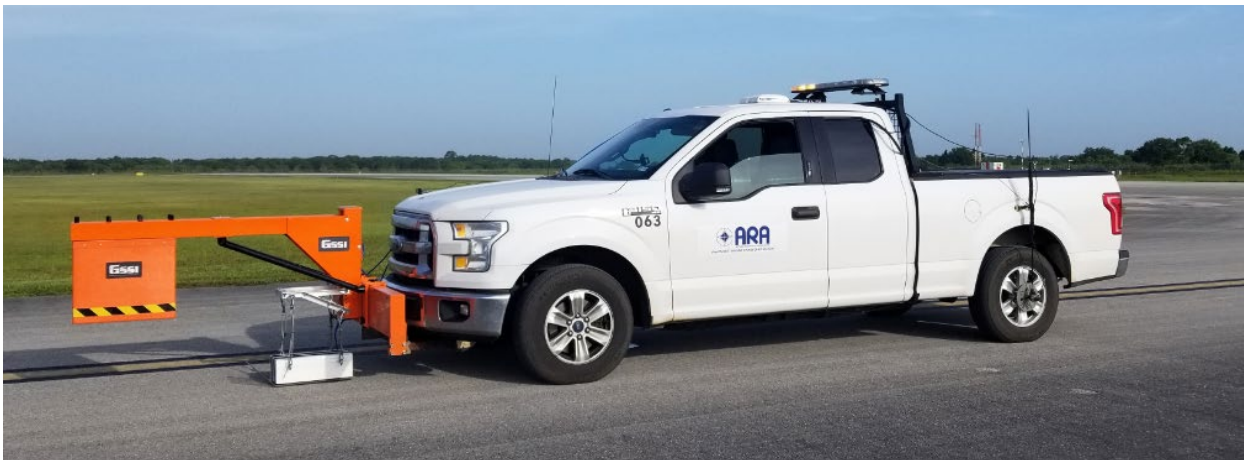
**Figure 4. GPR Unit with Double Antennas**

Continuous GPR testing was performed on the same pavement sections on I-55. GPR data was then processed to estimate the pavement layer thickness after being calibrated with ground truth data based on pavement cores. The testing was performed using the GSSI SIR-30 GPR. Two antennas were utilized in the data collection: an air-horn antenna with a frequency of 2.0 GHz and a ground-coupled antenna with a frequency of 900 MHz. The Air-horn antenna provides high accuracy measurements of the surface layer thickness, while the ground-coupled antenna provides measurements at up to 2-ft deep. Figure 4 presents the GPR equipment utilized for this project, while Figure 5 presents a screenshot from the raw GPR data on I-55 northbound.

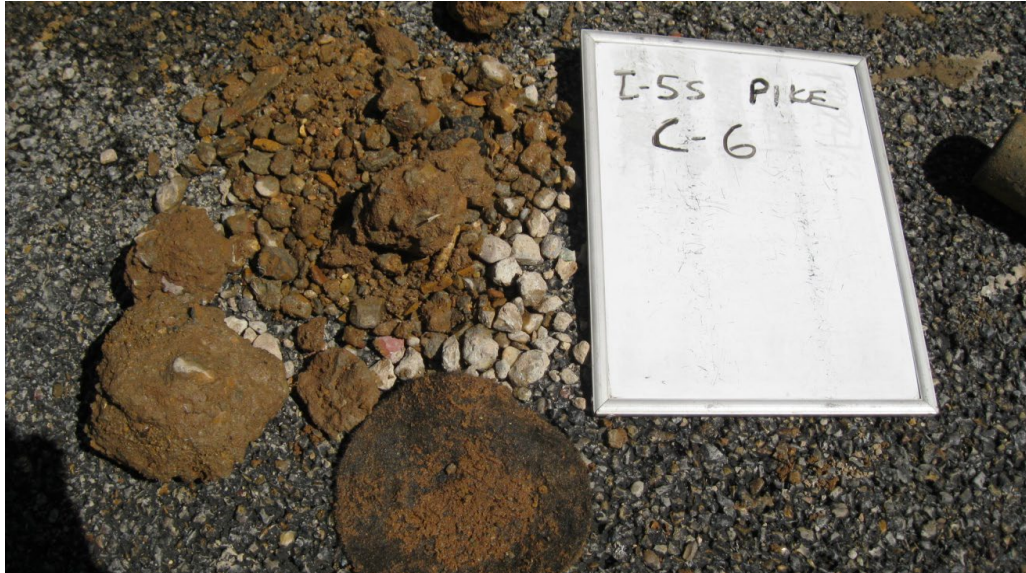
**Figure 8. Example from crushed concrete layer from Core #6 (no steel bars present)**

As shown on the extracted material from core #3 shown in Figure 7, the reinforcement steel bars on the rubblized concrete layer are visible. The figure below shows another example from core #6 where no steel bars are visible on the crushed concrete.

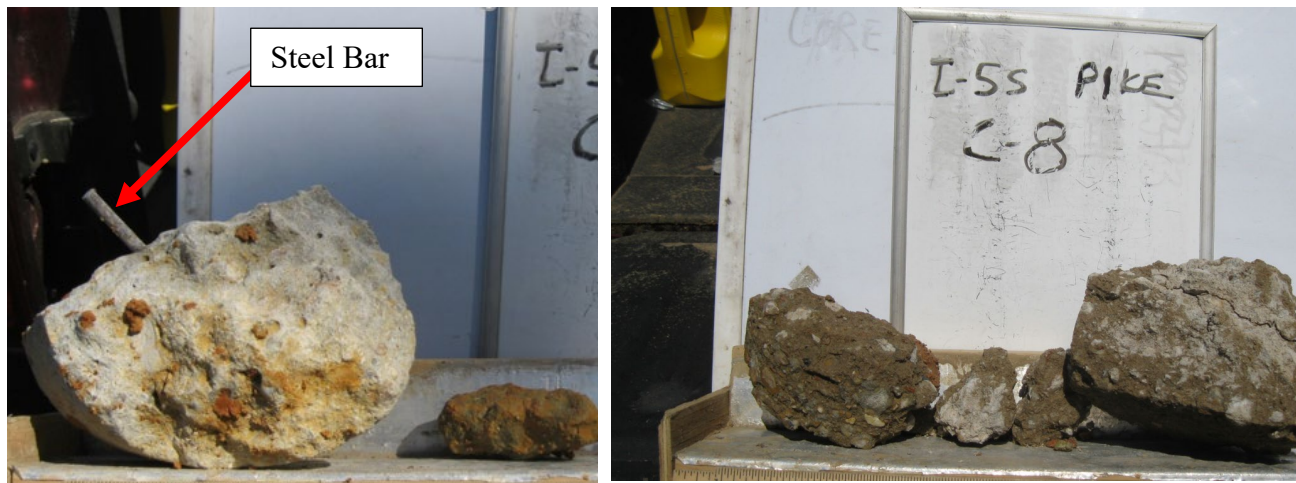
The figure below shows two side by side photos showing what was considered to be rubblized concrete (left hand side) versus what was considered to be crushed concrete (right hand side).

**Figure 9. Example from Rubblized vs Crushed Concrete**

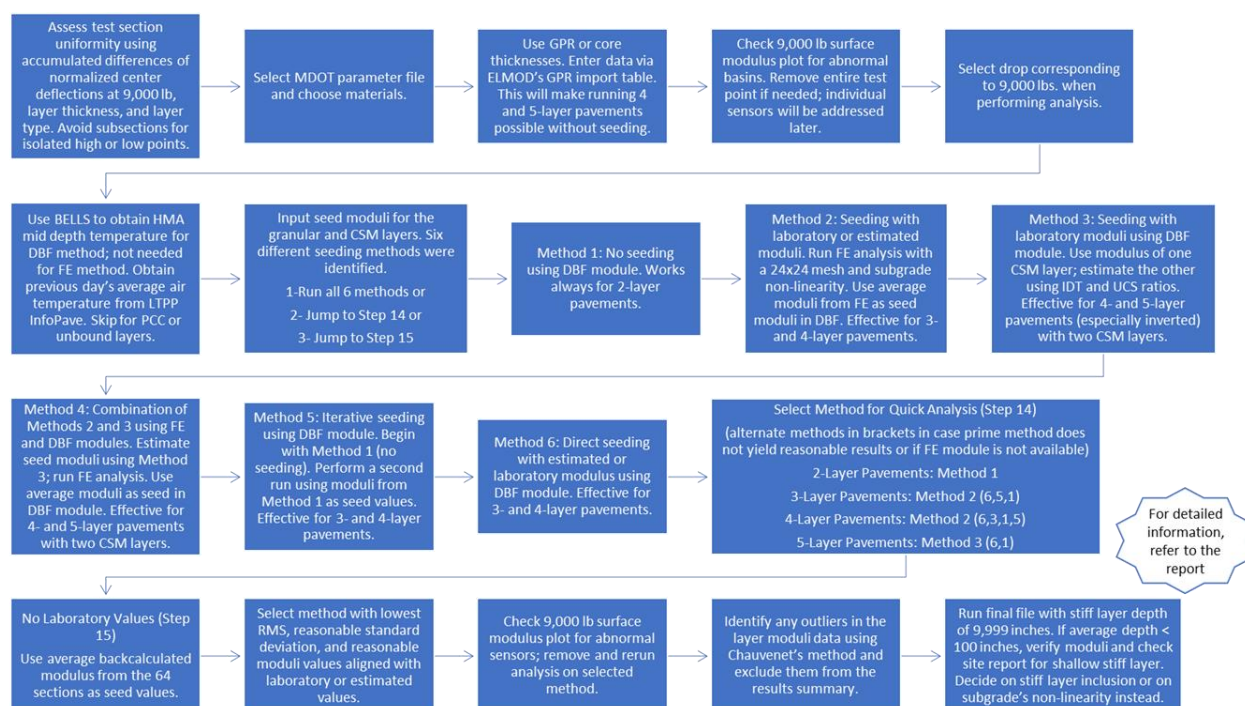
**Figure 23. Backcalculation Procedure from SS #304**
