DOT/FAA/PM-83/29  
DOT-TSC-FAA-83-1

# Evaluation of Visibility Sensors at the Eglin Air Force Base Climatic Chamber

October 1983  
Final Report

| 16. Abstract<br><br>Three transmissometers and five forward-scatter meters were evaluated for measuring fog, haze, rain, and snow in the large test chamber of the Eglin Air Force Base Climatic Laboratory. Methods were developed for generating moderately uniform and stable fog and haze conditions. Fog densities equivalent to Runway Visual Range (RVR) values of 100 to 600 feet were achieved; such fog densities are rare in nature and were the primary reason for undertaking the chamber tests. No unusual characteristics of the chamber fogs were noted. Laser transmissometers with 40- and 250-foot baselines served as standard sensors for the tests. Because of inhomogeneities in the chamber, only the 40-foot baseline gave good correlations with most of the test sensors. Consequently, one of the forward-scatter meters, the EG&G-207, was used as a secondary standard for high visibility (RVR above 1000 feet) conditions. With appropriate corrections, all the test sensors met the 15 percent root-mean-square error pass-fail criterion for measuring d

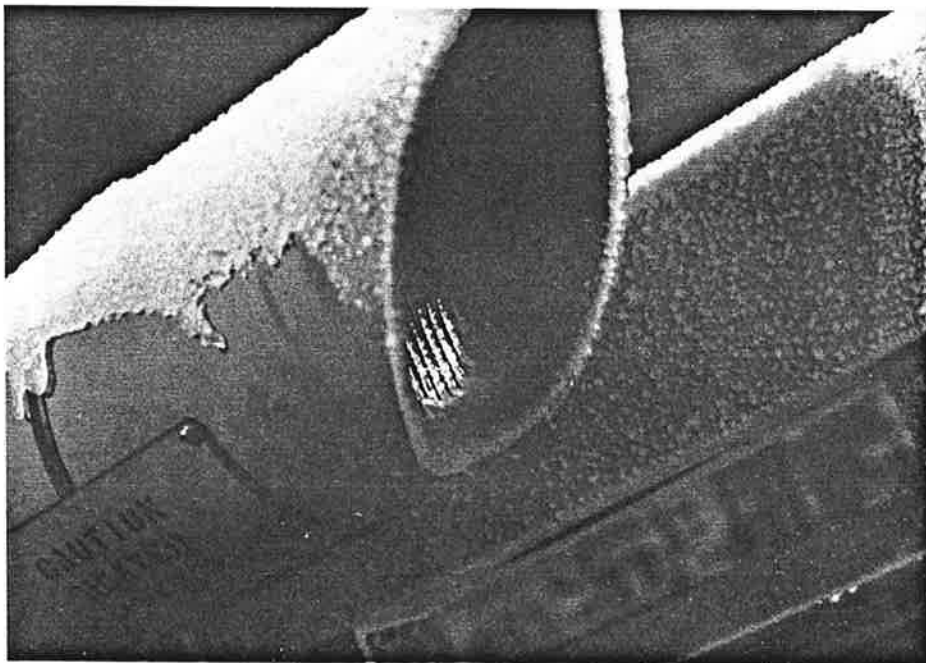
FIGURE 5-3. TASKER RVR 500 TRANSMISSOMETER:

(a) 14-FOOT TOWERS FOR 40-FOOT BASELINE, (b) PROJECTOR (Note RVR calibrator on right), (c) RECEIVER, (d) SNOW ON PROJECTOR GRID.

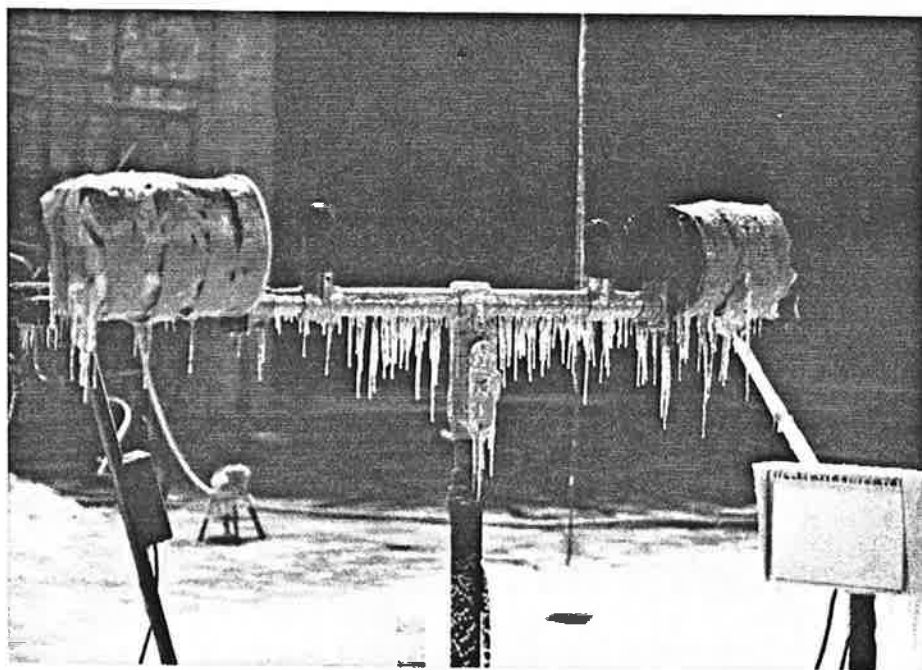
FIGURE 5-8. WRIGHT & WRIGHT FOG-15 FORWARD-SCATTER METER:  
(a) IN SNOW, (b) IN FREEZING RAIN, (c) PROJECTOR, (d) RECEIVER.

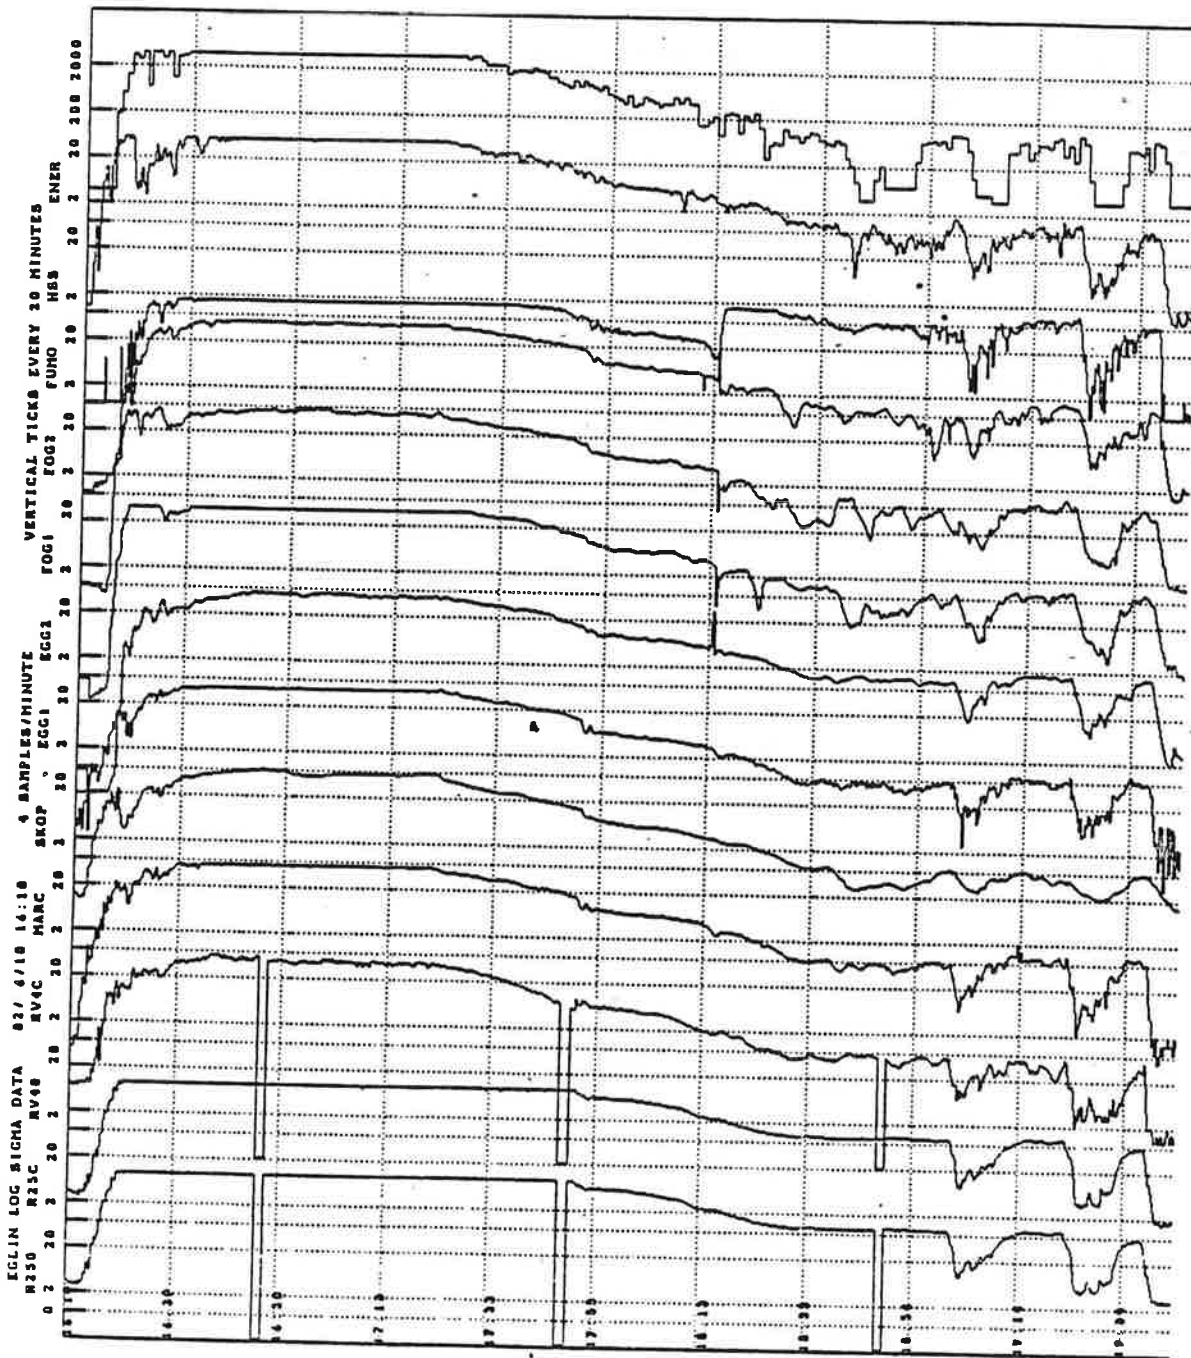
FIGURE 5-12. STRIPCHART FOR THE STEAM FOG EVENT ON 6/10/82.

Very dense fogs could be generated by saturating the chamber with steam so that all surfaces became wet. This type of fog would stabilize and decay slowly if all circulation (both floor fans and external circulating fans) were turned off. As the fog dissipated it would become less uniform. Turning on the floor fans tended to improve the homogeneity while reducing the fog density. Figure 5-12 shows an example of such an event. The fog density measured by all the sensors is plotted against time. The format of the stripchart will be explained in Section 6. The steam was turned on at about 16:11. (NOTE: All times are GMT). The steam and circulation were turned off at 17:23. The slight drop in the curves at 17:49 was caused by turning on the floor fans to homogenize the fog density. As the fog decayed it became patchy as is shown in the differing responses of the various sensors.

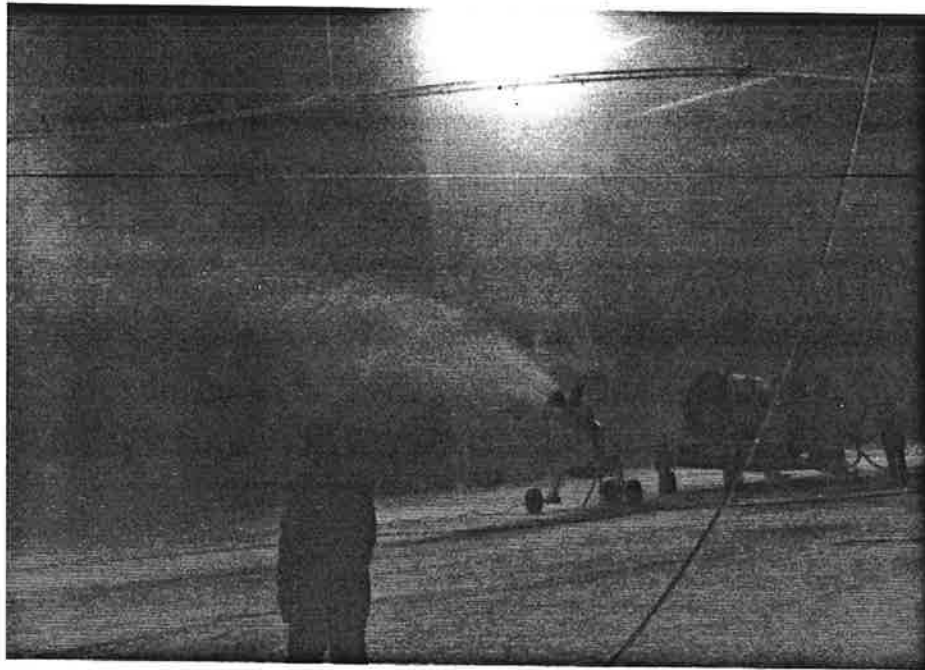
FIGURE 5-26. SNOW TESTS: (a) SNOW AND WIND MACHINES,  
(b) ROW OF FORWARD-SCATTER METERS.
