DOT HS 811 499

July 2011

# **System Capability Assessment of Cooperative Intersection Collision Avoidance System for Violations (CICAS-V)**

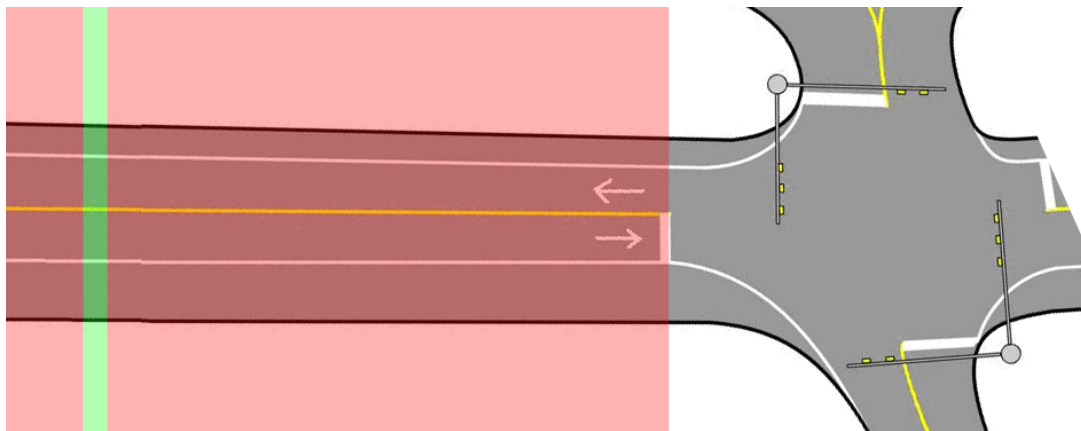
Figure 1. Geometry of Tests for Warning at Various Approach Speeds

The overall geometry of this test is shown in Figure 1. The optimum location for a warning for a vehicle traveling at the nominal speed would be in the green band. A warning in either red section would constitute a failure for the test run.

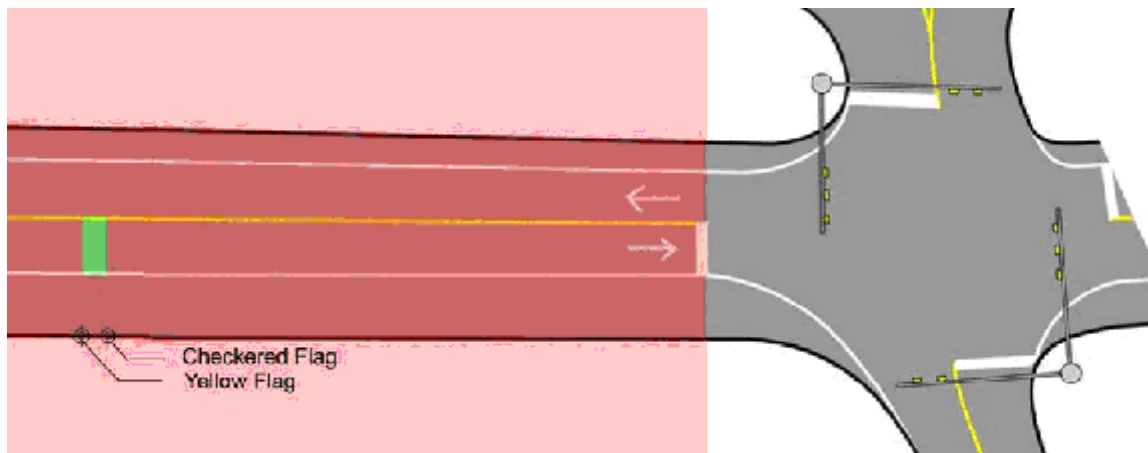
Figure 2. Geometry of Tests for Edge of Approach Lane Warning

This test seeks to verify that the system will appropriately warn the driver even if the vehicle is near the edge of the approach lane. In this case, for any run to be valid, the right tires must be within 0.5 m (20 inches) of the right lane marker. That is, they must be  $0.25 \pm 0.25$  m to the left of the right lane boundary. The SPaT system transmitted a red light signal for the specified approach lane and green light signals for the lanes on either side. The geometry of the test setup is shown in Figure 2. The green zone indicates the approximate region in which a warning would be appropriate at the nominal speed of 35 mph.

Sixteen test runs were conducted. All of the runs were valid. The pass/fail criteria were the same as those in Section 2.3.1 – all three warning modes within a 0.200 sec tolerance of the warning distance from Table 641-11 [4]. All 16 runs passed. The results for each run are given in Table 9. The average deviation from the nominal warning distance was +0.6 m with a standard deviation of 0.4 m.

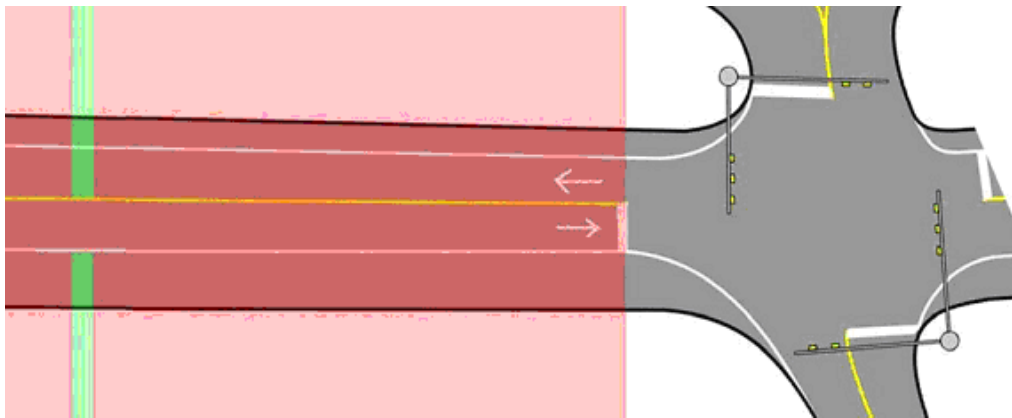
Figure 3. Geometry of Tests for Edge of Approach Lane Nuisance Warning

This set of edge of approach tests was identical to the previous set except that the specified approach lane was the only one with a green rather than a red signal light. The test sought to confirm that the system would not give an erroneous warning when no warning is required even though the vehicle is traveling within 0.5 m of a lane in which a warning would be appropriate. Figure 3 illustrates this scenario.

Once again, sixteen runs were conducted at a nominal speed of 35 mph. Only one of the sixteen runs was not valid using the stricter validation conditions imposed by the evaluators. The pass/fail criterion was that no warning should be observed. All fifteen valid runs passed as seen in Table 10.

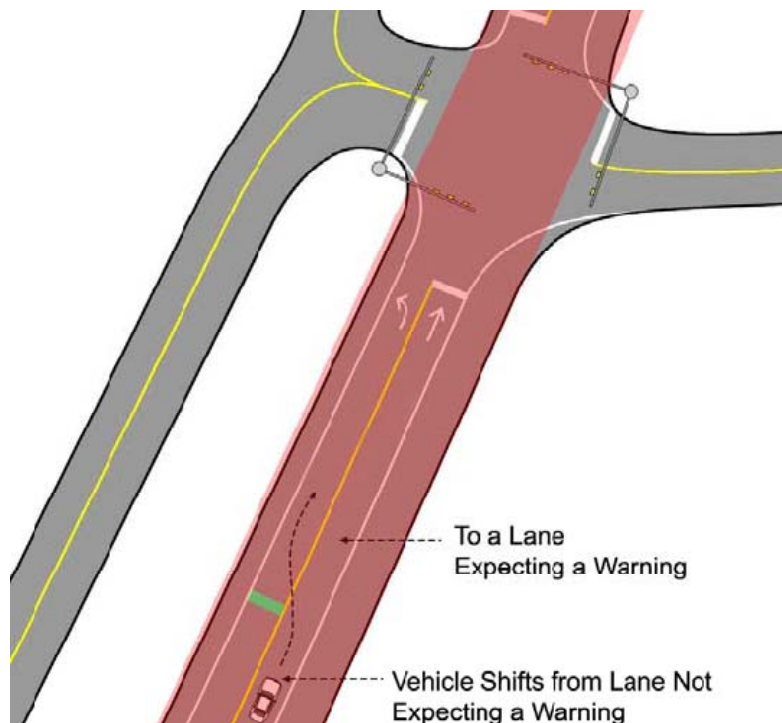
Figure 4. Geometry of Tests for Late Lane Shift Warning

In this test, the vehicle travels at a nominal speed of 35 mph. Two flags denoting the start and ending location for the lane change maneuver are located such that, at nominal speed, the vehicle will start the maneuver 1.5 seconds before reaching the optimum warning location (as defined by Table 641-11 [4]) and finish no later than 2.5 seconds after reaching the optimum warning distance. It was assumed that the maneuver would take no longer than four seconds. A test was considered valid if the lane change started after 1.5 seconds before the optimum warning distance and finished before 2.5 seconds after the optimum warning distance. The geometry for this test is shown in Figure 4.

Ten tests of this type were run. In the first run, the lane shift maneuver was not completed within the allotted four seconds. The evaluators chose to categorize this run as invalid. Nonetheless, all three warnings did activate in this run, though after the vehicle had passed the minimum warning distance.

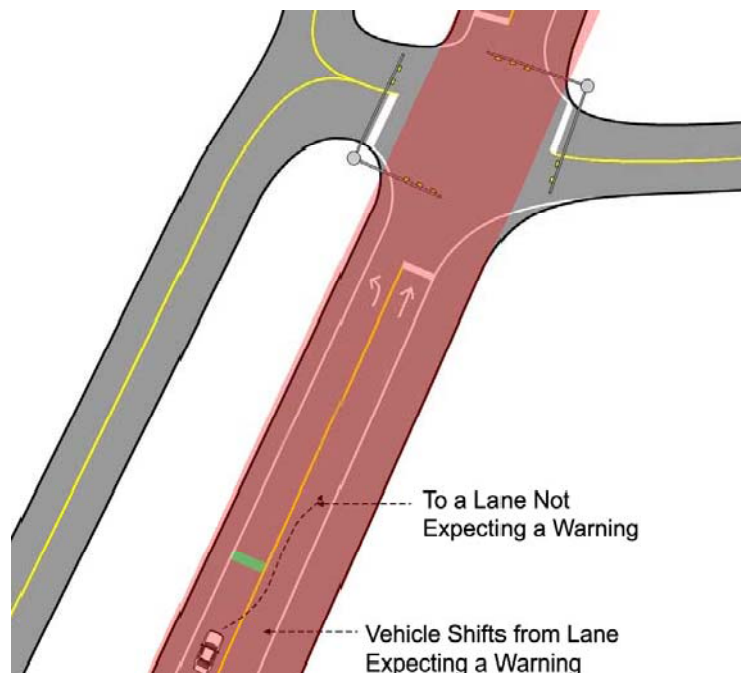
Figure 5. Geometry of Tests for Late Lane Shift Nuisance Warning

In this test, the vehicle traveled at a nominal speed of 35 mph. Two flags denoting the start and ending location for the lane change maneuver were located such that, at nominal speed, the vehicle would start the maneuver 1.5 seconds before reaching the optimum warning location (for the warning lane) and finish no later than 2.5 seconds after reaching the optimum warning distance. It is assumed that the maneuver will take no longer than four seconds. The geometry for this test is shown in Figure 5.

Eight tests of this type were run. In each run, the lane shift maneuver was completed within the allotted four seconds and in the allotted space. Thus, each run was valid. The pass/fail criterion was that no warning should occur. In the eight valid runs, no warnings occurred. Thus, all eight valid runs passed. Details of the runs are given in Table 12.

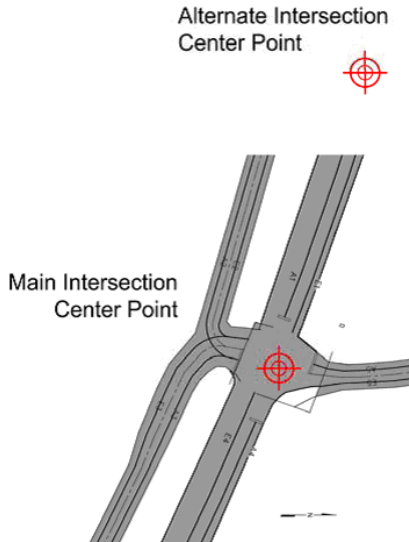
Figure 6. Geometry of Tests for Multiple Intersection Warning

The test track was set up with the GID and SPaT server indicating a second (virtual) intersection further down the road. Although there was no physical cross street, the GID was configured as if there were one, as shown in Figure 6. The second intersection was referred to as the “alternate intersection”. Care was taken that the GID of the alternate intersection did not overlap with the GID of the main intersection.

For the warning test, the SPaT broadcasts that the signals were red for all approaches of both the main and the alternate intersections. The test was set up so that the warning was issued in the appropriate range for the closer intersection. That is, the test sought to verify that the CICAS-V system did not delay the appropriate warning for the main intersection simply because of an as-yet non-critical warning further down the expected path at the alternate intersection. This ability to identify and differentiate the GID of the two intersections will be crucial to the ability of the system to operate properly in a field operational test.

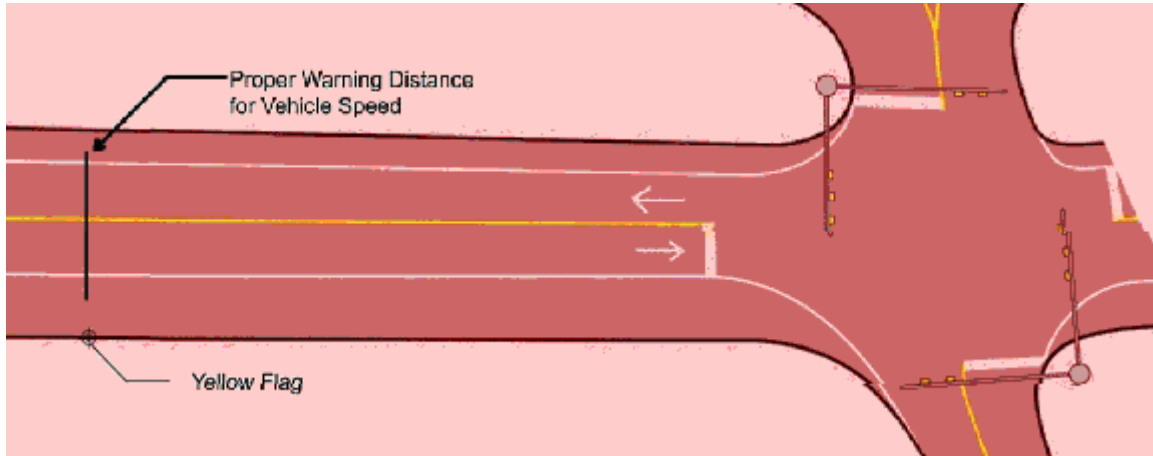
Figure 7. Geometry for Dynamic Signal Change Warning Tests

The first set of tests examined the case in which signals for the approach lanes transitioned to yellow too late for an effective warning. The traffic control device on the test track was configured to change from green to yellow as the test vehicle approached the nominal warning distance and remain yellow until after the vehicle passed the stop bar (so long as it continued at the nominal speed). The geometry of the intersection is shown in Figure 7.

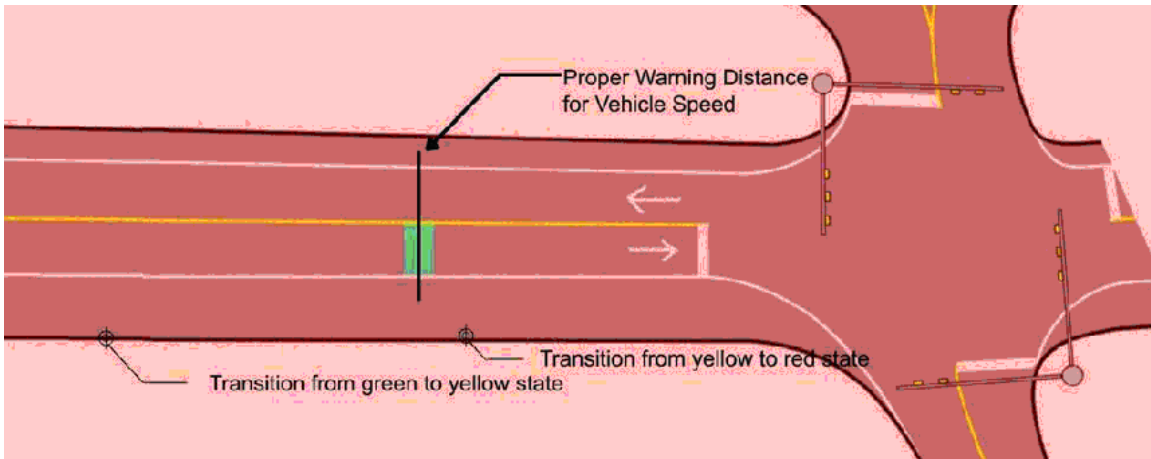
Figure 9. Geometry for Dynamic Signal Change to Red (Sufficient to Warn) Tests

This test sought to confirm that the CICAS-V system would alert the driver if it calculated that the traffic signal will change to red before the test vehicle reaches the stop bar, even if the traffic signal were still yellow when the vehicle reaches the optimum warning distance. The intersection geometry shown in Figure 9 is essentially the same as in the previous set of tests, but the timing of signal changes is different.

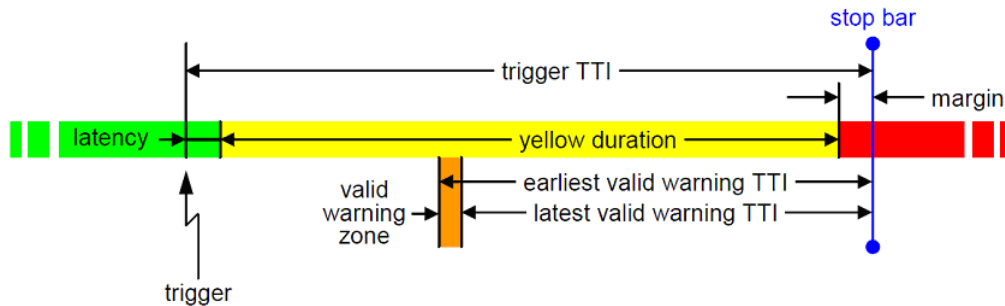
Figure 10. Time Sequence Schematic for Dynamic Signal Change to Red (Sufficient to Warn) Tests

At the beginning of each test run, the intersection traffic signal was green. The signal transitioned to yellow before the optimum warning distance for the nominal speed. The signal transitioned to red before the test vehicle reached the stop bar and remained red at least until the test vehicle reached the stop bar. In order for the system to pass a test run, it had to issue a warning in the appropriate range. Note that in the test protocol the test vehicle did not brake but retained the nominal speed when the traffic signal transitioned to yellow. The time sequence of this test is shown schematically in Figure 10. The nominal test speed is 35 mph.

The signal change was triggered based on the test vehicle's calculated TTI. As with the previous set of tests, the TTI trigger allowed for the system latency between sending the command and implementing it. A margin of safety should allow for variations in cruise control speed as well the time to assure the transition to red occurred before the test vehicle crossed the stop bar. The value of TTI that triggers the transition to yellow would thus be:

A practical maximum to the trigger value of TTI would be that value that would cause the transition to red while the test vehicle was in the optimum warning range. The most critical value for that would be if the actual test speed were 32.5 mph (52.3 km/h), in which case the warning would occur 2.4 sec before the stop bar.

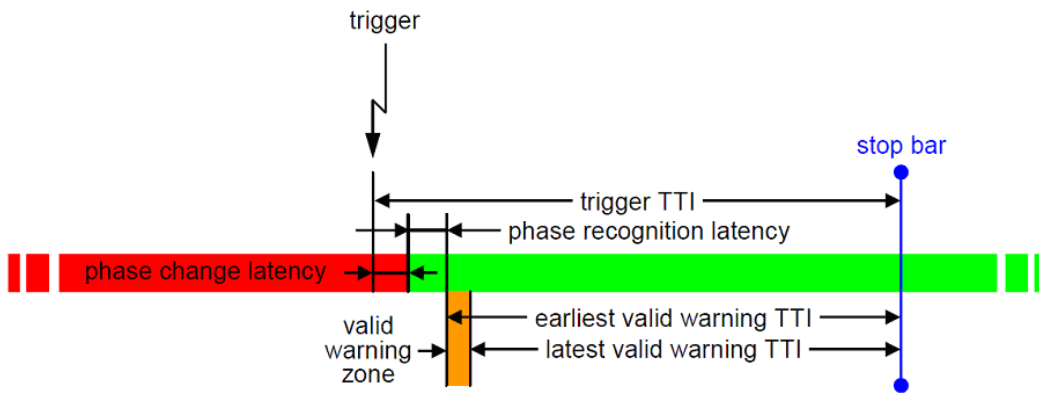
Figure 12. Time Sequence Schematic for Dynamic Signal Change to Green (No Warning Necessary) Tests

Once again, the phase change was triggered when a critical value of TTI (as calculated on the test vehicle) was reached. The maximum TTI of a warning in a valid test would be 2.78 sec for a 37.5 mph approach. As previously stated, the latency associated with the transmission, reception, and implementation of the command to change the signal was taken to be 0.2 sec. Similarly, the latency for the on-board equipment to receive, interpret, and react to the traffic signal phase change was also taken to be 0.2 sec. Hence, the value of TTI that triggered the phase change from red to green was set to 3.18 sec (2.78 sec + 0.2 sec + 0.2 sec). The time sequence of this test is shown schematically in Figure 12. A test will be considered valid if the traffic signal transitions from red to green before the earliest valid warning distance.

The system was considered to have passed for a given valid run if it did not issue any warning; any warning would have constituted failure of the run. Eight tests runs were conducted for this set of tests. All eight runs were valid. The system passed all eight tests. The details are summarized in Table 17.

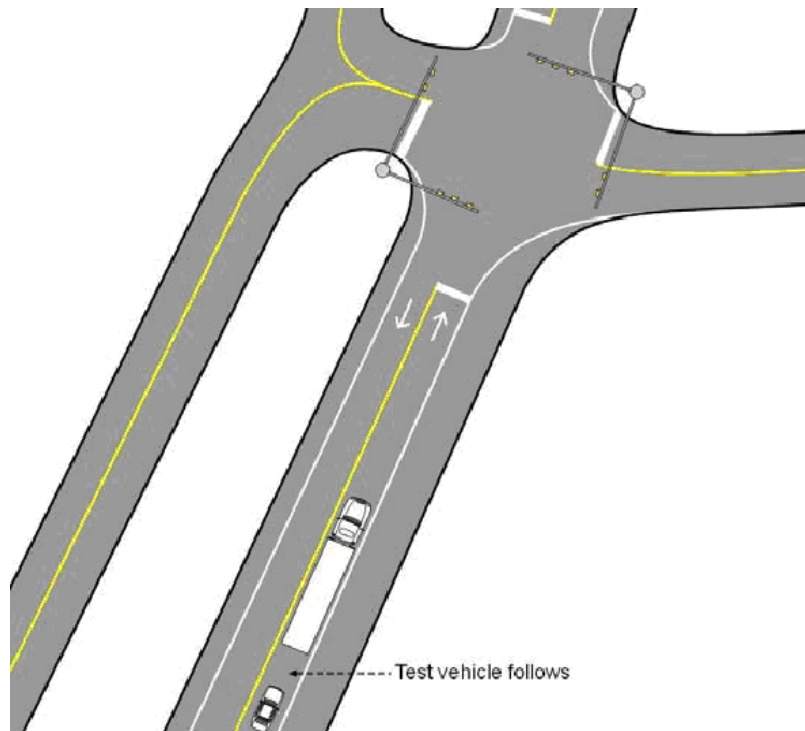
Figure 13. Geometry for SPaT Reflection and Reception Tests

In this set of tests, the test observer used an onboard equipment interface to clear the GID from the system and institute the standard initialized state. The observer used a hand-held laser range finder to determine the distance of the test vehicle behind the tractor-trailer. The SPaT server transmitted a red traffic signal for all approaches to the intersection. The tractor-trailer approached the intersection at  $35 \pm 5$  mph. With input from the laser range finder via test observer, the driver of the test vehicle maintained a distance of 3 to 6 m behind the tractor-trailer as shown in Figure 13. The maintenance of a distance of less than 6 m (as measured by the DAS radar) was required for a valid test.

The system was expected to give a normal warning in the expected warning range despite receiving the GID significantly later in each test run. Eight runs were performed. All eight runs were valid and recorded warnings in the appropriate range. The average warning distance deviation was +1.5 m with a standard deviation of 0.8 m. Table 18 provides detailed results of this set of tests.
