# **Simultaneous Structural and Environmental Loading of an Ultra-High Performance Concrete Component**

**July 2010**

**FHWA Publication No. FHWA-HRT-10-054**

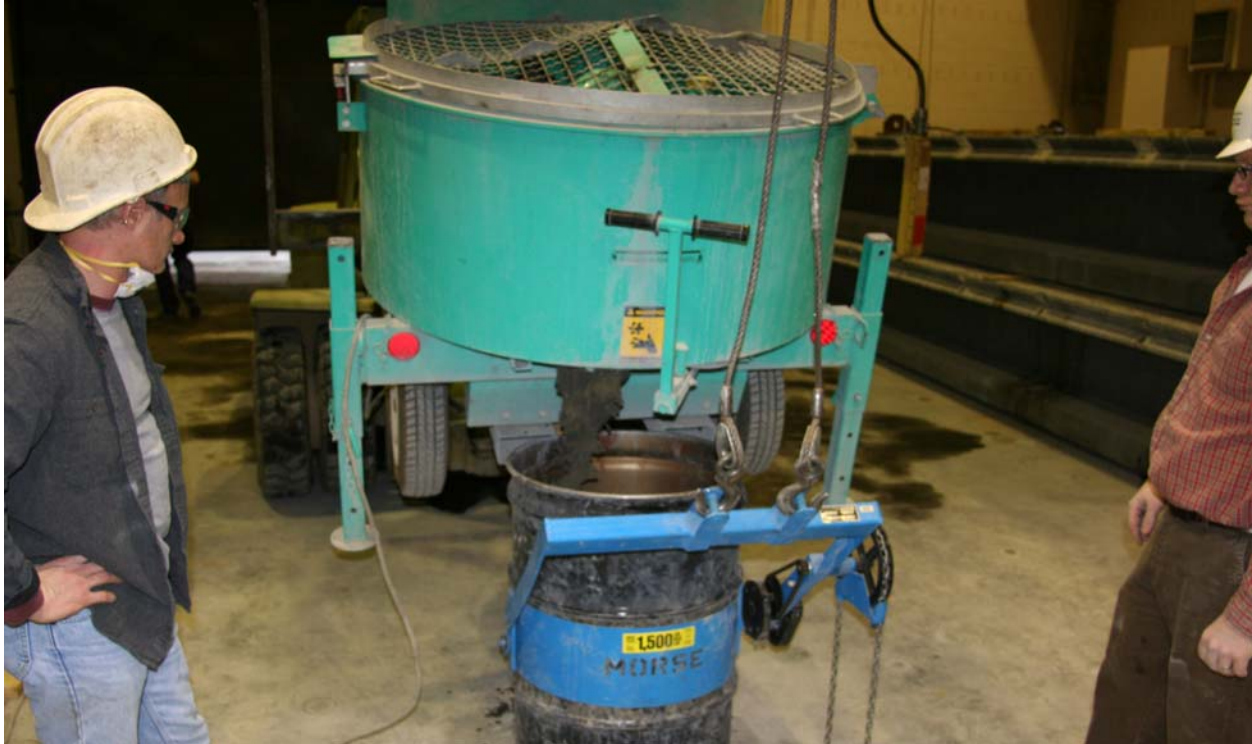
**Figure 1. Photo. Discharge of UHPC holding barrel.**

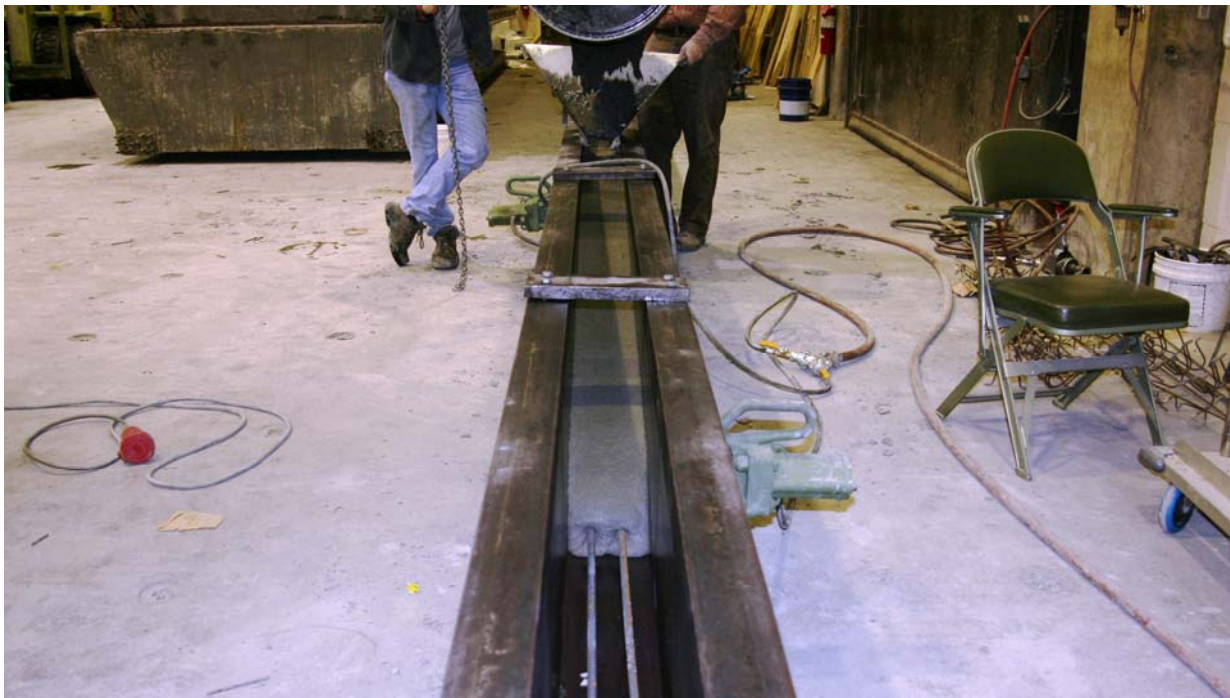
**Figure 2. Photo. Placement of UHPC into beam form.**

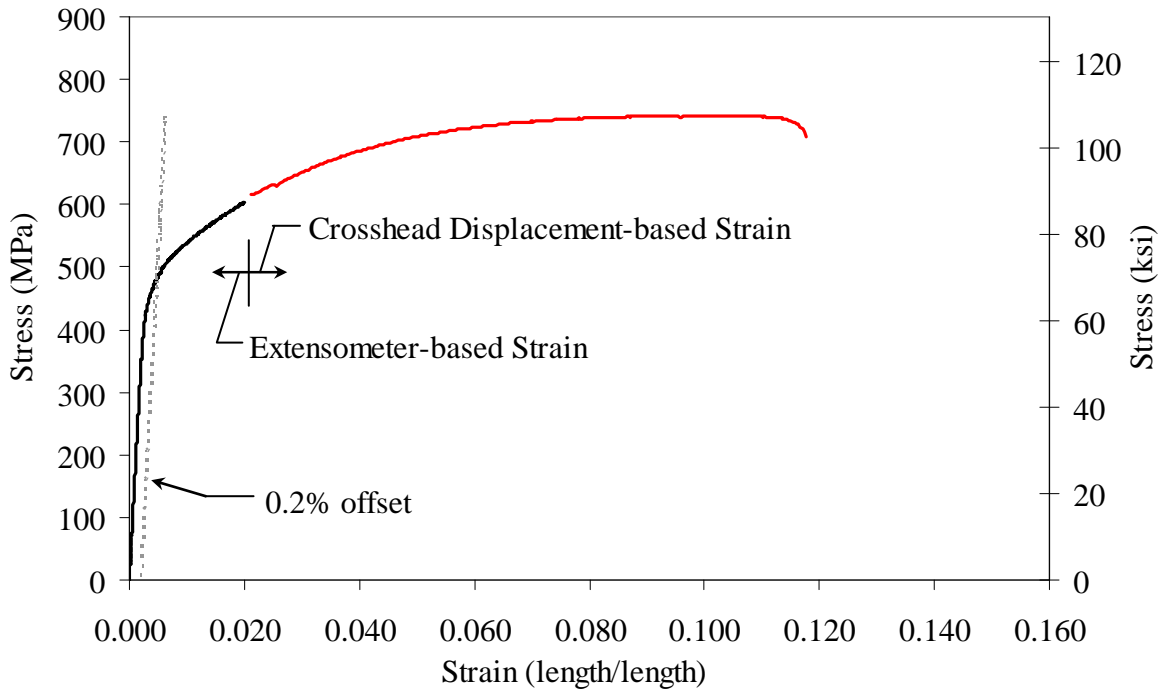
**Figure 4. Graph. Tensile stress-strain response of second mild steel reinforcing bar.**

Two #4 mild steel reinforcing bars, 5.03 m (198 inch) in length, were included as discrete flexural reinforcement along the length of the beam. Sample specimens were cut from overlength portions of each of these bars and tested in uniaxial tension according to ASTM A370<sup>(12)</sup>. The yield strengths of the steel were determined to be 460 and 481 MPa (66.7 and 69.8 ksi) for the two bars based on the 0.2% offset method. The ultimate strengths were 731 and 742 MPa (106.0 and 107.6 ksi). At failure, the elongations over an initial gage length of 200 mm (7.88 inch) were 14.7% and 11.3%. Figure 3 shows the stress-strain response from the first bar while Figure 4 shows the response from the second bar. Note that the stress is based on the nominal cross section of the bar and thus represents engineering stress. Additionally, note that the strain was calculated through readings captured by an extensometer placed on the bar up through a strain of approximately 0.02, after which the extensometer was removed and the machine cross-head displacement readings were used.

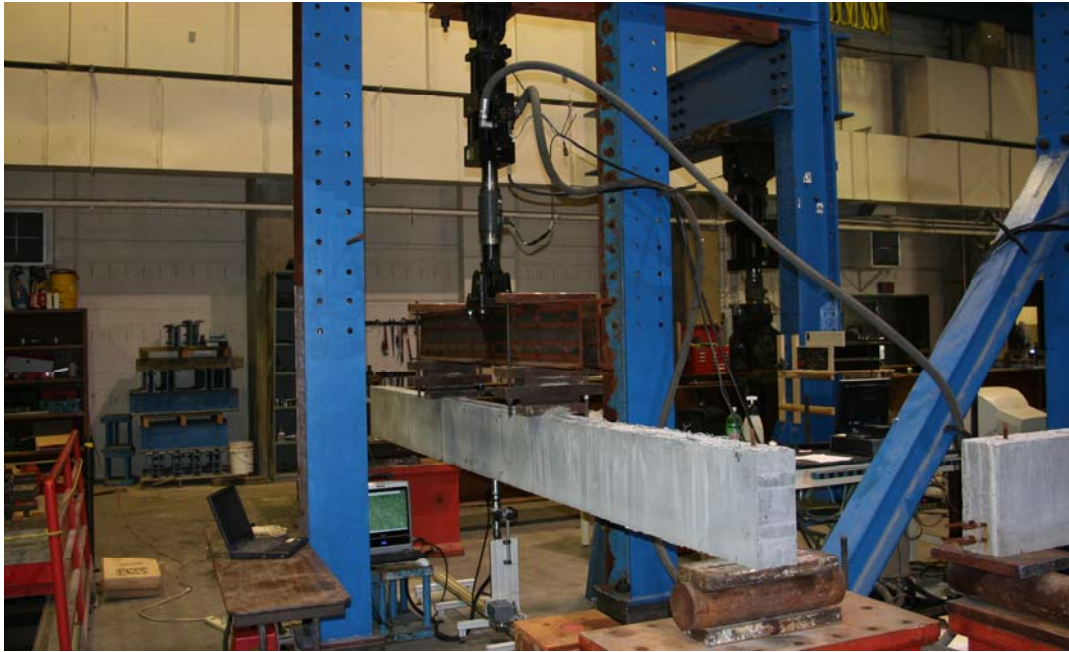
**Figure 5. Photo. Four-point bending test setup for cyclic flexural load application.**

The cyclic testing was conducted in three phases. The first was designed to allow for the observation of the initial flexural cracking of the beam. A structural load following a sinusoidal waveform at a frequency of 0.5 Hz was applied to the beam. The load range initially was 8.9 to 44.5 kN (2 to 10 kips). The peak load was incrementally increased to 53.4, 57.8, and 62.3 kN (12, 13, and 14 kips) after approximately 20 cycles at each load level. This phase was ceased when first flexural cracking was observed.

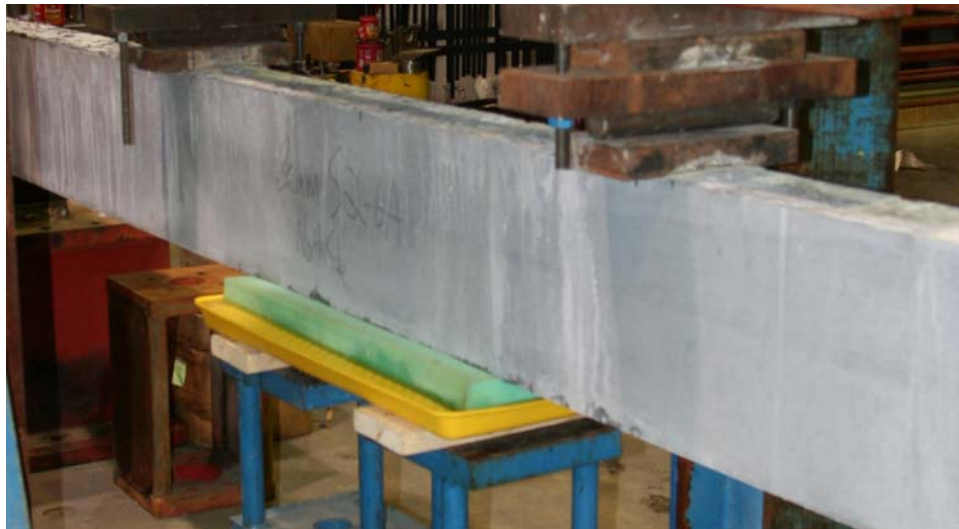
**Figure 6. Photo. Salt water solution application system.**

71.2 kN (2 to 16 kips). The total length of the foam was 0.89 m (35 inches), thus the tensile face of the beam was subjected to this environmental loading over this distance centered on midspan. Figure 6 provides a photograph of salt solution application system immediately after its insertion under the beam. The combined structural and environmental loading was continued for a total of 499,000 total structural loading cycles which were completed over a time period of 154 days.

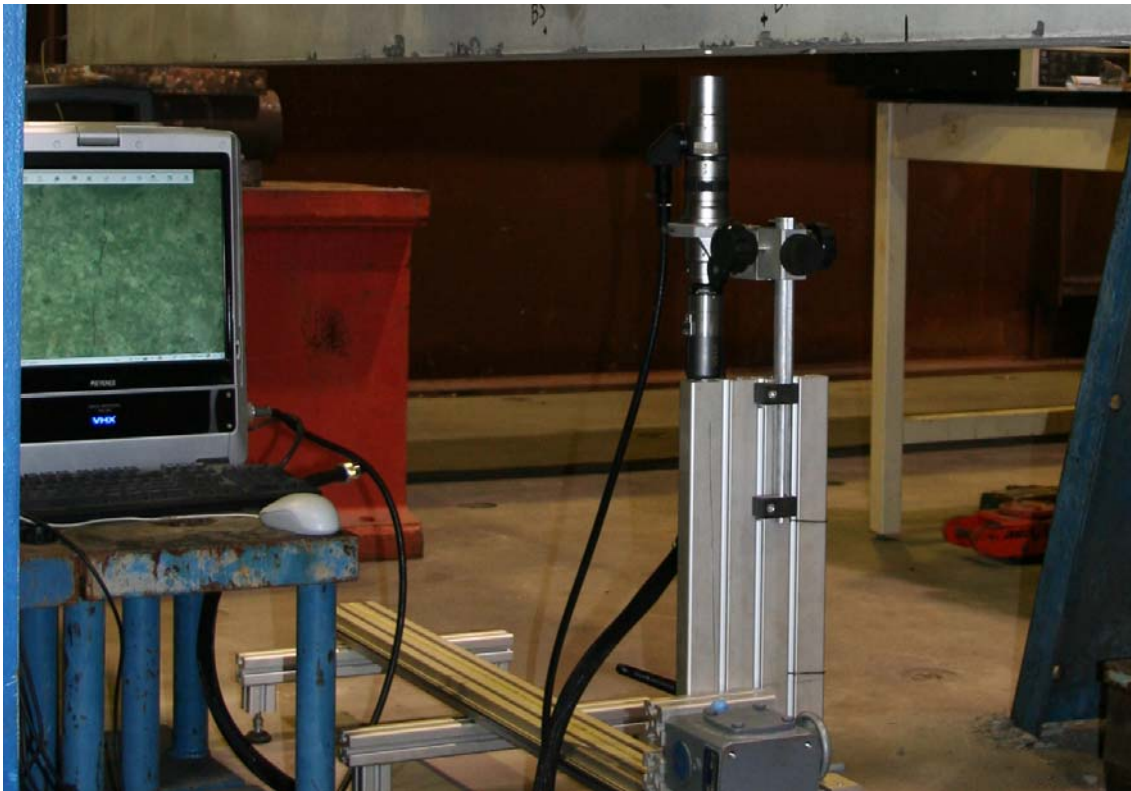
**Figure 7. Photo. Crack assessment microscope and linear traverse system.**

The cyclic behavior of the beam was assessed through a variety of techniques. Load and displacement were monitored through the hydraulic actuator's internal load cell and LVDT. Propagation of the salt solution along flexural cracks was monitored through visual observation of salt deposits on the vertical faces of the beam. Finally, crack locations and sizes on the tensile face of the beam were assessed through the use of a digital optical microscope mounted on a linear traverse system. This system was used to assess the cracks on the bottom face of the beam along the beam midline within 0.51 m (20 inches) of midspan. Figure 7 provides a photograph of the crack assessment setup including the microscope head, the associated digital display and computer control system, and the linear traverse system. This crack assessment setup with its 200x to 1000x variable power microscope was capable of identifying, sizing, and photographing cracks as small as 2- $\mu\text{m}$  (0.000079-inch) wide.

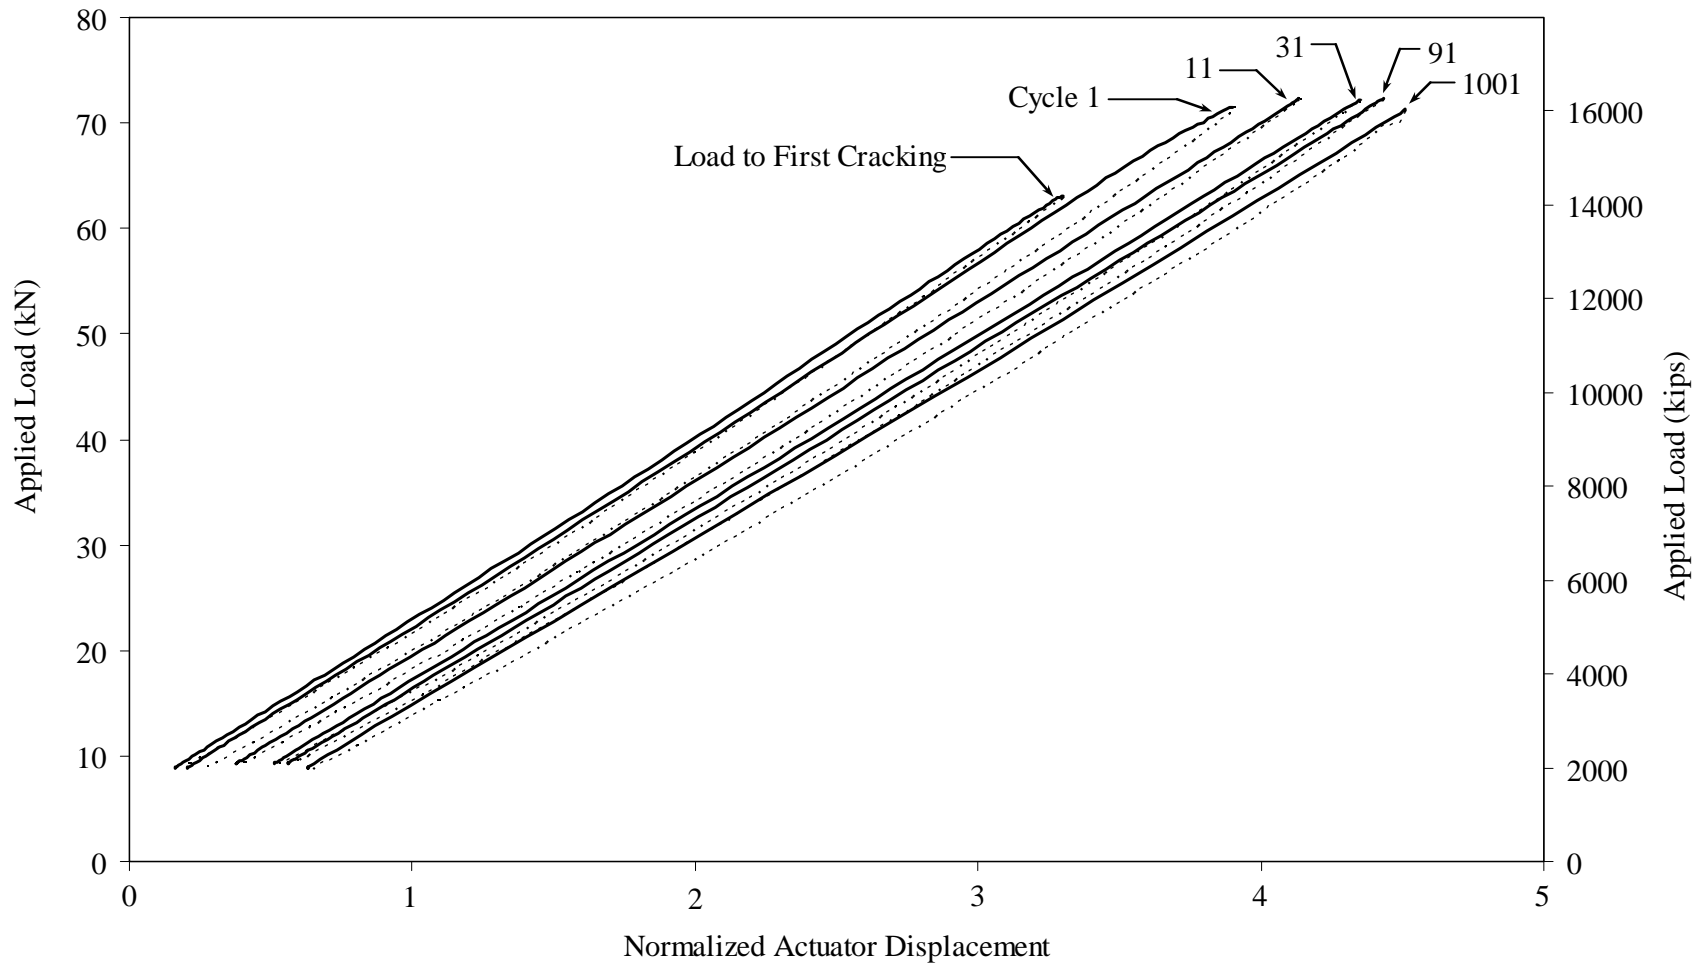
**Figure 8. Graph. Actuator load versus displacement response during second phase of cyclic loading.**

Actuator load and displacement data were collected periodically throughout this phase of the cyclic testing. Figure 8 shows these results at six specific cycles including the cycle which caused first flexural cracking. The solid lines in the figure represent portions of each cycle where the load was increasing; the dotted lines represent decreasing load in the same cycle. This figure demonstrates that there was a detectable change in response between first cracking and each of the subsequent cycles shown. It also demonstrates that the majority of the change in response occurred within the first 31 cycles, indicating that the majority of the crack initiation/propagation occurred within these cycles.

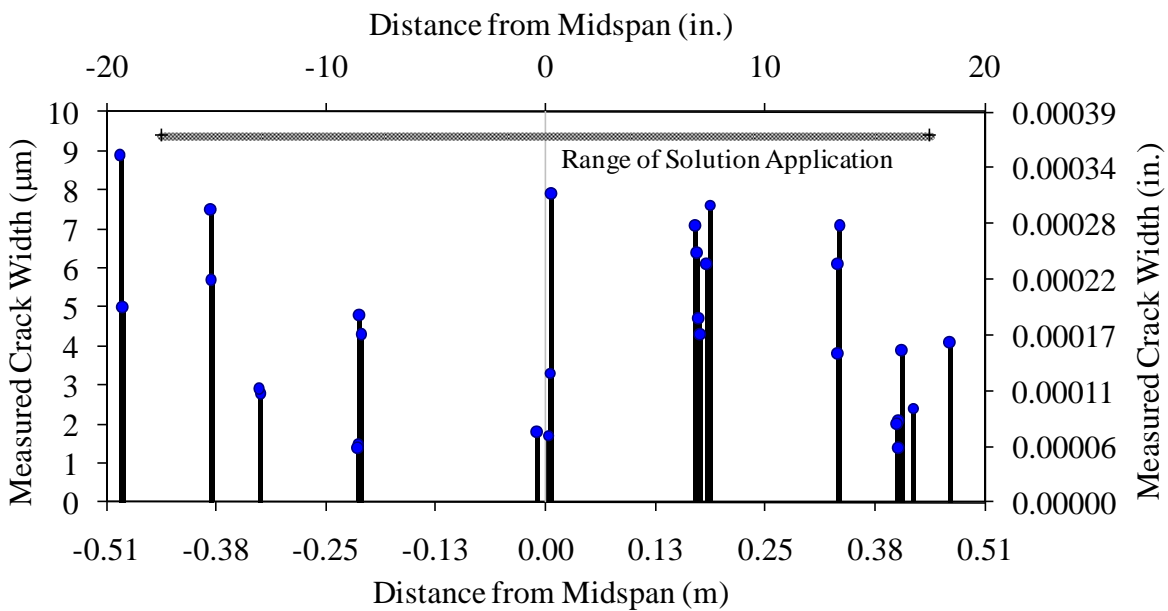
**Figure 10. Graph. Crack locations and widths after 1000 cycles of flexural loading.**

The flexural cracking of the beam was assessed following the completion of this phase of loading. The crack assessment system described above was used to quantify the cracks present along the midline of the bottom face of the beam within 508 mm (20 inches) of midspan. Each identified crack was noted for its location and width. Figure 10 displays the pertinent information on the 29 cracks identified. A total of 26 of these cracks fell within the region which would subsequently be subjected to the aggressive environment. These 26 cracks had an average width of 4.4  $\mu\text{m}$  (0.00017 in.) with a standard deviation of 2.2  $\mu\text{m}$  (0.000087 in.). Eight of these cracks exhibited widths greater than 6  $\mu\text{m}$  (0.00024 in.). Figure 11 provides three photographs of cracks identified within the area to be subjected to the aggressive environment. Of note, the 8- $\mu\text{m}$  (0.0003-in.) wide crack shown in Figure 11c is the widest observed crack within the portion of the bottom face of the beam to which the aggressive environment was applied.

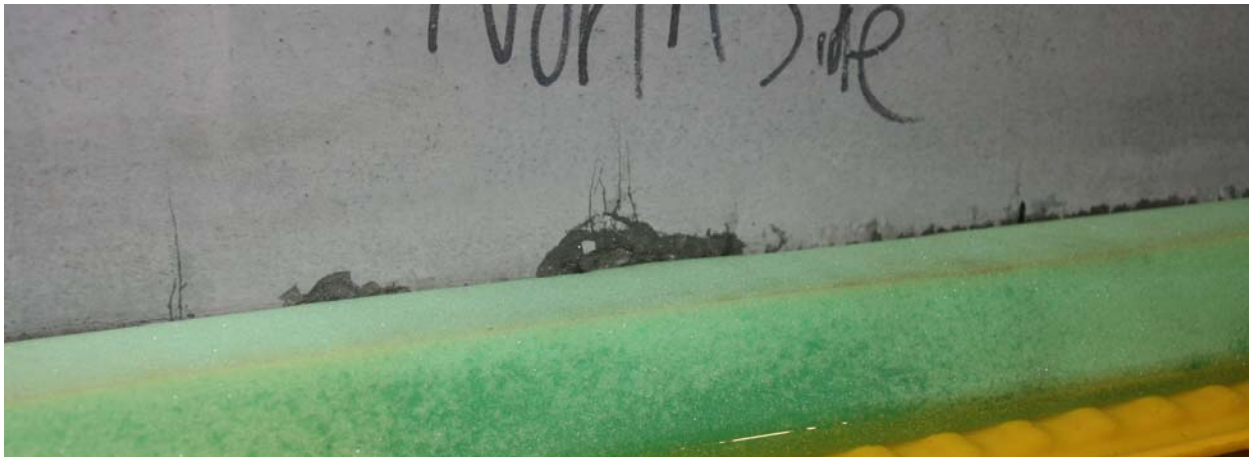
**Figure 12. Photo. North face of beam near midspan one hour after the initiation of the third phase of cyclic testing.**

Visual observations made during this phase of testing verified that the salt solution being applied to the bottom face of the beam was entering the flexural cracks. The photo in Figure 12, captured one hour after the start of this phase of testing, shows salt solution emanating from flexural cracks. The photo in Figure 13 shows that the salt solution migrated along and evaporated from many cracks, with salt residue being left behind. Salt residue was observed to be deposited on the face of the beam as high as 240-mm (9.5-in.) up from the bottom of the beam.

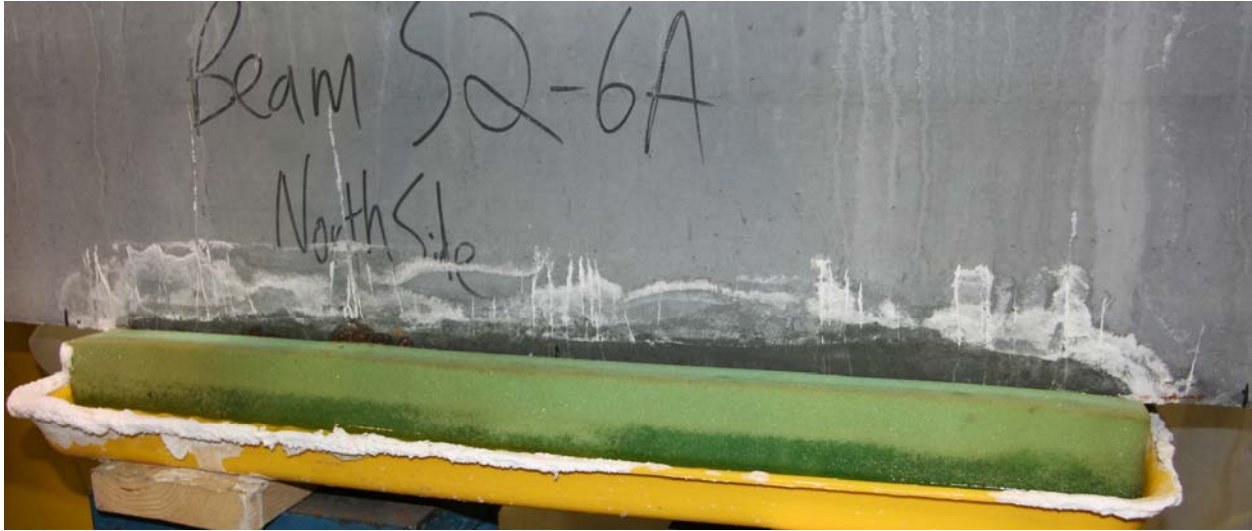
**Figure 13. Photo. North face of beam near midspan immediately after the conclusion of the third phase of cyclic testing.**

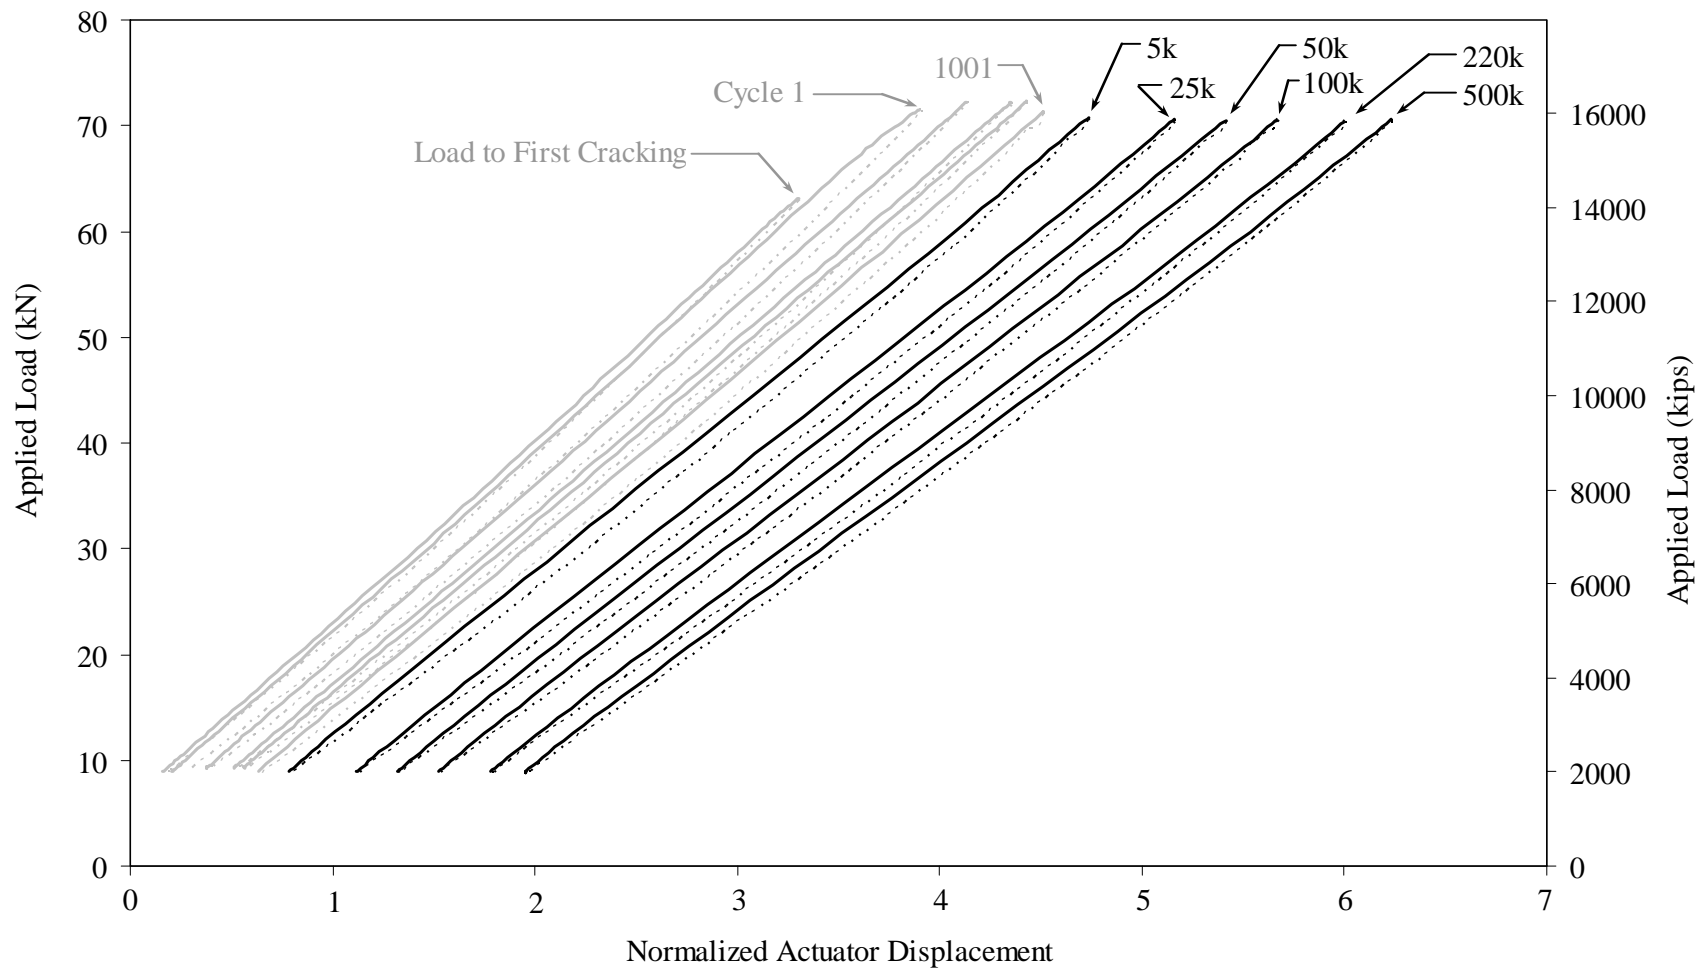
**Figure 14. Graph. Actuator load versus displacement response during third phase of cyclic loading.**

Actuator load and displacement data was collected periodically throughout this phase of the cyclic testing. The results previously presented in Figure 8 are expanded in Figure 14 to show the load displacement responses at twelve specific cycles ranging from first flexural cracking to the conclusion of this phase of testing. This figure demonstrates that the rate of change in flexural response decreased as the cycling progressed.

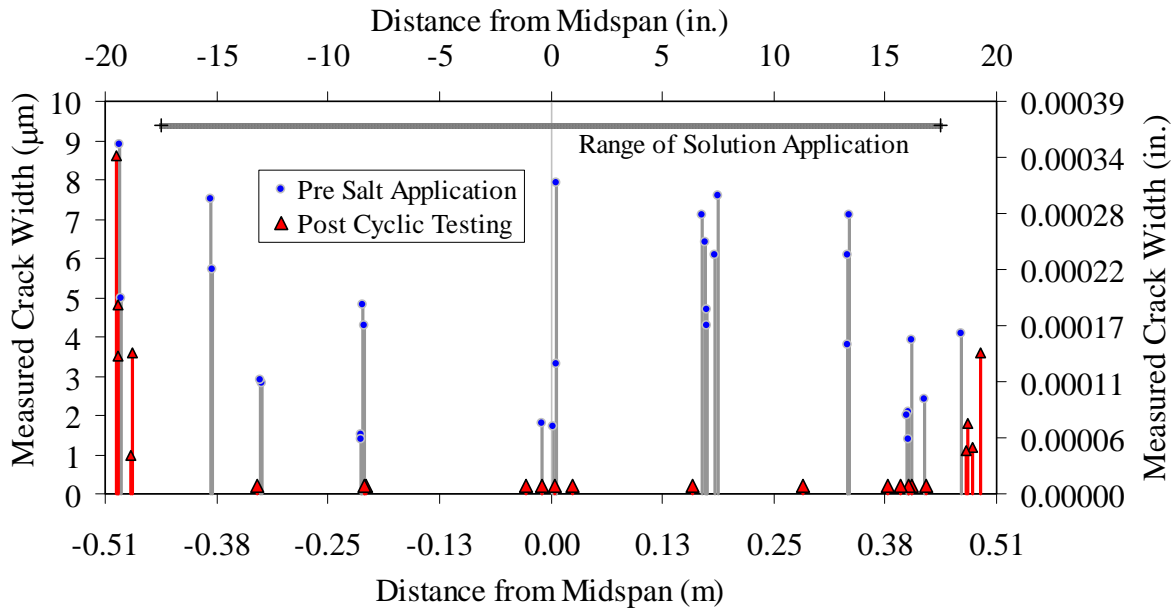
Figure 16. Graph. Crack assessment results after the conclusion of cyclic testing.

The flexural cracking of the beam was assessed following the completion of the cyclic loading through the same procedure as was used previously. Figure 16 displays the pertinent information on the 23 cracks identified, while also reproducing the information previously presented in Figure 10. Crack widths for cracks identified in the present assessment are only indicated for cracks occurring outside of the area subjected to the aggressive environment. Cracks identified within the area subjected to the aggressive environment were obscured by salt residues and thus were not able to be measured.

These crack assessment results demonstrate that this phase of cyclic flexural loading resulted in additional cracking of the beam. In the assessed areas outside of the area subjected to the aggressive environment, a total of nine cracks were identified whereas only three cracks has been identified prior to this phase of loading. Also, this figure demonstrates that some previously identified cracks were not identifiable during this assessment and that new cracks were identified in previously uncracked locations. Given the difficulty in locating cracks in areas subjected to

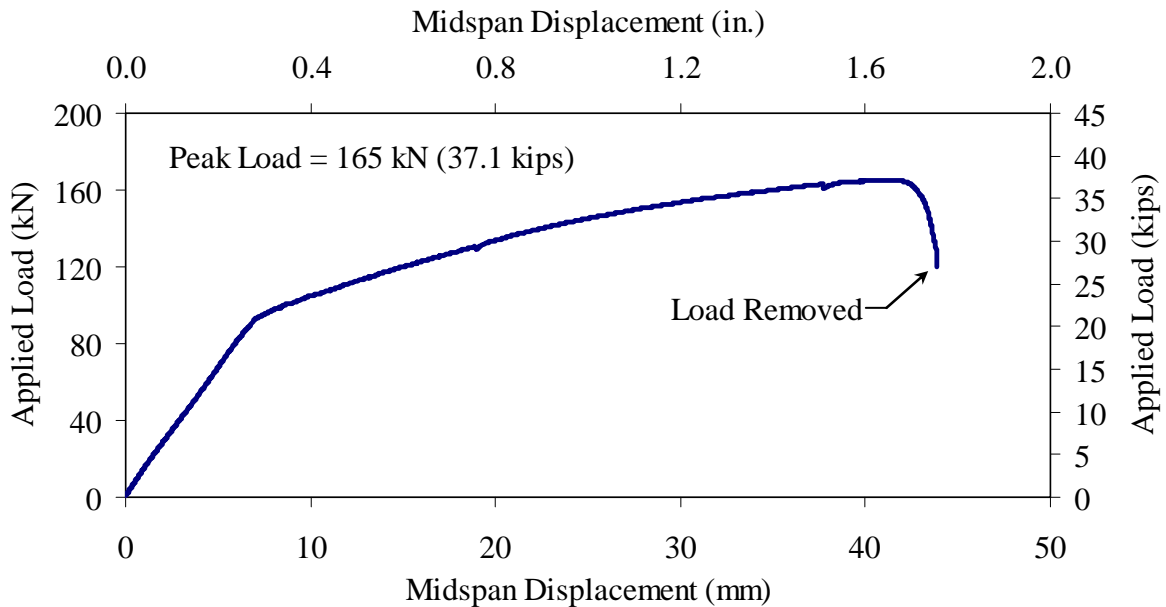
**Figure 19. Graph. Load versus midspan displacement response of beam subjected to static load to failure.**

Figure 19 presents the load-deflection response of the beam. The beam exhibited a linear-elastic response until the first new flexural cracking was audibly observed at an applied load of 86.7 kN (19.5 kips). At an applied load of approximately 93.4 kN (21 kips) the load-deflection response shows a clear softening. The applied load grew until the peak was reached at 165 kN (37.1 kips) which corresponds to a total midspan moment of 143 kN-m (1265 kip-in.). This peak load signified the point in the response when the fibers crossing an individual discrete flexural crack began to debond thus allowing the initiation of the hinging of the beam. The actuator continued to push the beam for an additional 2.5 mm (0.1 in.) of midspan displacement after the peak load was reached.

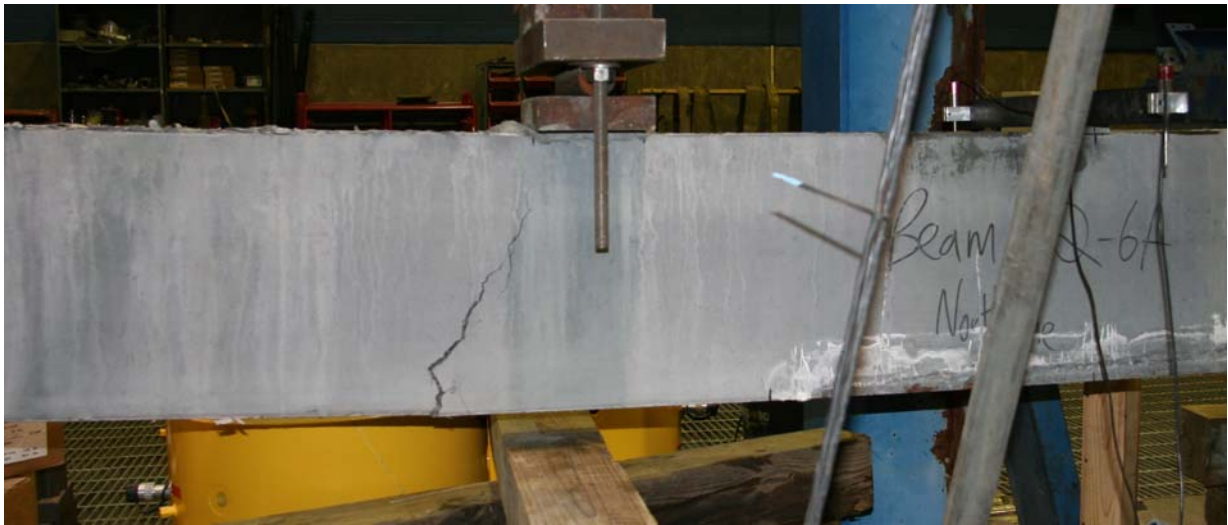
**Figure 20. Photo. Failure crack east of east load point.**

The failure crack as observed after the removal of the applied load is shown in Figure 20. This crack intersected the bottom of the beam approximately 203-mm (8-in.) east of the east load point. This failure location, although outside of the constant moment region wherein the largest moment was applied, did coincide with the cross section wherein a rebar chair supported the mild steel reinforcement during casting. The flexural failure of the cross section at this location indicates that the flexural capacity of the beam was not significantly degraded by the 154 day application of the aggressive environment during the cyclic flexural loading.

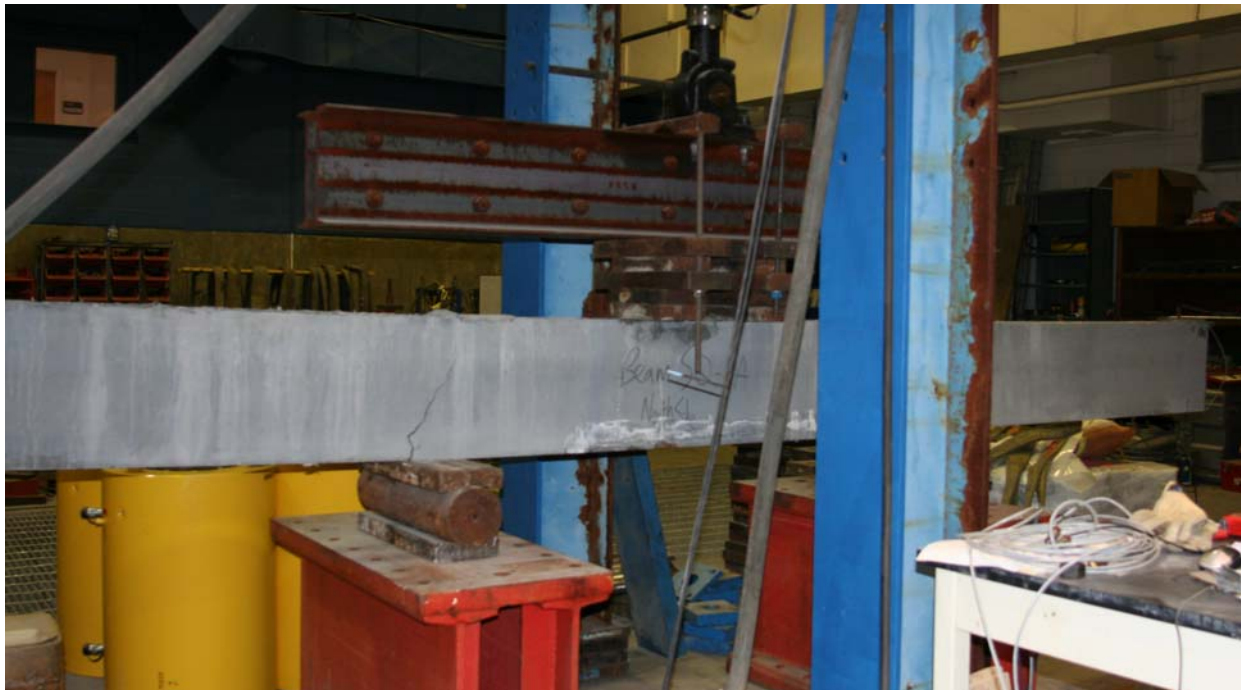
**Figure 21. Photo. Test setup for first subsequent flexural loading.**

wherein the constant moment region was entirely contained within the portion of the beam which was subjected to the aggressive environment. Electronic data was not collected during this loading as it was solely intended to cause the beam to fail across a pre-existing crack near midspan. Figure 21 shows the overall setup for this flexural loading.

The load was increased until the total applied load reached 302 kN (68 kips) which corresponded to a total maximum moment in the beam of 139 kN-m (1229 kip-in.). At this load, the beam displayed no indication that any individual crack was beginning to widen. This load was the maximum that could be applied through the present loading setup, thus the beam was unloaded without having achieved the desired flexural failure. This result again demonstrated a minimum flexural capacity for this beam.

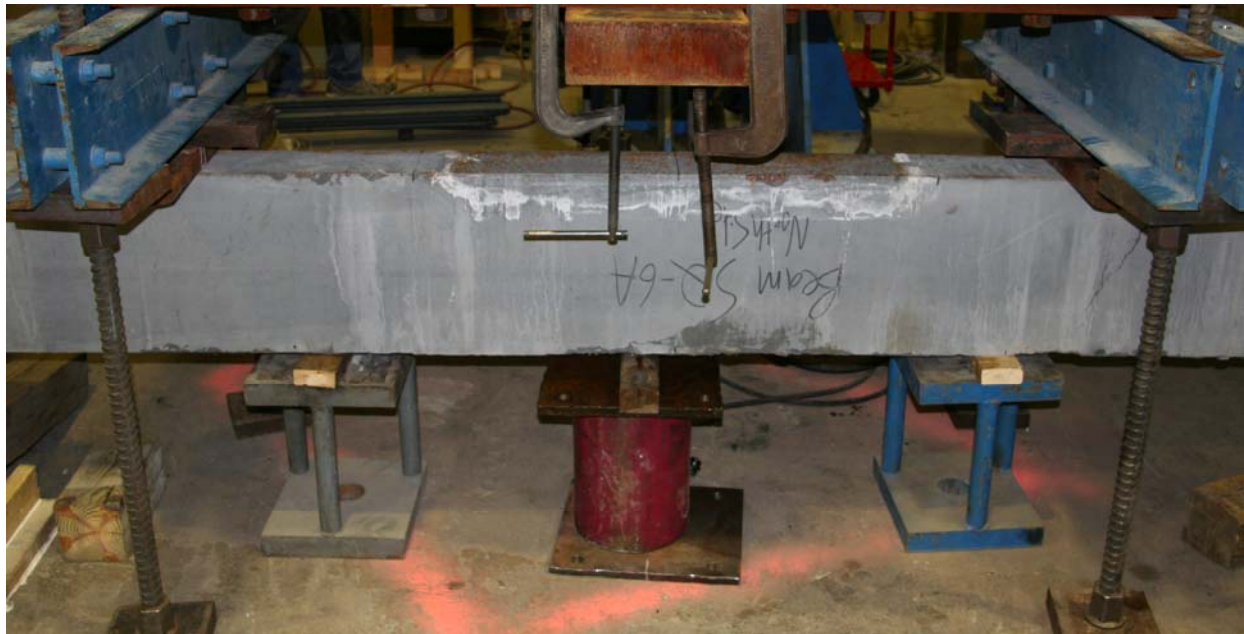
**Figure 22. Photo. Test setup for second subsequent flexural loading.**

A final effort was undertaken to force the beam to fail in flexure within the region subjected to the aggressive environment. The beam was removed from the original load frame, turned upside down, and placed into a three-point bending reaction frame. The frame included reaction tie-downs spaced at 1.83 m (72 in.) and a static hydraulic jack topped by a half-roller. The static jack was situated midway between the reaction points. The beam was placed so that the load application point was 50 mm (2 in.) toward the original west end of the beam from the original midspan location. Figure 22 shows a photograph of the test setup.

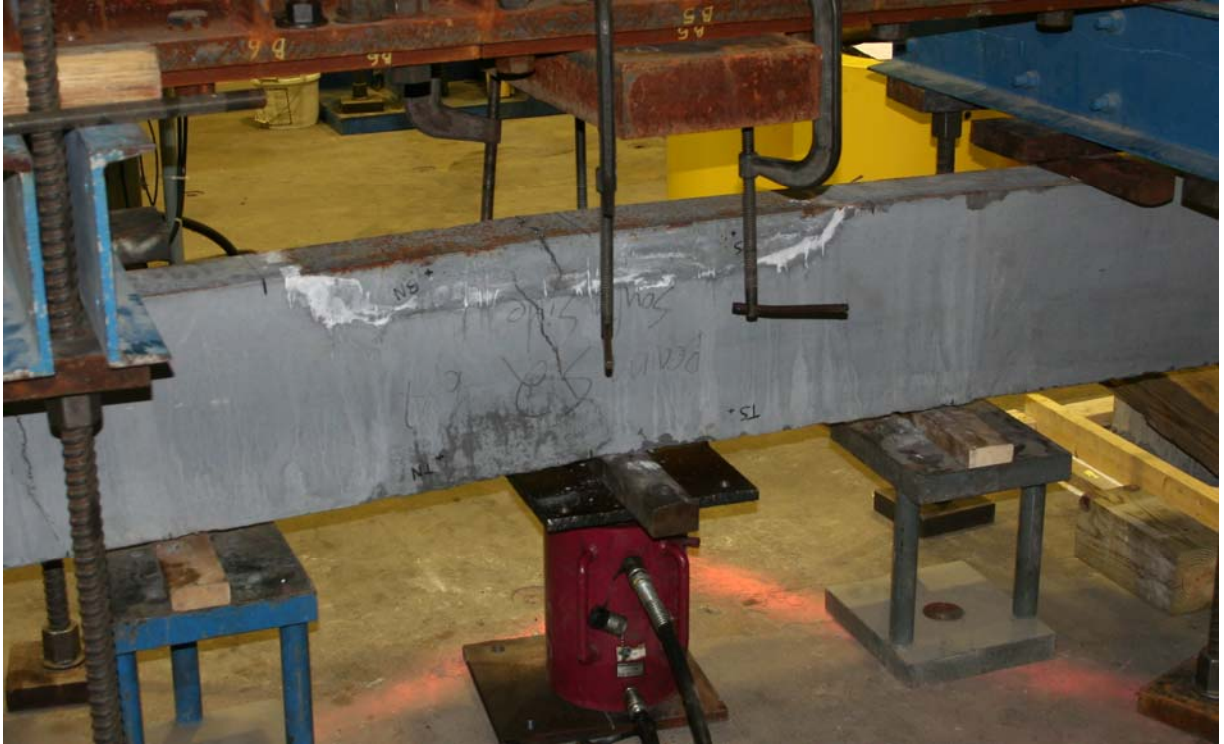
**Figure 23. Photo. Beam failure near midspan after second subsequent flexural loading.**

The midspan displacement imposed by the hydraulic jack was steadily increased until the beam failed in flexure. The applied load was not monitored and thus the peak applied moment was not captured. Figure 23 shows the beam after the initiation of fiber pullout and flexural failure. The flexural failure initiated within the region subjected to the aggressive environment, but was not

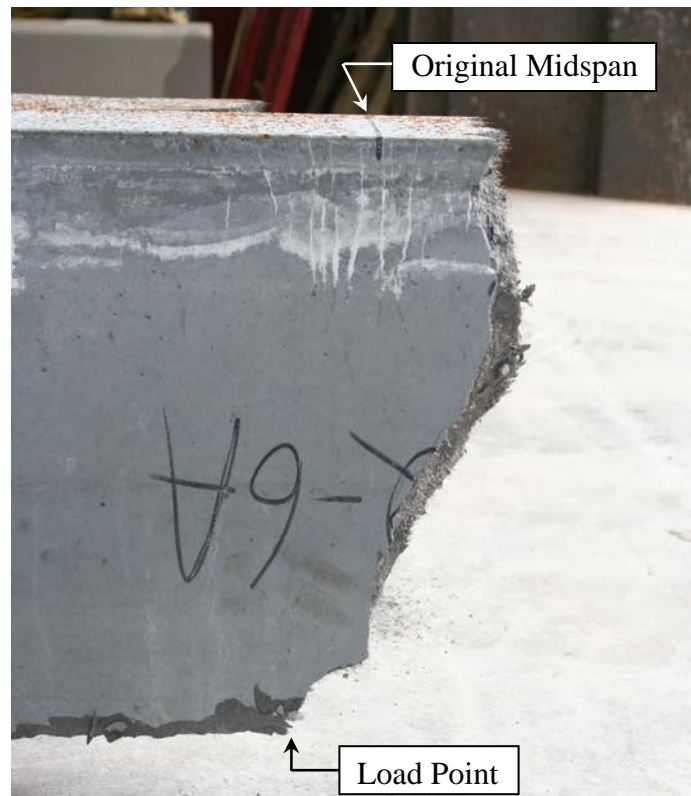
**Figure 24. Photo. Elevation view of failure location.**

coincident with any cracks which existed during the application of said environment. The hydraulic jack continued to impose displacement until the rebar ruptured and the beam separated into two pieces. Figure 24 provides an elevation view of half of the failed beam. Tensile flexural failure initiated approximately 100 mm (4 in.) east of the load application point.

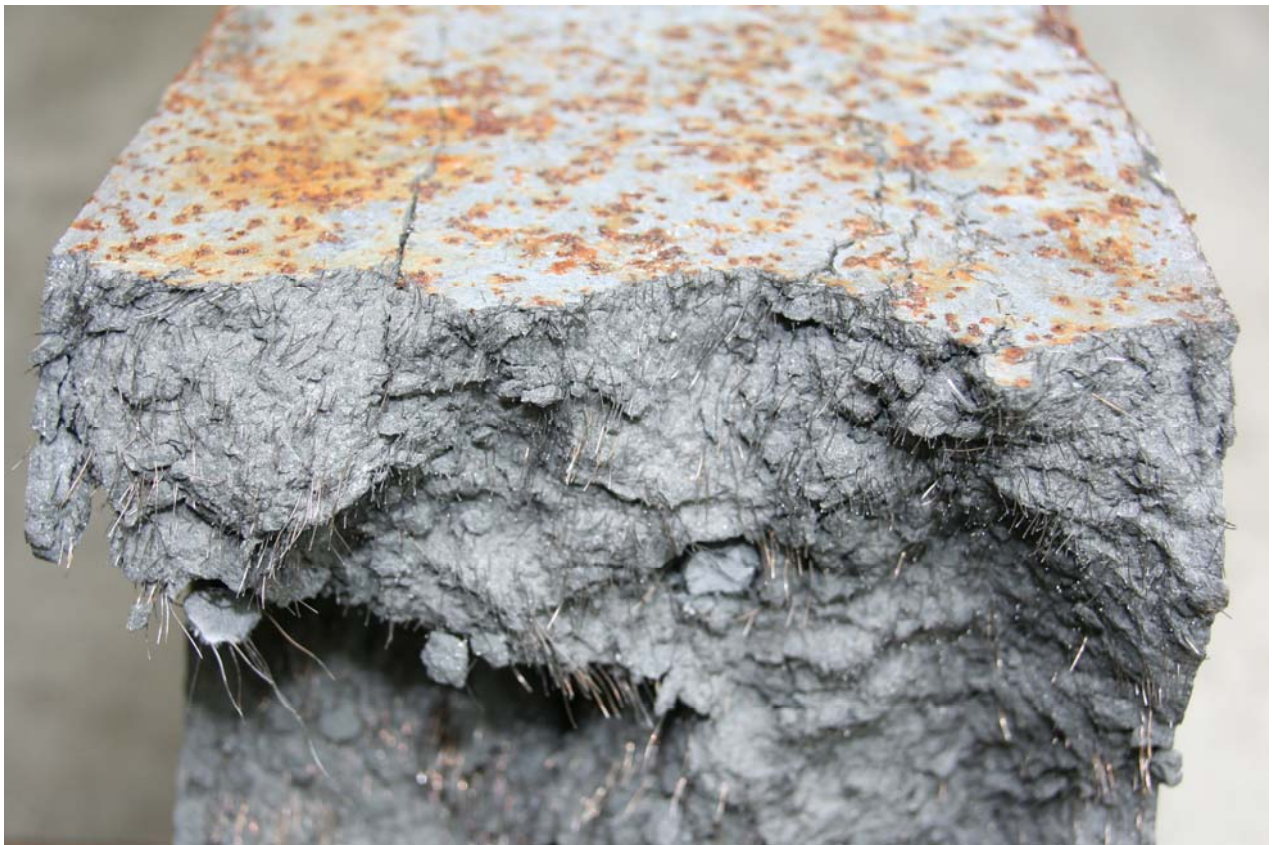
**Figure 26. Photo. Close-up of failure surface.**

Figure 25 shows a photo of the tensile flexural failure surfaces, and Figure 26 provides a close-up view of one of the failure surfaces. Visual inspection of the failure surfaces provided no indication that this failure location was impacted by the presence of the aggressive solution or the flexural fatigue loading. These failure surfaces displayed no indication of fiber fatigue failure, fiber rupture, or fiber corrosion. They also did not show any indication of rebar corrosion.

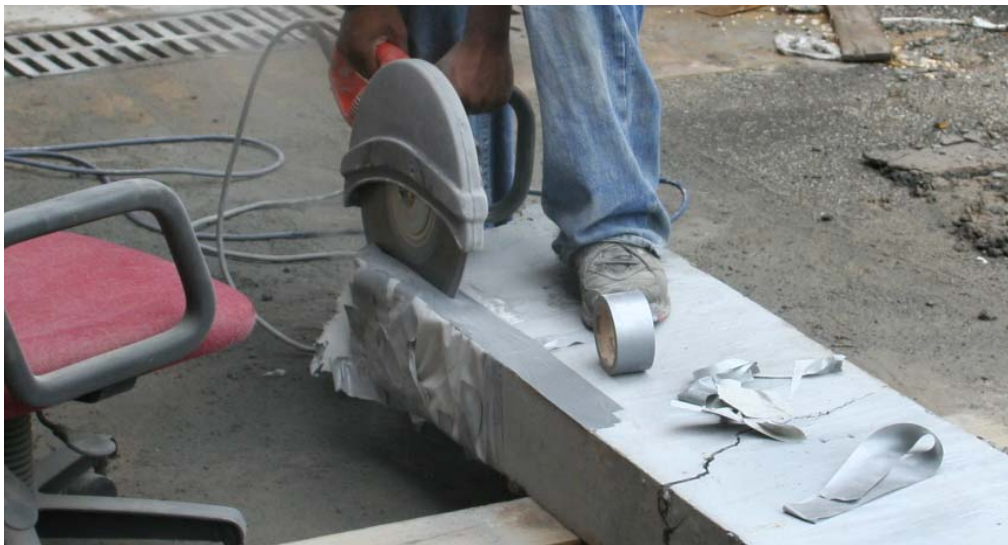
**Figure 28. Photo. Extraction of a prismatic specimen from beam tensile face.**

The prism was extracted from the tensile face of the beam near the flexural failure location. The prism was obtained through the use of a concrete saw with a diamond blade. The cutting was completed without the use of any water so as to ensure that the extraction process did not facilitate the hydration of unreacted cementitious particles on any exposed or cracked surfaces. Figure 28 shows a photo of the extraction process. The horizontal cut was completed immediately below the depth of the reinforcing bar. The dimensions of the resulting prism were 25.4 x 50.8 x 300 mm (1.0 x 2.0 x 11.9 in.), which were consistent along the length of the prism to within 1.6 mm (0.063 in.). One face of the prism was a cast face that had previously been subjected to the aggressive environment. A second face of the prism was a vertical face of the beam which was adjacent to the aggressive environment.

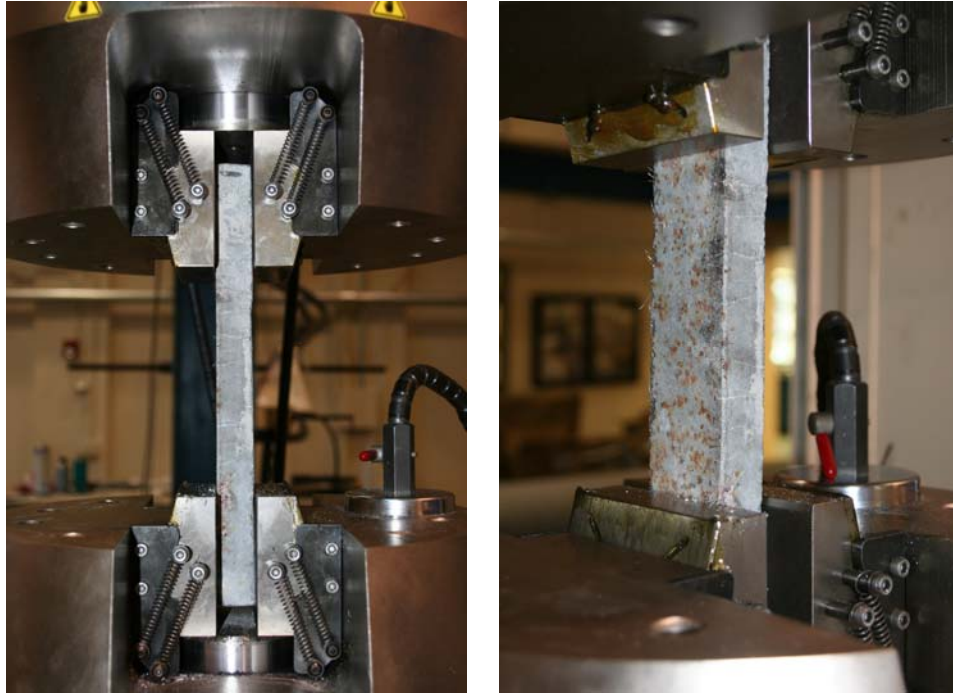
**Figure 29. Photo. Two photos of the direct tensile testing of a UHPC prism.**

The prism was tested in direct tension through the use of a 500-kN (112-kip) capacity Instron uniaxial testing machine. This testing machine included flat-plate hydraulic grips for engaging two faces of the prism, thus allowing for the generation of uniaxial tensile forces in the prism through friction between the gripped ends and the machine grips. The cross-head movement was maintained at a constant 0.762 mm/minute (0.03 in./minute) displacement rate for the duration of the first two tests; 0.254 mm/minute (0.01 in./minute) was used for the third test. Applied load and cross-head displacement were monitored and captured throughout each test. Figure 29 provides two photos of the extracted prism just prior the initiation of the first direct tensile test. Note the lines of salt residue which are visible in the figure, indicating the location of cracks generated during the cyclic flexural testing.

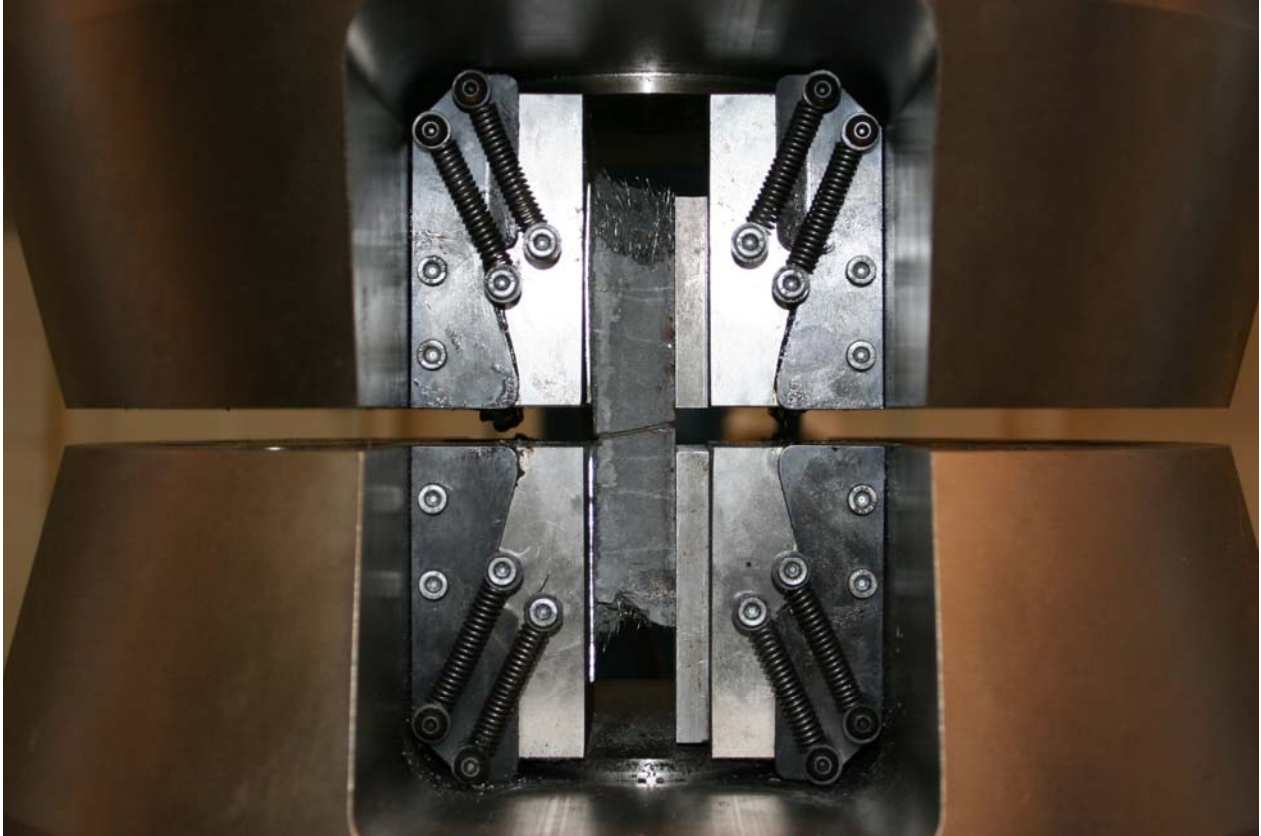
**Figure 32. Photo. Third direct tensile test of a UHPC prism.**

The third prism test was completed through the use of the portion of the original prism which fell between the failure surfaces of the first and second prism tests. In an attempt to force the tensile failure to occur along a crack generated during the cyclic testing, a crack near the center of the prism was selected for routing. The portions of the intersection of the crack plane with the exterior of the prism which were not indicated by salt residue were marked through the use of an alcohol-based evaporative identification technique. The crack was then routed to a depth of between 1 and 1.5 mm (0.04 and 0.06 in.) around the entire perimeter of the prism. A rotary tool with a 1 mm (0.04 in.) diameter head was used to complete the routing. Once inserted into the testing machine, the exposed length of prism between the grip faces was approximately 25 mm (1 in.). Figure 32 shows this test specimen immediately prior to the initiation of testing and Figure 33 shows the crack which was routed for this test.
