# **Simultaneous Structural and Environmental Loading of an Ultra-High Performance Concrete Component**

**July 2010**

**FHWA Publication No. FHWA-HRT-10-054**

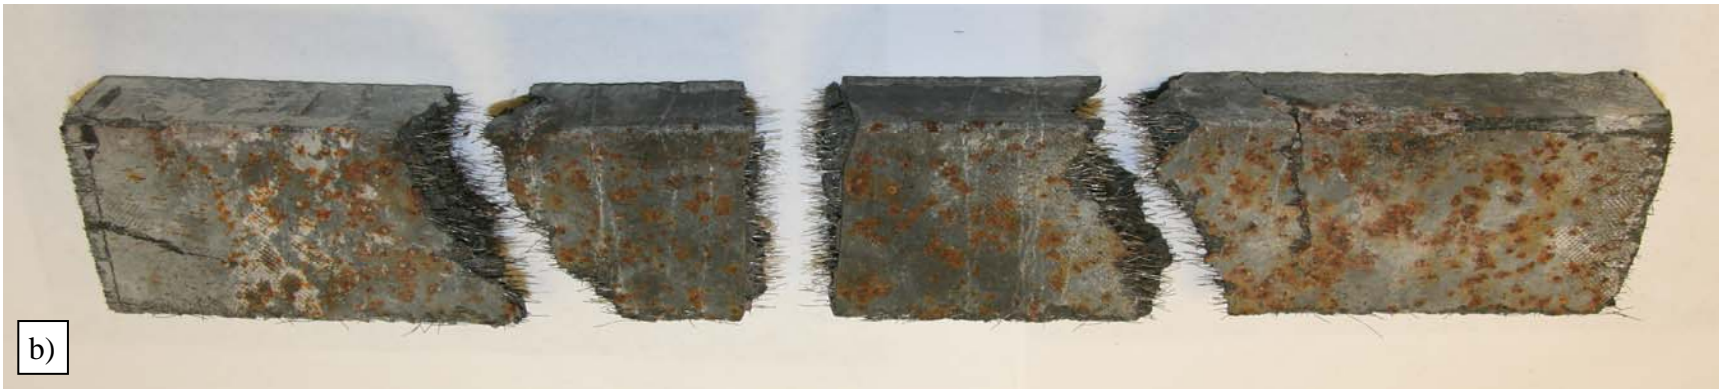
**Figure 33. Photo. Failed UHPC tensile prism after a) second test and b) third test.**

The third prism test was completed through the use of the portion of the original prism which fell between the failure surfaces of the first and second prism tests. In an attempt to force the tensile failure to occur along a crack generated during the cyclic testing, a crack near the center of the prism was selected for routing. The portions of the intersection of the crack plane with the exterior of the prism which were not indicated by salt residue were marked through the use of an alcohol-based evaporative identification technique. The crack was then routed to a depth of between 1 and 1.5 mm (0.04 and 0.06 in.) around the entire perimeter of the prism. A rotary tool with a 1 mm (0.04 in.) diameter head was used to complete the routing. Once inserted into the testing machine, the exposed length of prism between the grip faces was approximately 25 mm (1 in.). Figure 32 shows this test specimen immediately prior to the initiation of testing and Figure 33 shows the crack which was routed for this test.
