**TRAIN-TO-TRAIN IMPACT TEST:  
ANALYSIS OF STRUCTURAL MEASUREMENTS**

**ABSTRACT**

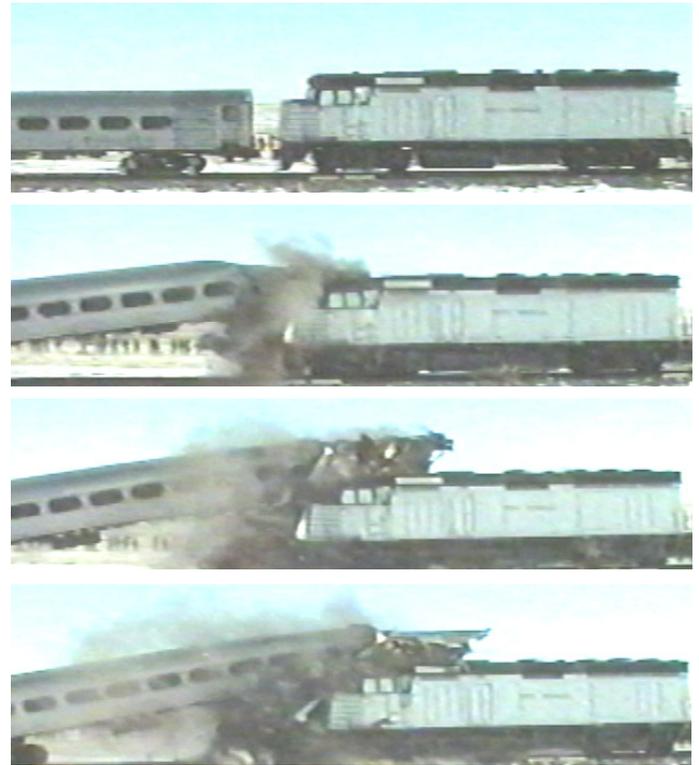
The entire duration of the test, from initial impact until both trains stopped, was ~9.6 seconds. Immediately after the initial impact, the cab car led train began to slow down, while the locomotive-led train began to move. After ~0.2 seconds, the underframe of the cab car had crushed by ~6 feet, about the same as the maximum cab car crush observed in the single-car and two-car tests [12, 15]. After ~0.3 seconds, both axles of the lead truck of the cab car were off the track, and after ~0.5 seconds the lead truck separated from the cab car. The

cab car underframe overrode the locomotive short hood and impacted the window structure of the locomotive after ~0.7 seconds, and finally rode up onto the roof of the locomotive cab after ~1 second. By ~1.2 seconds, the cab car underframe had crushed by ~22 feet. Eventually, just more than ~2 seconds after initial contact of the cab car and locomotive, both trains were moving at the same speed, ~15 mph. Subsequently, the cab car led train began to slow down at a greater rate than the locomotive-led train, and the cab car fell off the locomotive and the trains separated approximately ~6.5 seconds after initial contact. Both trains came to a stop ~9.6 seconds after the initial impact. The last frame of Figure 4 shows the cab car at approximately ~1.2 seconds, the time of maximum override.

Figure 4. Override of Locomotive by Cab Car, Observed in Train-to-Train Test

The principal results of the train-to-train test include the loss of occupant volume, the mode of structural deformation and the interaction of the colliding equipment. During the test, the colliding cab car overrode the locomotive. The cab car sustained approximately 22 feet of crush of the underframe. In addition, the cab car started to deflect to its left as it overrode the locomotive. There was relatively little damage to the colliding locomotive, with a modest amount of crush of the windshield. A portion of the cab car roof penetrated the locomotive through the windshield on the conductor’s side. There was essentially no damage to the three coach cars and locomotive trailing the impacted cab car, or to the two ballasted freight cars trailing the impacted locomotive. Figure 4 shows the interaction of the colliding cab car and locomotive in a series of frames taken from high-speed video recorded during the test.

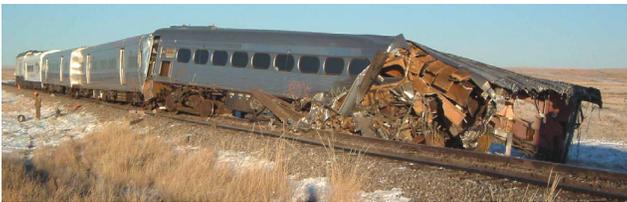
After the impact, there was approximately 22 feet of crush of the underframe and right sidewall of the cab car. Most of the roof and the left side wall of the cab car remained. The end frame of the car was pushed underneath, and ended up near the center of the car. The lead truck separated from the cab car during the impact, and after the impact was beside the remaining left sidewall at the crushed end of the cab car. The coupler and draft gear from the lead end of the cab car ended up underneath the lead axle of the lead truck of the first coach car. Figure 6 shows the cab car led consist immediately after the test.

Figure 6. Cab Car-led Consist from Train-to-Train Test, After Test

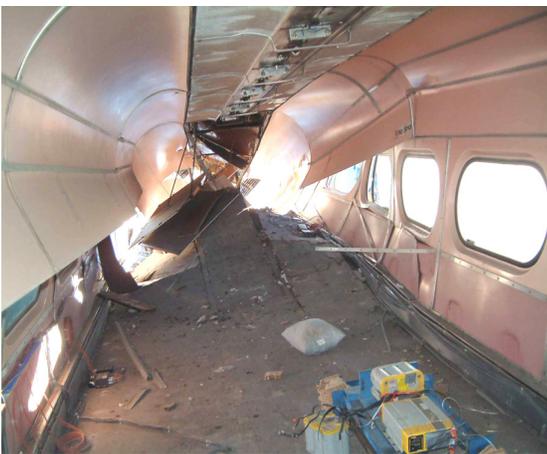
During the test, the space for the operator's seat and for approximately ten rows of passenger seats was lost. In total, seating for approximately 47 passengers and one crew was crushed during the test. Figure 7 shows a view of the crushed end of the cab car from the interior. The floor pushed upward, owing to the end crush of the cab car; interior wall and roof panels broke loose and intruded into the occupant space. Seats are presumed lost in the area where the floor is pushed up and the roof is coming down.

Figure 7. Interior of Cab Car, Looking Toward Crushed End

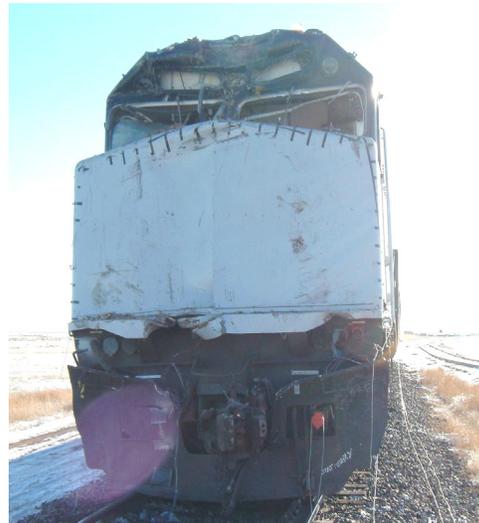
The impacted locomotive sustained a relatively small amount of damage. The coupler was pushed to the left and the left side and bottom of the bellmouth were broken. The short skirt on the underside of the anti-climber was dented on the right side, although the anti-climber itself remained essentially intact. There were a number of small dents in the front face of the short hood, especially near the top-center. The center pillar of the windshield was pushed back, and the conductor's side window was pushed into the operator's cab. The operator's side window remained partially in its frame. The windshield panes each remained as a single sheet, but were heavily crazed with substantial amounts of spall. The conductor's side pane was pushed into the cab by a portion of the cab car roof. The roof was dented above the center pillar of the windshield. Figure 8 shows the short hood end of the impacted locomotive after the test.

Figure 8. Impacted Locomotive, After Test

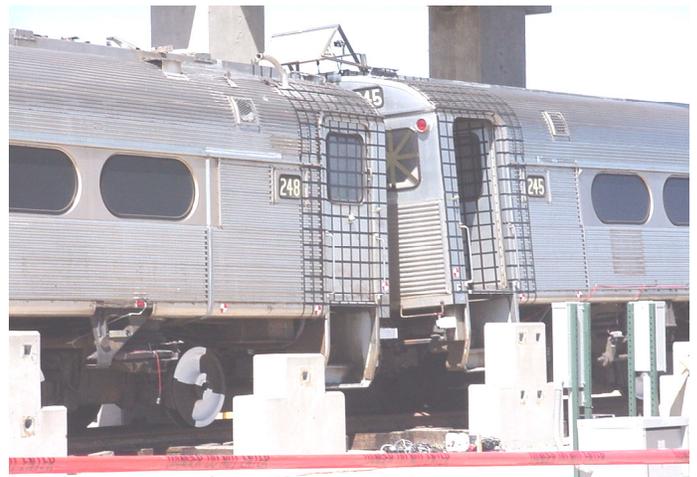
During the two-car test, the cars remained coupled, but buckled in a saw-tooth mode [15, 25, 26]. This buckling is due to the linkage behavior of the couplers used on North American passenger equipment. These couplers form a rigid link between cars; when there is a high longitudinal load present, with only a small perturbation, the link formed by the couplers pushes laterally on the ends of the cars. As a result, the ends of the cars are laterally offset from each other when they contact. The maximum lateral displacement between the cars during the collision was approximately 30 inches. The final lateral displacement was 15 inches. The left rail rolled under the lateral load from the front truck of the trailing car, allowing the right wheels of the front truck of the trailing car to drop. Figure A-2 shows the coupled connection between the two cars at their final lateral displacement.

Figure A- 2. Sawtooth Lateral Buckling of Coupled Cars Observed in Two-Car Test

Once the cars are misaligned, the high longitudinal force acting on one car exerts a significant lateral component on an adjacent car. Consequently, the train will continue to buckle out into a large-displacement pattern if there is sufficient energy from the collision. Depending on the severity, this mode may progress until the cars have side-to-side impacts. Sawtooth buckling, large-displacement buckling, and side-to-side impacts due to large-displacement buckling have been observed in accidents [27, 28]. The progression of the cars from in-line, to the sawtooth lateral buckling pattern, then to the large amplitude pattern has been simulated [4] with computational models.

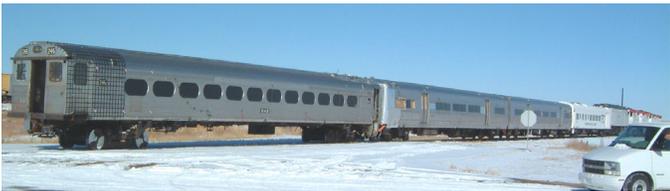
The cab car-led train was made up of a Budd Pioneer cab car, two Budd M1 cars, the T7 track geometry-measuring car, built by St. Louis Car, and a GM/EMD F-40ph. The locomotive-led train was made up of a GM/EMD F-40ph, and two ballasted open-top hopper cars. It had been originally planned to use four M1 cars in the initially moving consist, and not use the T7 car. T7 was substituted for two M1 cars because of difficulties in shipping the M1 cars from Long Island Railroad to TTC. As used in the test, the T7 car weighs nearly as much as two M1 cars. Figure B-1 shows the initially moving cab car-led train just prior to the test.

Figure B-1. Cab Car-led Consist from Train-to-Train Test, Prior to Test

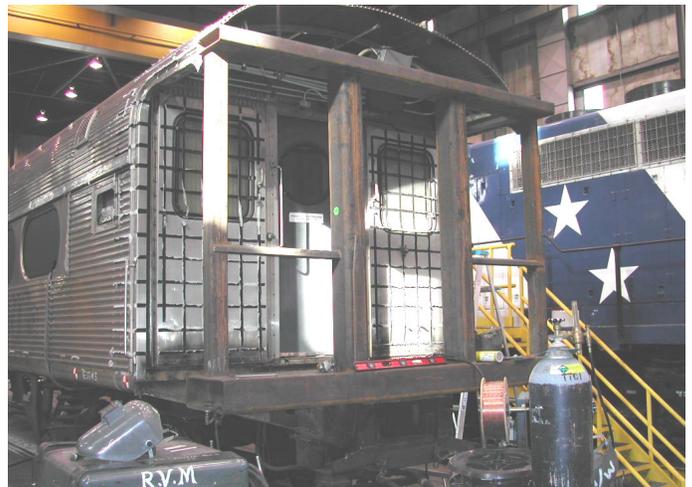
The end structure of the cab car was modified to comply with standards in place prior to 1999. A new end structure, consisting of corner posts, collision posts, an end beam and an anti-telescoping plate was fabricated and attached to the draft sill and roof plates. The design of the end structure was developed as part of the fullscale test program. (A report describing the design in detail is currently being written.) A photograph of the end structure is shown in Figure B-2. The front skin was attached to the end structure prior to the test.

Figure B-2. Modified Cab Car End Frame

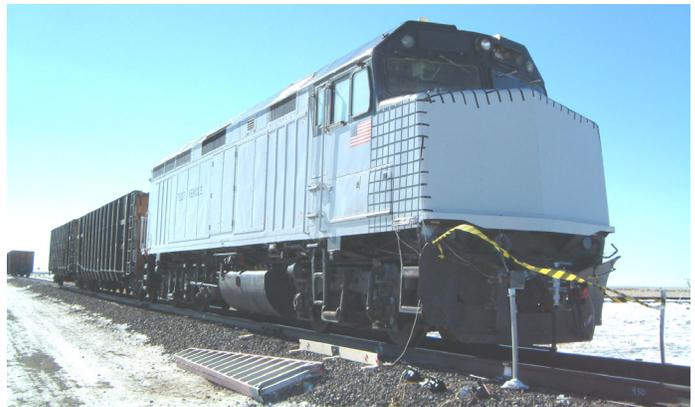
The end structure of the locomotive was modified to comply with the current AAR S-580. The collision posts and front sheet of the short hood were replaced. The locomotive structural design was adapted from the design for locomotives supplied to the Metra commuter railroad provided by GM/EMD. The new front sheet did not include details such as cutouts for lights. Figure B-3 shows the impacting locomotive the test track shortly before the test, along with the two ballasted open-top hopper cars.

Figure B-3. Locomotive-led Consist from Train-to-Train Test, Prior to Impact
