Publication No. FHWA-RD-93-104

Testing of Small and Large Sign Support Systems FOIL Test Number: 92F016

U.S. Department of Transportation
Federal Highway Administration

Research and Development
Turner-Fairbank Highway Research Center
6300 Georgetown Pike
McLean, Virginia 22101-2296

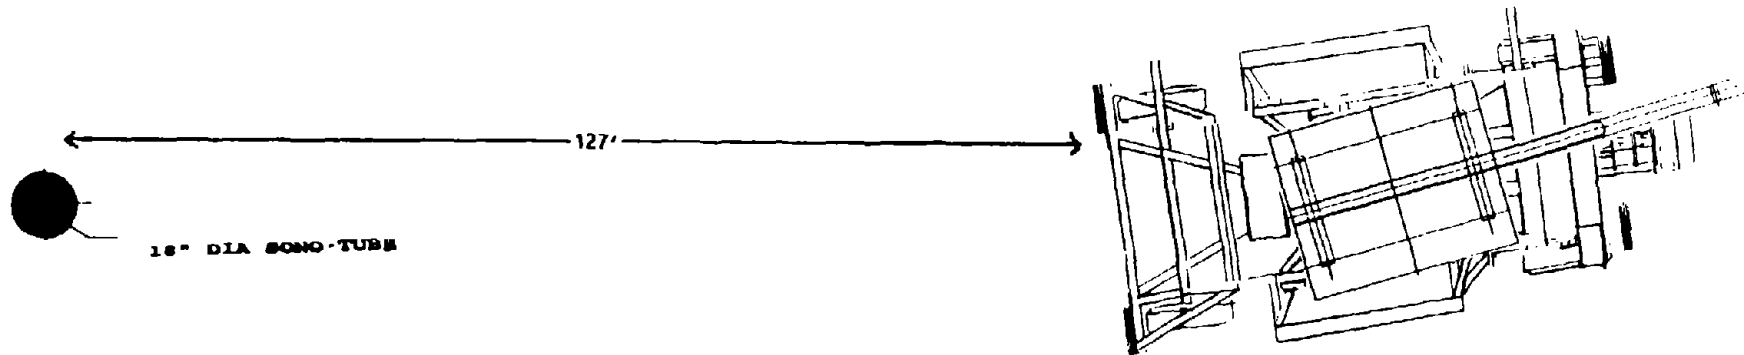
Figure 4. Summary of test 92F016.

Test number..... 92F016
 Date..... June 23, 1992
 Test vehicle..... FOIL Bogie
 Vehicle weight..... 1850 lb (839 kg)
 Test article..... Small Sign Support
 Material..... 5 inch diameter wood
 Embedment depth..... 3.5 feet
 Panel type..... 4 foot by 5 foot alum. sheet
 Height..... 12 feet
 Foundation..... 18 inch dia. soilcrete footer in S-2 Weak Soil
 Impact speed..... 31.1 ft/s (9.5 m/s)
 Impact angle..... 0 degrees
 Impact location..... Head-on, centerline

Vehicle analysis:	<u>Observed</u>	<u>Design/Limit</u>
Longitudinal:		
Occupant Delta V at 2 ft.....	5.3 ft/s	≤16 ft/s
Ridedown Acceleration.....	0.9 g's	15/20 g's
Lateral:		
Occupant Delta V at 1 ft.....	no contact	no spec
Ridedown Acceleration.....	no contact	no spec
Peak 50 msec acceleration		
Longitudinal.....		2.6 g's
Lateral.....		NA
Vehicle Damage (TAD)..... NA		
(VDI)..... NA		
Honeycomb crush.....		8.7 inches
Vehicle velocity change.....		7.2 ft/s
Exit angle.....		0 degrees
