Cascade Lakes Highway Corridor and Bicycle Facilities Study

November 2019

Prepared By Western Federal Lands Highway Division
for Deschutes County and Deschutes National Forest

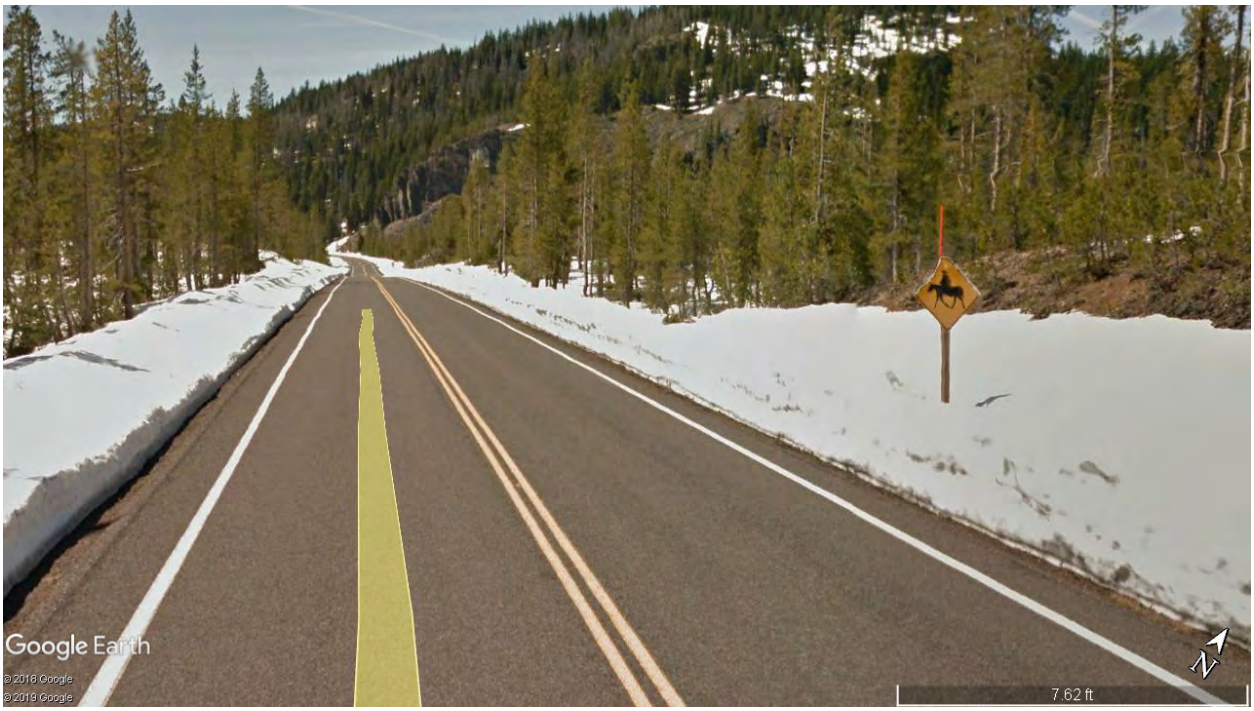
Figure 25 - Horse Warning Sign East of Todd Lake Intersection, Looking West

To the east of the intersection, a warning sign for equestrian use is shown in Google Earth for the eastbound direction.

East of this sign, there is another equestrian warning sign for the westbound direction. This indicates a regular crossing may occur in between the two signs. There are no known issues with crossings in this area. CLH is on a tangent through here with apparent adequate stopping sight distance.

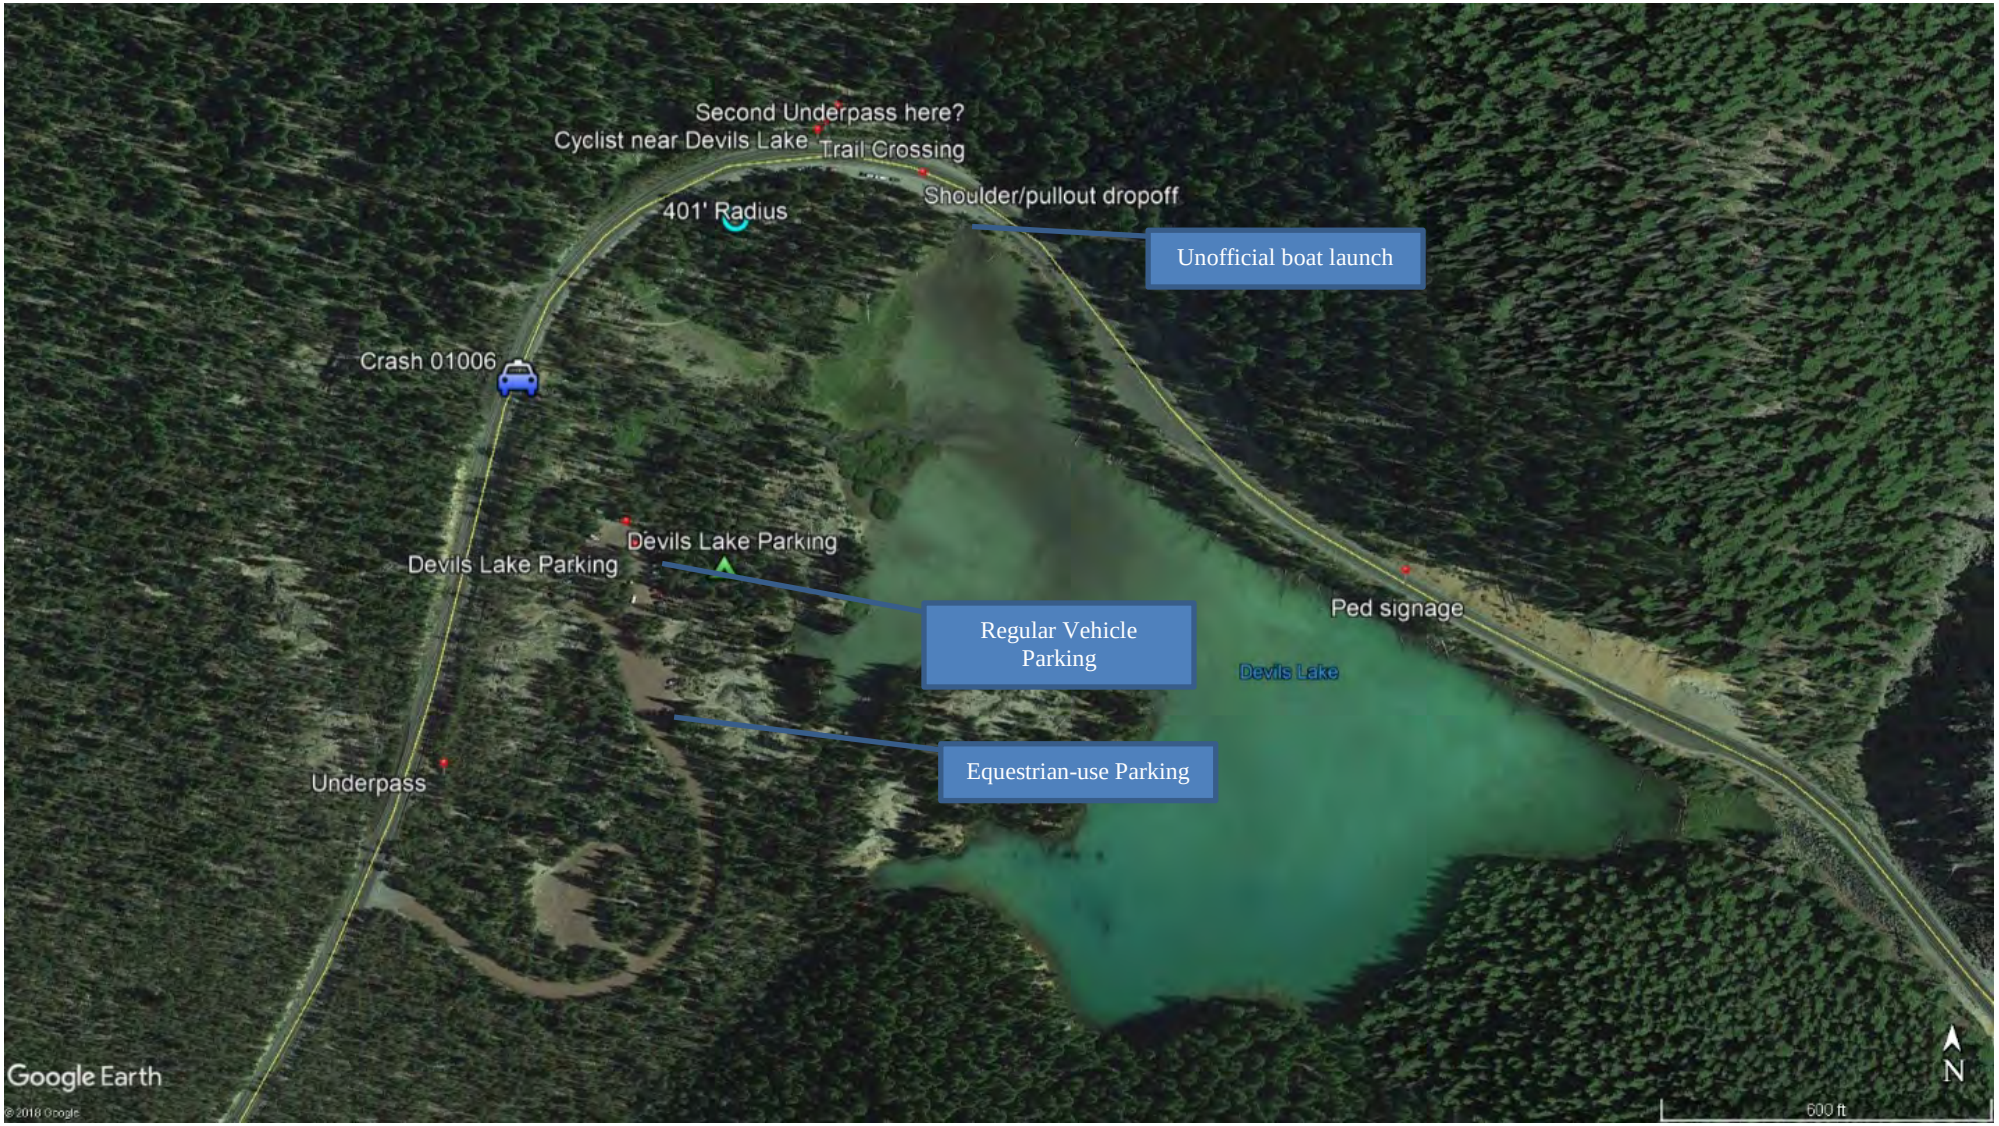
Figure 30 - Devils Lake Overview

This parking lot and trailhead area is a launch point for the South Sister hike and other trails. Recreation also occurs in and near Devils Lake, with a unofficial boat launch point within the gravel turnout on the inside of the horizontal curve along CLH.

According to the Forest Service, on Saturday, September 8, the parking lot was full by 8:00am. At 3:15pm, the total of parked vehicles was 295, of which 96 vehicles were parked on the CLH and 199 in the parking lot.

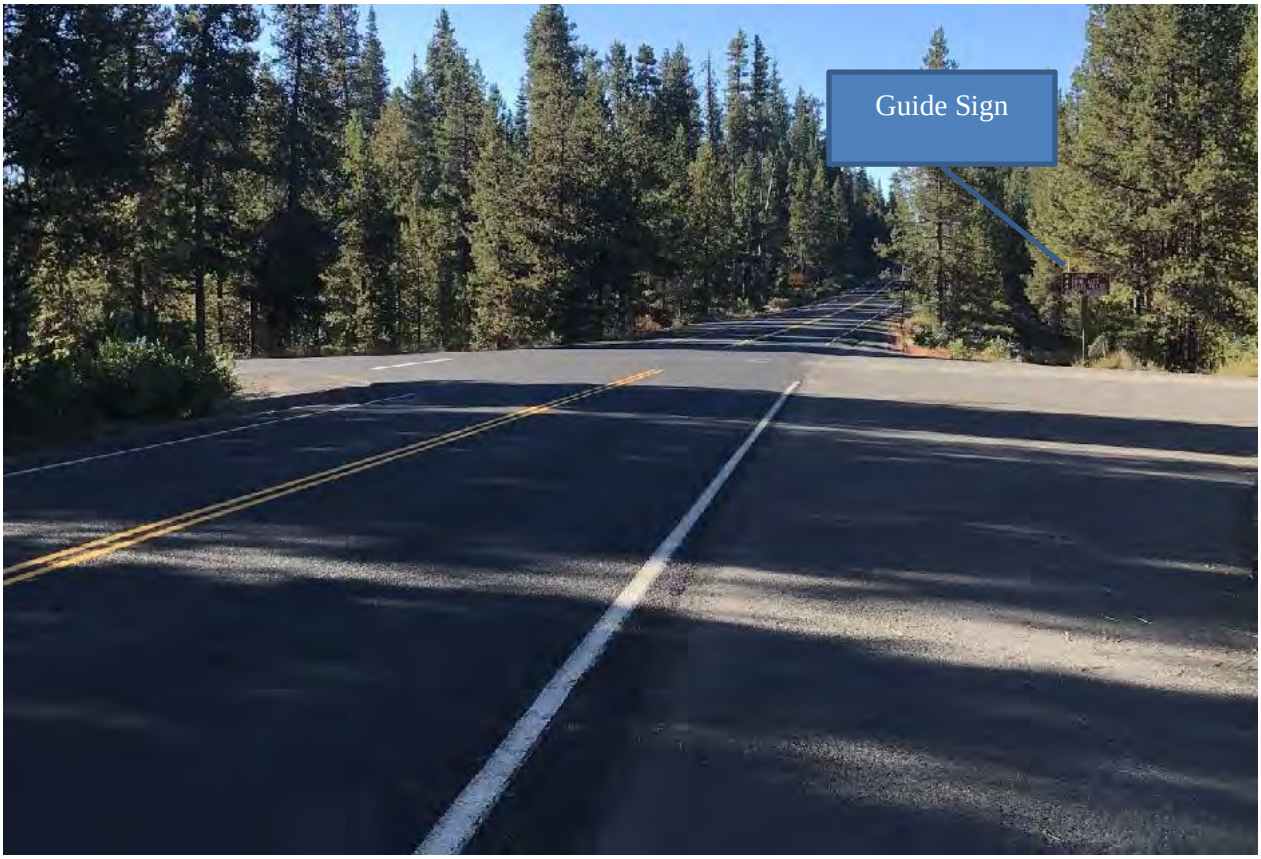
Figure 59 - Intersection with S. Century Dr., North Approach (Approx. 140' north of intersection), Looking South

Approaching the intersection from the north, the first guide sign is located right at the intersection so it is easy to miss or requires a motorist to slow down from 55+mph in order to read the details.

There is an existing widened area to pullout here if a motorist is unfamiliar with the geography but this sign could be missed or lead to safety concerns with motorists slowing down in the roadway to read signs.

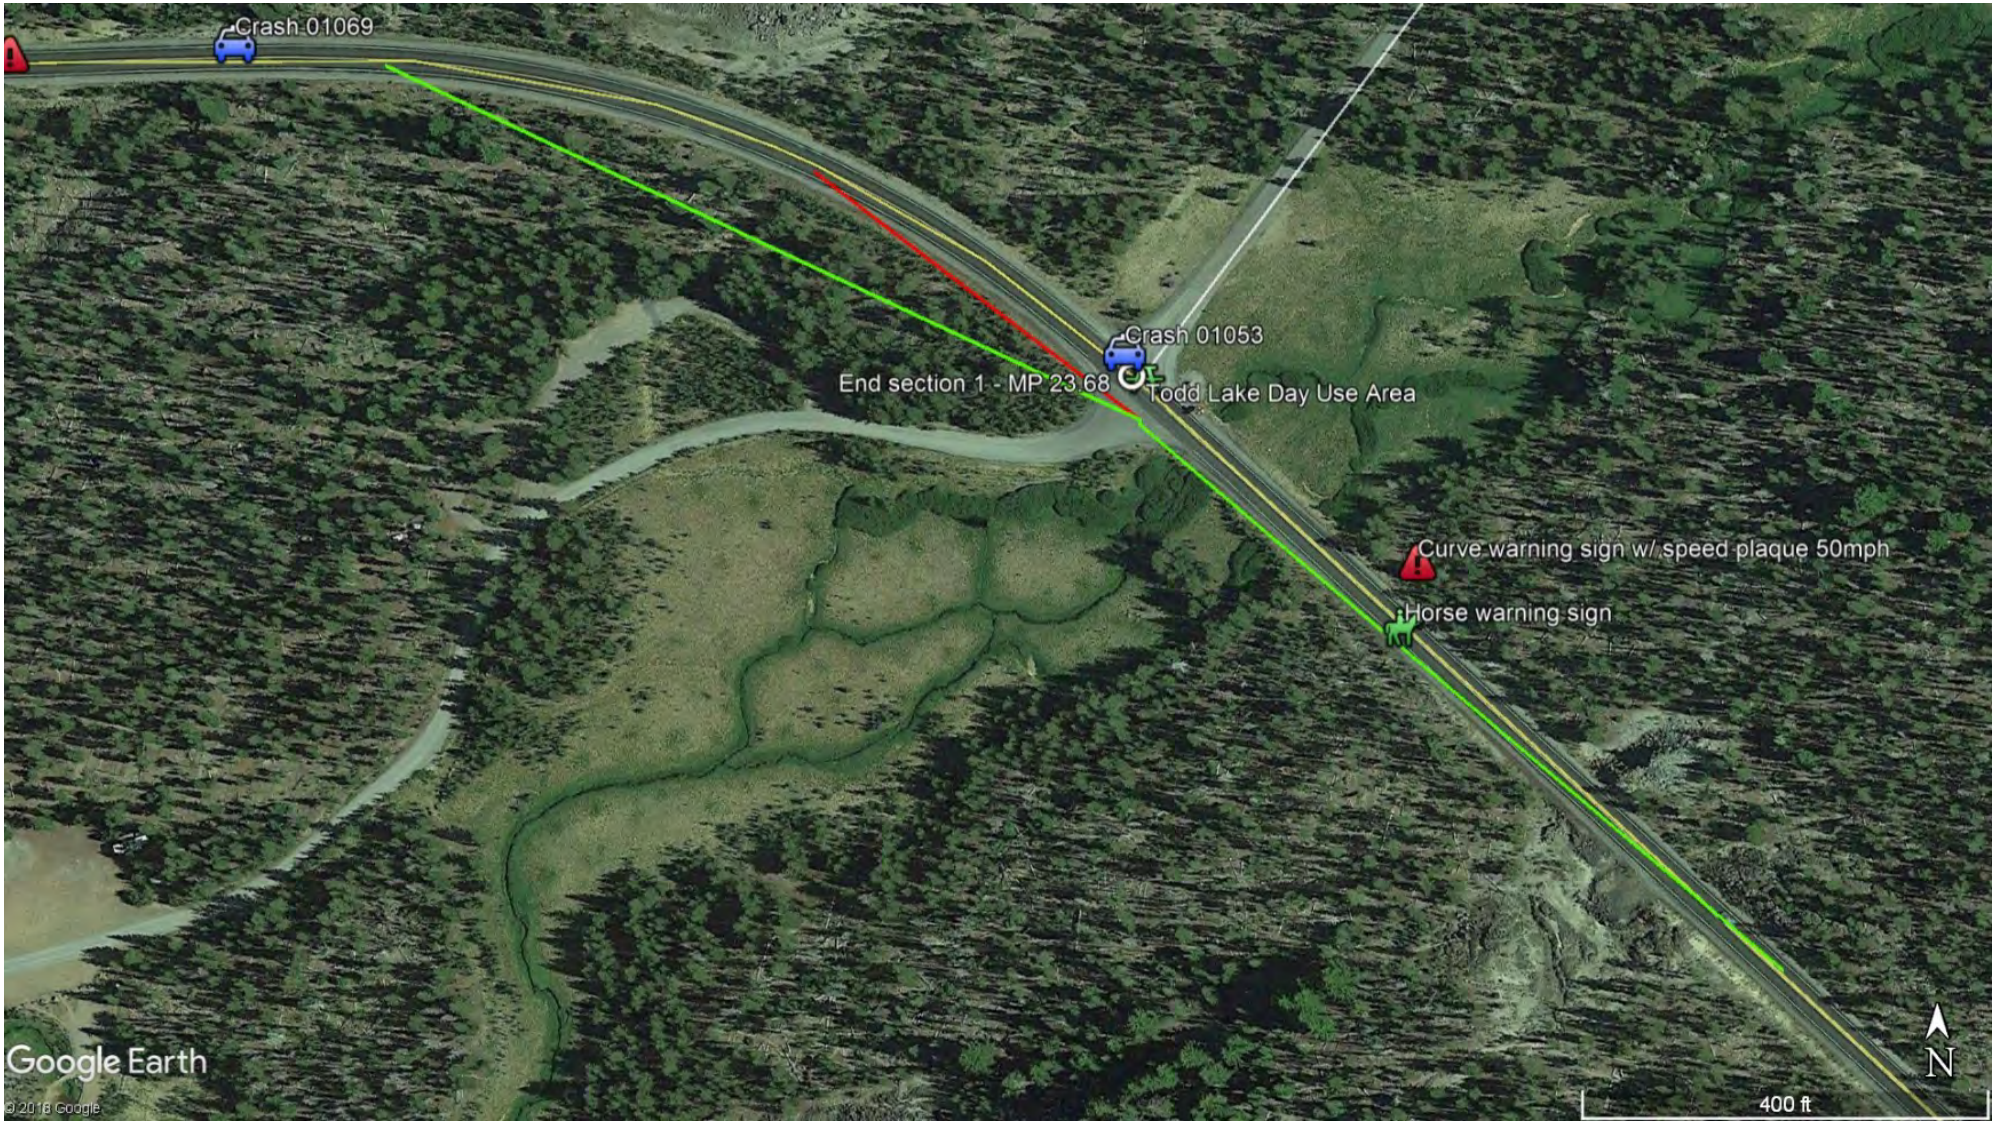
Figure 68 - Todd Lake ISD Improvements

The Todd Lake intersection is near the end of a horizontal curve to the west. Figure 23 and Figure 24 show the reduced intersection sight distance due to vegetation and trees growing along the roadside. Removing these trees and vegetation to establish clear sight triangles is recommended. There is no official speed data at this time for CLH, but based on anecdotal evidence from LEOs, using a design speed of 60mph is recommended rather than the 55mph basic rule speed. Chapter 9.5 in the Green Book gives criteria for intersection sight distance for various scenarios. For the Todd Lake intersection, Case B1 is the controlling case for vehicles making turns out of either approach road. Table 9-5 gives time gap values used to calculate the recommended intersection sight distance (ISD). The traffic mix along CLH is generally passenger cars (and pickup trucks) but there are significant amounts of vehicles pulling trailers especially at some locations like the equestrian area on the south approach of the Todd Lake intersection. Vehicles pulling trailers require more time to pull out of the approach and into their respective lane along mainline. Due to a high use of vehicles pulling trailers at this intersection, the “Single-unit truck” time gap value of 9.5 seconds is used to approximate this effect. The calculation from equation 9-1 gives an ISD of 838’, rounded to 840’ for design. Figure 66 shows the existing ISD to the west in red and the theoretical ISD in green (840’).

It can be seen that substantial clearing would be needed to the west of the intersection. Some of this clearing would need to occur outside of the assumed 50’ easement from centerline of CLH. If this is not possible, it is recommended to clear as much as possible to improve ISD to the maximum extent practical. Adding warning signs as noted below is recommended in either case.

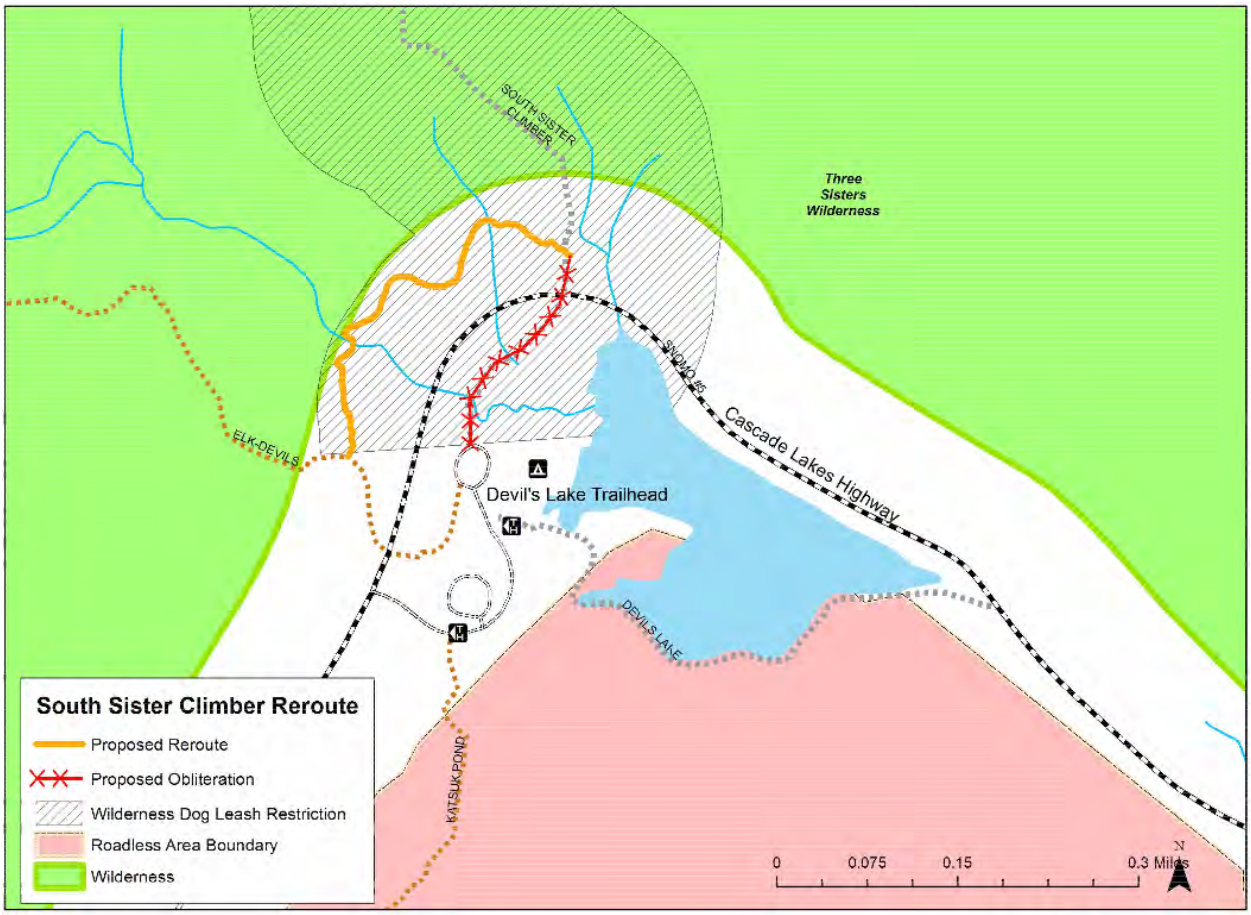
Figure 72 - Deschutes National Forest South Sister Climber Trail Reroute Proposal [18]

A secondary proposal by the Forest Service at this location is the trail reroute of the South Sisters Climber Trail #36 to start and coincide with the Elk Devils Trail #12 before branching off to be rejoined with the rest of the South Sisters Trail. This means that the South Sisters Trail would no longer officially cross the CLH and would instead share the underpass on the Elk Devils Trail #12. Assuming this proposal proceeds to completion, this will also significantly improve the safety of hikers and pedestrians in this area. Trail users can then park in the Devils Lake parking lot and cross under CLH to access either trail.

While the proposed Wilderness Area strategies will likely nearly eliminate parking along CLH to access the trails as well as pedestrians crossing across the highway, there is still a chance that trail users will inadvertently or deliberately park along CLH to access the trails based on previous experience or a desire to park as close to the trails as possible. There is still a chance that there will be pedestrian crossings as well with the large turnout located on the inside of the curve, etc. The team offers strategies to reduce this likelihood.
