**Urban Mass
Transportation
Administration**

Bill Handling Problems in Bus Fare Collection

Prepared by:
Custom Engineering, Inc.
Englewood CO 80110

October 1982

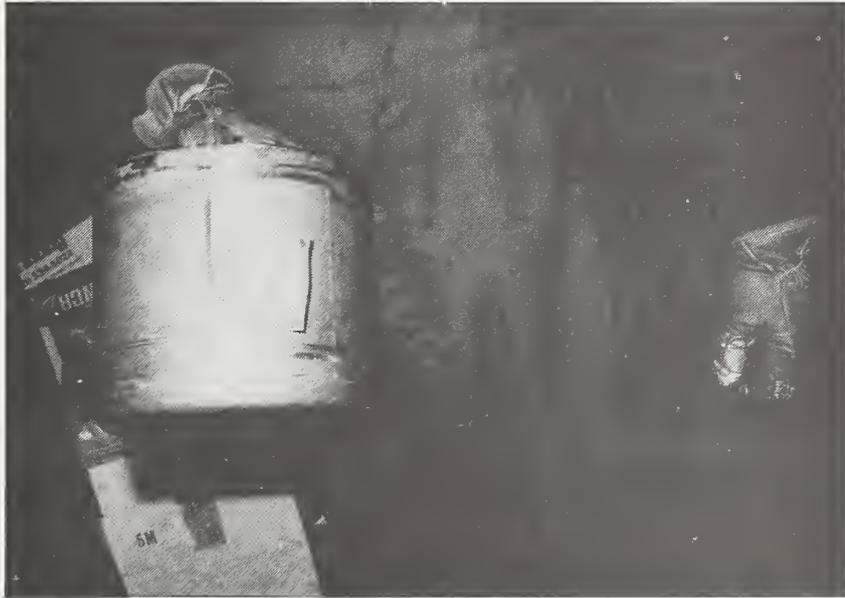
FIGURE 4A

Typical problems caused by bills are shown in Figure 4. It is not unusual for one or more bills to be exposed as shown in Figure 4A. This happens due to the gap between the inner vault wall and the sliding door being greater than the thickness of a dollar bill. If the bills are completely flat, as shown, they may get torn, or they may not end up in the properties account. If the entrapped bill(s) are folded, as shown in Figure 11A, a jam is likely to occur, resulting in the bus being pulled from service.

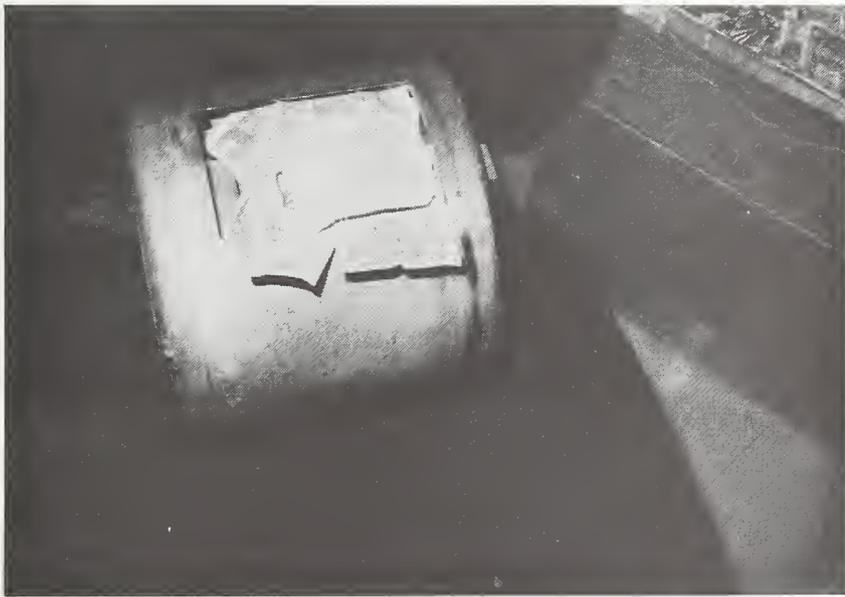
FIGURE 4B

A second problem associated with farebox vaults that do not stack the bills, is shown in Figure 4B. The bills fall into the vault in a random fashion, as shown. If the fare structure is such that the fare consists of many bills and lightweight coins (pennies, nickels or dimes), one or more coins can slide along the bills to the outside of the vault and wedge between the sliding vault door and the inner wall of the vault. Coins can also jam between the outer vault wall and the farebox receiver when an attempt is made to close the vault door to remove it from the farebox (Figure 2A). This can make it impossible to remove the vault from the farebox by hand. Hence, a bus is pulled from service. Even if the vault is removed, a jam is possible when trying to empty it in the fare collection vault (Figure 2C). The reason for this jam possibility is the same as for the previous case; a light coin sliding across a bill due to the motion during vault transfer from the farebox to the fare collection vault.

EFFECTS OF BILLS IN FAREBOX VAULTS

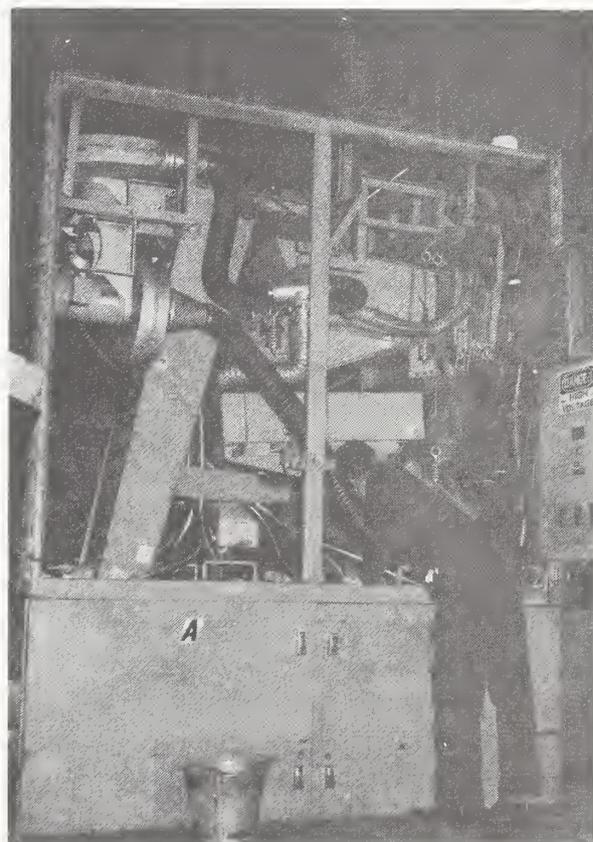
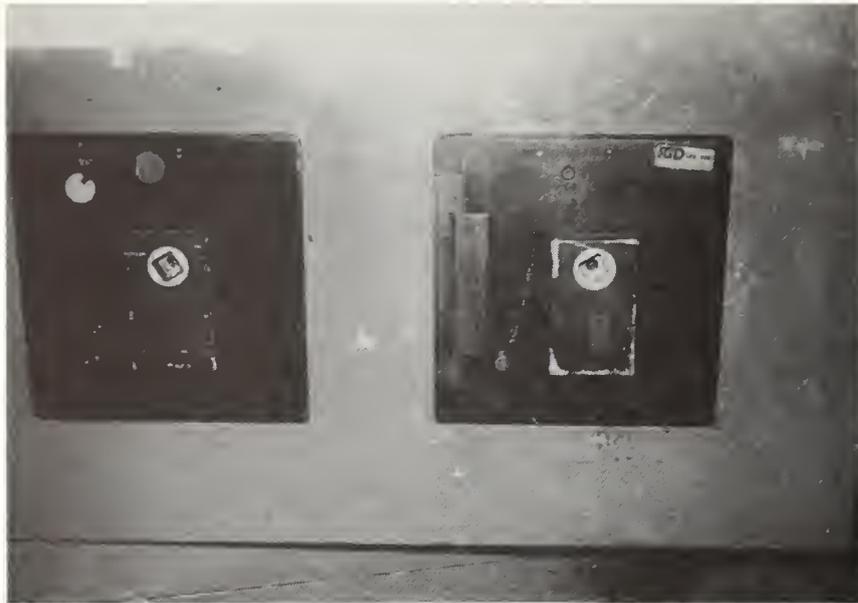
FIGURE 6

There are automated money separating machines on the market. The ones used by the RTD are shown in Figure 6. The particular ones they use have two vault openers, each individually keyed, on the left side of the machine as shown in Figure 6A. These door-mounted openers are shown in Figure 7. When the vault door opens it drops the money (bills, coins, and tokens) onto a moving, double-belt, money transport system on the left of the machine in Figure 6B. The money is raised to the top of the machine and deposited onto a horizontal moving belt at the top of the machine. As the money reaches the right side of the machine, the bills are "blown" off by a blower/vacuum system. This carries them to a bill bin in the bottom of the machine. The coins are deposited onto the vibrating coin sorting grid shown in Figure 8A. These grids have a slight angle to them. Hence, when a coin reaches the proper grid, it is transported to the low end of the grid and into the tube that transports it to a separate bin in the bottom of the machine. Some of the problems with the machine are shown in Figure 8. Under a heavy load of bills, not all are "blown" off at the proper point, resulting in bills riding on top of the coin grid as shown in Figure 8A. These bills block the coin sorting tubes causing bills and coins to backup along the grid. Eventually they overflow the sides of the grid and fall to the interior ledge over the money bins. This is shown in Figures 8B and 8C. This money must be retrieved manually and put back into the process or separately transported to the money room. On the day we observed the process, over $200 in bills were removed from this interior ledge.

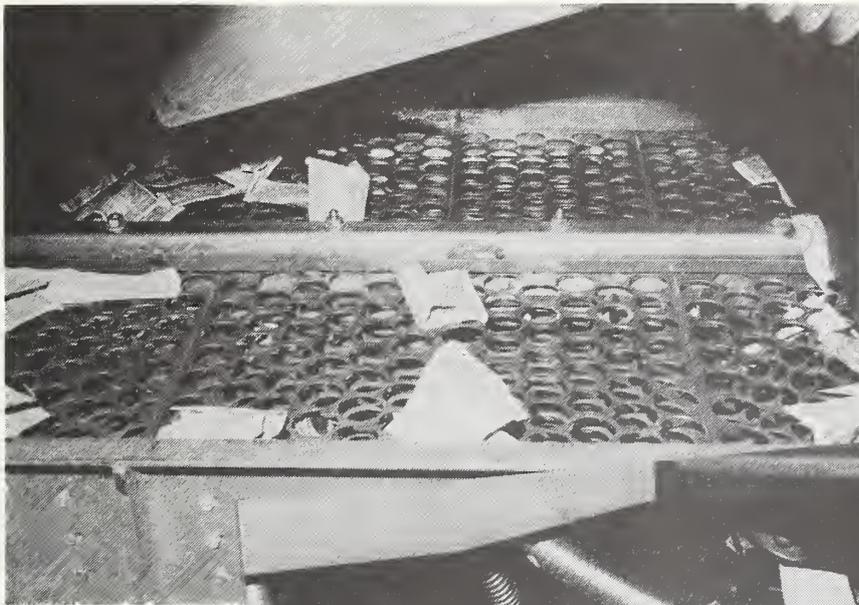
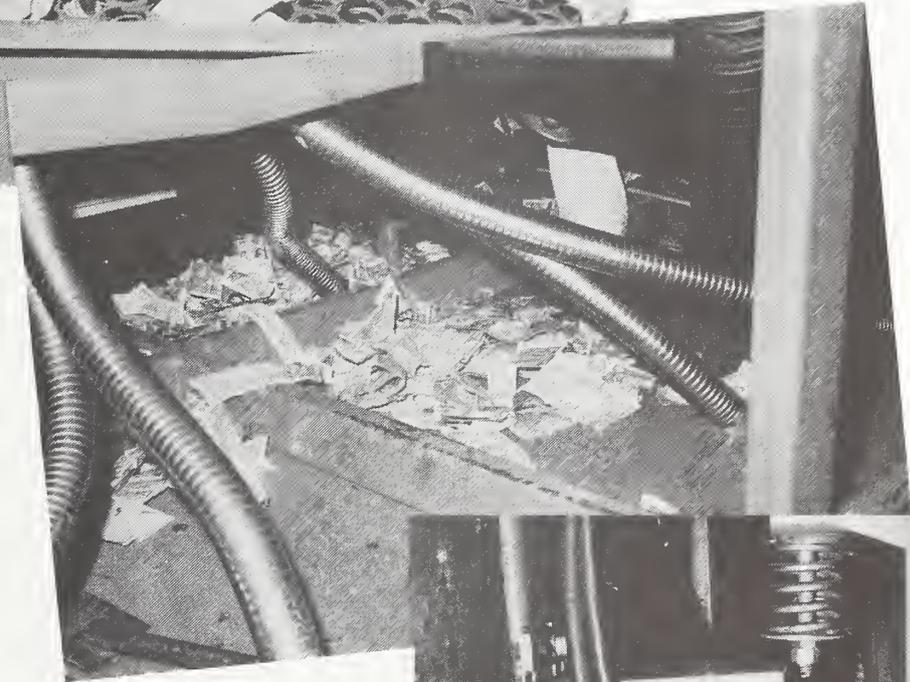
FIGURE 8

Further, elimination of the bills from the coin sorting machine (Figure 8) not only increases productivity in bill handling, but increases coin handling productivity. Whether or not the increase in money handling productivity would be the order of magnitude necessary to pay for the present higher costs of bill accepting electronic registering fareboxes is speculative; that it would provide a major increase in productivity is self-evident.

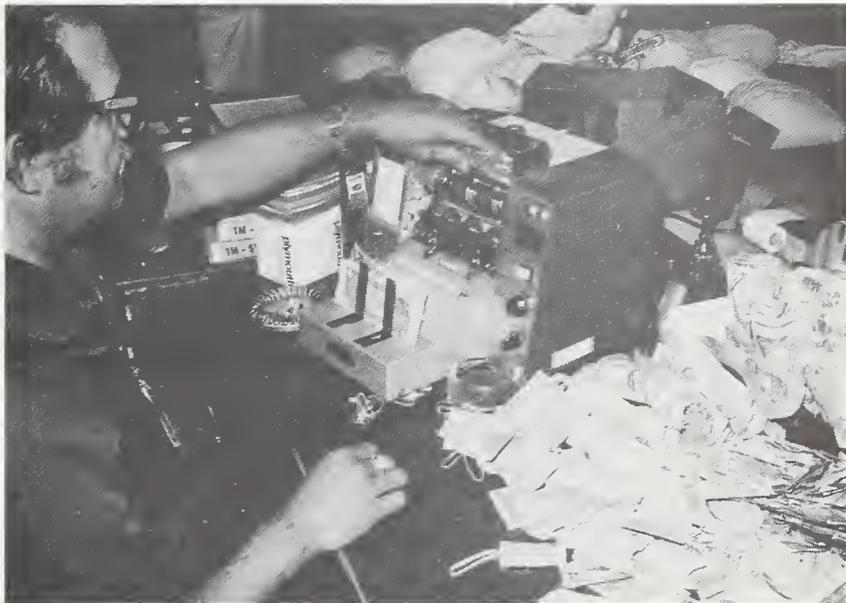
FIGURE 10A

The 640 bills handled per person per hour, reported earlier, is significantly higher than that reported by any other property. Having observed their operation, this figure appears reasonable for handling the large pile in Figure 10A, neglecting the hand transfer time shown in the Figures, the time spent unfolding bills and that spent matching torn bills. All are required operations in handling bills. Hence, it is believed the other properties' data is more representative of the cost of handling dollar bills.

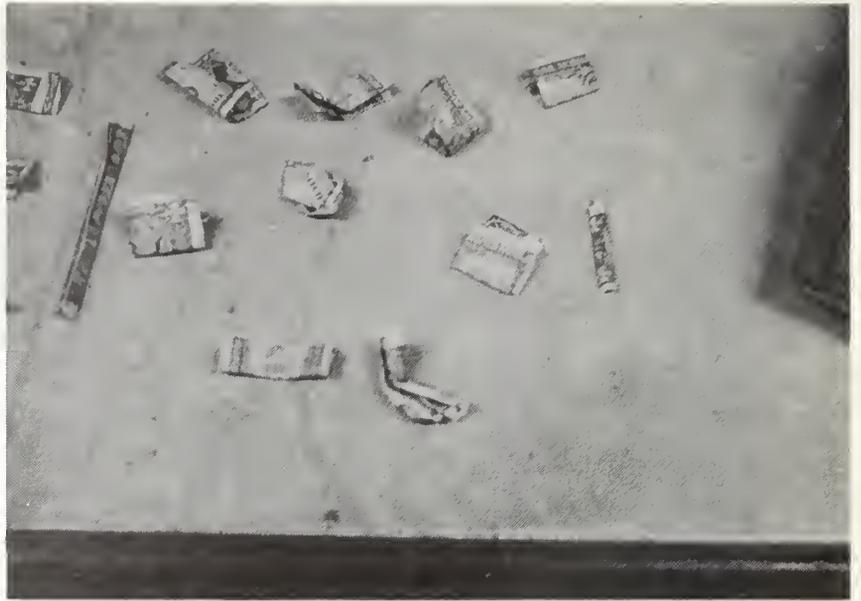
FIGURE 11A

While waiting for the bus, they fold, twist and manipulate the bill they are planning to use for the fare. If the bills don't jam in the entrance to the farebox, or in passage to the vault, they end up in the money room as shown in Figure 11A.

They must be straightened out, stacked and sorted before being counted. Considering the fact that drivers no longer make change, and that the maximum fare is $1.75 for inter-city service, the variety of bills shown in Figure 11B is somewhat amazing. It also adds to the bill sorting time. Other factors adding to these costs are the torn bill-matching time and separating out foreign currency implied by Figure 11C.

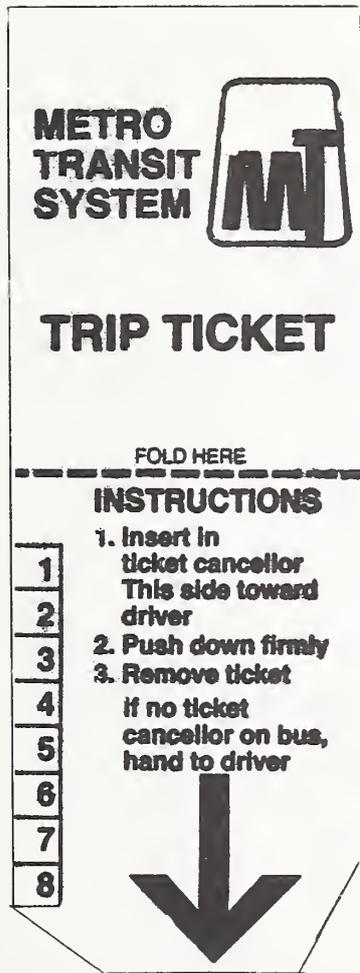
FIGURE 12

SYSTEM PROBLEMS: Two problems are being experienced with the system. One is that movie ticket stubs inserted into the ticket readers can cause jams. The second is a loss of ticket strength when folded, as shown in Figure 12, in order to fit it into a wallet. The loss in strength keeps one from inserting the ticket far enough into the reader to obtain the last valid fare. Moving the fold to a higher position on the ticket solved the problem with the few tickets we tried.

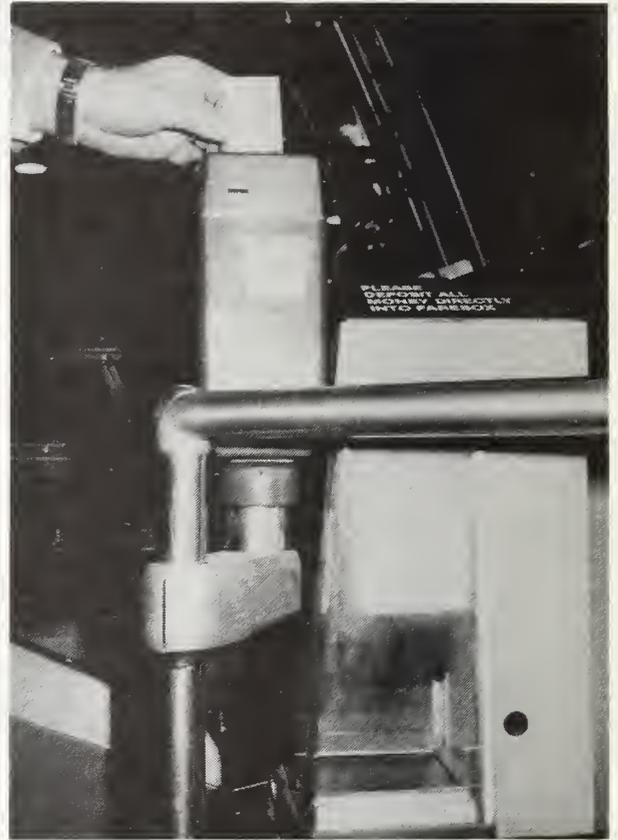
FIGURE 13

The reader/cancellor is a small unit mounted next to the farebox. Mounted on a short tube stub, it is easily removed for maintenance as shown in Figure 14A. In use for sometime in Europe, the particular unit they've installed has proven to be very reliable.

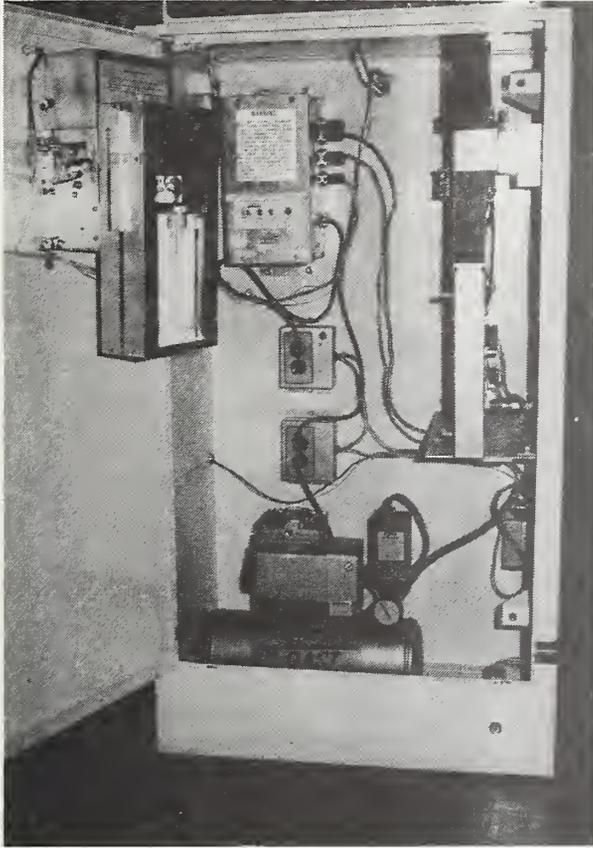
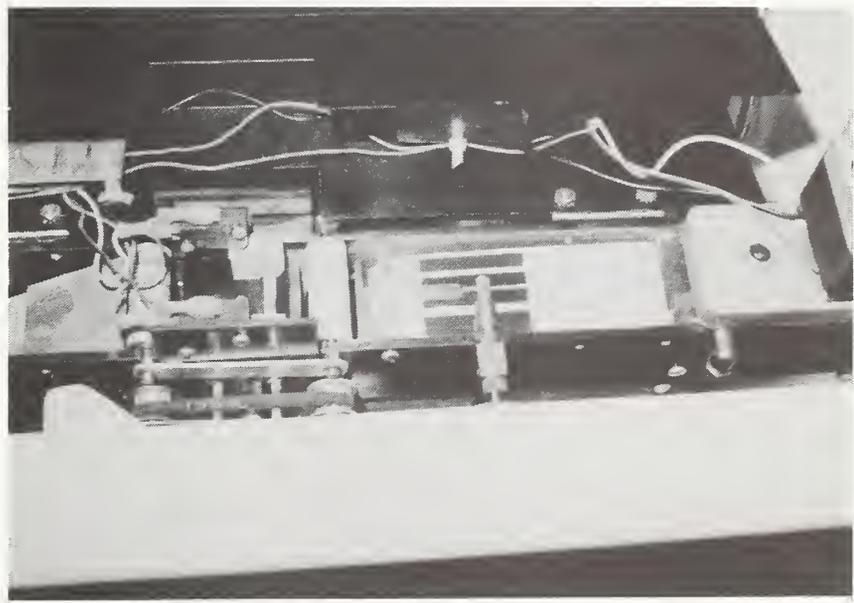
FIGURE 16

The ticket vending machine is a new development for this program. Bills ($5) are inserted into a standard bill reader and stacked on the interior of the machine door (Figure 16A). This activates a set of solenoids that results in two tickets being dispensed; these are good for 16 rides.

Tickets are stacked in a spring-loaded elevator with the top ticket (Figure 16B) being dispensed by a jet of air provided by the compressor on the floor of the machine.

Initial problems with the dispenser, since corrected, involved regulation of the air pressure at a sufficient level to lift the ticket off the stack. They reported no electronic problems.
