THE SHOCK TUNNEL:
HISTORY AND RESULTS

Final Report

SCIENTIFIC SERVICE, INC.

C. Wilton, K. Kaplan, and B.L. Gabrielsen

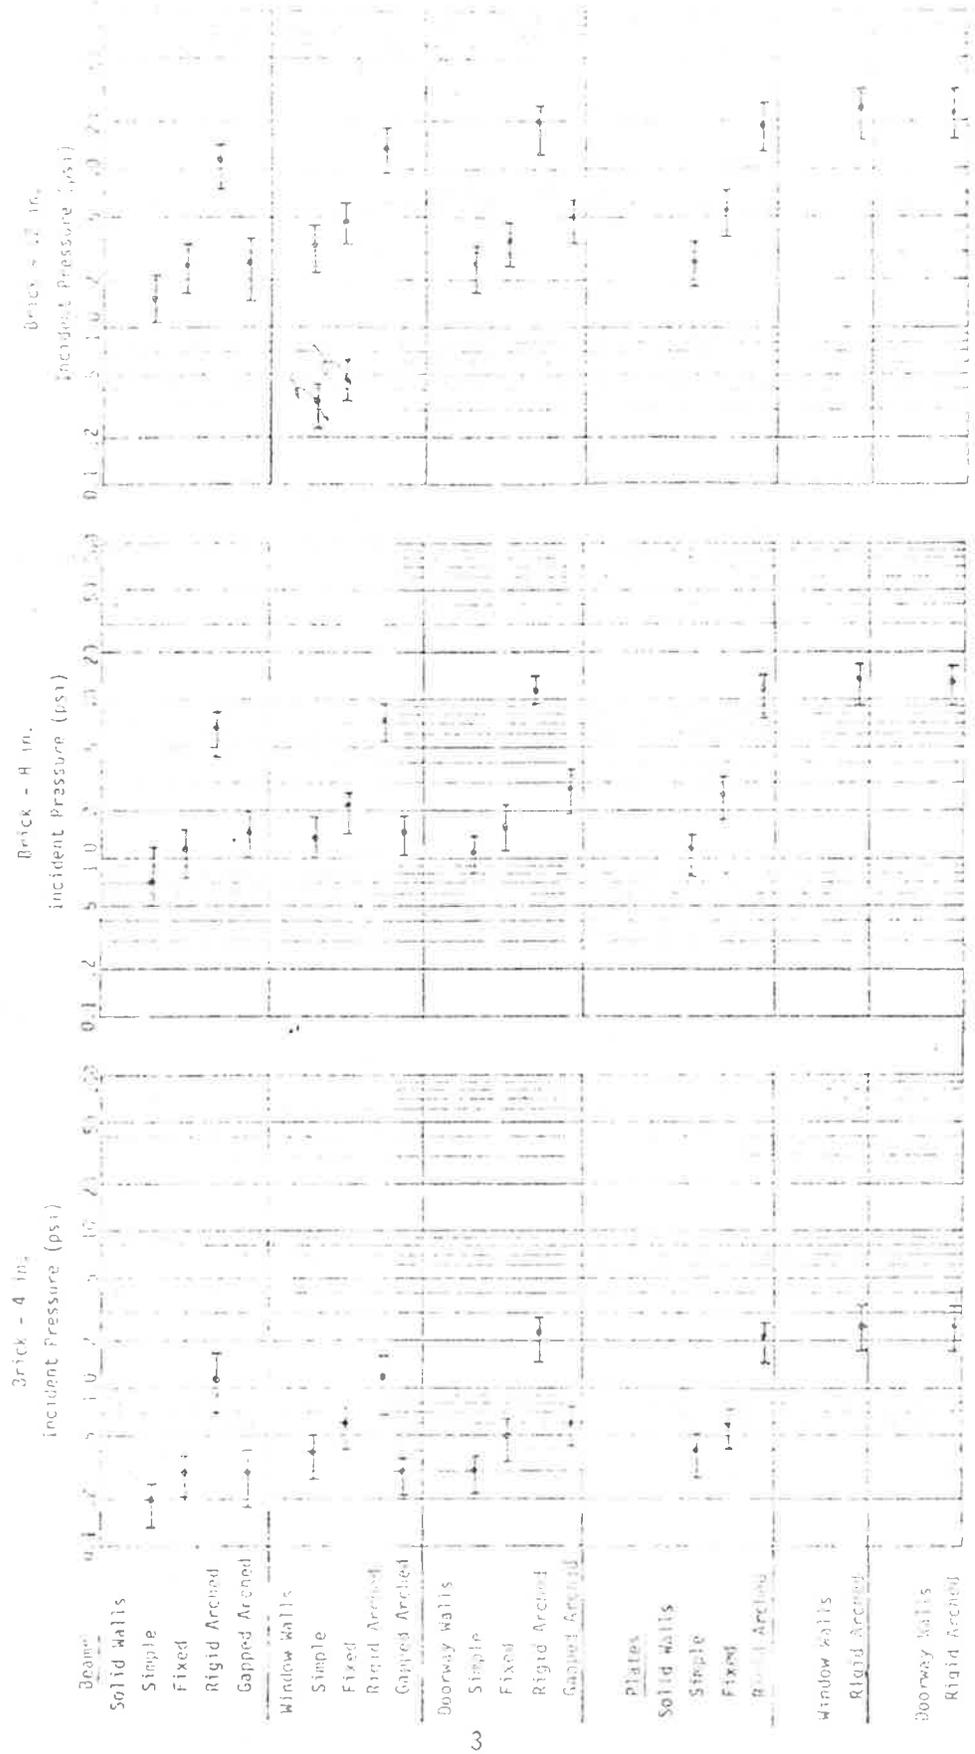
Fig. 1.

One of the most interesting results of this study was to summarize (in Volume 5) all the brick and concrete block wall panel results in a simple failure pressure chart. These are shown in Figs. 1 and 2 of this summary.

FAILURE PRESSURE CHART
Brick Walls

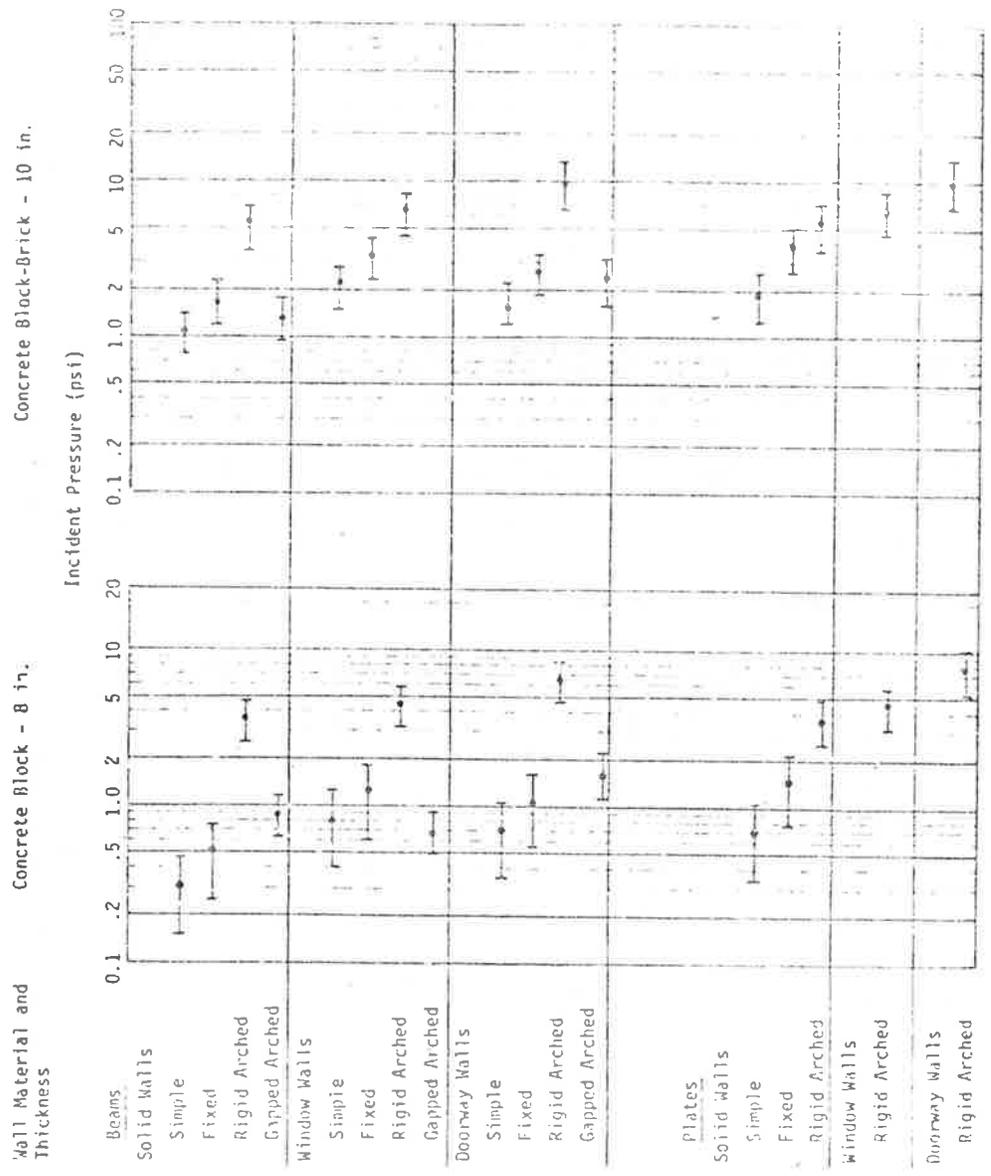
Fig. 2.

FAILURE PRESSURE CHART

Concrete Block and Composite Brick-Concrete Block Walls

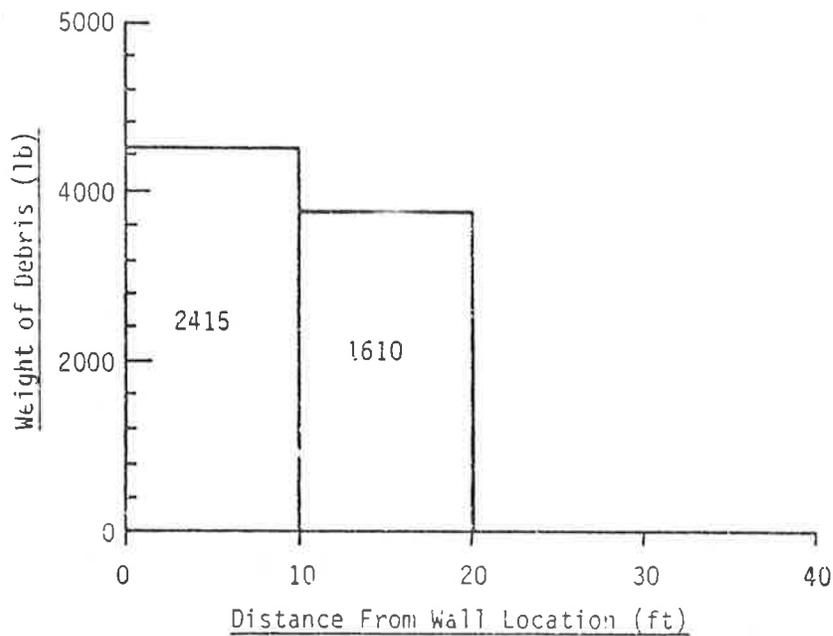
Fig. 2-22. Photograph of Debris, and a Debris Distribution Chart from Tests on 8-in. Thick Brick Walls, Mounted as Simple Beams, and Subject to Blast Loading Pressures of 3.6 psi. The Numbers on the Charts Represent the Weight of the Largest Piece of Debris Found in the Distance Range in lb.

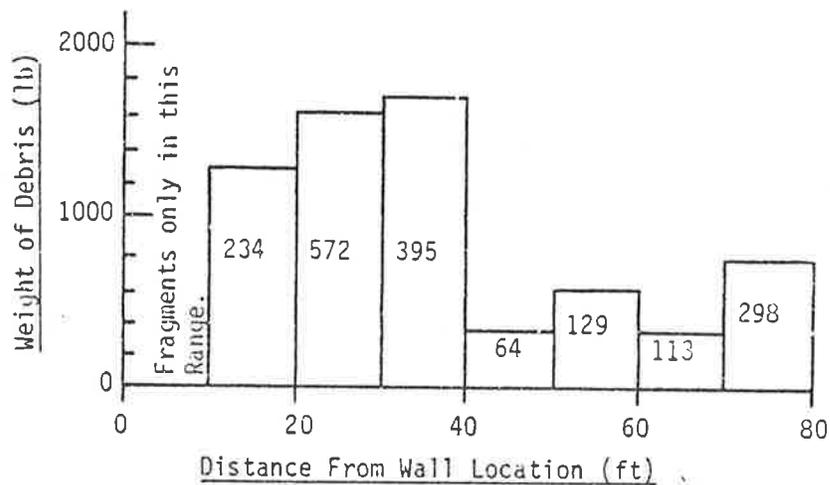
Fig.2-23. Photograph of Debris, and a Debris Distribution Chart from Tests
on 8-in. Thick Brick Walls Mounted as Simple Beams and Subject
to Blast Loading Pressures of 10 psi. The Numbers in each Bar
of the Chart Represent the Weight of the Largest Piece of Debris
Found in the Distance Range in lb.

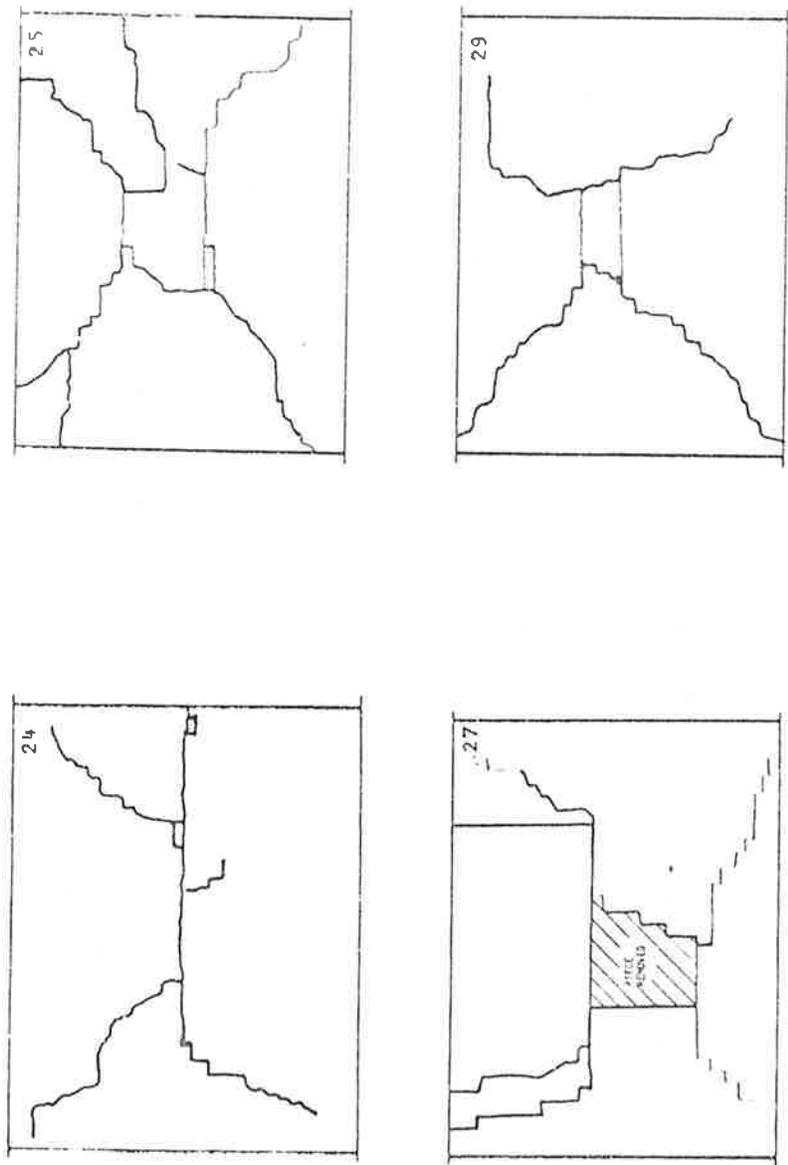
Fig. 5-4. Crack Patterns from Plate-Mounted Solid Walls, Peak Reflected Pressures = 3.2 to 3.8 psi. Walls No. 24, 25, 27, 29.
