FINAL REPORT

EVALUATION OF NONDESTRUCTIVE EVALUATION METHODS FOR APPLICATION IN EARLY DETECTION OF DETERIORATION IN CONCRETE PAVEMENTS

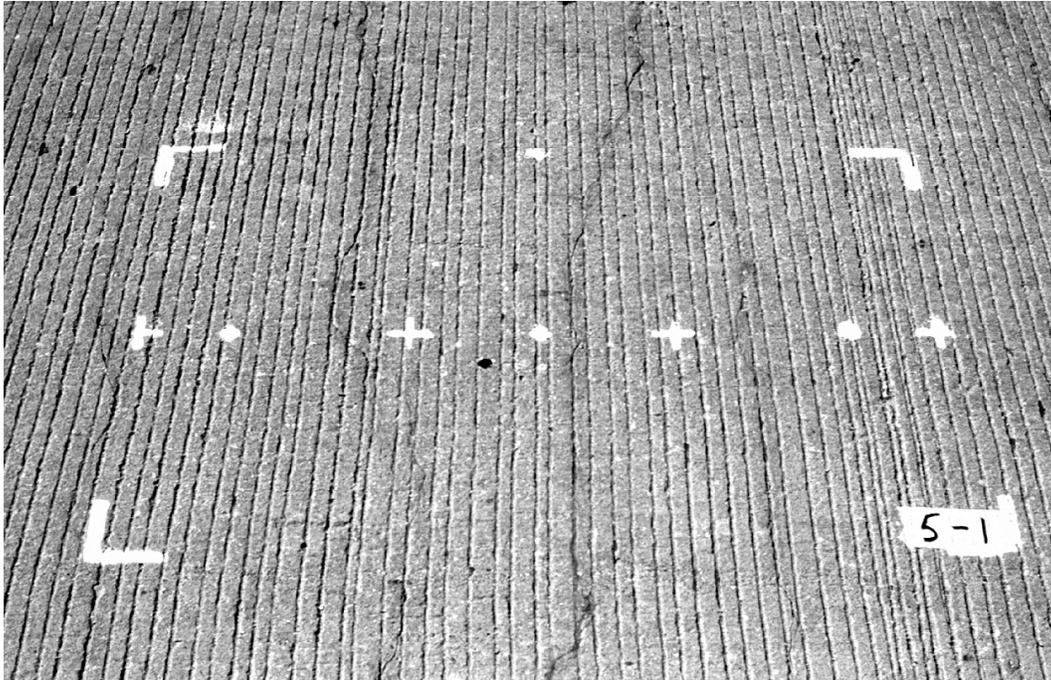
Figure 1. Test location 5-1 with transverse cracks. The corresponding scale and significance of the various paint markings are provided in Figure 4.

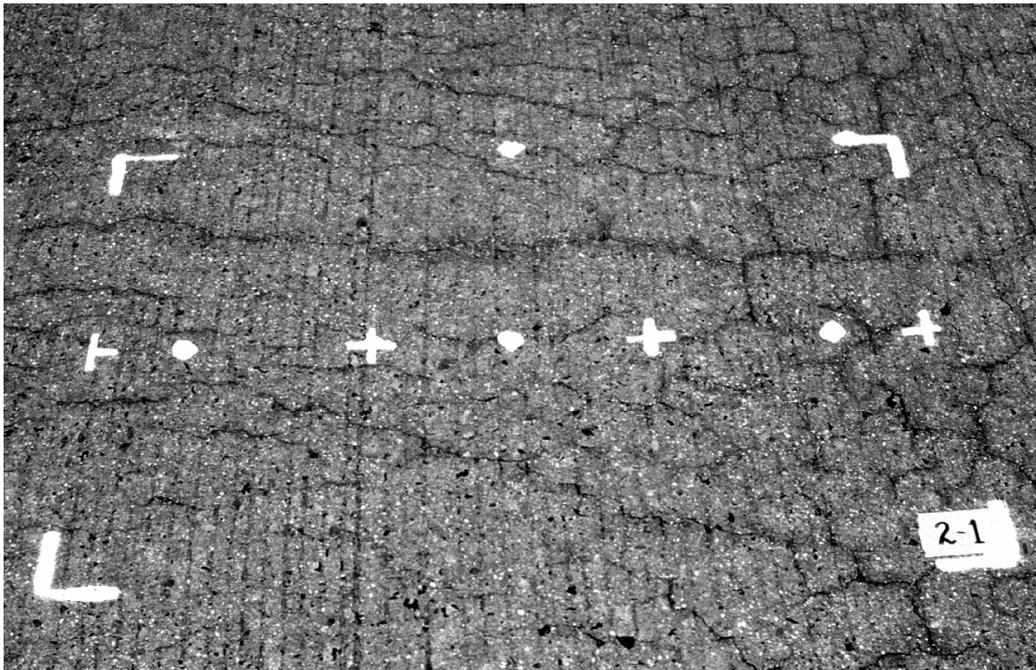
Figure 2. Test location 2-1 showing longitudinal and map cracking.

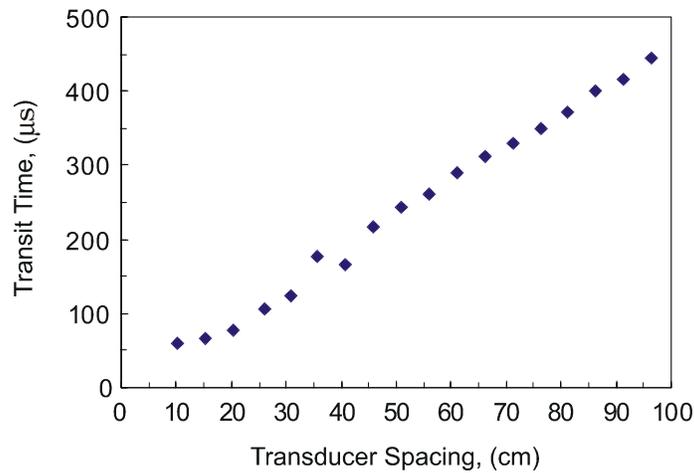
Figure 5. Plots of *t* versus *d* obtained from surface measurements of UPV made at test location 1-7.

As described earlier, if the concrete in a test location is in good condition, the resulting plot of t versus d for the surface UPV measurements conducted at each test location should be linear. Figure 5, which graphically illustrates the results of surface UPV measurements at test location 1-7, shows data points that generally fall within a straight-tending line, indicating concrete in good condition. The slight deviation (→20 :sec) from the straight line in the vicinity of a 36-cm transducer separation distance is probably due to less than uniform contacts of the transducer coupling on the textured concrete surface at different test points at the location and the natural heterogeneity of the concrete. Figure 6, on the other hand, depicts a line with a more pronounced deviation from linearity and, therefore, is a clear indication of a defect in the concrete. In this example, which is for test location 1-3, the deviation from linearity, in fact, fragmentation into two lines at a separation of 0.70 to 0.80 m, corresponded to a transverse crack on the pavement at approximately 0.68 m.

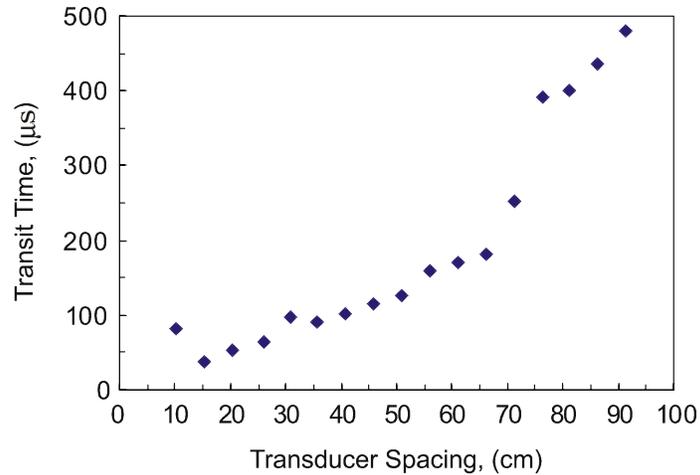
heterogeneity in the concrete (Figure 5). The presence of a crack or other defect in the concrete may result in a significant deviation from linearity in the plot, as illustrated in Figure 6.

Figure 6. Plots of *t* versus d obtained from surface measurements of UPV made at test location 1-3.

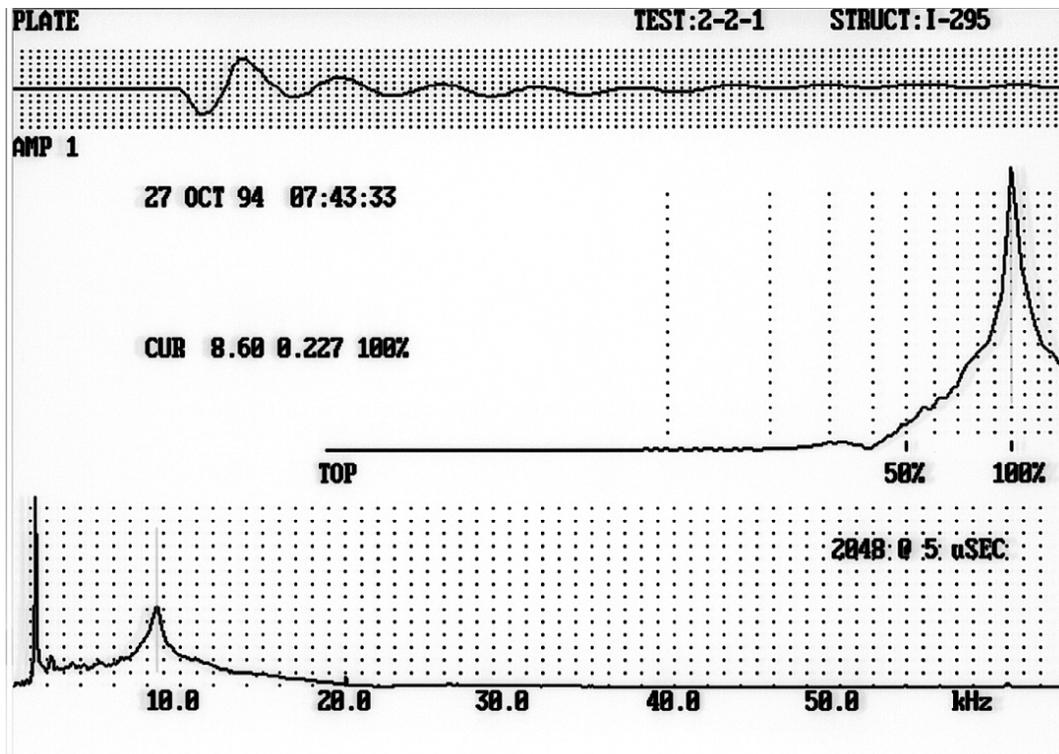
The IE test result for test point 2-2-1 in test location 2-2, as illustrated in Figure 11, can be considered. The time-domain waveform, shown at the top, represents a series of relatively healthy and repetitive stress wave reflections from the bottom of a sturdy concrete slab. Its corresponding amplitude/frequency and normalized depth spectra were relatively "clean" too. Combined, these results indicated that the concrete at this point was free of delamination, which is a form of advanced damage in the concrete. However, since this method relies on the disruption of stress wave propagation arising from the presence of distinct discontinuities within the concrete to assess the condition of the concrete, it often cannot detect microscopic cracks resulting from ASR. A case in point is that petrographic examinations of cores from this test location indicated that microscopic ASR-induced cracks were already present. In many cases of concrete affected by ASR, the reaction product, a viscous gel, can occupy cracks within the concrete, providing a medium with transmission properties fairly similar to those of normal concrete, thus masking the presence of discontinuities related to ASR difficult to discern.

Figure 11. IE results of test obtained with field system from test location 2-2-1 showing sound concrete. The top is the surface displacement time-domain waveform; the middle is its normalized depth spectrum; the bottom is the amplitude/frequency spectrum resulting from fast-Fournier transform analysis of the displacement waveform. The 8.60-KHz peak in the amplitude spectrum corresponds to the resonance frequency *(f)* of the reflection from the bottom of the slab.

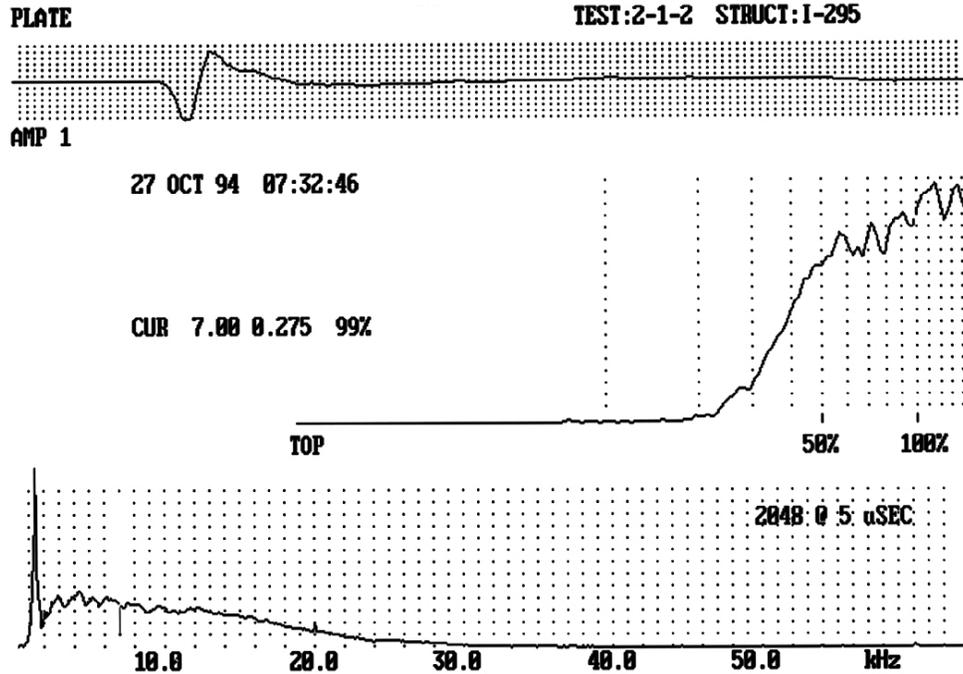
Figure 12 illustrates the IE results for test location 2-1, which had extensive macroscopic damage on the pavement and core surfaces. In contrast to Figure 11, these results lack the well-defined reflection from the bottom of the slab and the cleaned spectra that characterize macroscopically sound concrete. In this location, the concrete damage had progressed to a stage where the irregular cracks became material discontinuities that scatter the stress waves and prevent strong reflections. Figures 11 and 12 illustrate how IE may be used to evaluate the integrity of a concrete member, but they also indicate that the results can be misleading for concrete in the early stages of ASR distress.

Figure 12. IE results for test location 2-1-2, which had map cracking on the surface of the concrete. Notice the differences between the displacement waveform and the depth spectra shown here and those in Figure 11, which were obtained from a location with relatively sound concrete.

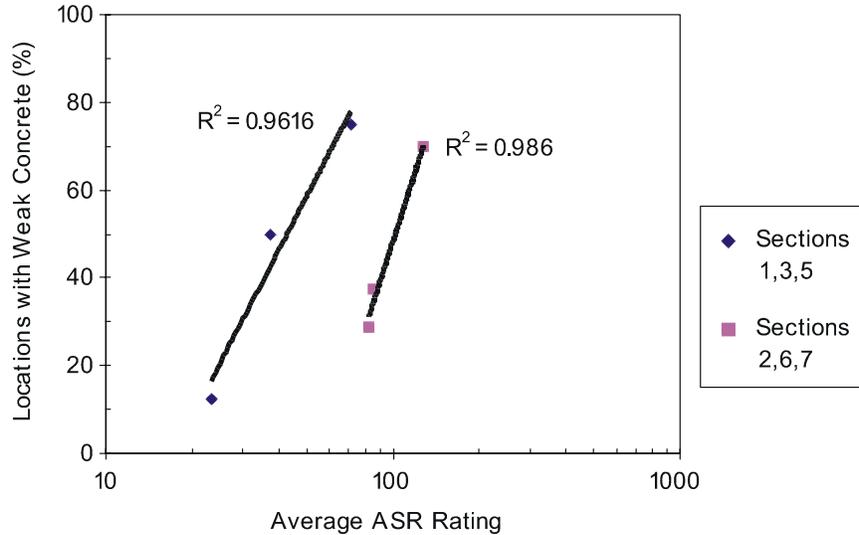
Such a strong correlation may mean that the SPA could be used to survey a long stretch of pavement for indications of the relative condition of different sections of the pavement. Further, the relatively high degree of correlation between weak concrete and high ASR ratings in

the test sections where early stage ASR was present may indicate that use of the SPA can predict ASR long before cracks become apparent on the surface. As Table 6 shows, use of the SPA was

Figure 13. Correlation between average petrographic ASR rating and percentage of test locations with weak concrete in each test section as assessed by SPA. Transverse cracks and longitudinal cracks were the predominant distress in sections 1, 3, and 5 and sections 2, 6, and 7, respectively.

- *Verify the correlation between the SPA ratings of the overall condition of pavement sections and petrographic ASR ratings of concrete.*
