TIRC 1 – Cornell University Research Consortium

Project Title: **Concrete Deck Material Properties**

RFP No.: **SPR Project C-02-03**
New York State Department of Transportation

Final Report

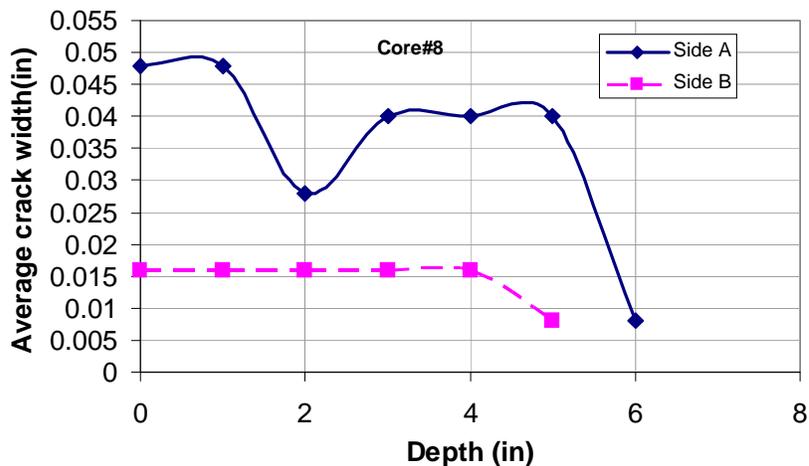
Core #	% of crack length w/respect core length
5	47.0%
8	50.0%

Figure 10: Crack profiles as a function of depth for BIN 1000440

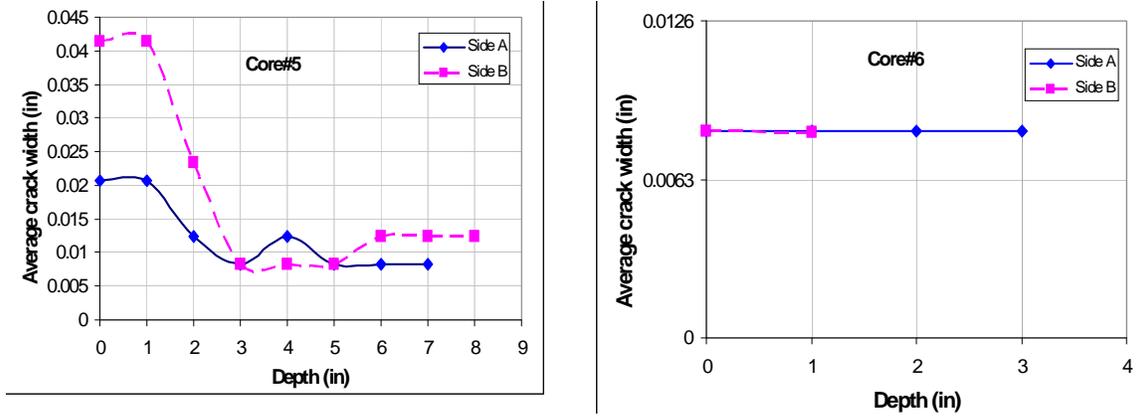
Core #	% of crack around aggregate
5	100.0%
6	100.0%
Core #	% of crack length w/respect core length
5	89.2%
6	44.0%

Figure 11: Crack profiles as a function of depth for BIN 1008840

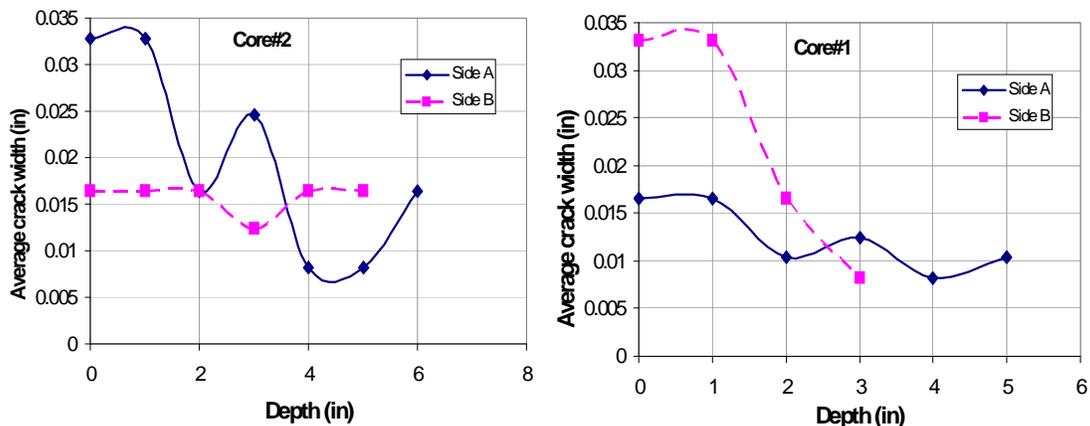
Core #	% of crack around aggregate
1	57.6%
2	65.6%
Core #	% of crack length w/respect core length
1	67.9%
2	77.6%

Figure 13: Crack profiles as a function of depth for BIN 1021350

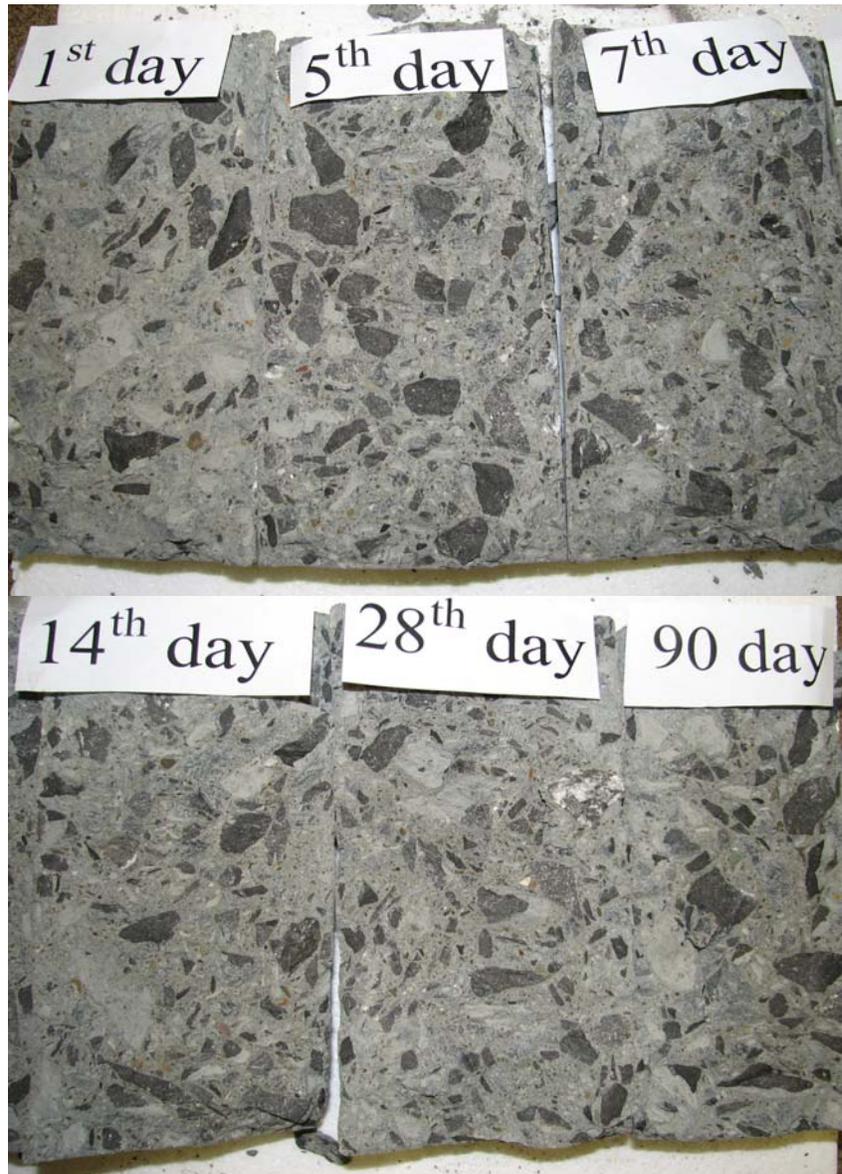
Figure 48: Failure surface of Region 1 specimens at various ages under split cylinder test

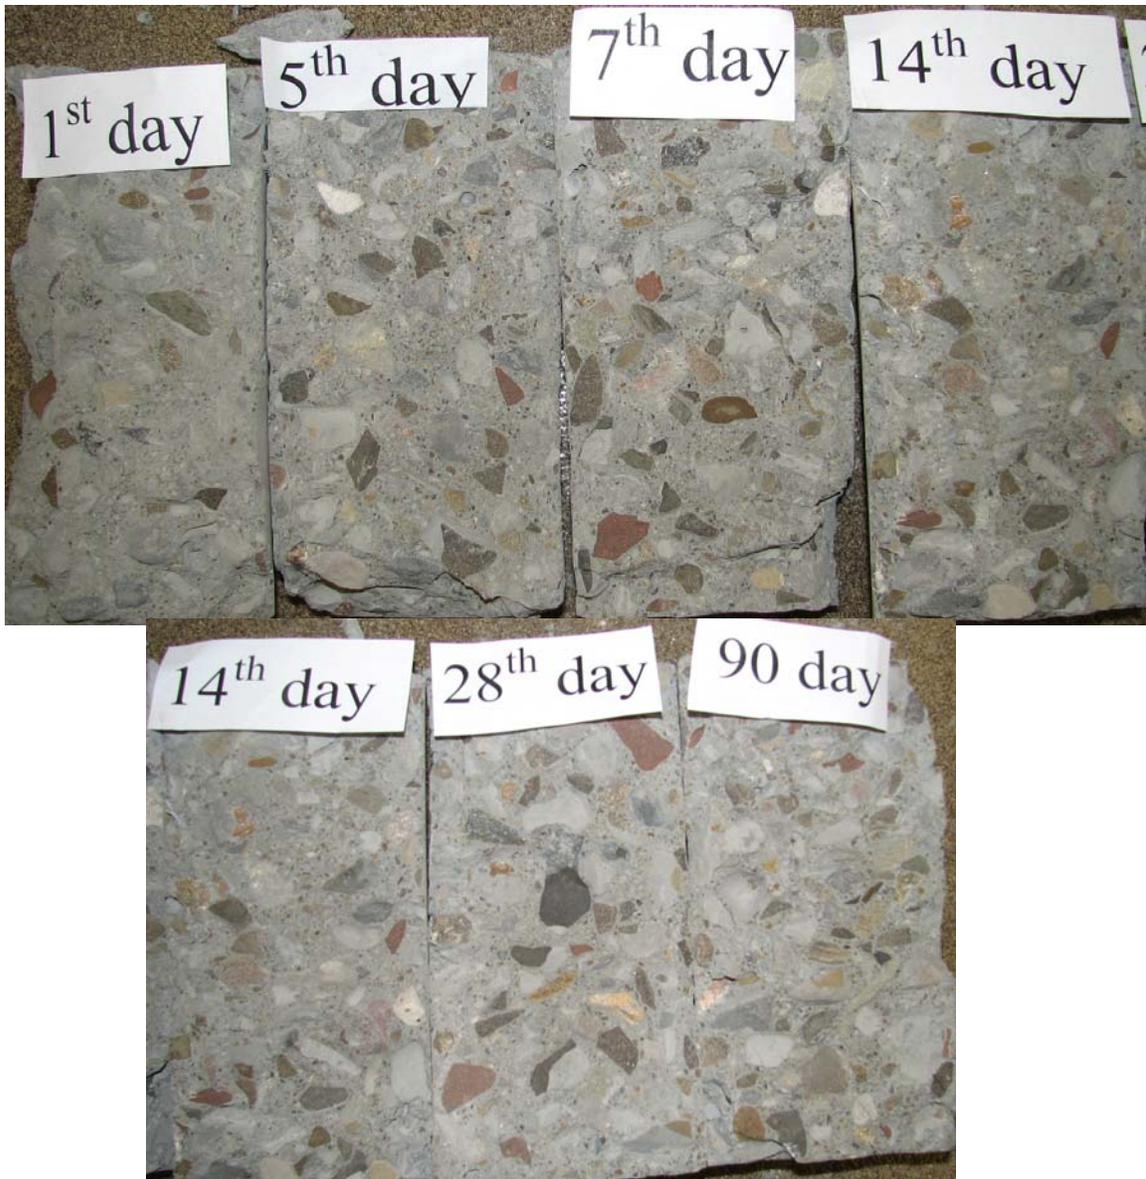
Figure 49: Failure surface of Region 3 specimens at various ages under split cylinder test

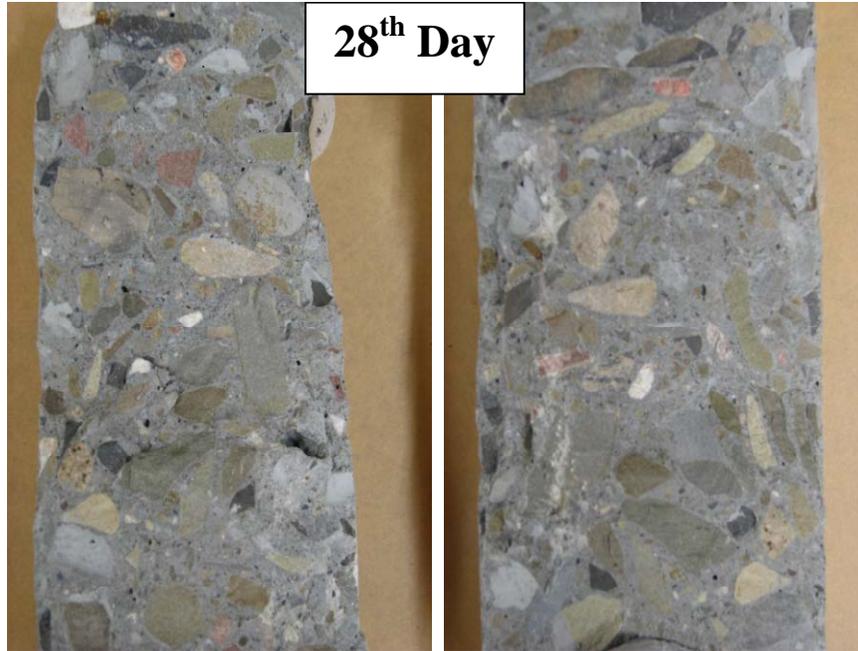
Figure 50: Failure surface of Region 9 specimens at 28th day under split cylinder test
