REMAINING LIFE ASSESSMENT OF
IN-SERVICE LUMINAIRE SUPPORT STRUCTURES

1. REPORT NO. TNW2010-01	2. GOVERNMENT ACCESSION NO.	3. RECIPIENT'S CATALOG NO.
4. TITLE AND SUBTITLE REMAINING LIFE ASSESSMENT OF IN-SERVICE LUMINAIRE SUPPORT STRUCTURES		5. REPORT DATE January 2010

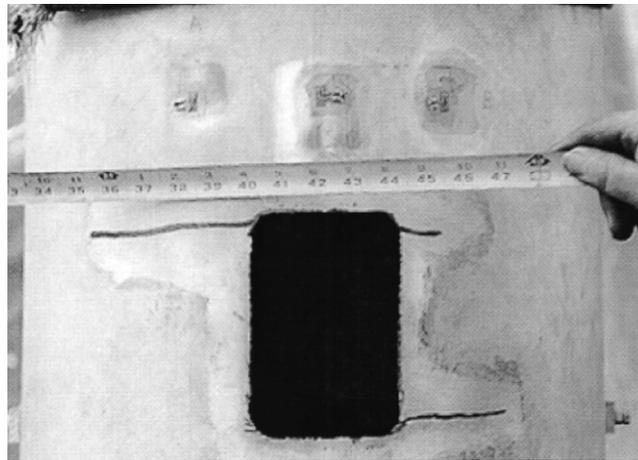
Figure 2.12: Cracking at the corners of the conduit hole in specimen AB1 (Gilani and Whittaker, 2000b)

2. 6 mm (¼ in.) thick holes were drilled at the ends of the crack to prevent further growth;

5. the repaired weld was ground flush with the outside of the pole;

6. a 305 mm X 610 mm X 16 mm (12 in. X 24 in. X 0.625 in.) patch plate was placed over the conduit hole and attached to the outside of the pole with a continuous fillet weld.

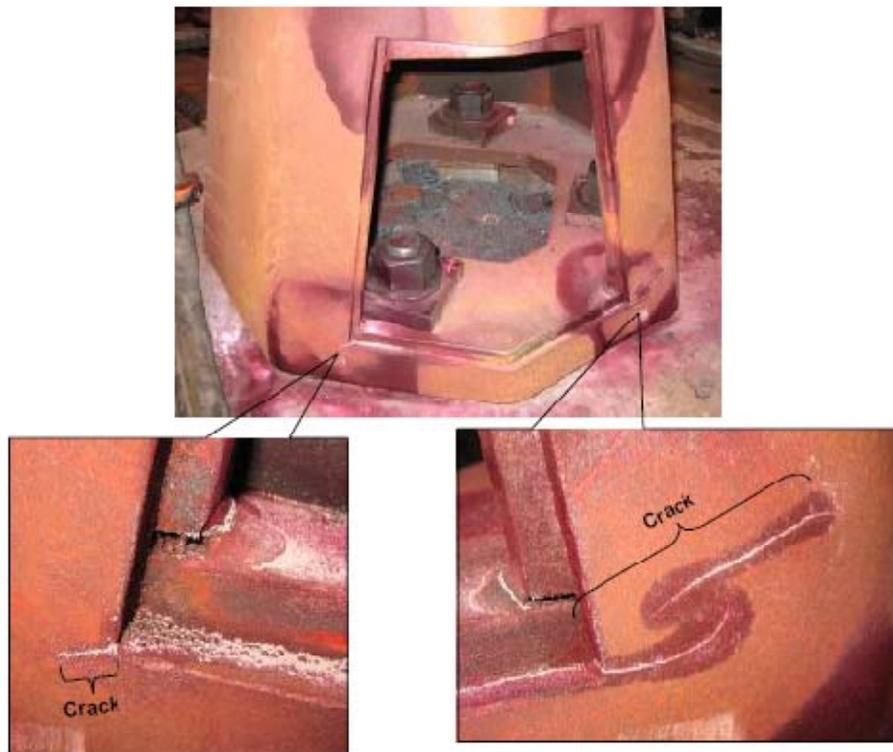
Figure 2.44: Cracking in access hole of Type 2 integrated transformer base (Ocel et al., 2006)

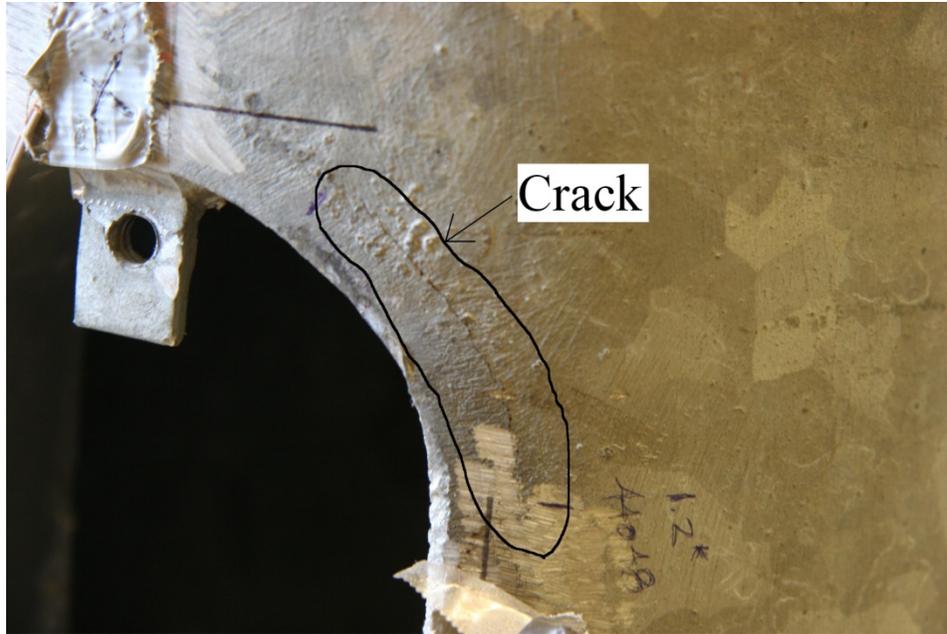
Figure 4.1: Hand hole of Specimen 1 at 1,362,627 cycles

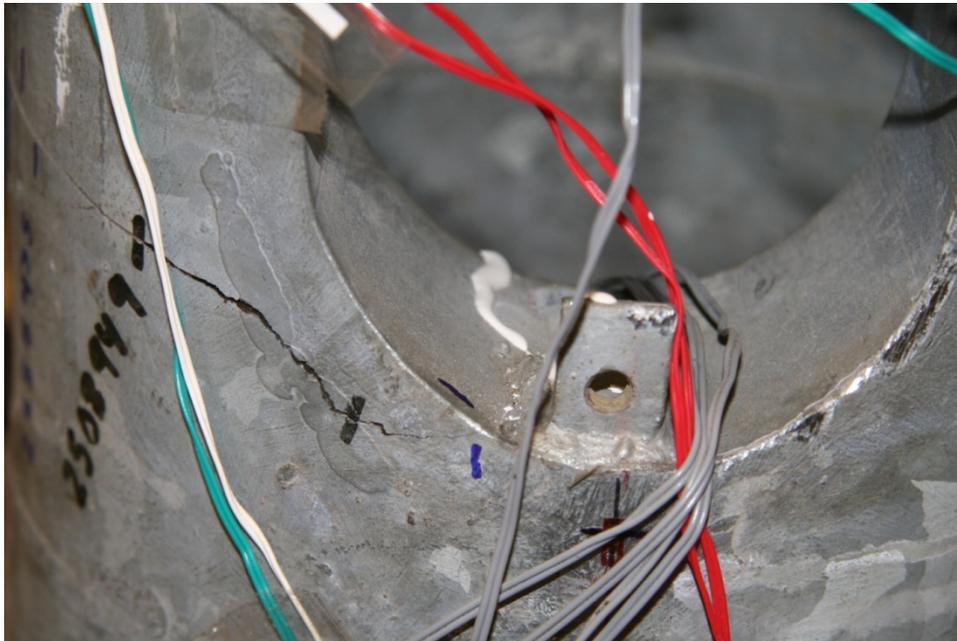
Figure 4.2: Cracking in Specimen 2 at lower left corner of the hand hole after 2,508,949 cycles

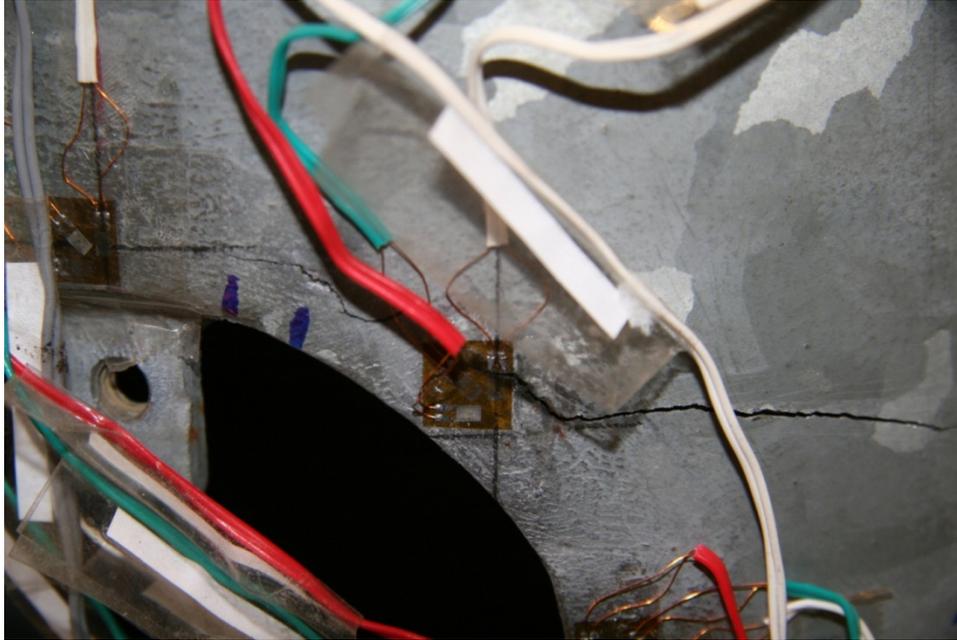
Figure 4.3: Cracking in Specimen 2 at the upper right corner of the hand hole at 2,557,552 cycles
