STUDY ON THE USE OF SELF-CONSOLIDATING CONCRETE ON THE INTERSTATE 25 BRIDGE REPLACEMENT IN TRINIDAD, CO

December 2010

COLORADO DEPARTMENT OF TRANSPORTATION
DTD APPLIED RESEARCH AND INNOVATION BRANCH

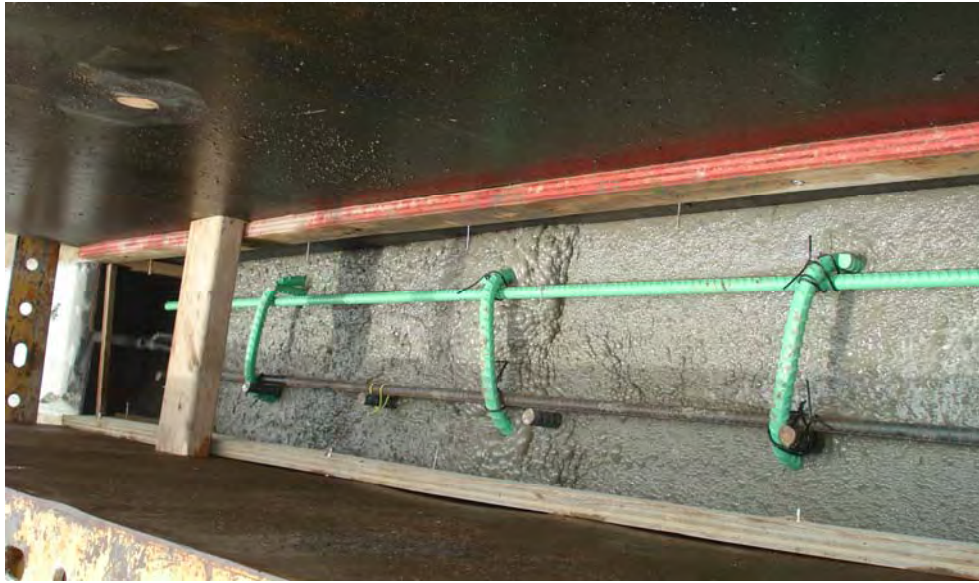
Figure 10: Bubbles in SCC

The placement of the first half of the wall was not observed by a Colorado School of Mines researcher. During the placement of the second half of the wall, it was noted that each accepted truck delivered concrete that had a slump flow of at least 24 inches, with a maximum slump flow of 27 inches. However, a few trucks (in one case, 5 trucks in a row) were rejected due to air contents above 8%. The initial truck loads delivered concrete with air content below 5%. Adjustments were made on site. This prompted the contractor to increase the air additives at the batching plant, which unfortunately resulted in unacceptably high air contents in the following trucks. Visual observation during the second wall placement revealed that the top two to three inches of the concrete did not contain a sufficient amount of aggregate indicating mix instability. Also, in this top layer, the SCC that traveled

the longest distances developed a "soapy" texture as shown in Figure 10. This was initially attributed to a reaction or mixing with the form release agents. It is more likely that the observed texture was the result of segregation that resulted in a mortar of higher air content flowing on the top layer of placement.

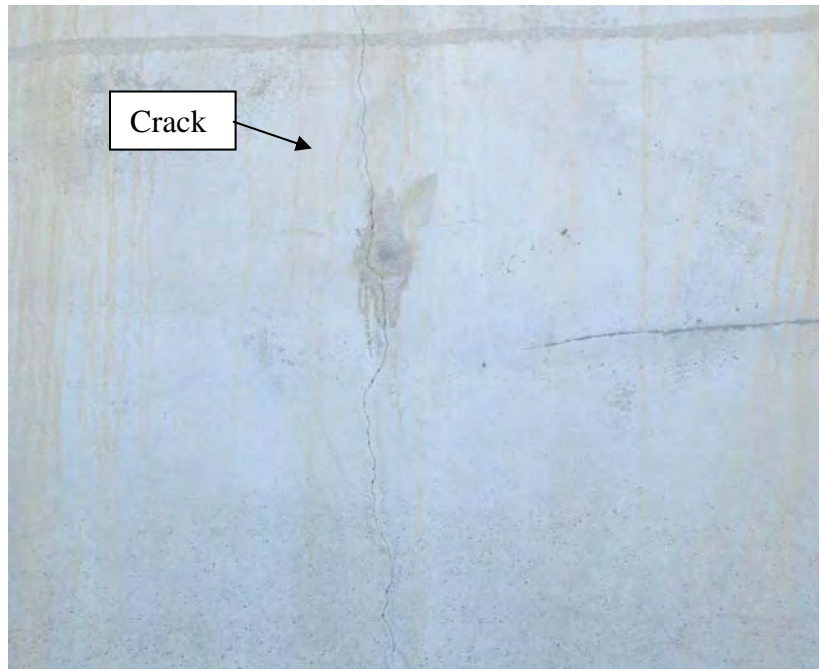
Figure 12: Second Retaining Wall Placement

The second wall placement produced noticeably better results as shown in Figure 12. The second portion of the wall had both vertical and horizontal cracking. Whereas the vertical walls cracks are easily attributed to drying and/or autogenous shrinkage, the horizontal cracks are not as easy to explain. Typically horizontal cracks in walls are due to loading. However, in this case, the horizontal crack is on the compressive side of the backfill load, suggesting a potential placement defect. The vertical reinforcement of the wall counters

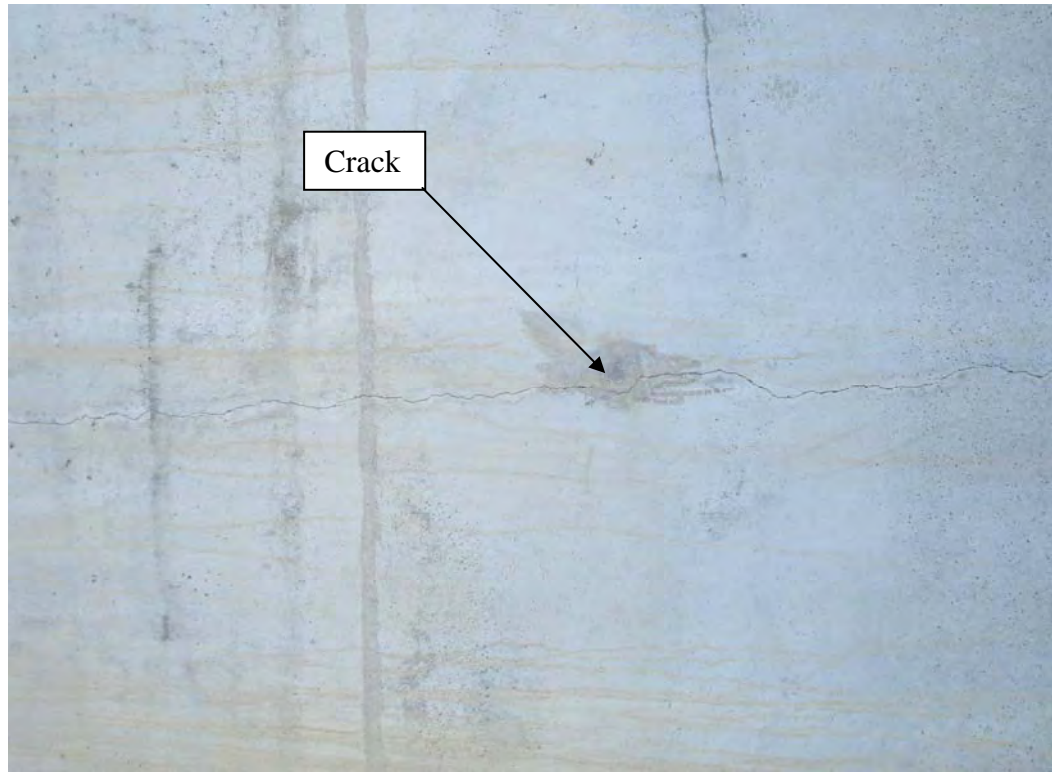
**Figure 13: Vertical Crack in Second Placement**

the structural threat. The vertical and horizontal cracks are shown in Figure 13 and Figure 14, respectively.
