Forces in Wingwalls from Thermal Expansion of Skewed Semi-Integral Bridges

Final Report

Ohio University
Ohio Research Institute for Transportation and the Environment
Department of Civil Engineering
Athens, Ohio

November, 2010

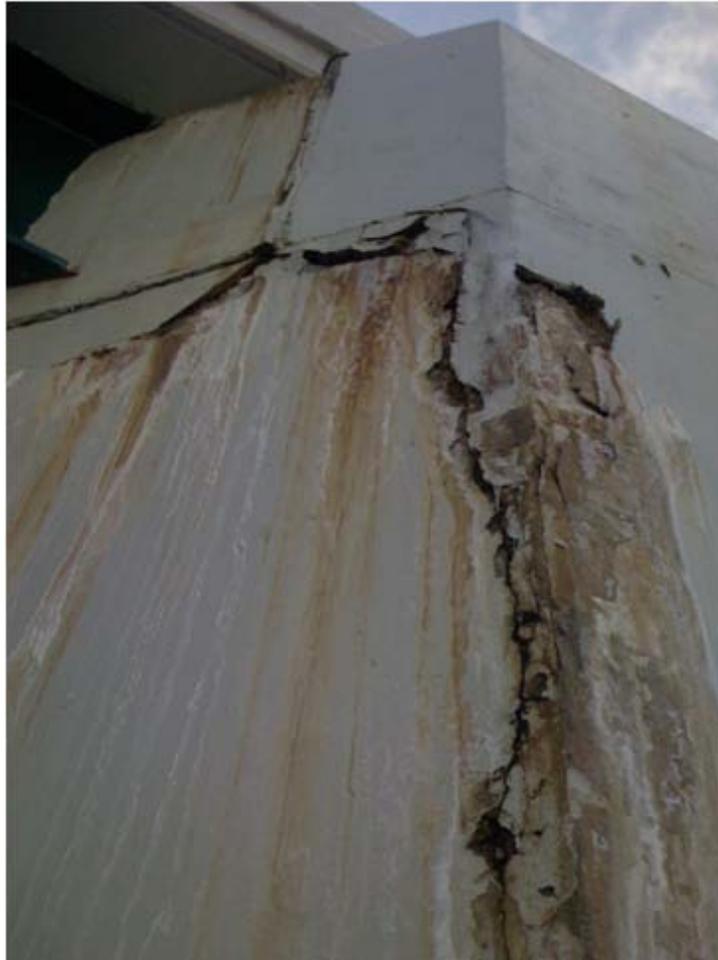
After the bridge was open to traffic, signs of distress were observed as cracks at the abutment/wingwall interface of the west wall of the west bound bridge as well as the east wall of the east bound bridge. Pictures of the observed distresses are shown for the west wall (Figure 11) and the east wall (Figure 12), respectively. Initially, the cracks were patched but only proved to resurface again. Over time, the cracks were observed to have propagated as shown in Figure 13.

Figure 13: Propagated Cracks of West Wall (West Bound Bridge)

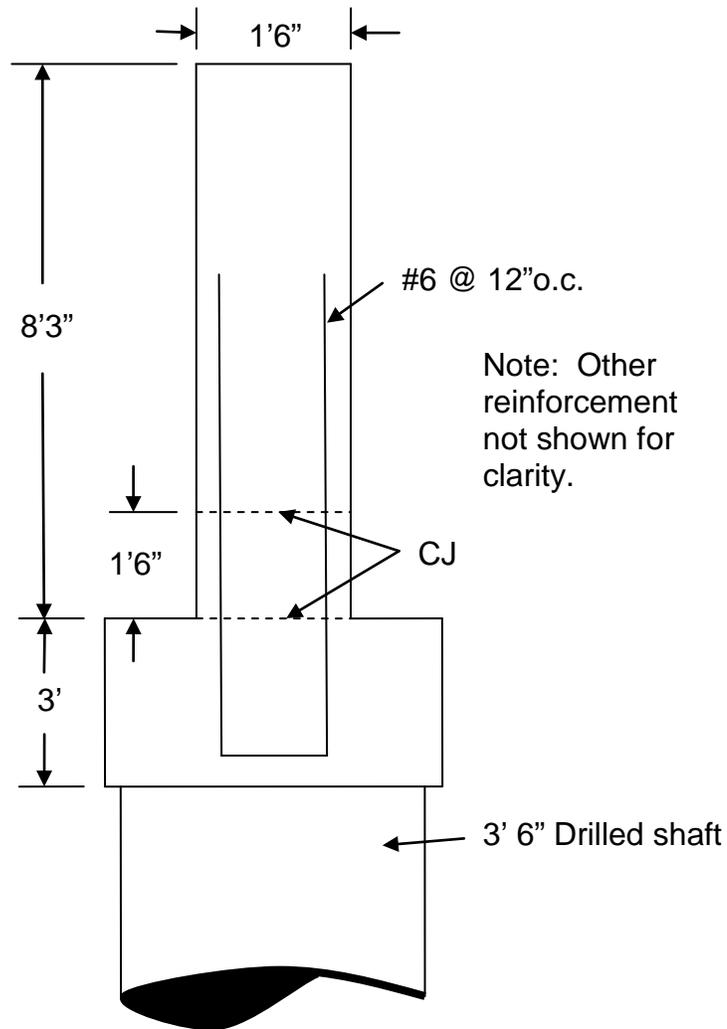
Figure 52: Wingwall Detail (DEF-24-0981)

The stress determined from the VW strain gages varied over the depth of the wingwall and in time. However, the majority of average stress measurements did not exceed 150 psi. This 150 psi stress is an extreme loading when considering the construction joint at the base of the wingwall (see Figure 52). Shear through the wingwall is not an issue, but bending at the base of the wingwall is a concern even with the #6 reinforcing bars on 12" centers. The tension caused

by bending is also on the surface of the wingwall that is not viewable for inspection. It is also difficult to determine how the stress from the diaphragm distributes along the length of the wingwall to lessen the effect of the bending. Soil on the outside of the wingwall can also assist in resisting the moment from the diaphragm.

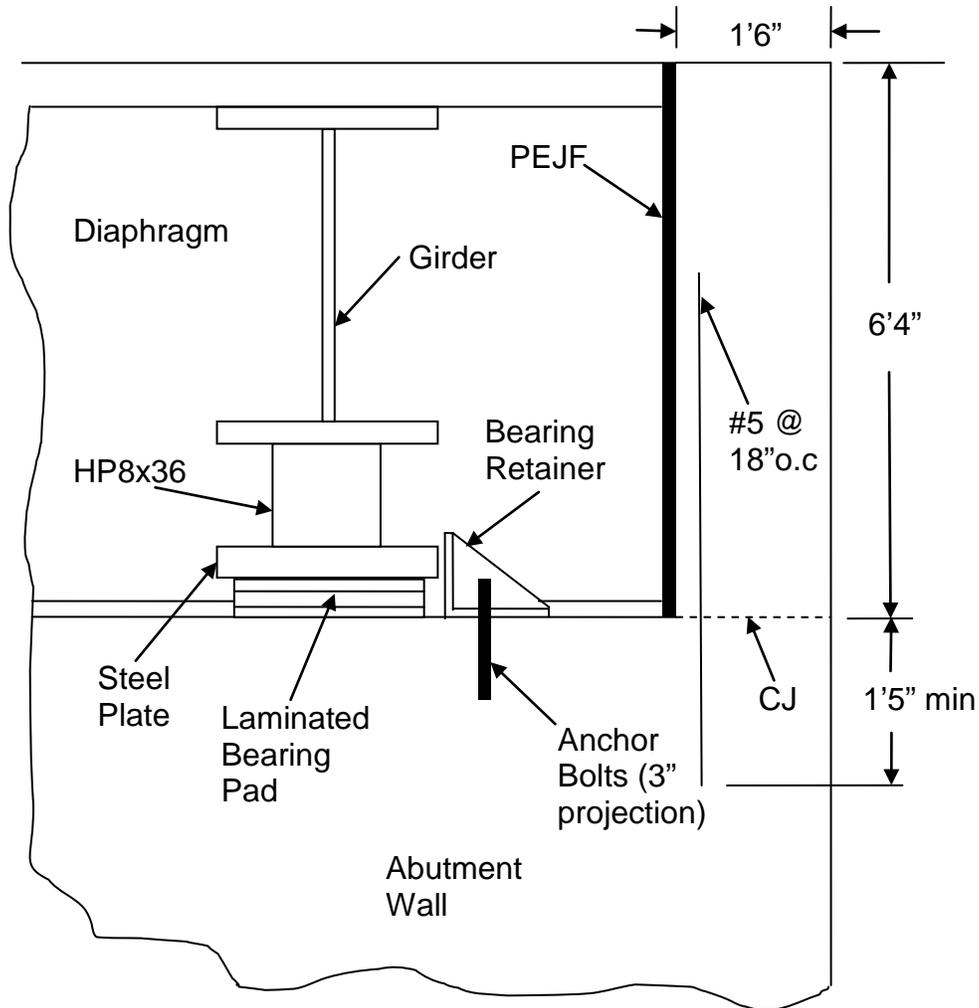
Figure 53: Wingwall Detail (MUS-16-0261)

Another issue is related to the bending of the wingwall caused by the force from the diaphragm. The reinforcement to resist the tensile force generated by the bending
