1. Report No. FHWA/VTRC 06-CR5	2. Government Accession No.	3. Recipient's Catalog No.
4. Title and Subtitle Construction of a Virginia Short-Span Bridge with the Strongwell 36-Inch Double-Web I-Beam		5. Report Date October 2005
		6. Performing Organization Code
7. Author(s) Thomas E. Cousins and John J. Lesko		8. Performing Organization Report No. VTRC 06-CR5
9. Performing Organization and Address Virginia Transportation Research Council 530 Edgemont Road Charlottesville, VA 22903		10. Work Unit No. (TRAIS)
		11. Contract or Grant No. 55941
12. Sponsoring Agencies' Name and Address Virginia Department of Transportation FHWA 1401 E. Broad Street P.O. Box 10249 Richmond, VA 23219 Richmond, VA 23240		13. Type of Report and Period Covered Final
		14. Sponsoring Agency Code
15. Supplementary Notes

CONSTRUCTION OF A VIRGINIA SHORT-SPAN BRIDGE
WITH THE STRONGWELL 36-INCH DOUBLE-WEB I-BEAM

Thomas E. Cousins
Associate Professor
Via Department of Civil and Environmental Engineering
Virginia Polytechnic Institute & State University

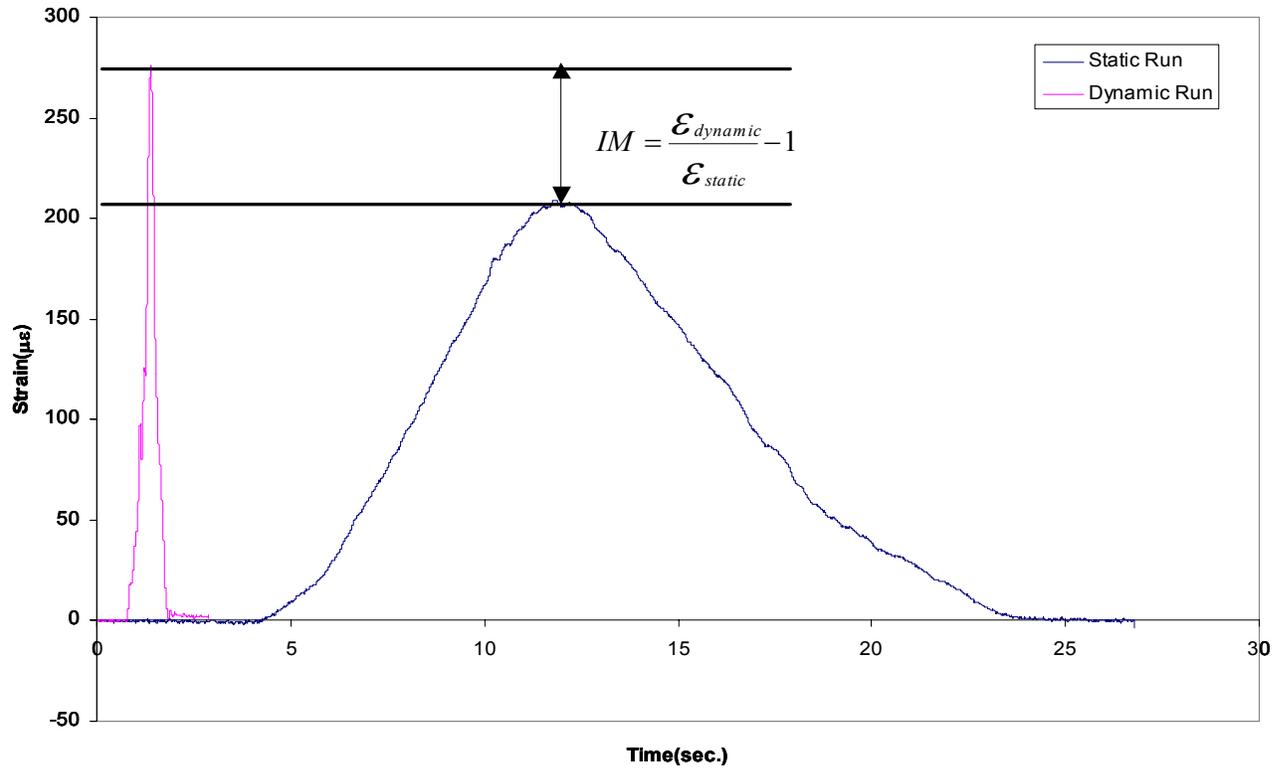
Figure 6. Typical Rt. 601 Bridge girder response due to truck loads with static and dynamic results superimposed.

The Rt. 601 bridge experienced settlement at both approaches shortly after construction and before the first live load test in October 2001, as a result of inadequate compaction of the soil back fill toward the abutment ends. Settlement on the order of 1 in or more ensued on both approaches, creating a non-ideal condition at the approaches. Many highway bridges use approach slabs to prevent excessive settlement at the approaches, but for bridges on rural roads the use of approach slabs is not practical due to the low amount of traffic and the cost associated with construction of approach slabs.

It is believed that the settlement at the approaches caused the truck to ramp over the bridge. The ramping effect increased with the speed of the test trucks. A similar phenomenon occurred during testing of the Washington School House Lane Bridge in Cecil, Maryland (STI, 1998). Structural Testing Incorporated (STI) reported that some strain readings on the FRP composite slab bridge from static runs were higher than the truck runs at higher speeds. They attributed this behavior of a negative dynamic load effect to a combination of a short span and the varying contours at the approaches of the bridge.

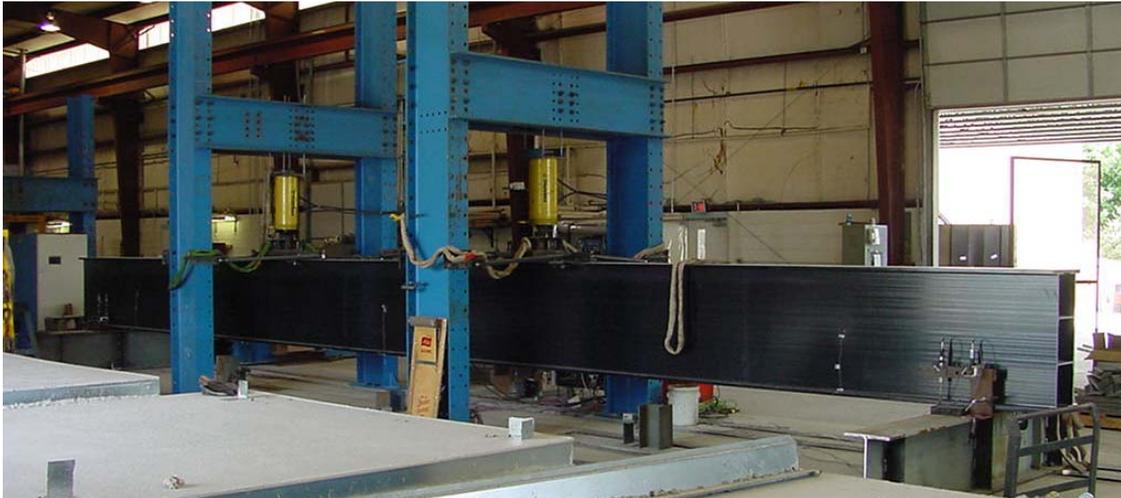
Figure 10. Four-point bend test set-up for 36 inch DWB (18.3 m or 60 ft span shown).

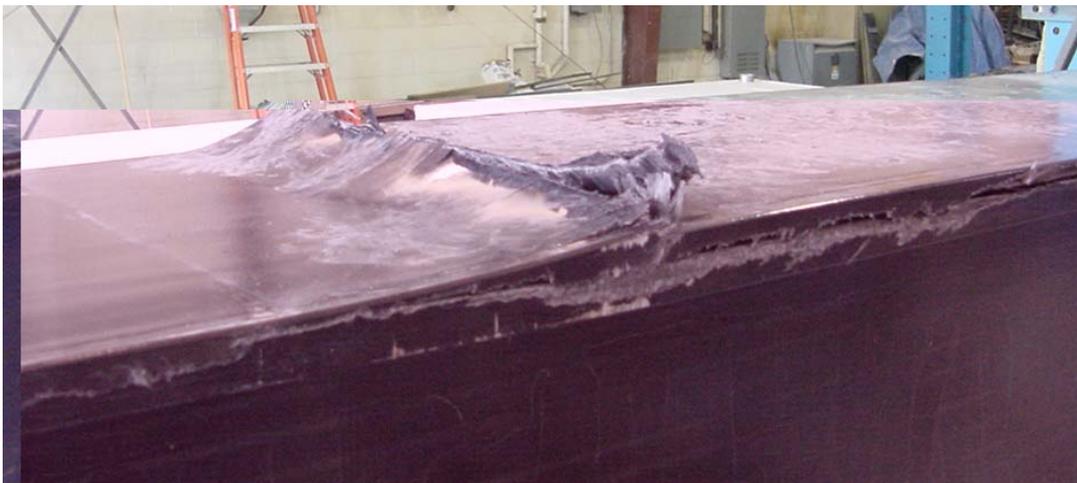
One 36 in double web beam was tested to failure. This girder experienced linear behavior to failure with a failure moment of about 1400 ft-kips. The failure mode was due to top flange delamination near a load point. The interface between the carbon and glass fiber mats in the top flange is an area high interlaminar stress due to the mismatch of material moduli and hence probably the location and source of failure. Even after failure the beam retained 73% of its pre-test stiffness.

**Figure11. Failure of the compressive flange of a 36 inch DWB under the loading patch.**

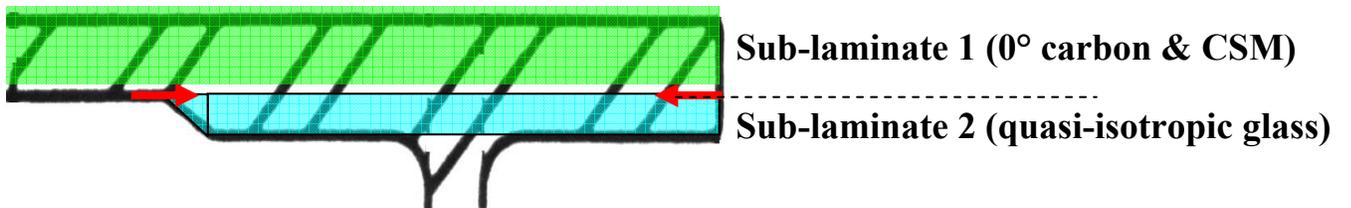
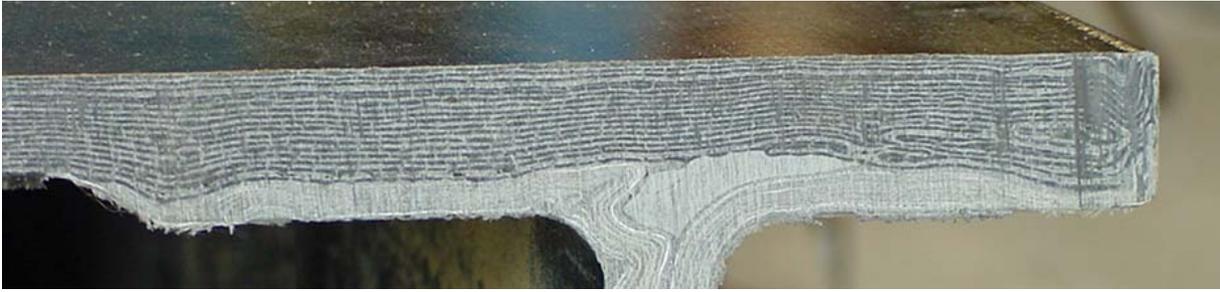
The lay-up of the 36 inch DWB is proprietary, but the flange can be represented as two sub-laminates as shown in Figure 13. The outer sub-laminate essentially consists of alternating layers of unidirectional carbon tows and glass fiber continuous strand mat (CSM), while the inner sub-laminate is formed from half of the web material and is basically a quasi-isotropic lay-up of glass fibers only. Although the intent in the final structure was to uniformly position each of the plies within the section, the reality of the processing leads to non-uniform distribution of fiber tows and plies as shown in Figure 14. Possible delamination initiation sites include the free edge or the inner flange taper at the interface between the two sub-laminates, where the innermost carbon ply is adjacent to a [0/90] glass fabric (see Figure 15). The problem of delamination at material and geometric discontinuities such as free edges and tapers is well known and was studied in an effort to describe the initiation of damage and failure of the beam.

Figure 13. Sub-laminate construction of the DWB's flange. Arrows indicate possible delamination sites.

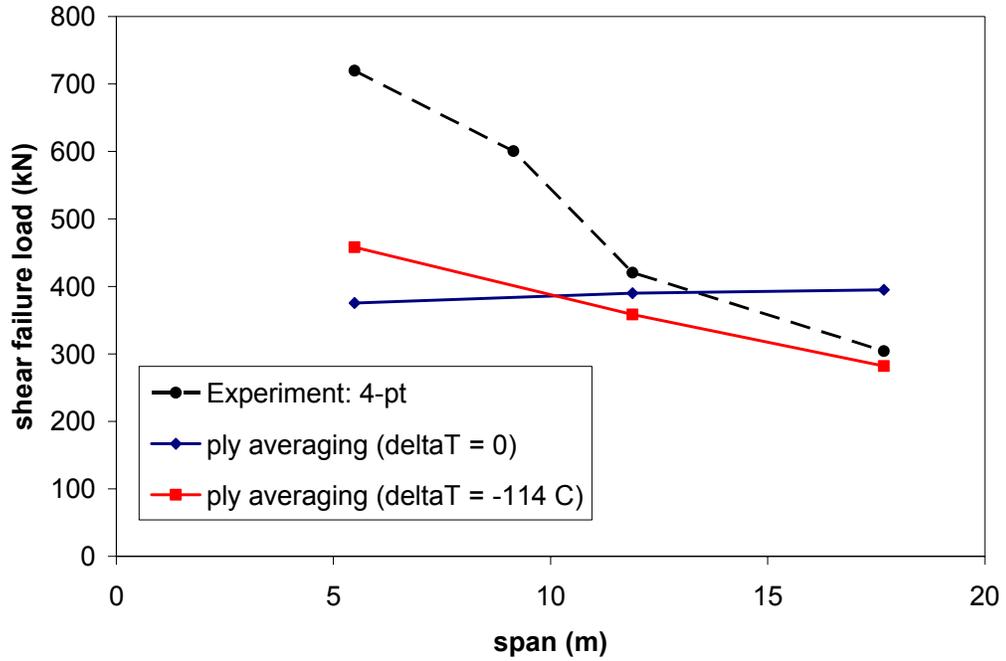
These models were used to compute the local stresses at ply interface as well as within plies and compared against the appropriate failure criteria. We examined the interlaminar shear stress at both the free edge and interior flange taper. When comparing the predicted failure load given various interlaminar failure criteria, it was determined that a shear-induced failure might not be what is controlling the failure, as shown in Figure 18. There is poor agreement between the observed shear capacity as a function of span and that predicted for the taper edge delamination failure mode using the ply width stress averaging technique (Hayes 2003).

**Figure 18. Comparison of the predicted shear capacity vs. span length for
the taper edge delamination failure mode using the ply width stress

averaging technique and the experimental results.**

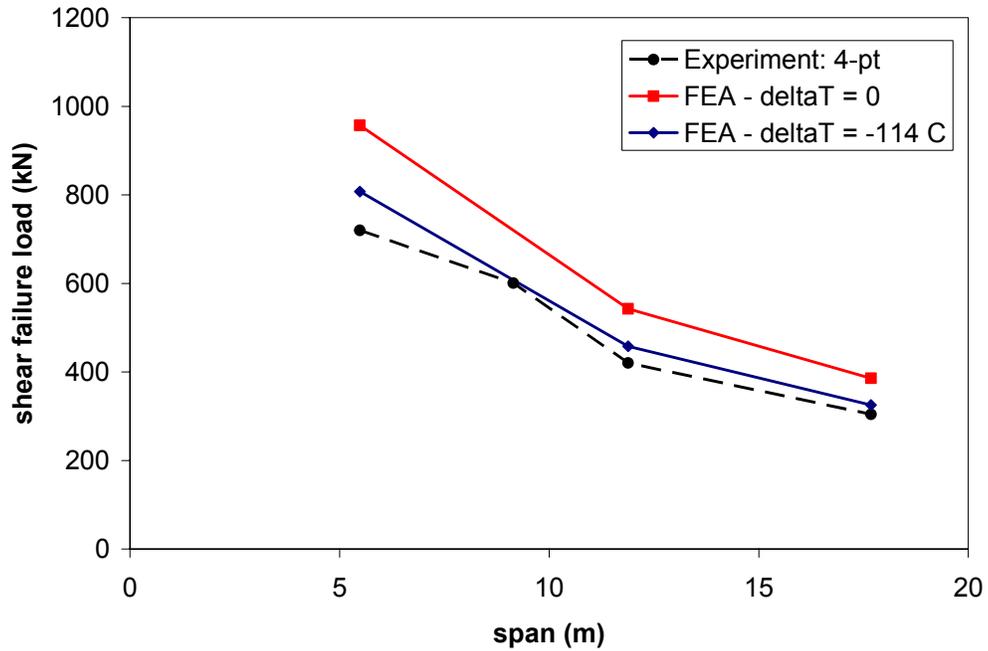
Reexamining the in-plane stress and considering the possibility that the controlling or first failure was controlled by compression, these in-plane stresses were compared to measured compression strengths for coupons extracted from the DWB flange. End loaded side supported compression testing revealed a lower than normal strength of 75.1 ksi for the predominately carbon/vinyl ester section of the flange. When compared with the predicted in-plane stresses from the FEA sub-modeling it suggests that compression strength of the flange controlled the failure of the 36-inch DWB, as shown in Figure 19.

**Figure 19. Comparison of the predicted shear capacity vs. span length for the compressive failure mode and
the experimental results.**
