STATEWIDE CORROSIVITY STUDY ON CORRUGATED STEEL CULVERT PIPE

FHWA/MT-01-001/8148

Final Report

By:
Jon J. Hepfner, P.E.
NTL Engineering and Geoscience, Inc.
Great Falls, Montana

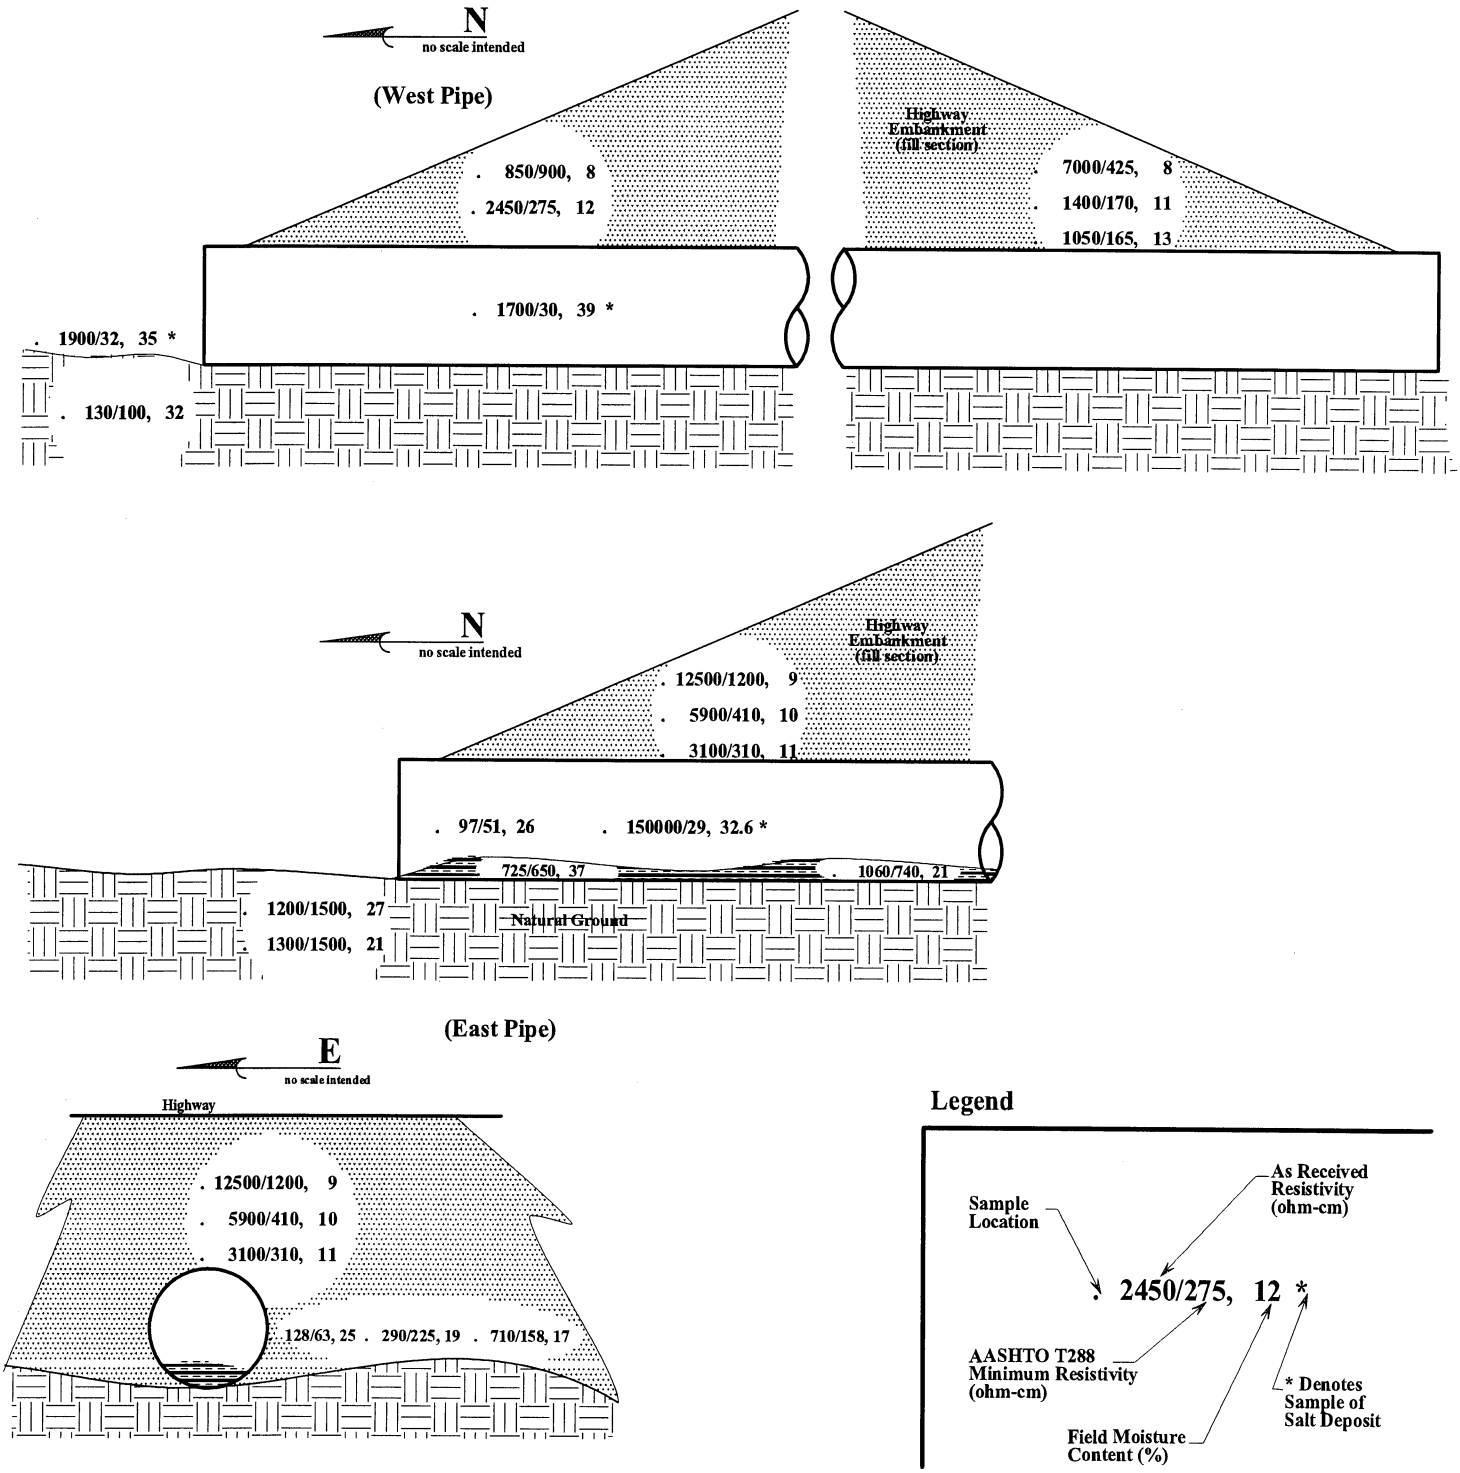
Figure 12 Case study culvert profiles

Case Study--Pipes East of Winnett

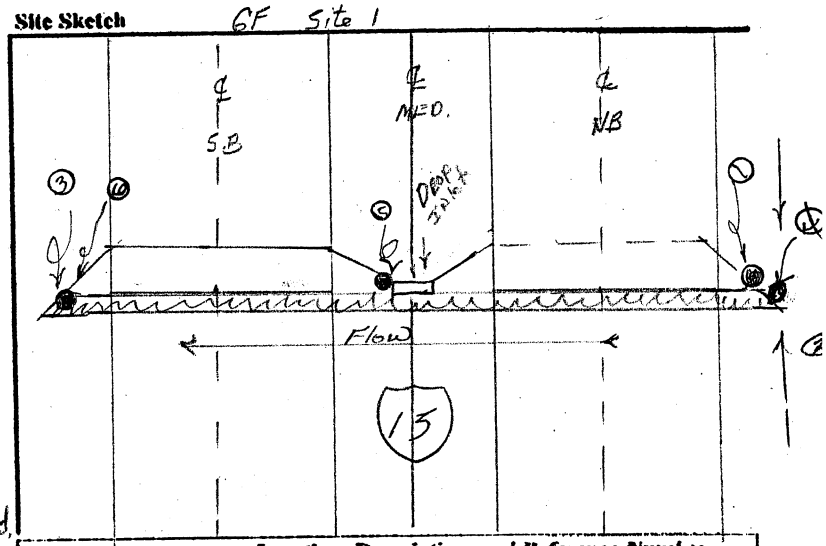
Site Sketch GF Site 1

Sample Locations: 5 Soil Sample, 1 Water Sample. 1- corroded Pipe Mat'l.
Soil Sample #1 - Backfill Mat'l
Depth = 0.6'-3.7' North side Culvert, 92.5' Rt ℄ Med.
Soil Sample #2 - Native Mat'l at 118 Rt ℄ Med.
Soil Sample #3 - Backfill mat'l - Thru. hole in Culvert.
Sample 4 - Water sample 98 Rt inlet end.
Sample 5 - Backfill mat'l 2' Lt mod. Corr.
Sample 6 - Corroded Mat'l.

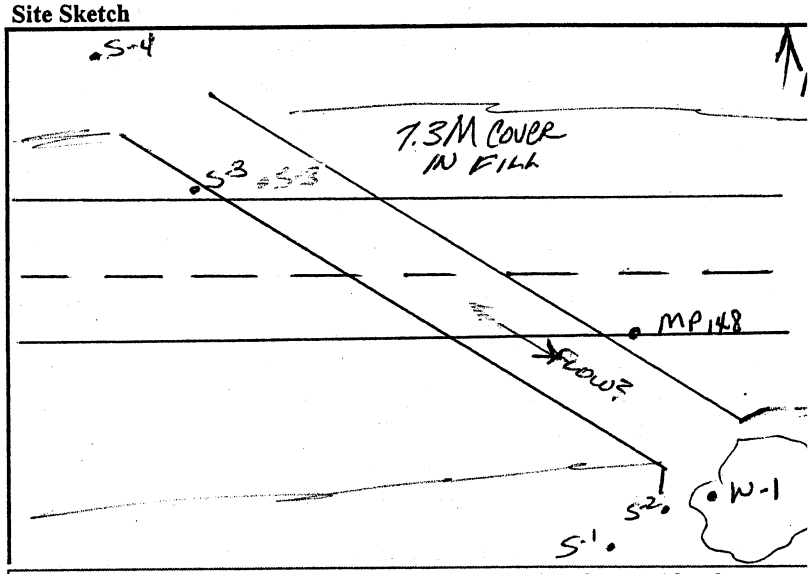
Site Sketch

Location, Description, and Reference Number
☑ Photographs	P1-P9 SAMPLE SITES DRAINAGE INTERIOR, BACKFILL, SEVERE CORROSION - SEE COMMENTS
☐ Maps

Roadway Station: 567+75.1 **Length:** 50 M **General Condition:** POOR
Culvert Type: SSPPC **Diameter:** 3505 mm (138") **Photograph Number(s):** B/J SITE 2 P1-P9
Approximate Age: 1954 = 46 yr. **Coating:** GALVANIZED **Location of Soil Samples:** INLET DRAINAGE BACKFILL, OUTLET DRAINAGE

Remarks/Comments: PIPE IS CORRODED, HOLES IN AN AREA MID TO UPPER ON ONE SIDE - RUSTED 4' ACROSS BOTTOM - STANDING WATER 2/3 THROUGH. ALKALI SOILS SURROUNDING AREA. 7.32 M COVER

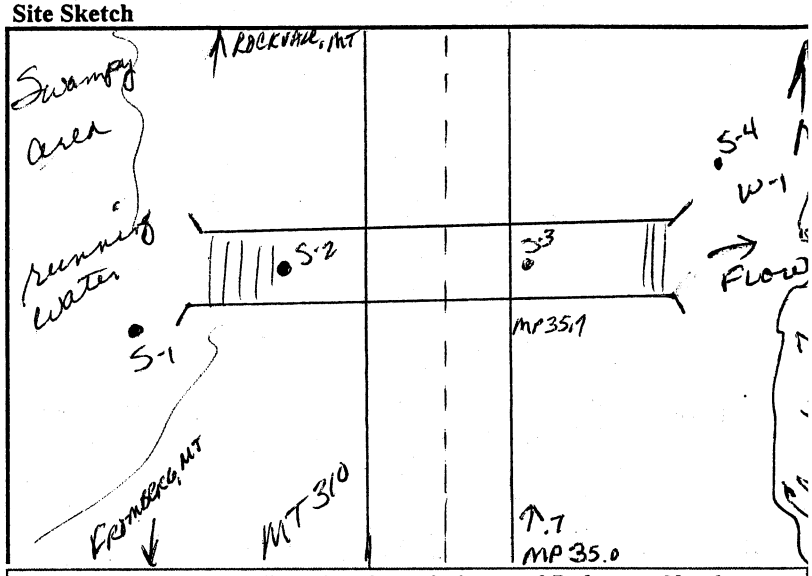
Site Sketch

Sample Locations: S-1 NATURAL SOIL NEAR INLET - CORRODED PIPE.
S-2 BACKFILL TOP OF INLET - LT. CL.
S-3 BACKFILL TOP OF OUTLET RT. CL
S-4 DRAINAGE OUTLET RT. CL.

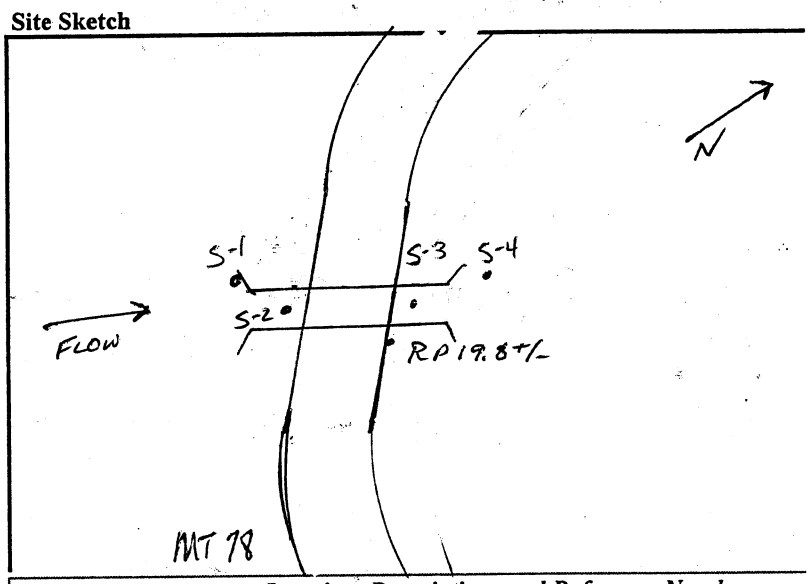
Site Sketch

Roadway Station: 1053+24 **Length:** 64' **General Condition:** VERY GOOD

Remarks/Comments: PIPE HAS SLIGHT CORROSION ACROSS BOTTOM NOTE P-2 APPROX 8"-10" OF MATERIAL ON BOTTOM. STOCKPASS.
