Final Report

# Movable Bridge Maintenance Monitoring

October 2013

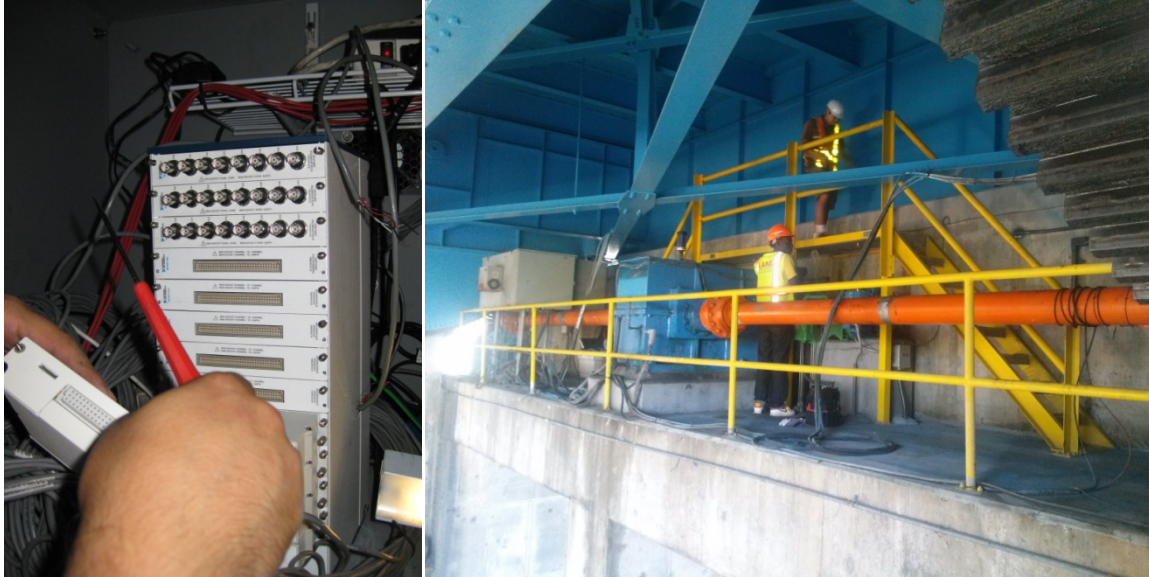
Figure 1-Picture from the field visit for fixing DAQ system and replacing malfunctioned sensors

10. Field Visit 10 (August 9, 2013): The SHM system at East leaf was stopped working around July 17, 2013 as the monitoring data could not be collected. The objectives of the trips were to investigate the happen and fix the system if it can be. Having experience from last failure of the DAQ system, some fuses were brought in case they needed to be replaced. The problem was as same as the happening on May 7, 2012, a fuse was broken causing the system to be stopped working. The broken fuse was replaced, and the system was returned to normal operating. Figure 1 shows one the visit to Sunrise Bridge.

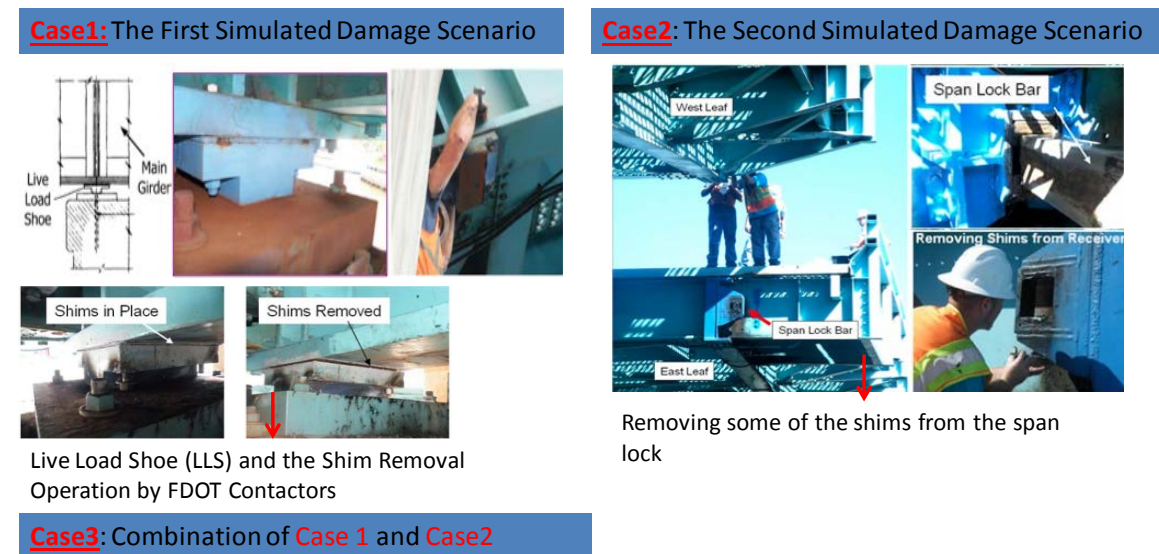
Case-1 is the creation of a gap (around 1/8" up to 3/16") between the West South LLS and resting support pads, which corresponds to non-fully seated LLS (Figure 31). This will cause misalignment and problems for proper opening and closing of the leaves. Moreover, because of the inadequate support conditions, bouncing may occur in the girders, creating additional stresses due to impact, as well as stress redistribution, possibly subjecting the structure to different internal forces.

Figure 31 -Implemented damage scenarios on the Sunrise Bridge

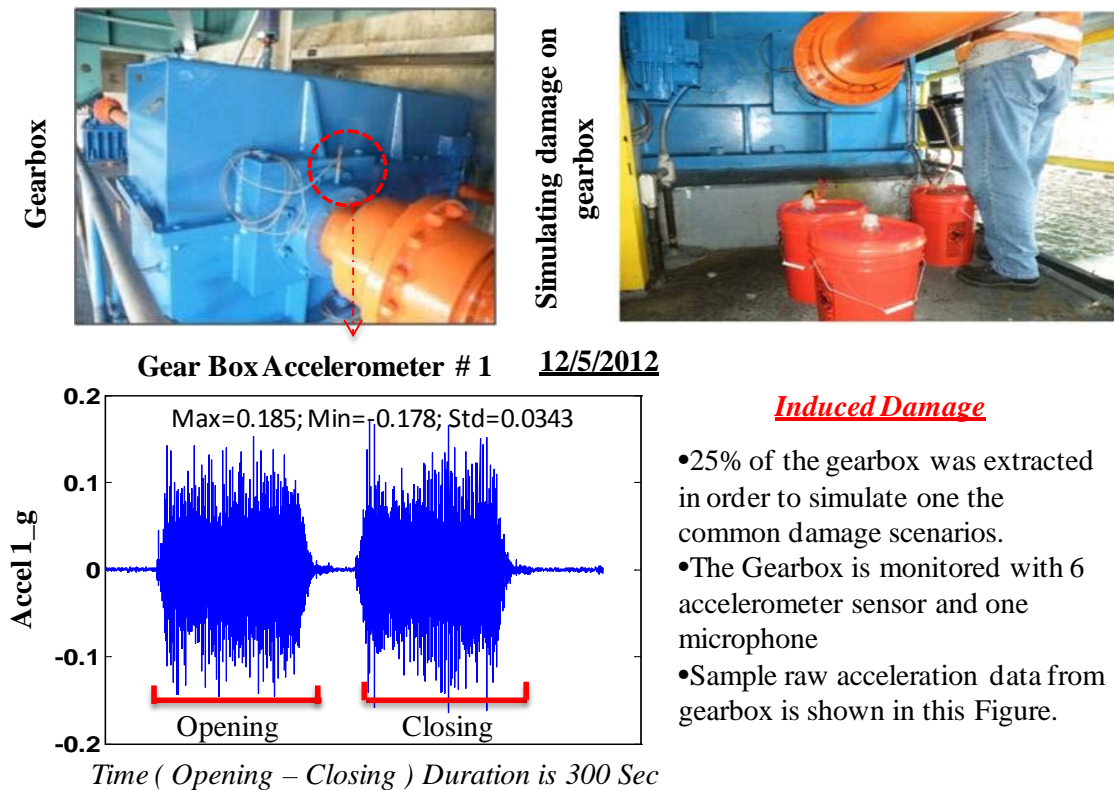
The gearbox, also called the transmission, uses gears to provide speed and torque conversion from a rotating power source to another device. The gearbox is equipped to provide the necessary amount of oil to the various gear meshes and bearings, thereby resulting in smooth and trouble free operation. The gearbox should be regularly checked for any leaks to see if the gearbox has adequate oil. In this project, the oil in the gearbox was partially removed to provide data corresponding to such an undesirable condition. Figure 35 shows the removal of the oil from the gearbox. Only 25% of the oil was removed, and the effect of the oil reduction was monitored by six accelerometers attached to the gearbox during a few openings of the bridge spans.

Figure 35- Removal of the oil from the gearbox and raw acceleration data from gearbox

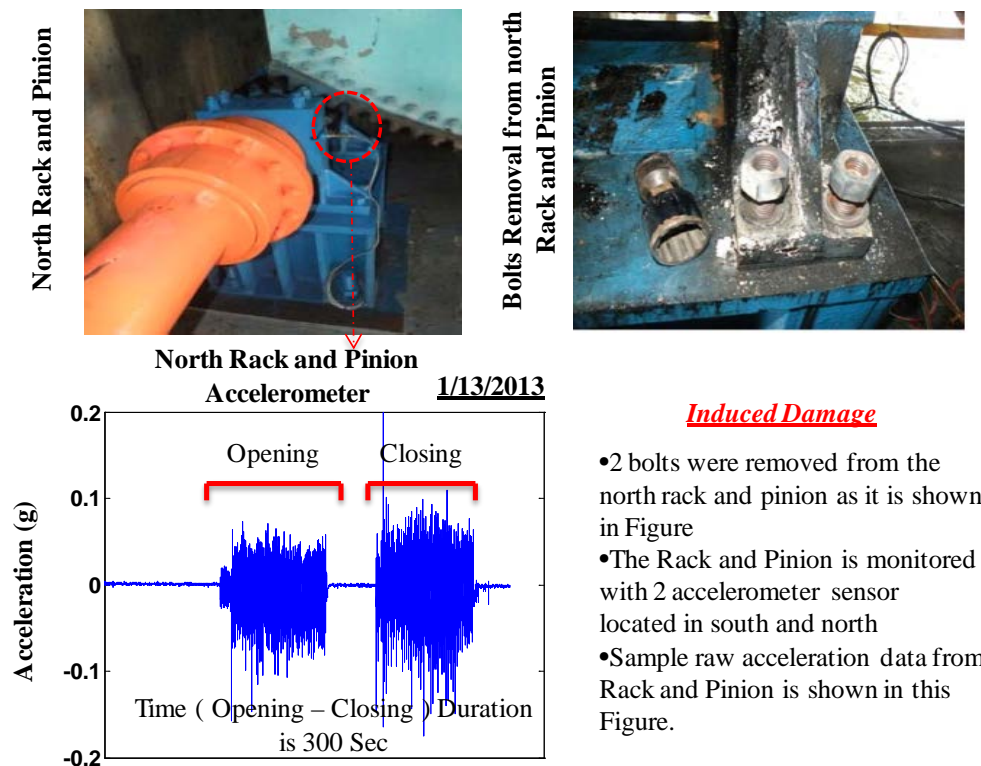
Figure 36- Bolts removal from the south rack and pinion and raw acceleration data from the deck rack and pinion

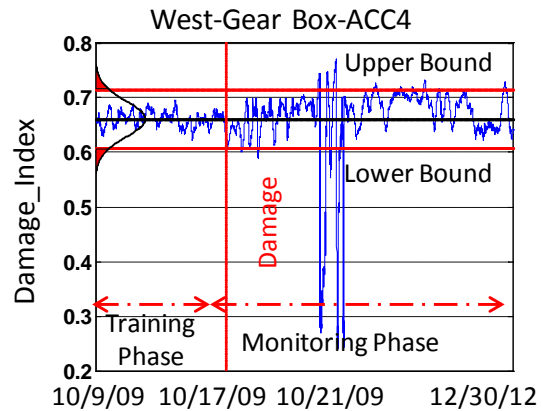
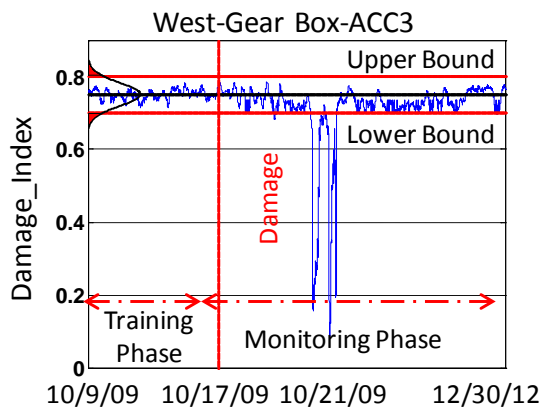
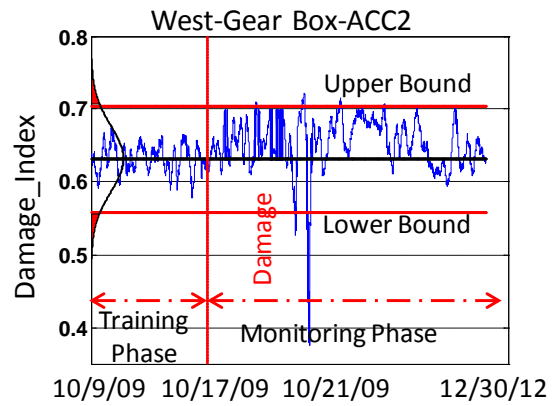
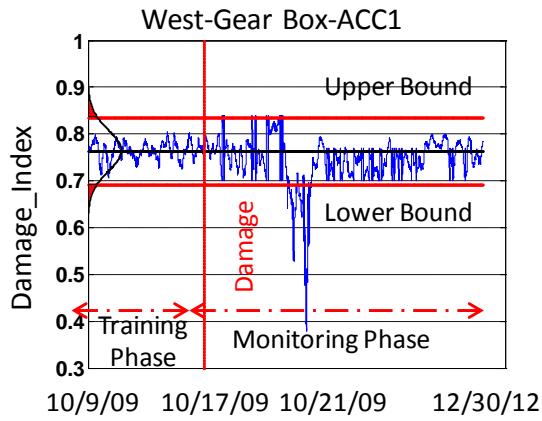
**Mechanical Component: Gearbox**          **Removal of Oil From Gearbox**

Figure 37-Results of MPCA application for gearbox malfunction detection

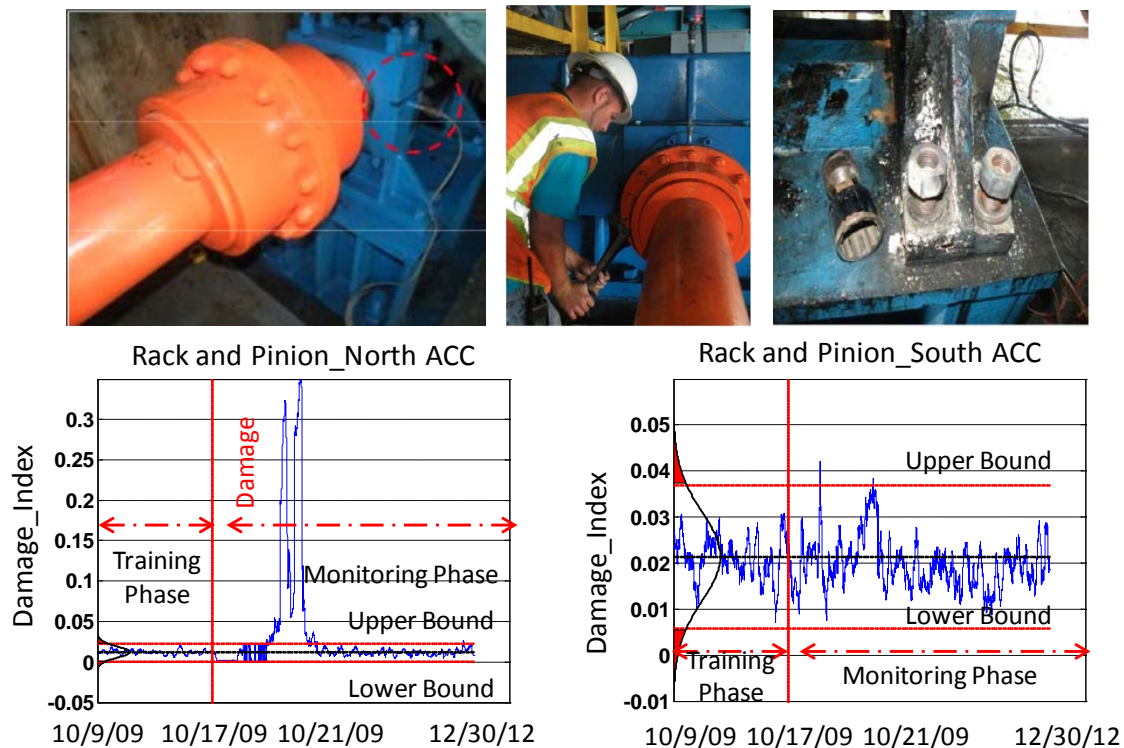
As shown in Figure 38 a representative damage scenario that was selected for the rack and pinion was to remove bolts from the system. Two bolts were removed from the north rack and pinion in order to simulate this common scenario. The results are illustrated in Figure 38 individually for north and south rack and pinion systems. It is obvious from the results that the damage index for the north rack and pinion exhibits an abrupt jump during the damage, while there is not any significant variation for the other system. The principal component values did not exceed the confidence interval for the south rack and pinion system, which indicates it was undamaged. The north rack and pinion system, where two bolts were removed, shows a dramatic change during the damage phase. The same index for the north rack and pinion system is bounded within the developed confidence interval before the damage and after it was repaired. Therefore, the MPCA can also be considered as an effective technique for damage detection of the rack and pinion systems.

Figure 38- Results of MPCA application for rack and pinion malfunction detection

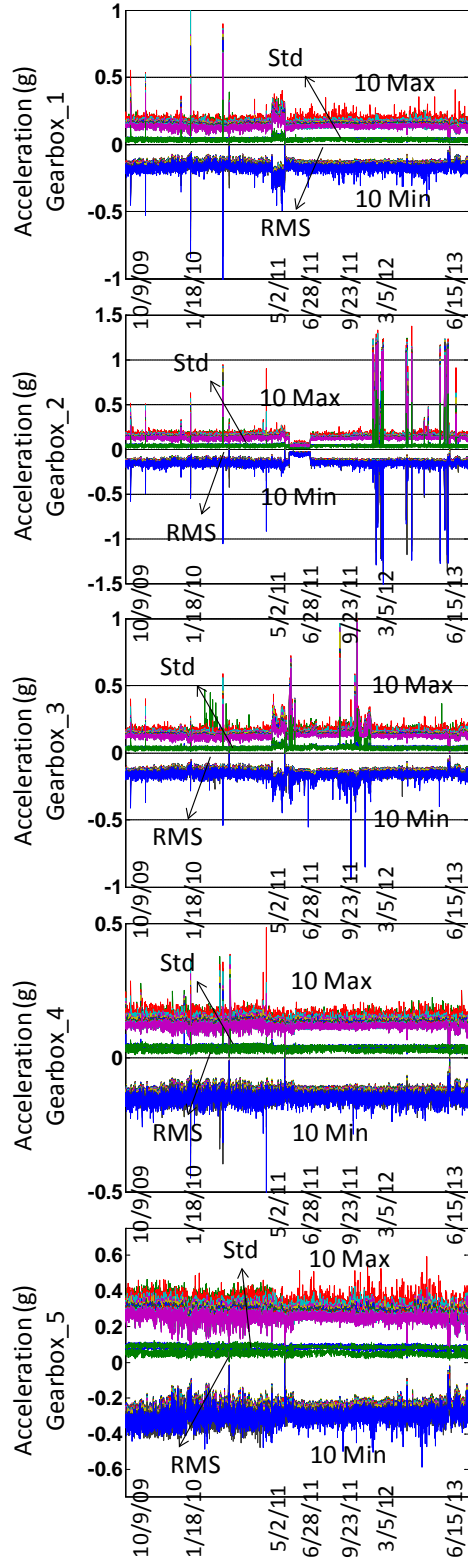
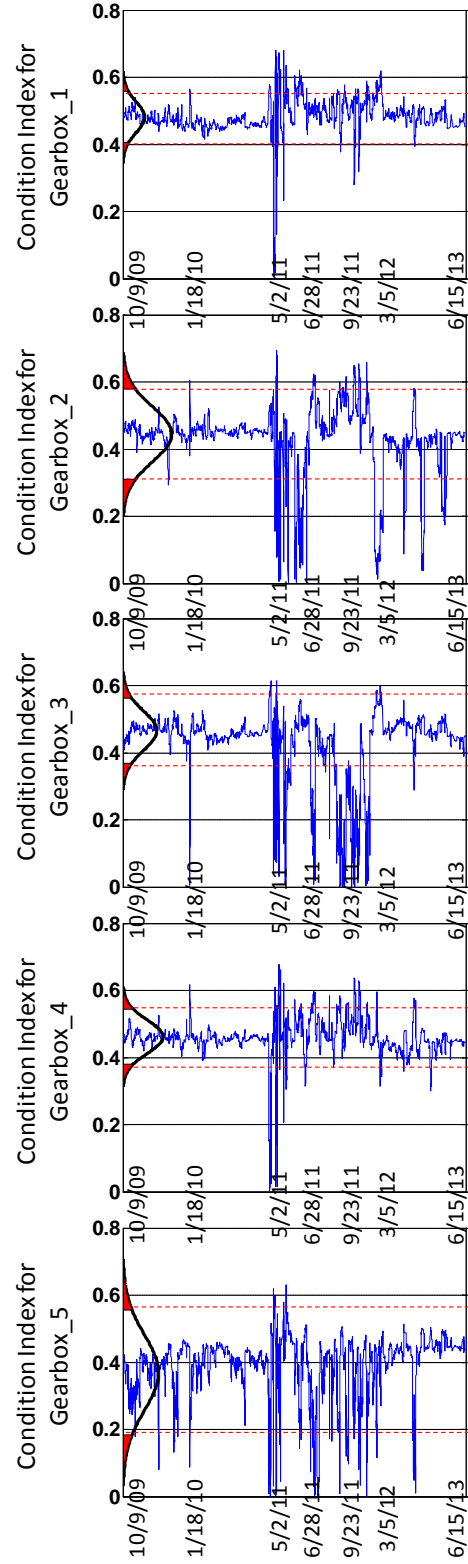
Figure 40- Long-term condition assessment of the gearbox using MPCA algorithm
