Maine Department of Transportation

Technical Report 00-19

Comparison of "Saw and Seal" Procedure and Performance Grade Binder to Minimize Thermal Cracking

Interim Report - Second Year, July 2004

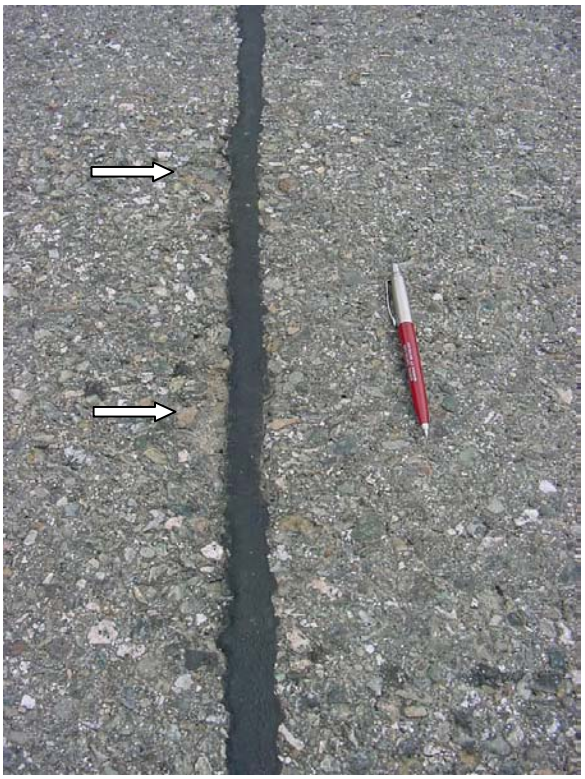
The Saw & Seal section has no transverse cracks but fifty percent of the centerline joint has initial cracking. Pavement has raveled on two of the sealed joints in the south bound lane. Photo one illustrates one of the two joints. Ravel is limited to an area between wheel paths and appears to be attributed to winter snow plowing. The sealant is pliable, flush to the roadway, and well adhered to the saw cut side-walls.

Photo 1: Saw and seal HMA ravel

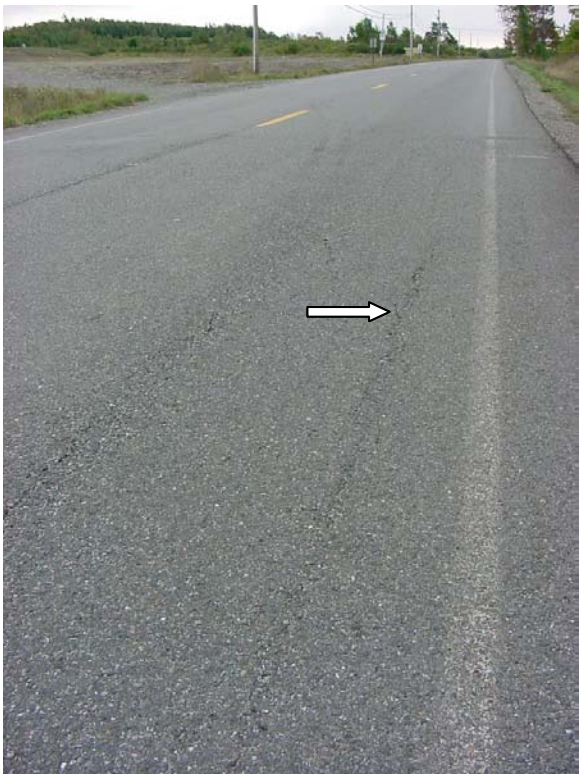
The Control Section has no transverse cracks with initial cracking throughout thirty three percent of the centerline joint. Ten meters (thirty three feet) of initial load cracking was observed in the south bound lane and can be seen in Photo 2.

Photo 2: Control section initial load cracking
