CONSTRUCTION AND MONITORING OF THIN OVERLAY AND CRACK SEALANT TEST SECTIONS AT THE PECOS TEST TRACK

Report 9-1529-2
Project 9-1529
Project Title: Low-Cost Safety Solutions, Pavement Preservation and Maintenance Practices for Rural Highways

TEXAS A&M TRANSPORTATION INSTITUTE
College Station, Texas 77843-3135

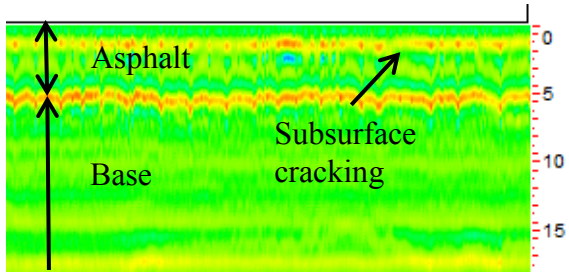
Figure 3. Test Track GPR Profile.

The southeast part of the circular track at the Pecos RTC facilities was used for the crack sealant tests (Figure 1). While most of the circular track was heavily distressed, the pavement in this section only had transverse cracking. Both older and newer pavement sections were evaluated (Figure 2). The older pavement was in the outside lane and had well-developed, deep, 1/4-inch wide transverse cracks every 15 to 20 ft. This lane was also super elevated, which led to some issues during sealant construction. The newer pavement consisted of two mill-and-overlay sections in the center lane. It had a mix of full-width and developing transverse cracks. These cracks were much narrower (1/8-inch wide max) and crack spacing was not consistent. The ground penetrating radar (GPR) data indicate that cracking extends to the bottom of the asphalt (see Figure 3).

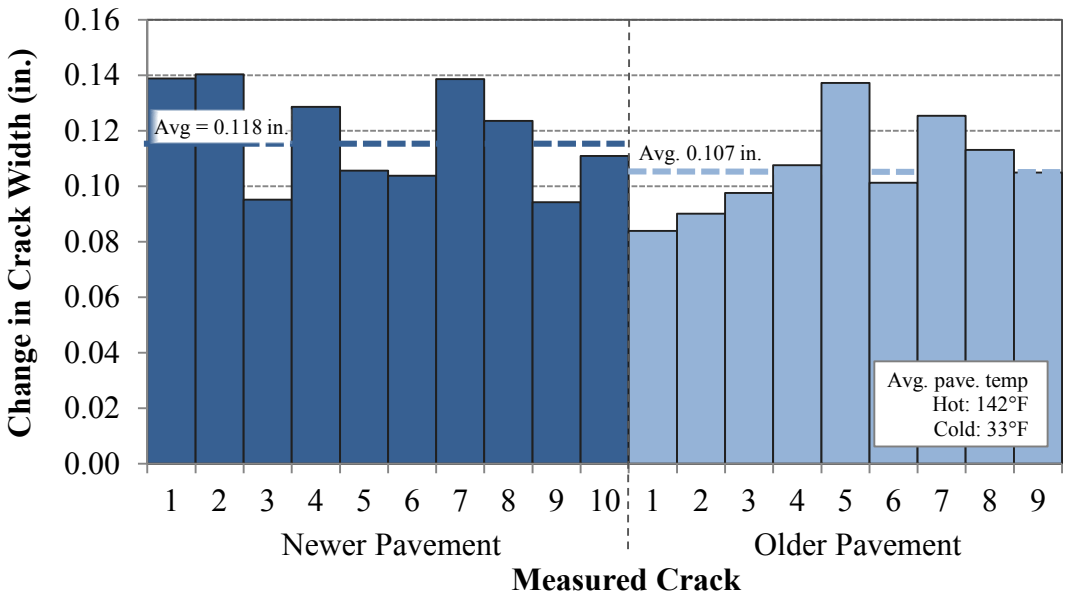
Figure 5. Crack Movement.

Crack movement from winter to summer is summarized in Figure 5. Movement ranged from 0.08 to 0.14 inches over a change in surface temperature of about 100°F. The average crack movement for the newer and older pavements was essentially the same, a little over 0.1 inches. For reference, the definition of an active crack according to the Federal Highway Administration (FHWA) is 0.125 inches of annual movement and is the amount to warrant routing. When testing crack sealant in the Overlay Tester, the maximum opening is set to 0.1 inches, which matches the maximum crack opening observed in the field.

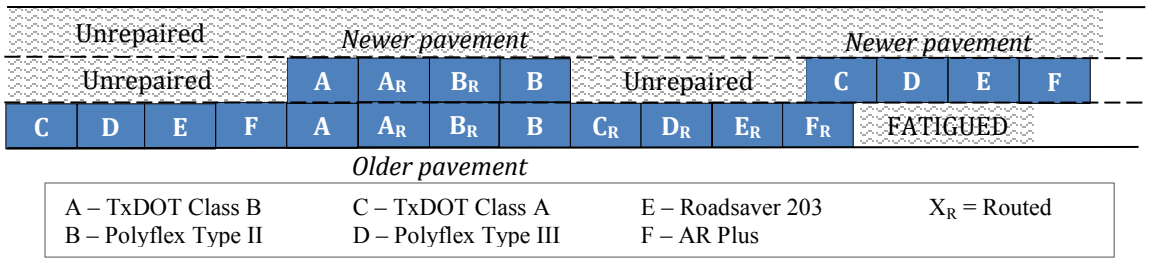
Figure 6. Section Layout.

Figure 6 shows the layout of the test sections. Each section contained 15 full-width transverse cracks with little to no branching. Section length was variable. Each section was evaluated visually the summer after construction. A heavy vehicle was slowly driven over the sealant sections to check for high temperature susceptibility. Sealants were also tested in the laboratory for adhesion properties at 45°F and 33°F.

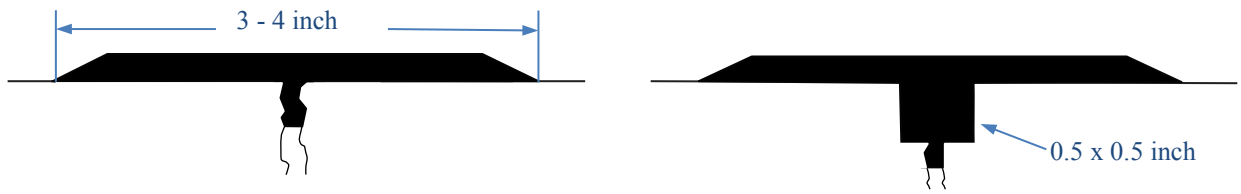
Figure 8. Sealant Configurations.

(a) Simple Overband (Non-Routed) **(b) Reservoir Fill with Overband (Routed)**

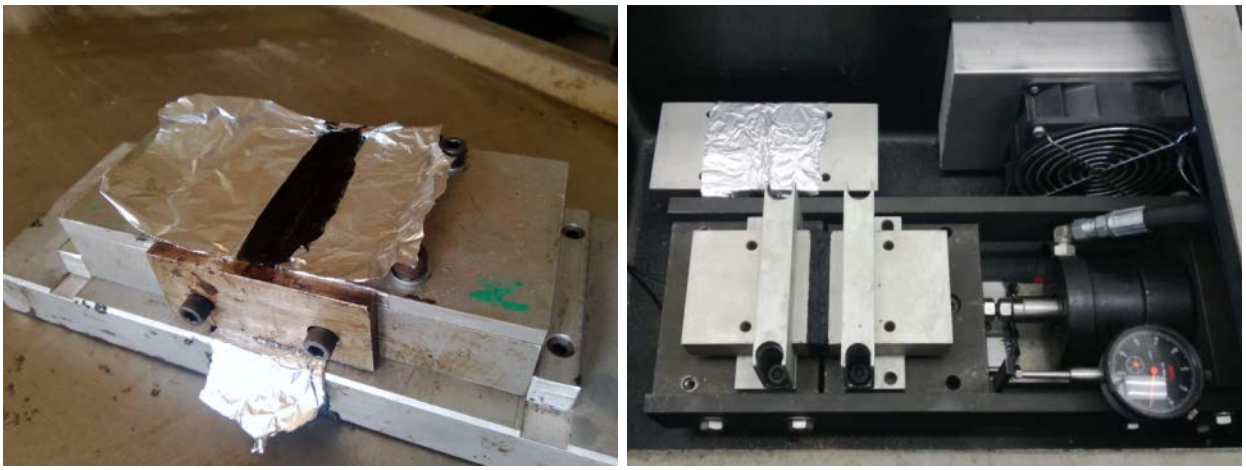
Figure 12. Crack Sealant Adhesion Test.

(a) Mold and Sample **(b) Sample during Testing**

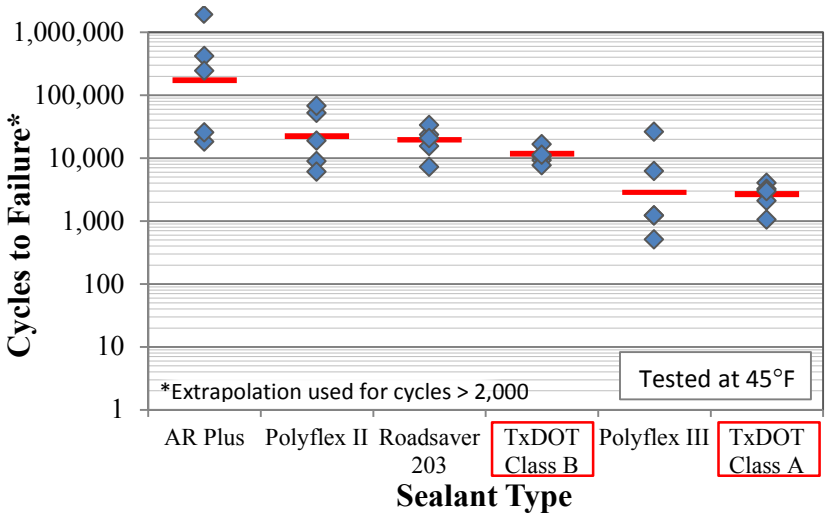
Figure 13. Adhesion Test Results at 45°F.

The test results are illustrated in Figure 13 and Figure 14, and the data with statistical groupings are in Table 1. The thick horizontal bars in each figure are the geometric averages (as opposed to the arithmetic average), which is most appropriate for logarithmically scaled data. At 45°F, there was minor differentiation among sealants statistically. Sealants AR Plus, Polyflex Type II, and Roadsaver 203 were in the highest performance group A. Group B consisted of all sealants

except AR Plus. Therefore, at 45°F, only AR plus had significantly better performance, and there was no statistical difference among sealants in the lower performing group. When testing at 33°F, there was more differentiation among the materials. Roadsaver 203 statistically performed better than all other sealants but AR Plus. The two worst performing sealants were TxDOT Class A and Polyflex Type III, each statistically independent. Other groupings are not discussed here, but are shown in the table. Appendix B contains the complete results of the statistical analysis.

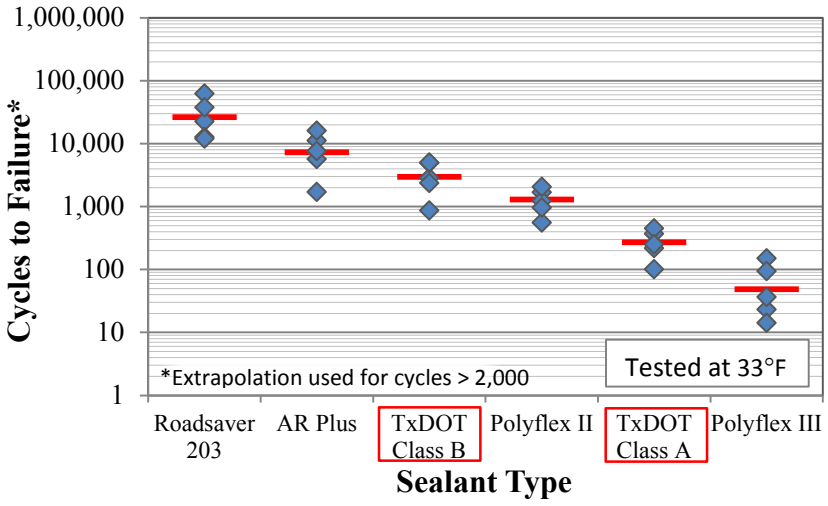
Figure 14. Adhesion Test Results at 33°F.

These findings suggest that there are sealants on the market that perform better than both current TxDOT crack sealant specifications (Class A and B). At 45°F, that sealant is AR Plus, and at 33°F, Roadsaver 203. In future testing, these sealants should be placed in the field beside current TxDOT sealants for performance comparisons. If these sealants can remain intact a few years longer, maintenance funds could be applied to address other needs.

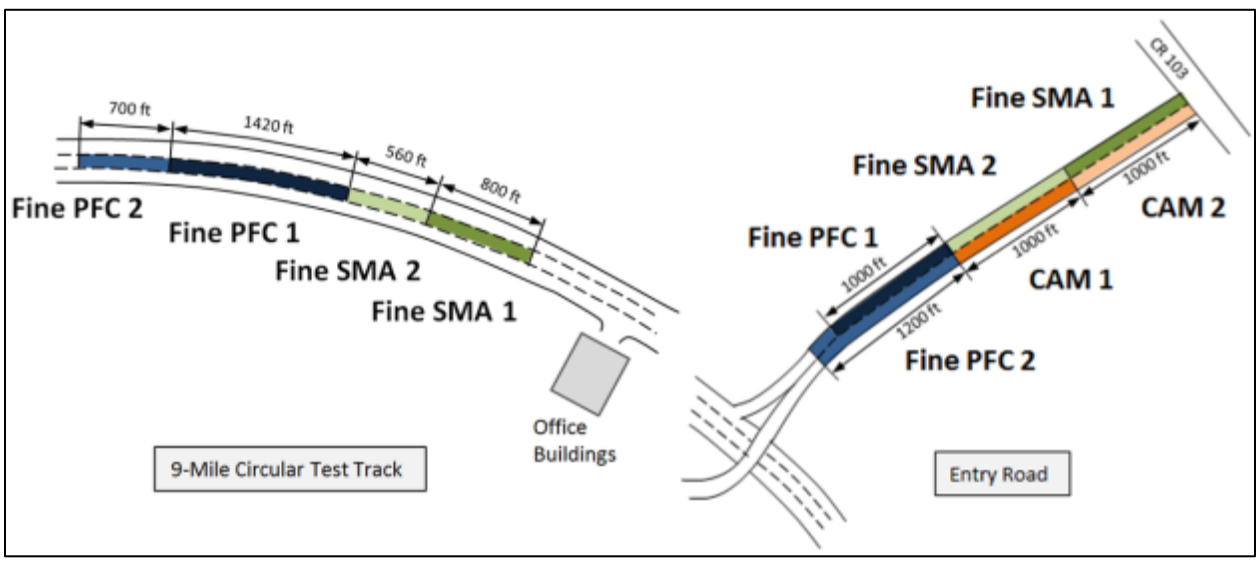
Figure 15. Section Layout.

Figure 15 and Figure 16 show the schematic of the test sections constructed at the Pecos facility. Figure 16 shows a before and after photo of the roadway condition. These sections have all performed very well and the implementation described later was only possible based on the excellent performance of these original sections.

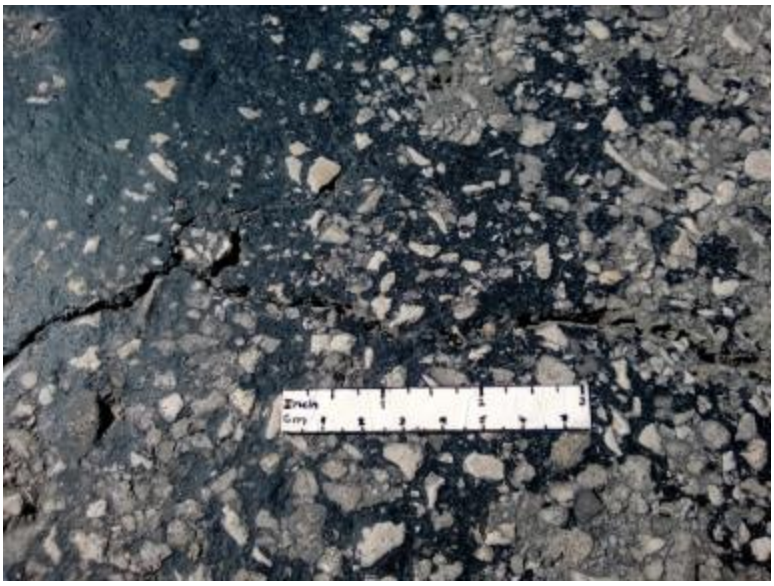
Figure 30. Existing Crack.

This project was located on SH 16 in the San Antonio District, starting on the Bexar-Atascosa County line. Sealant sections were placed in the northbound, outside-lane. The pavement condition was characterized by low- to moderate-severity longitudinal cracking in the wheel path with occasional transverse cracking, as shown in Figure 29 and Figure 30. The cracks had been sealed previously, but most of the cracks had reappeared. The average crack width was 0.25 inch.

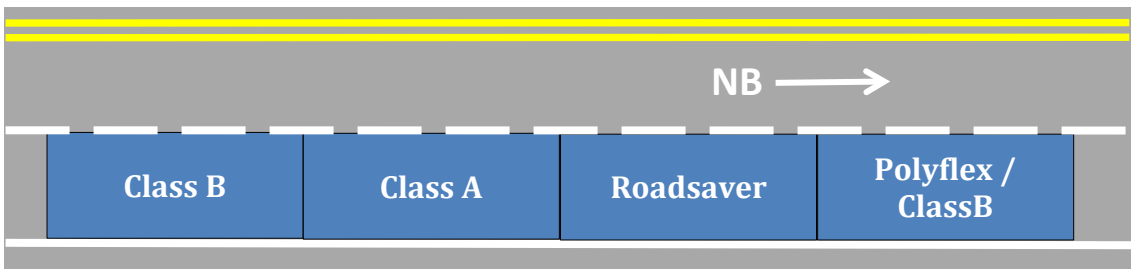
Figure 31. Section Layout.

The layout of the test sections is shown in Figure 31. In each section, 15 longitudinal crack segments, 10-ft long, were identified. These segments were sealed with the specific test sealant while all other crack segments in the section were sealed by maintenance crews with their own TxDOT Class B sealant.

*Each section contains 15 10-ft longitudinal cracks
