Developing a Reliable Signal Wire Attachment Method for Rail

4. TITLE AND SUBTITLE Developing a Reliable Signal Wire Attachment Method	5. FUNDING NUMBERS DTFR53-12-C-00002
6. AUTHOR(S) Dave Workman, Cameron Stuart

9. SPONSORING/MONITORING AGENCY NAME(S) AND ADDRESS(ES) U.S. Department of Transportation Federal Railroad Administration Office of Railroad Policy and Development Office of Research and Development Washington, DC 20590	10. SPONSORING/MONITORING AGENCY REPORT NUMBER DOT/FRA/ORD-14/33

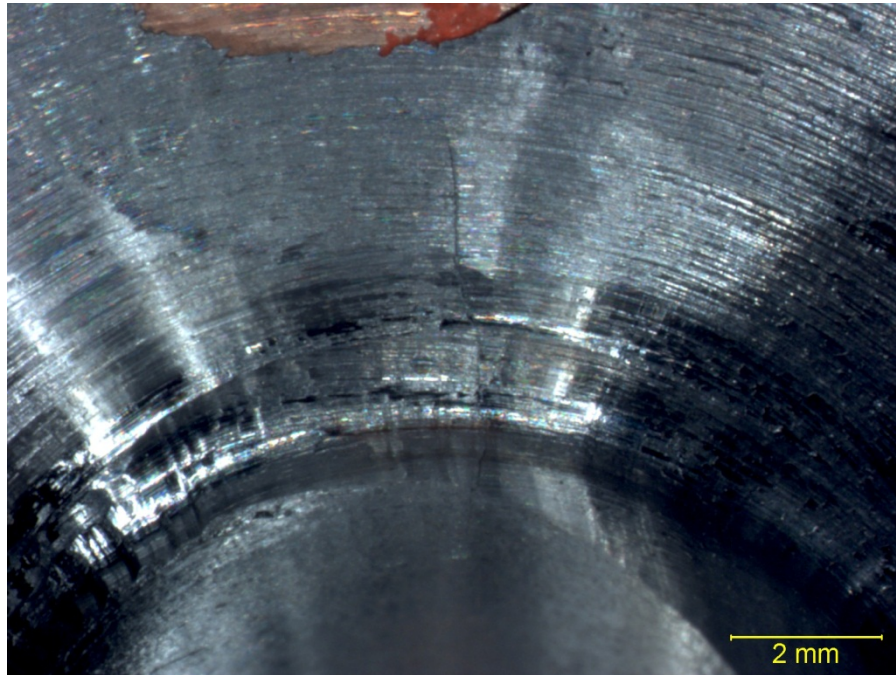
Figure 4. Perspective View of Crack on Backside of Sample

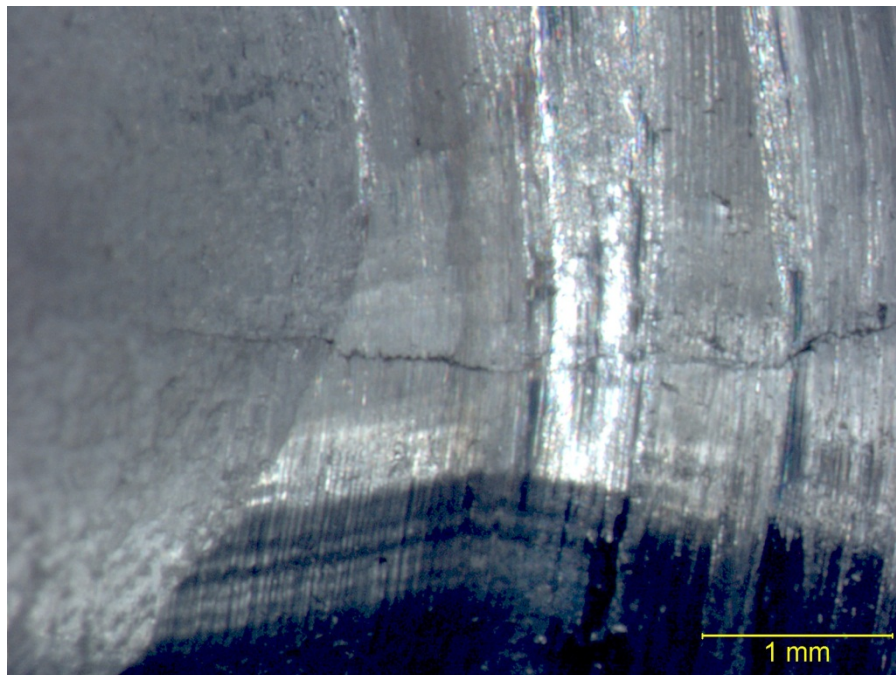
Figure 5. Detail View of Crack in Section

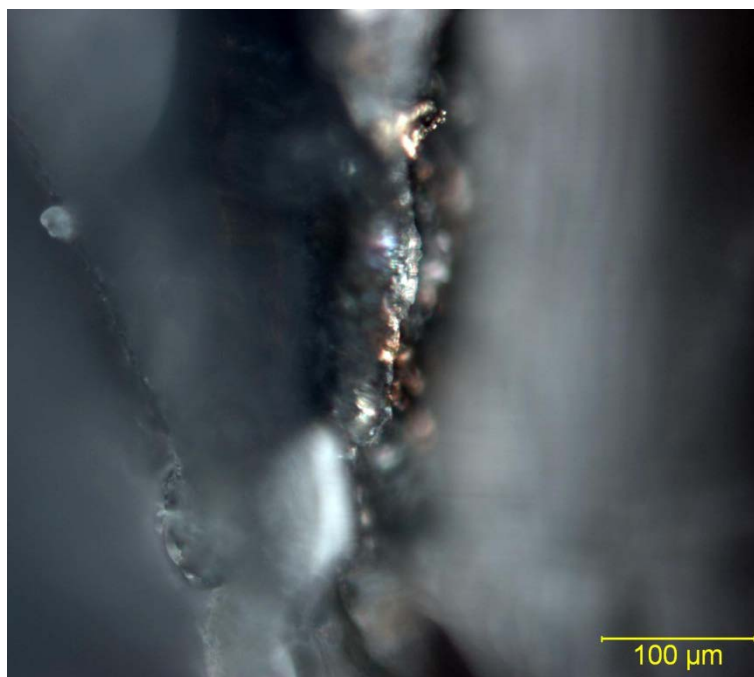
The smaller section of the crack was broken open and viewed optically to determine what the fracture face contained. As shown in Figure 6, copper decorates the surface of the crack face. Others areas of the sample showed similar evidence of copper on the crack face, clearly indicating copper contamination or liquid metal embrittlement (LME). LME occurs when a lower melting metal flows across a higher melting metal under tensile stress. Note that a tensile stress is present in the rail in order to maintain the neutral rail temperature and the braze and solder materials used are known to cause LME in steel.

Figure 6. View of Crack Face Showing Copper on the Surface

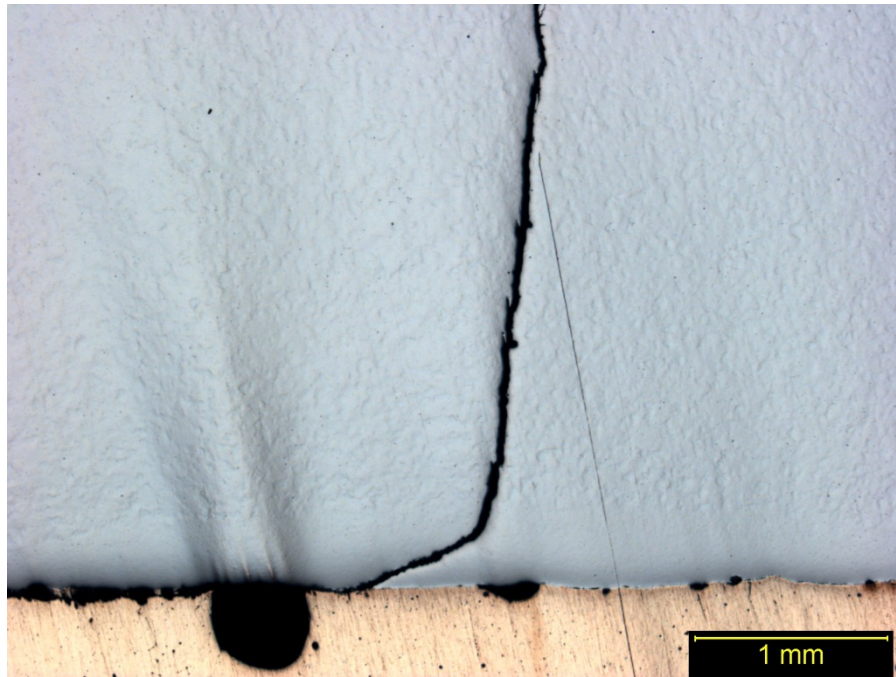
The results of the initial grinding of the crack section are shown in Figures 7 and 8. Additional photos of the area adjacent to the crack are shown in Figures 9–11, where areas of possible LME are present.

Figure 7. Macro View of Crack at First Grind Level

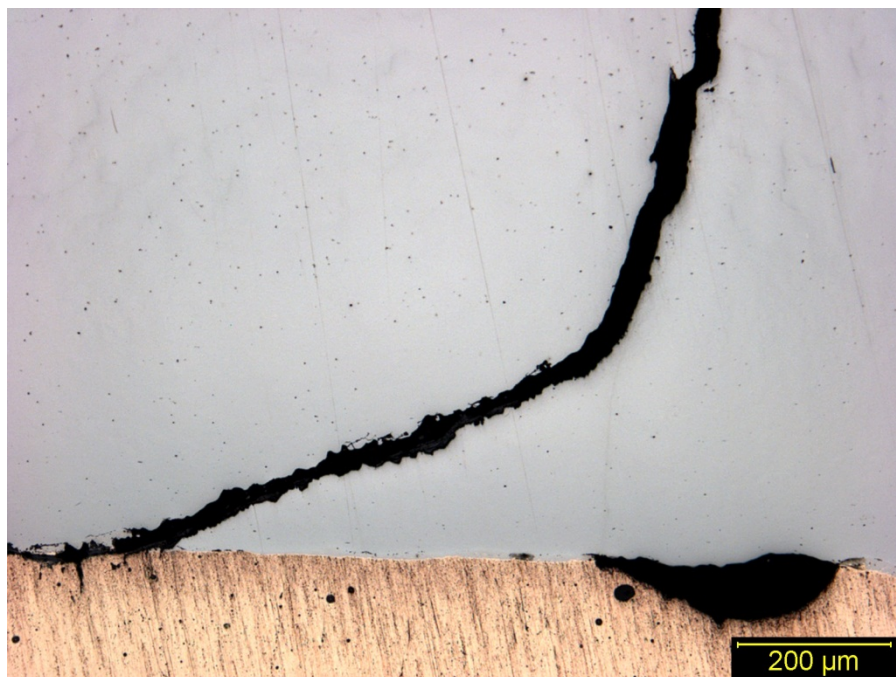
Figure 8. Close-Up of Crack Area at First Grind Level

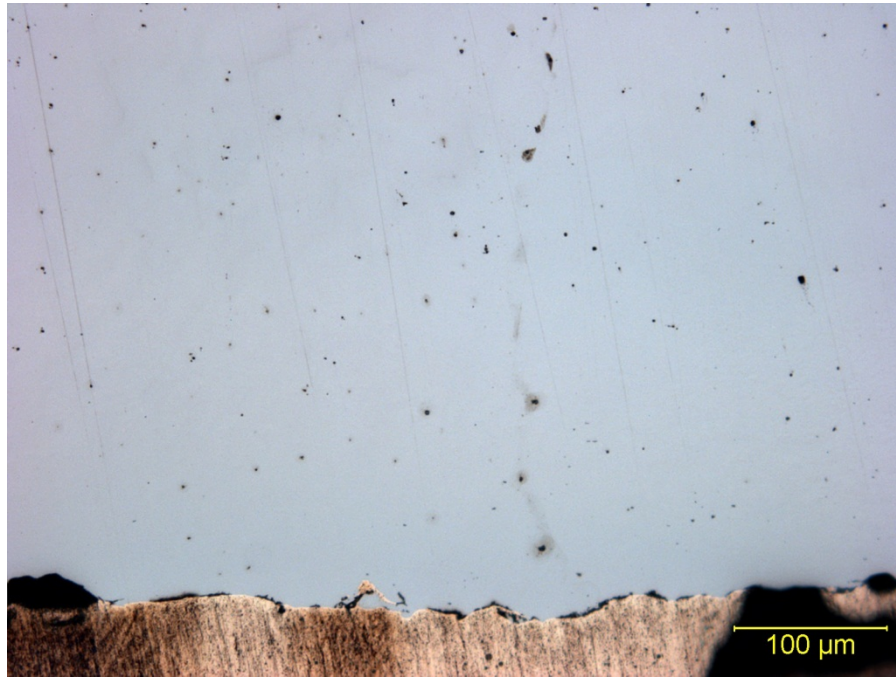
Figure 9. Adjacent Area of Suspected LME Copper Contamination

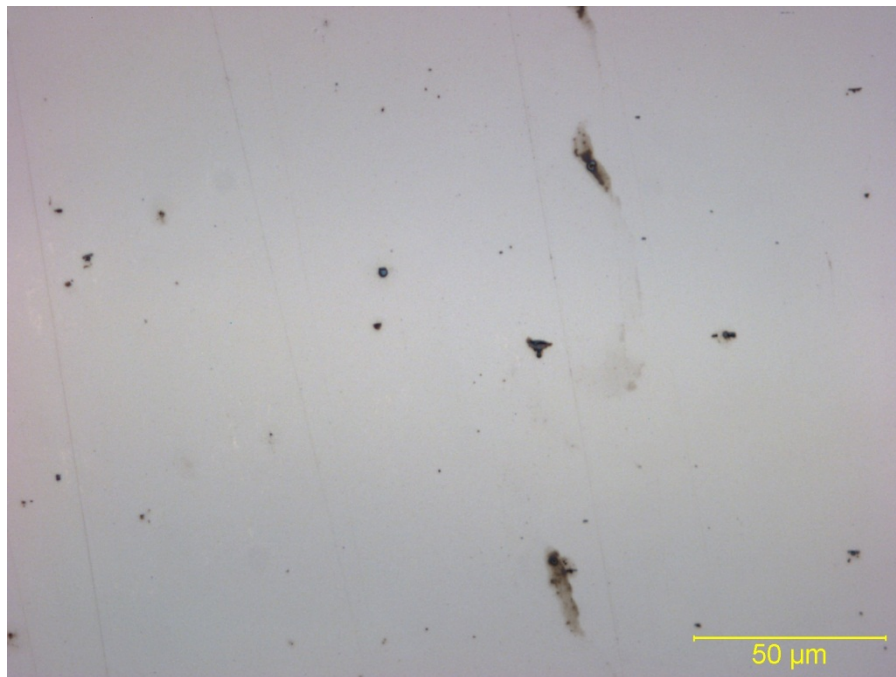
Figure 10. Suspected LME Area Detail

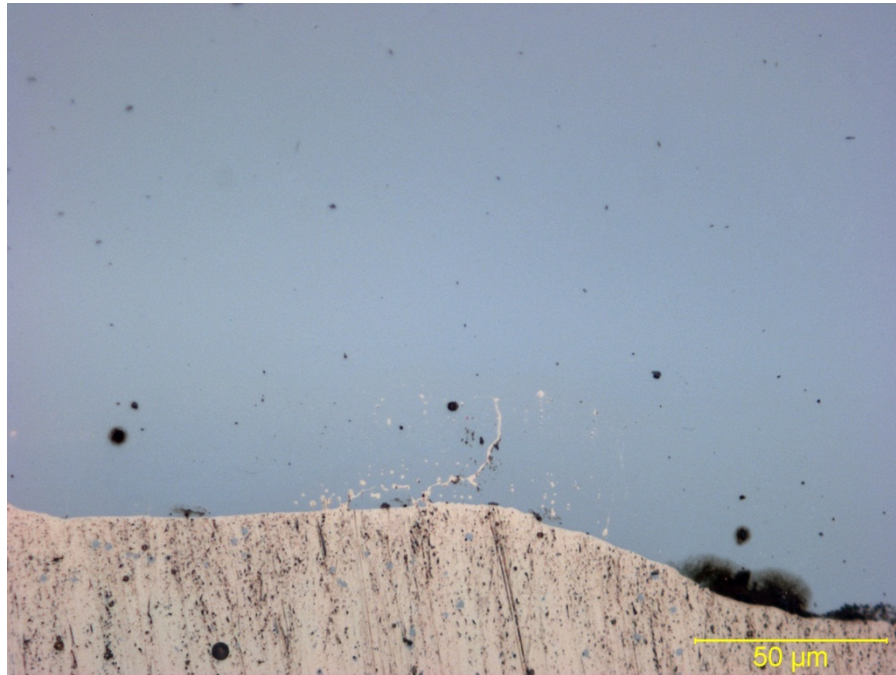
Figure 11. Adjacent Area of Suspected LME in Stage 1 Grind

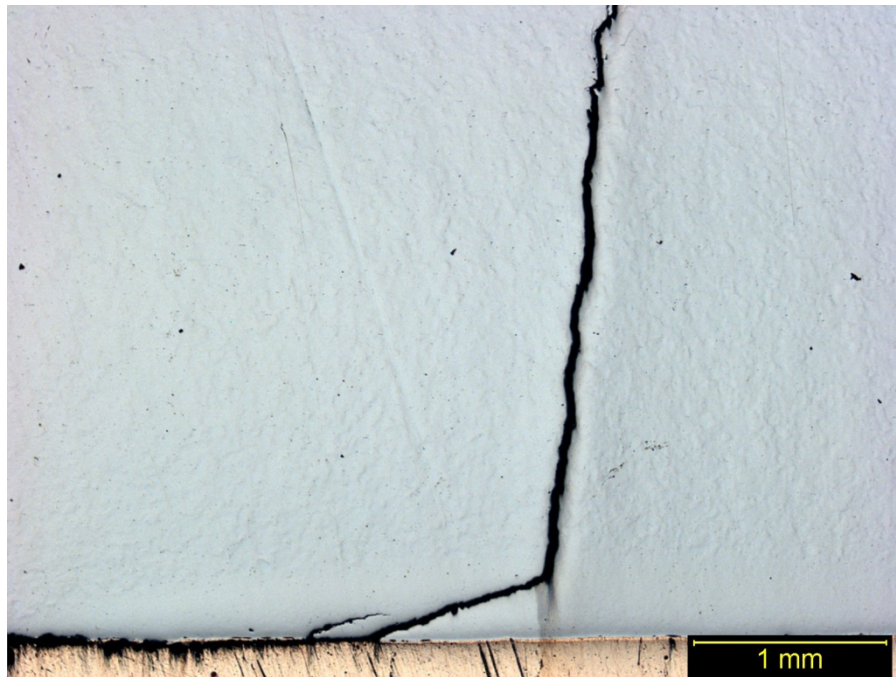
The secondary grind macro view is shown in Figure 12, and a detailed image of the secondary crack that develops at greater grind depth is shown in Figure 13. Figure 14 shows an area where copper appears to be attached to the crack edge although there is a possibility of contamination from the grinding process. More detailed photos in Figures 15 and 16 show the copper migrating along the fusion boundary between the weld alloy and the steel at shallow depths.

Figure 12. Macro View of Crack at Stage 2 Grind

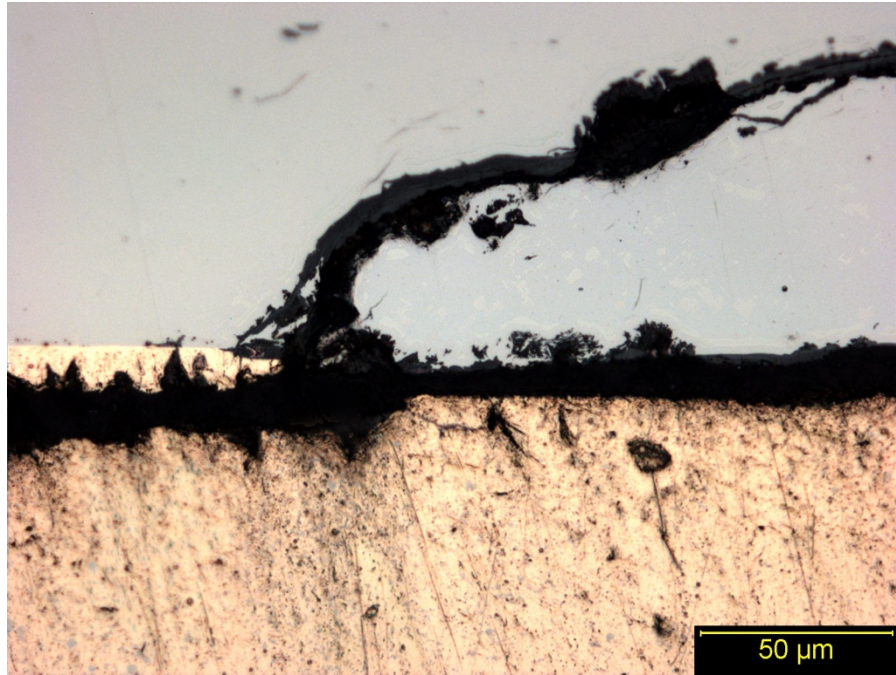
Figure 13. More Detailed View of Secondary Crack

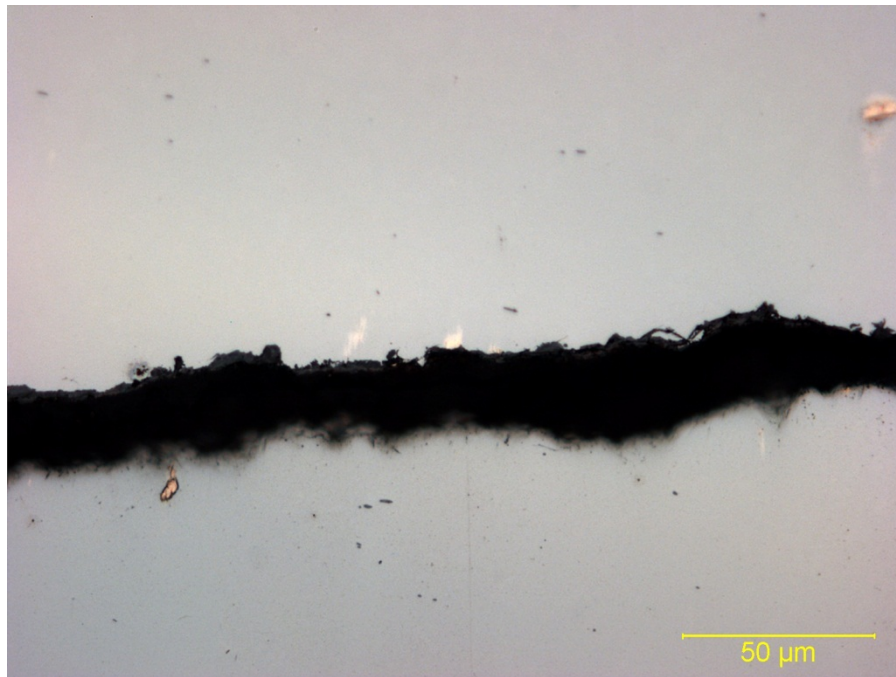
Figure 14. Area of Crack Showing Potential Copper Contamination on Crack Edges

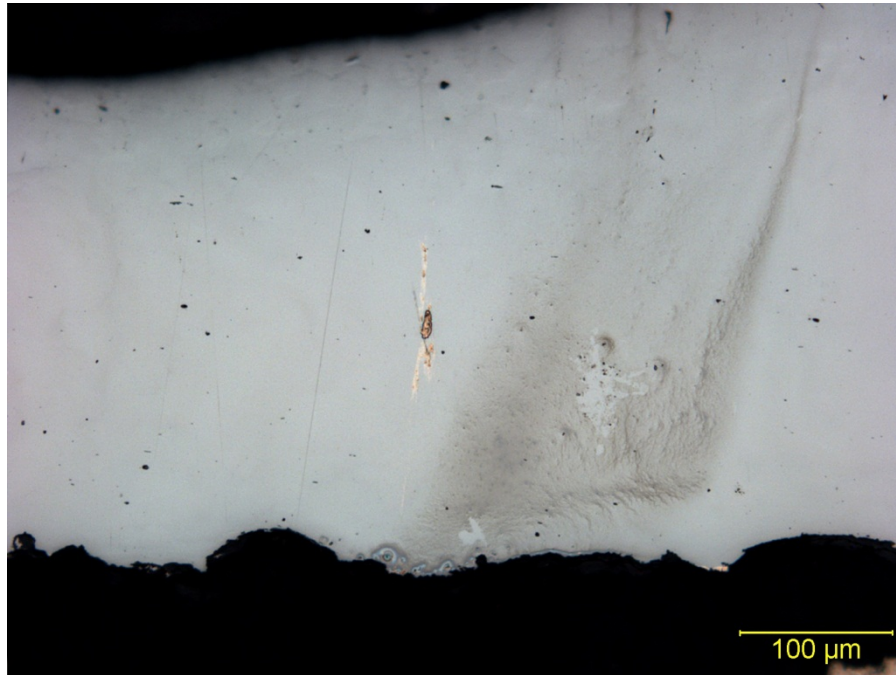
Figure 15. Adjacent Area to Crack Showing More Typical LME

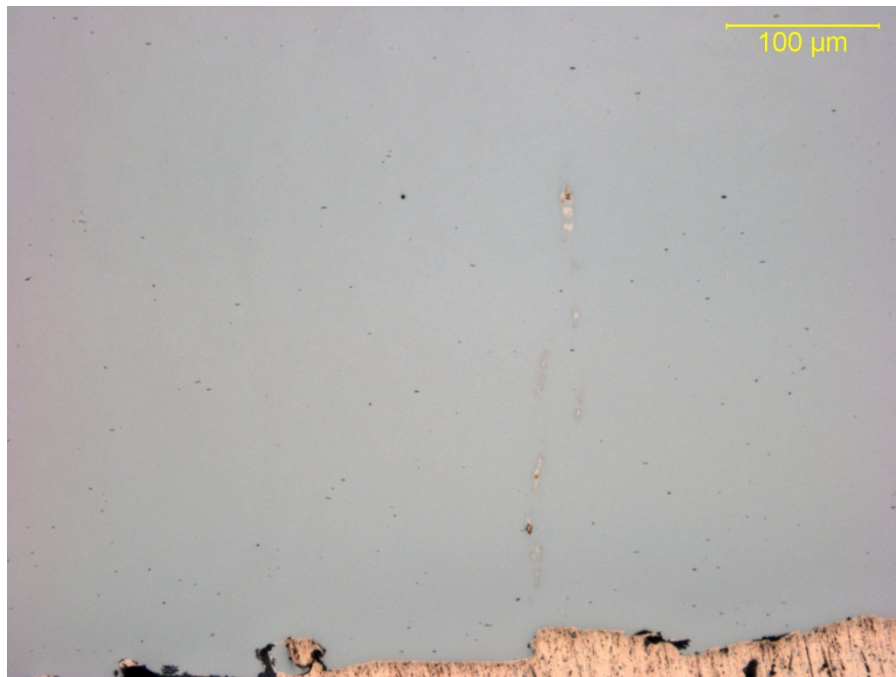
Figure 16. Potential Copper Penetration into the Steel

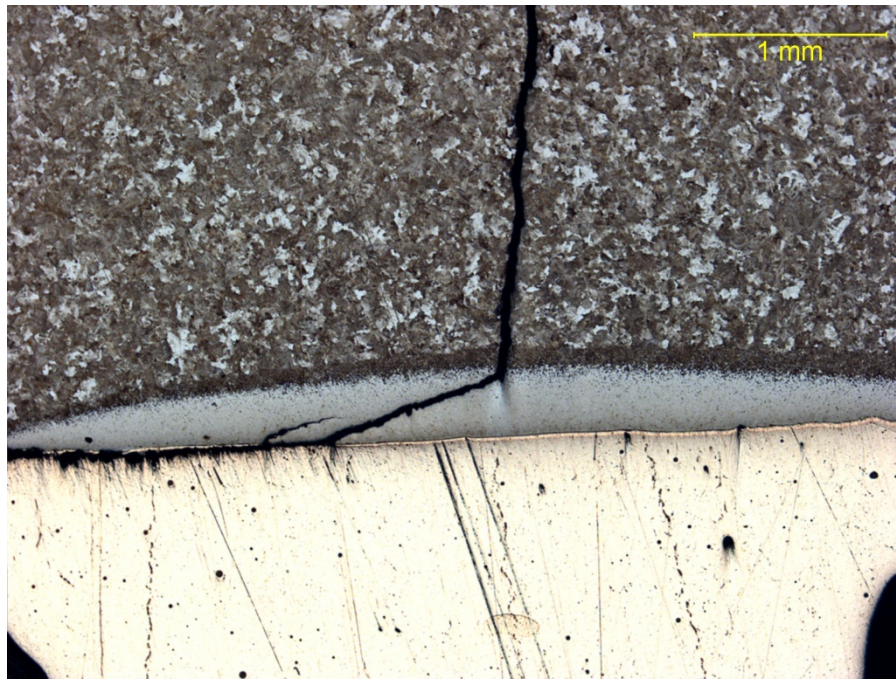
In addition, there is an area of microstructurally modified steel at the copper-to-steel interface. The round copper inclusions and the grain structure in the fusion zone indicate that the steel in this area was melted and re-solidified with the copper being rejected during terminal solidification. Additional images of this area are provided in Figures 19 and 20.

Figure 17. Etched Section of Crack Area

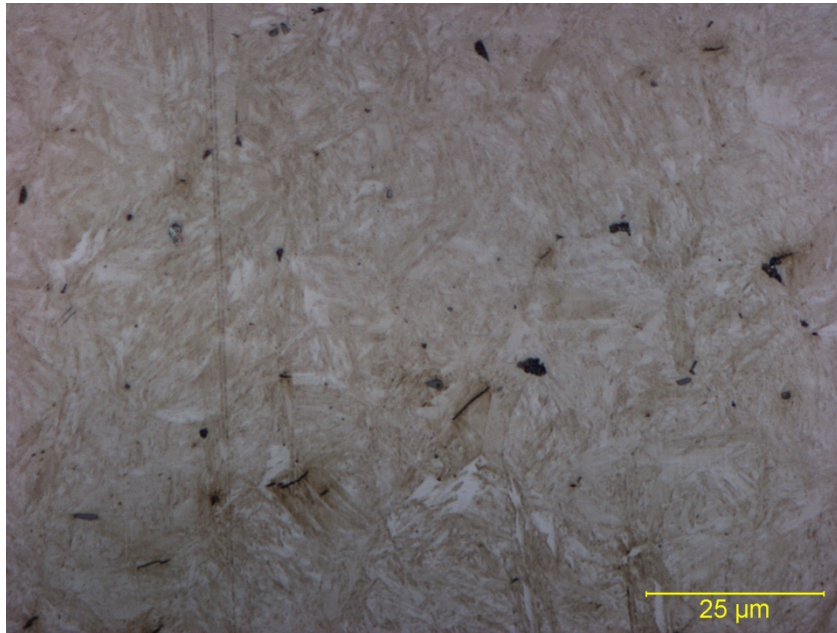
Figure 18. Microstructure in HAZ

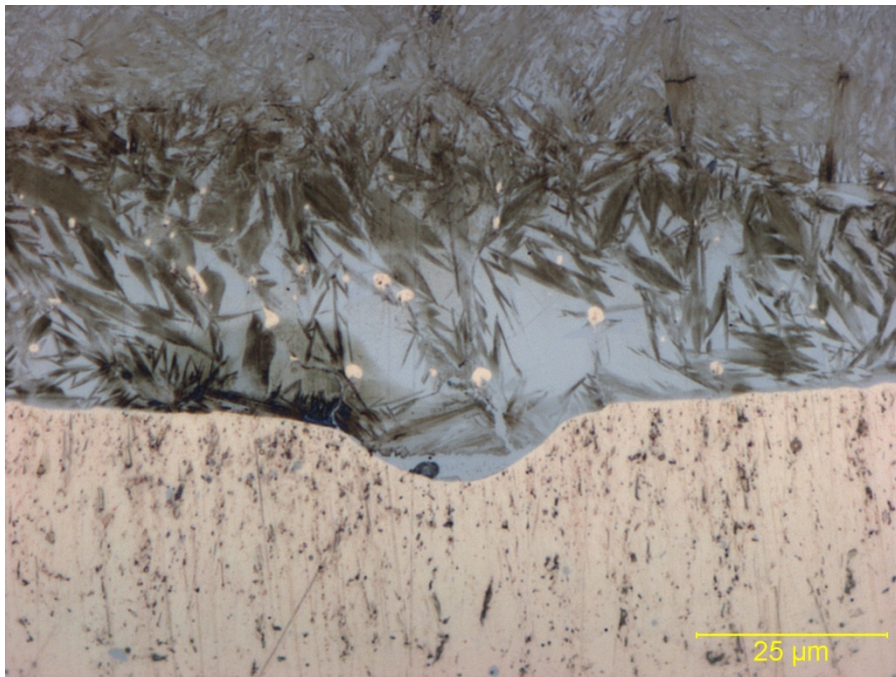
Figure 19. Detail of Copper Globules in HAZ

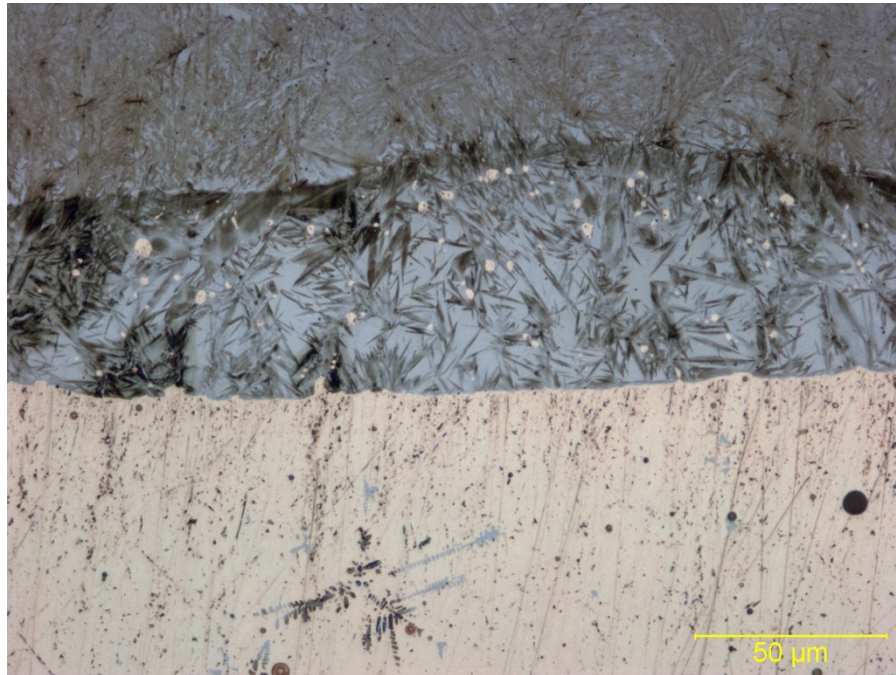
Figure 20. Copper Globules in HAZ

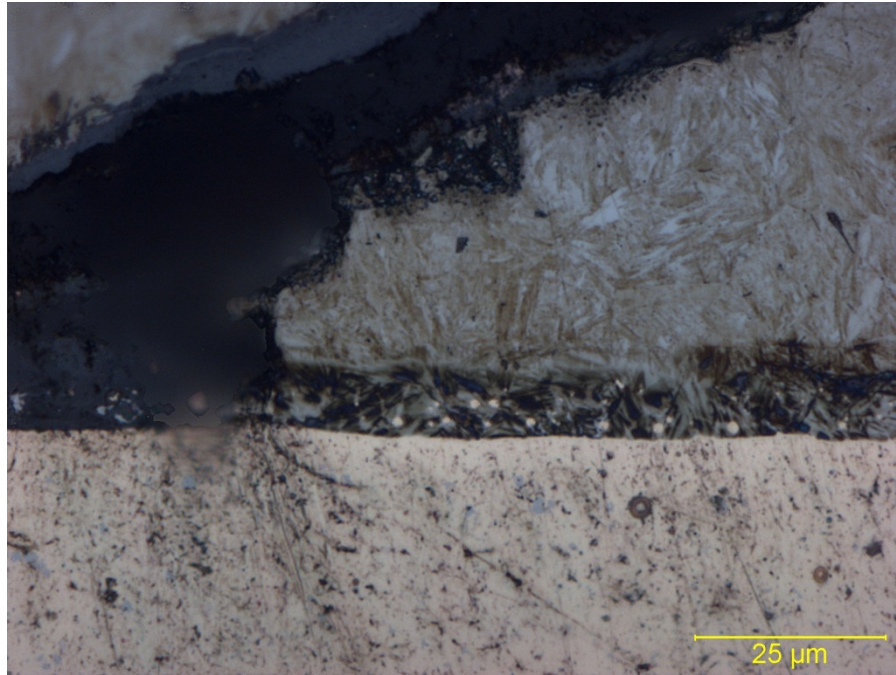
It is possible that the steel immediately adjacent to the weld interface was melted by an overheated weld alloy. This condition allows the copper to dissolve into the molten steel and, upon cooling, decorate the grain boundaries in inter-dendritic regions. It is possible that the increase in temperature allowed the copper to go into solution in the steel in the areas adjacent to the fusion boundary. This theory is supported by the copper-iron phase data shown in Figure 21. Copper solubility decreases upon cooling and it is rejected along the grain boundaries. Figure 22 shows the presence of copper in the HAZ next to the crack.

Figure 22. Crack Area Showing Copper Globules Next to Fusion Boundary

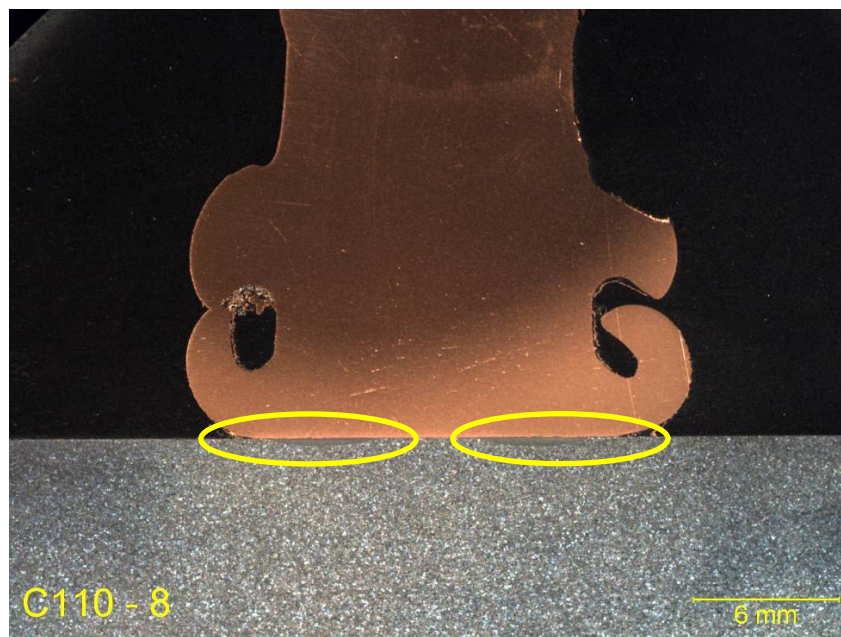
Figure 26 shows the cross section of a weld at low energy produced with C110 copper. Note that the depth of martensite in this weld exceeded the depth observed with other materials. This difference was likely due to the higher surface velocity required to join the very conductive C110 material to the rail.

Figure 26. Cross Section of C110 Weld Produced with Inertia Friction Welding

Because of its high conductivity, the copper can extract heat from the joint at a very rapid rate. This leads to an imbalance in heating between the two sides of the joint. It is believed that this conductivity mismatch drives the need for lower weld forces and/or higher surface velocity to generate higher temperatures at the interface. These two parameters must be shifted upward to create a sound joint, creating the higher peak temperatures in the joint necessary to successfully join the C110 to the steel. As previously mentioned, the goal of the process development was to make joints with minimal heat input to avoid the steel transformation temperature.

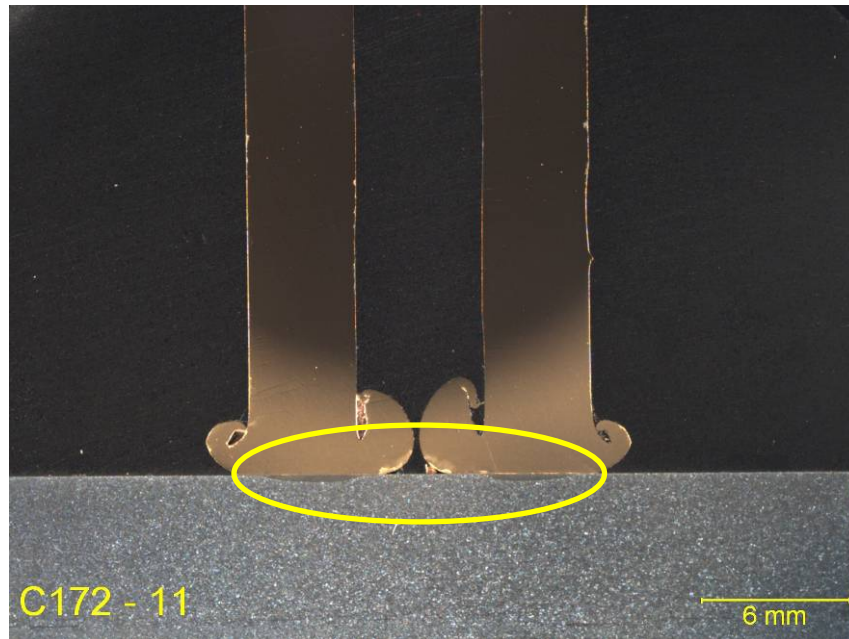
The C172 alloy required high weld forces. This is likely due to the material's inherently high strength and the short heating time required for joining. This short duration allows the precipitates to remain somewhat intact, thus maintaining the material's high strength. The material produced sound welds, but it also produced very shallow HAZ in the rail steel with martensite formation at the bondline, as shown in Figure 27.

Figure 27. Cross Section of C172 Weld 11 Showing Small Areas of Martensite below Weld Joint

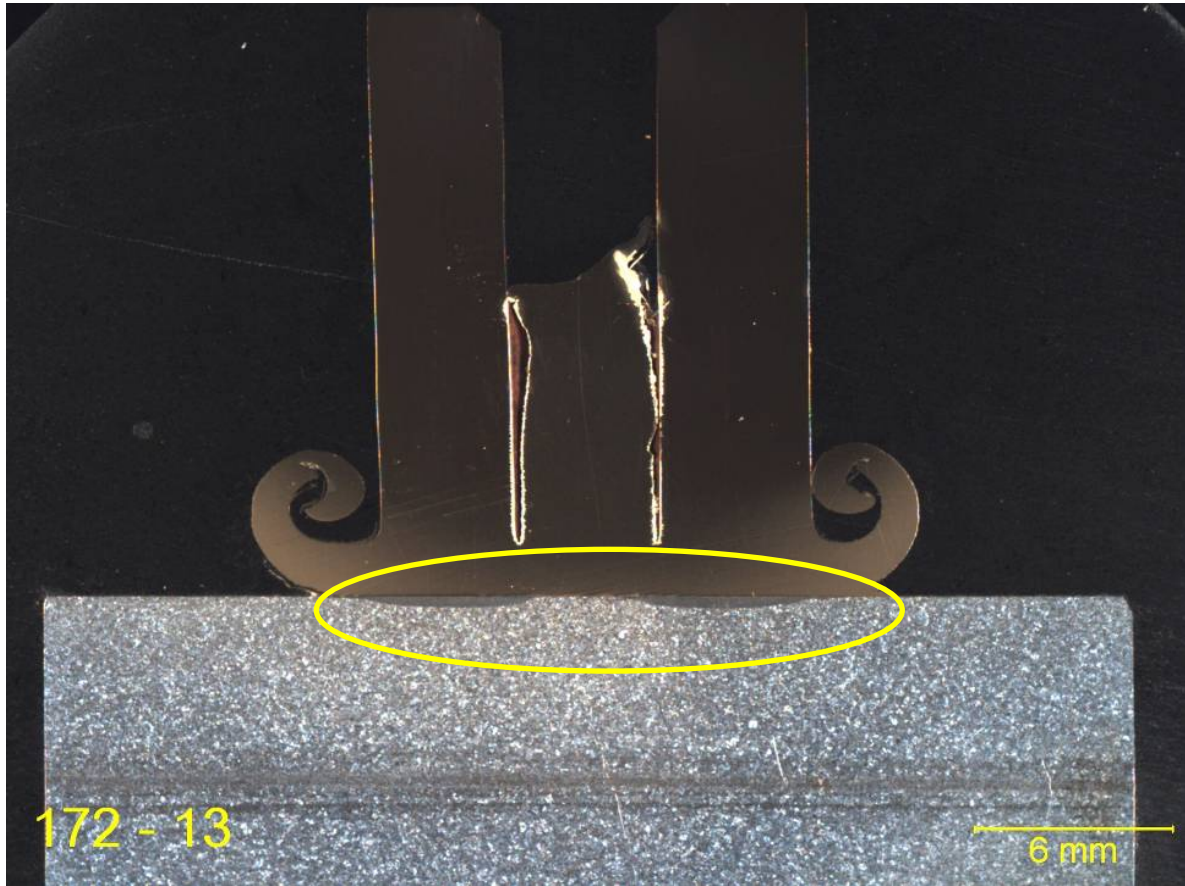
Use of lower surface velocity (i.e., lower RPMs) was possible with this alloy because of its low conductivity, and the heat generated tended to stay at the weld joint interface, creating a bond with lower upset levels. However, the lower surface velocity used in the welds required additional rotational mass in the form of weights to be added to the inertia welding system. This in turn increased the heat input into the weld joint. The strength of the material itself is close to that of the rail steel. High torque levels were required to create the shearing and upset needed to make a friction weld joint. Overall, this material would be difficult to use in the field because of the high thrust loads and larger rotating mass requirements. Higher thrust loads add weight to the inertia welding system and the additional energy required to form a joint with the material risks forming martensite. Figure 28 shows a weld made with the approximate limit to thrust load, 6,000 lb, in C172 where a notable band of martensite was still present under the joint in the rail steel.

Figure 28. Weld Made with Maximum Allowable Thrust Load in C172 Alloy with Heavy Martensite Present under Joint

This alloy showed promise, but in order to keep the weight of the in-field equipment to a manageable level, the thrust load required to make a weld would have to be below 6,000 lb. No martensite-free welds were produced with the thrust load below this level. It is assumed that higher thrust loads with this alloy would produce martensite-free welds, but in order to focus the work on a field deployable solution, we concluded that other alloys provide a better solution. Work was discontinued on this alloy.

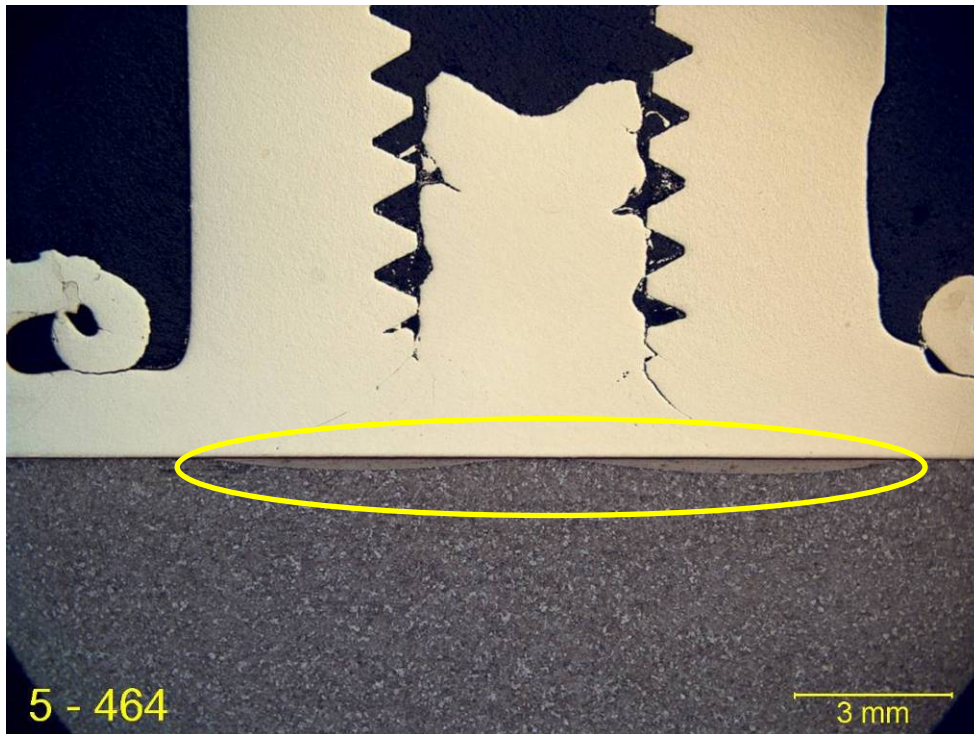
Initially, welding trials with the C464 naval brass showed martensite under the joint in the rail steel just like the other alloys exhibited (see Figure 29). Table 5 shows the welding trials conducted on the C464 alloy with a variety of speeds and thrust loads.

Figure 29. C464 Naval Brass Weld Exhibiting Narrow Band of Martensite in Rail Steel during Early Development

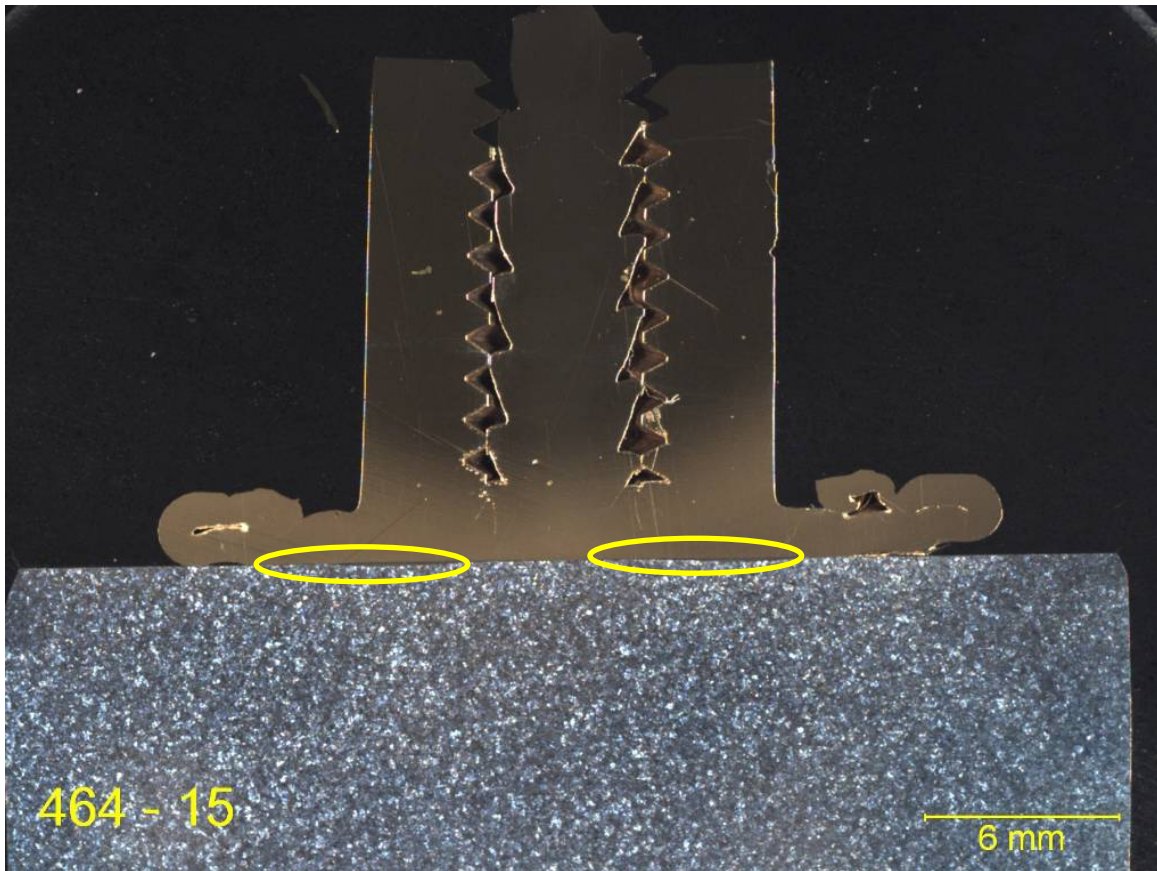
As welding thrust load was increased and total energy in the weld was decreased, the size of the martensite layer shrank notably. The C464 alloy was unique in that the size of the martensite layer could be modified through changes in process parameters. Figure 30 shows a section of a weld taken with higher thrust load and reduced energy welding parameters. Note the size change in the martensite layer.

Figure 30. C464 Alloy Weld Showing Different Sized Layer of Martensite Responding Significantly to Parametric Changes

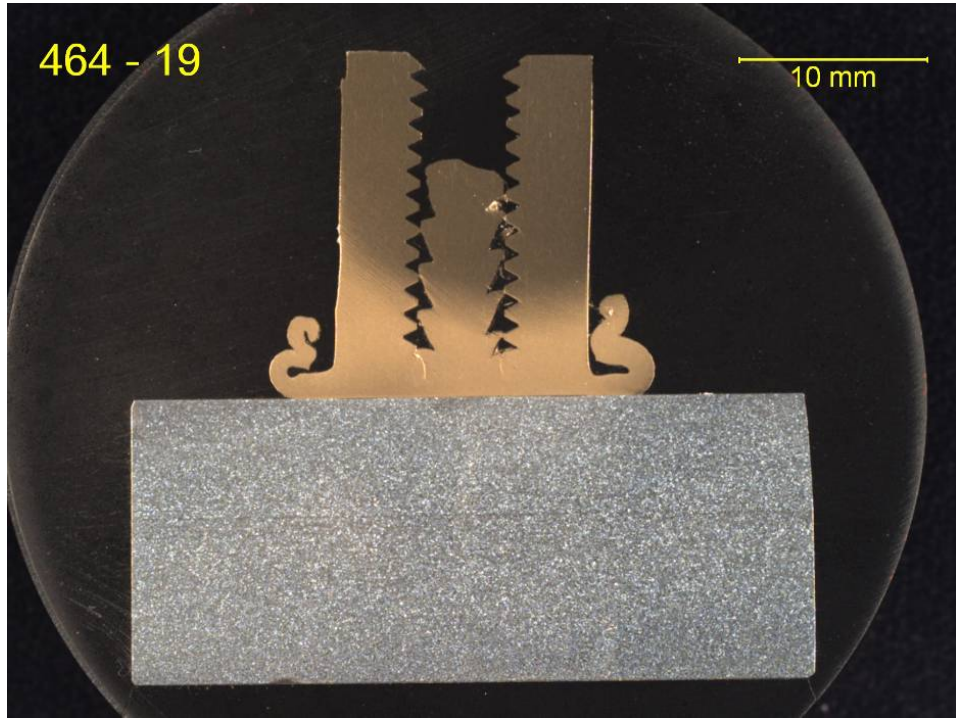
In the welding trials, it was noted that a minimum surface velocity was required to form a weld with each material. In the C464 alloy, that surface velocity or speed in RPMs was approximately 4,500 RPMs. Welding trials were conducted at 4,000 and 4,500 RPMs in Welding Trial Numbers 19 and 20. Figures 31 and 32 show the welds in macro view, respectively. No martensite was present in these welds at higher magnification, as shown in a detail of the bondline in Weld 19 (Figure 33). SEM analysis of the bondline area is shown in Figure 34. The deformation of the lamellae in the pearlite of the steel is apparent without the presence of martensite.

Figure 31. Macro View of Weld 19 in C464 Showing Martensite-Free Joint

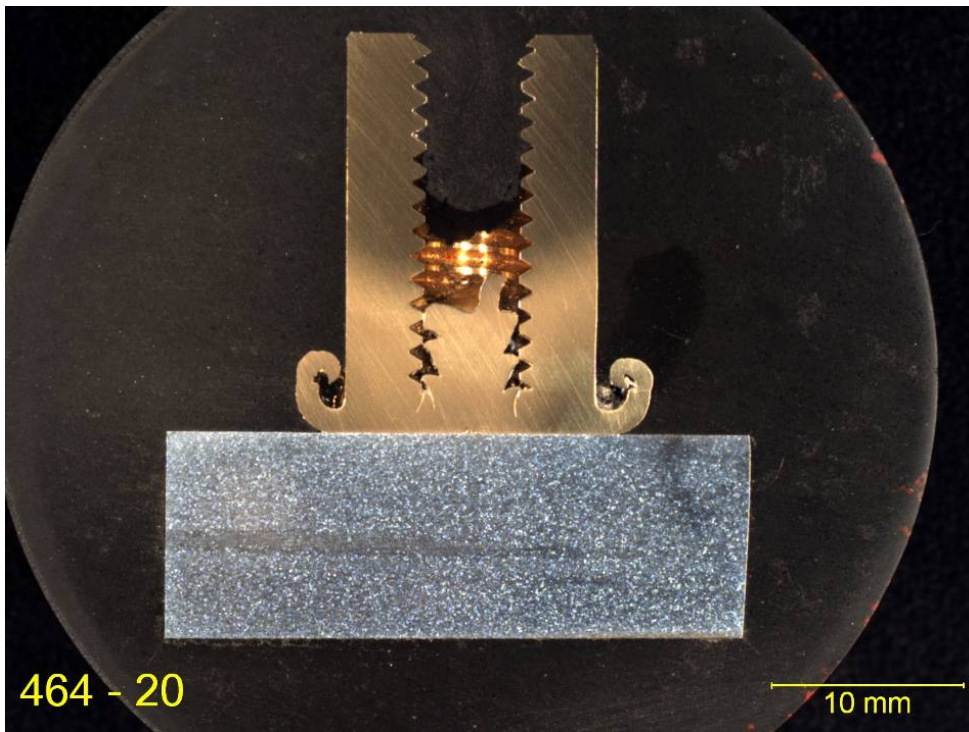
Figure 32. Macro View of Weld 20 in C464 Showing Martensite-Free Joint

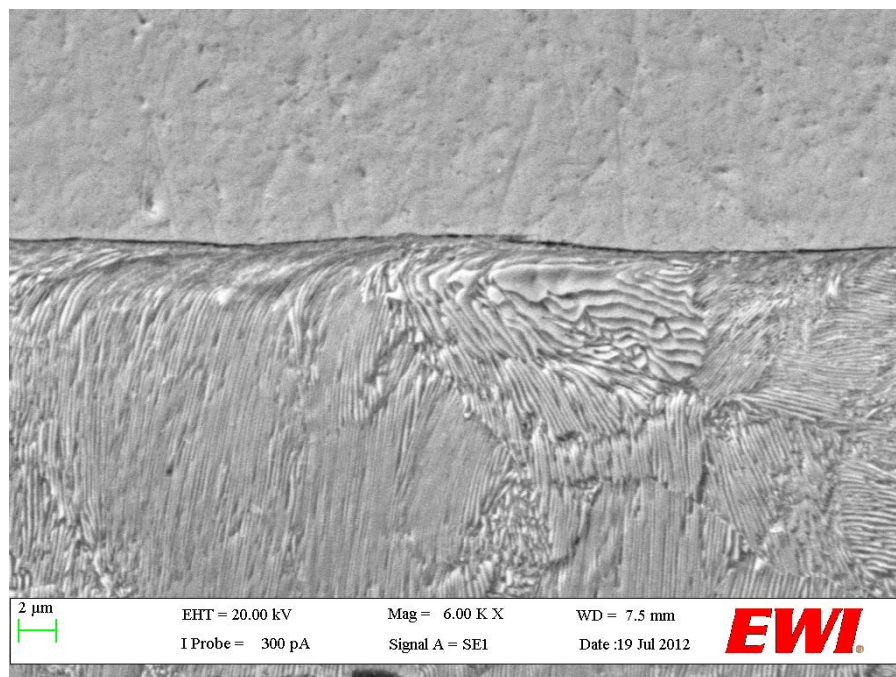
SEM analysis of the welds was conducted in order to verify that no martensite was present in the weld joints. In Figure 34, it is obvious that the lamellae of the pearlite lay immediately adjacent to the bondline and the C464 alloy in the joint.

Figure 34. SEM Image of Bondline Showing No Martensite in Weld Joint

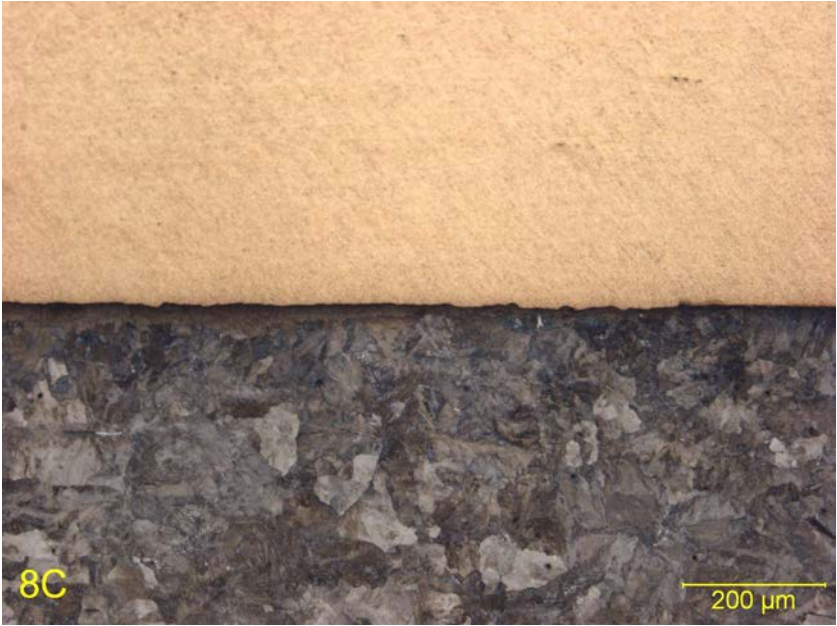
Note that several parameter sets produced welds with more than adequate strength and free of martensite. Martensite layers in these welds were not visible in the macro views of the cross sections; however, 100× magnification views showed very slight formation (approximately 35 micrometers deep) of martensite in two of the weld joints that had appreciable strength. These are shown in Figures 35 and 36 for Welds DOE 8 and 9, respectively.

**Figure 35. Detail of Bondline in DOE Weld 8**

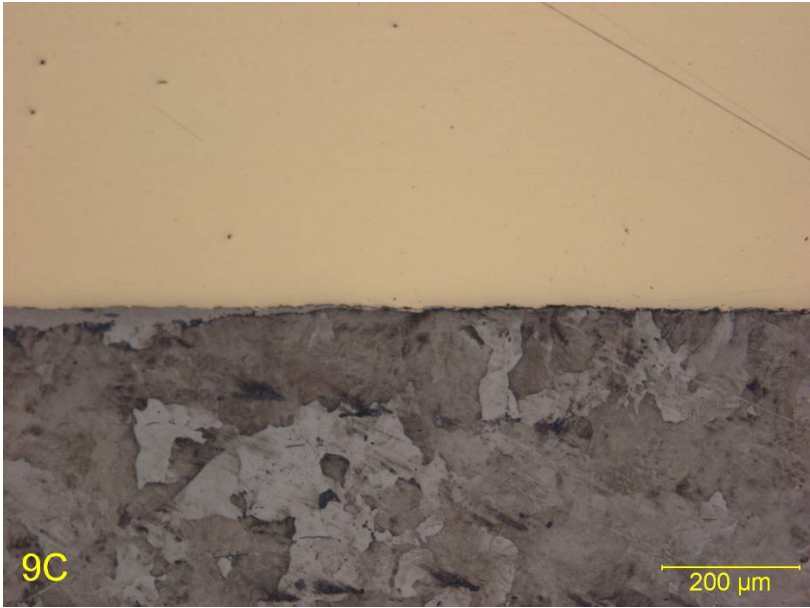
Figure 36. Detail of Bondline in DOE Weld 9 Showing Minimal Presence of Martensite

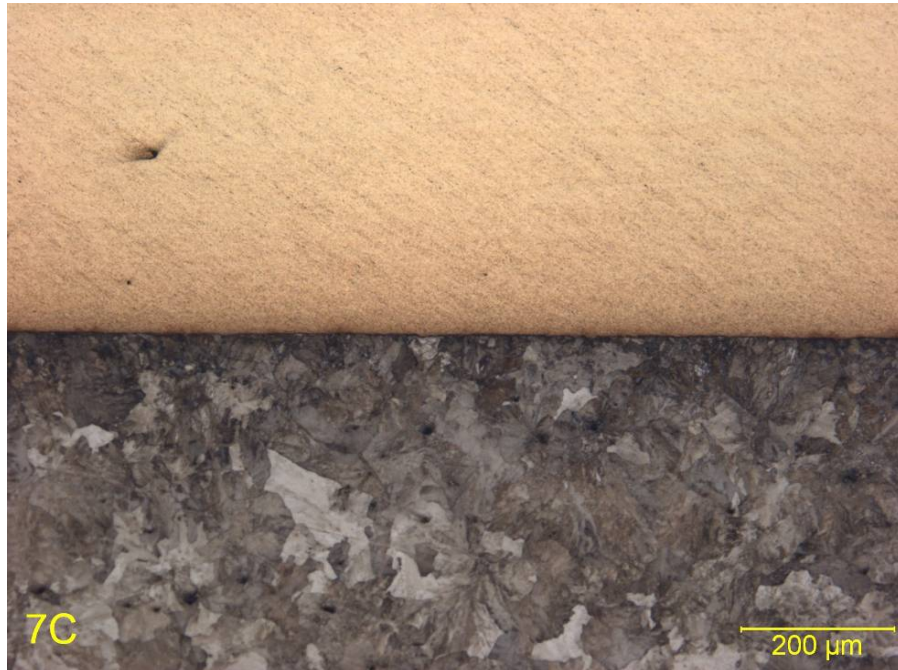
Rotational speeds below 4000 RPM did not produce welds with adequate tensile strength. Higher surface velocity or speed, combined with higher thrust loads, produced strong welds, but the increased thrust load produced higher frictional heating. This resulted in the weld joint exceeding the critical temperature and forming martensite in the joint, as shown in Figures 35 and 36. In Figure 37, Weld 7 shows no martensite and produced a weld with appreciable strength.

Figure 37. Section from DOE Weld 7 Showing No Martensite along Bondline

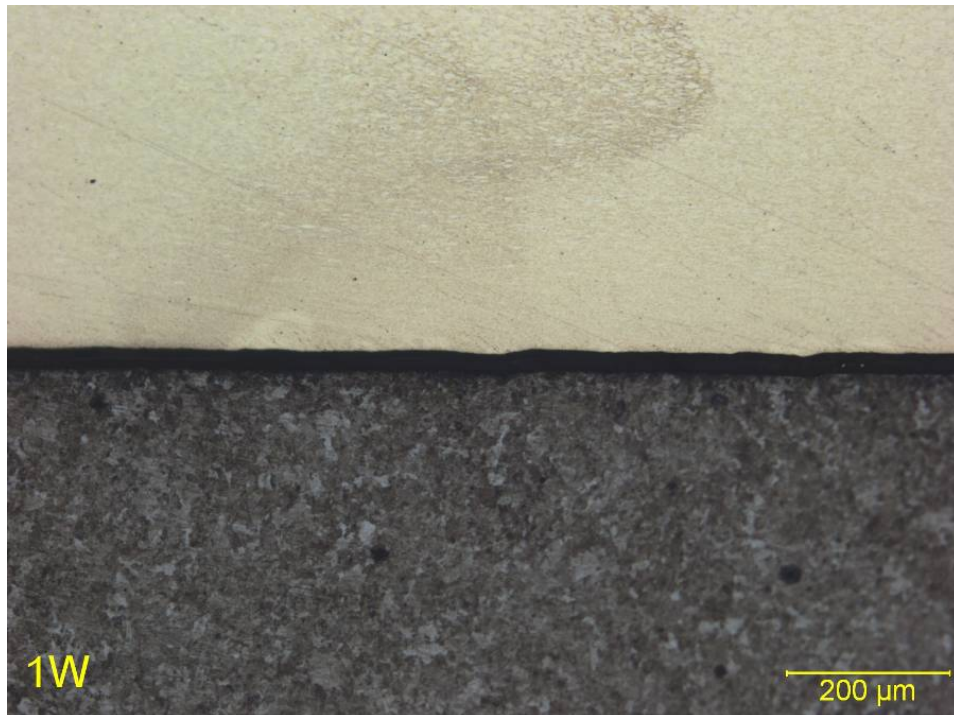
The first weld was produced then forcibly removed and a second weld was produced over the same spot. This process was repeated until the ten welds were completed. The repair welds all showed repeatable weld strength and no indication of martensite in the underlying rail steel. The metallographic sections are shown in Series 1 through 10 in Appendix B. For comparison, the first weld is shown in Figure 38 and the tenth weld is shown in Figure 39. In addition, the tensile tests results from the first, fifth, and tenth weld all remained similar at 4650, 4720, and 4800 lb, respectively.

Figure 38. Initial Weld Made in Reparability Study

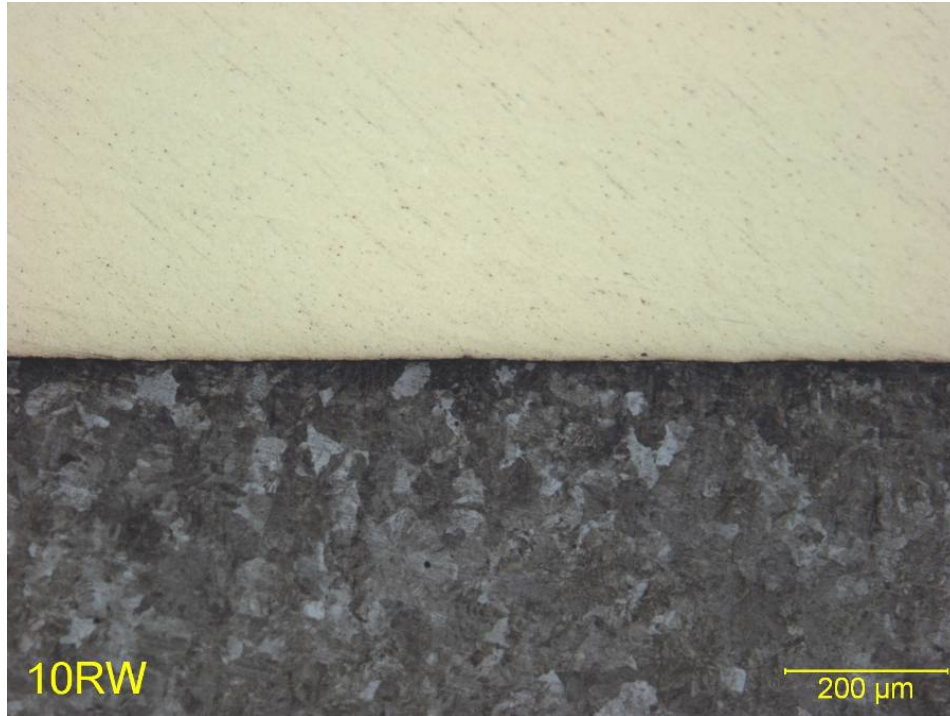
Figure 39. Tenth Repair Weld Made in Reparability Study
