Developing a Reliable Signal Wire Attachment Method for Rail

4. TITLE AND SUBTITLE Developing a Reliable Signal Wire Attachment Method	5. FUNDING NUMBERS DTFR53-12-C-00002
6. AUTHOR(S) Dave Workman, Cameron Stuart

9. SPONSORING/MONITORING AGENCY NAME(S) AND ADDRESS(ES) U.S. Department of Transportation Federal Railroad Administration Office of Railroad Policy and Development Office of Research and Development Washington, DC 20590	10. SPONSORING/MONITORING AGENCY REPORT NUMBER DOT/FRA/ORD-14/33

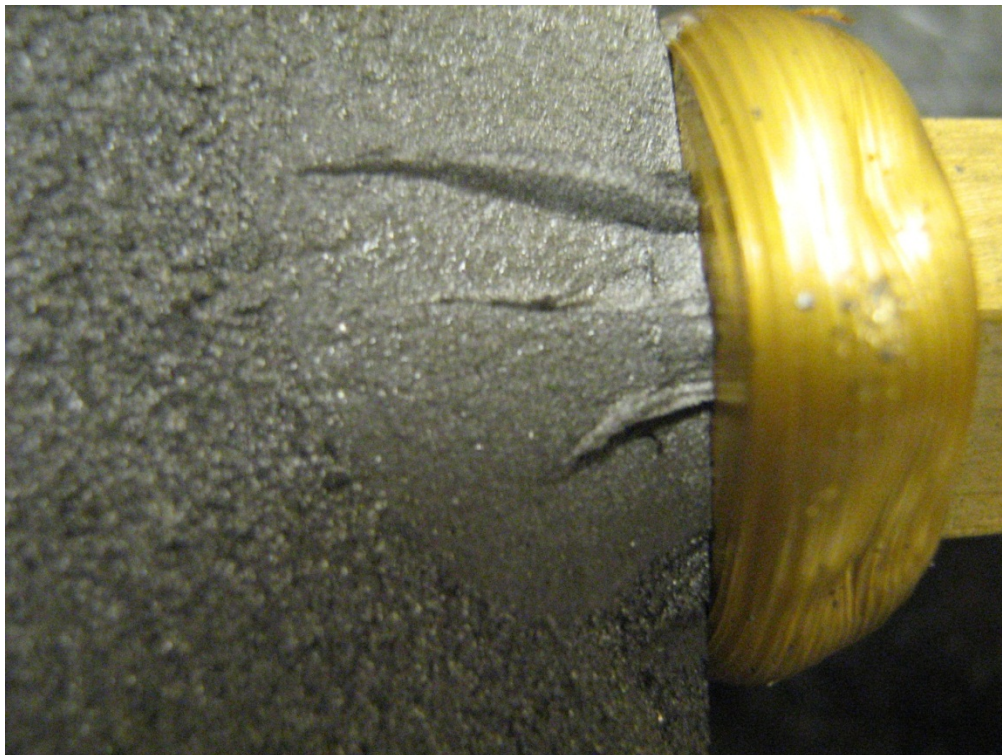
It should be noted that failures at the signal wire joint location were expected. This location experienced the highest cyclical loads during the test. In general, the cycles-to-failure was very similar to that measured from plain rail.

**Figure 48. CAD Weld Driven Failure due to Formation of Martensite**

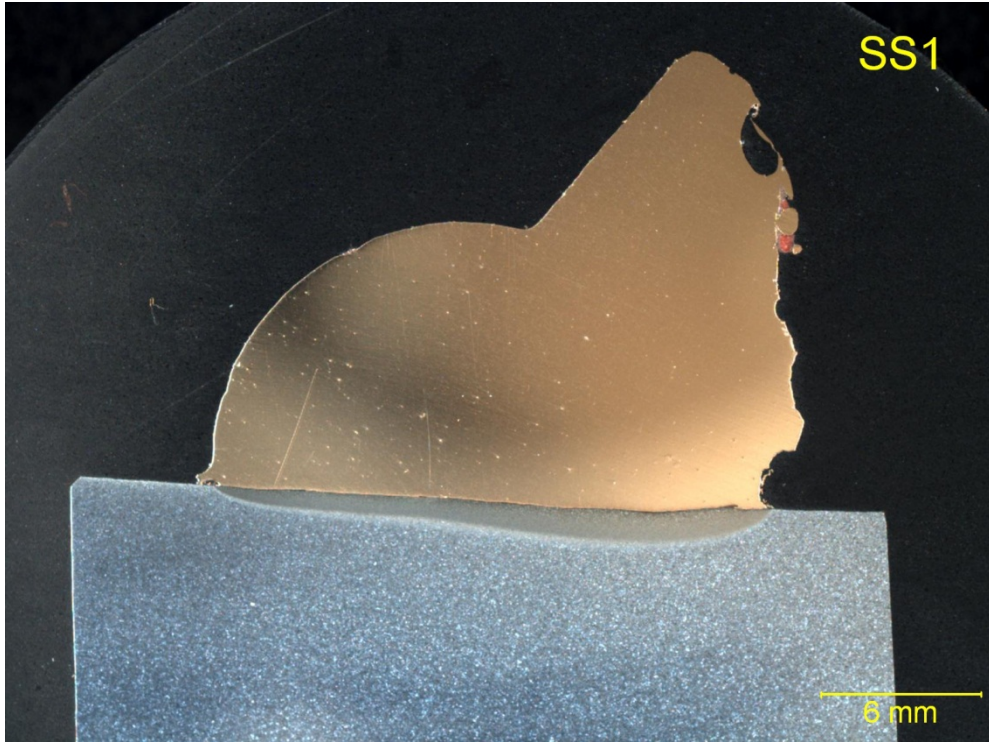
The standard chemistry rail sections (SS) are shown in Figures 56 and 57 for the IFW joints and Figures 58 and 59 for the CAD joints. In these sections, the naval brass is apparent on one side of the joint, and the other side is the unaffected steel. An area of martensite is apparent in the CAD sections shown in Figures 58 and 59.

Figure 58. CAD Weld Joint Standard Chemistry Rail #1

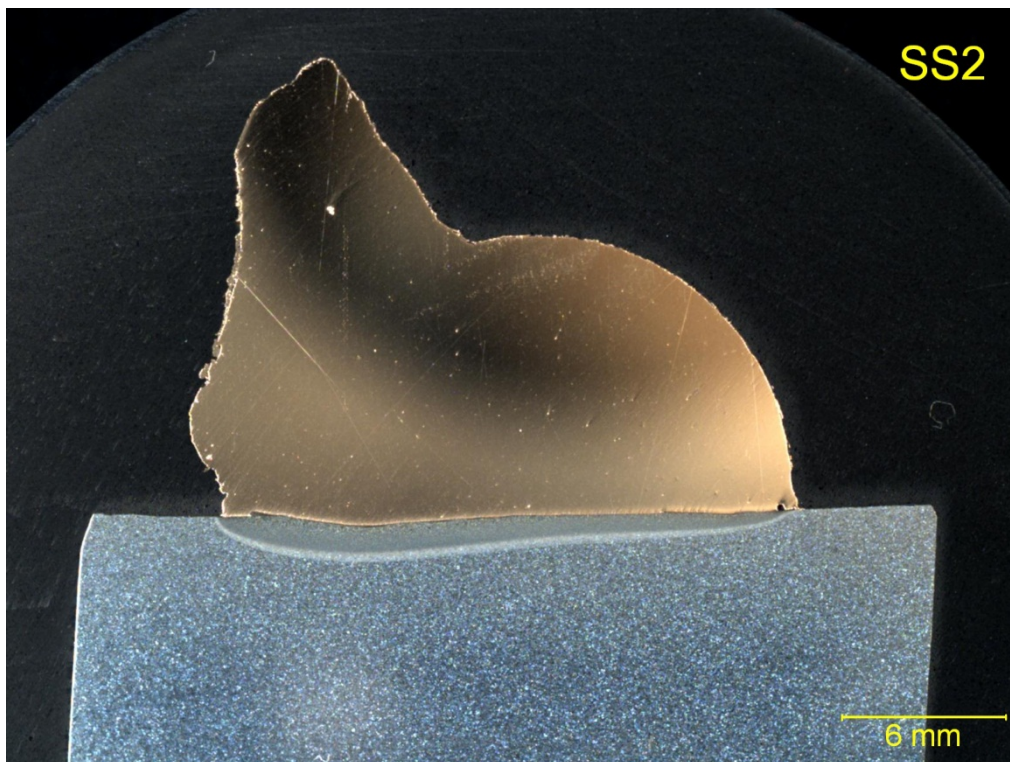
Figure 59. CAD Weld Joint Standard Chemistry Rail #2

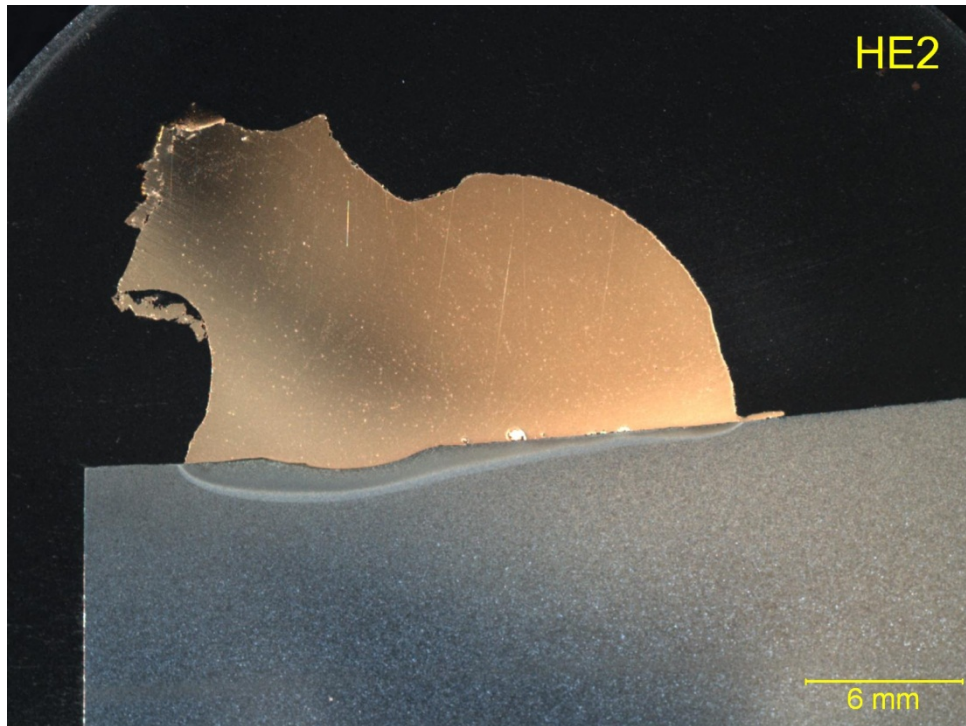
The hyper-eutectoid chemistry rail sections (HE) are shown in Figures 61 and 62 for the IFW joints and Figures 63 and 64 for the CAD joints. In the IFW joints, Figures 61 and 62, the naval brass is apparent on one side of the joint and the other side is the unaffected steel. In the CAD joints in Figures 63 and 64, the HAZ in the steel is much more obvious with both a hardened zone up close to the attachment and a softened zone further away from the attachment.

Figure 64. CAD Weld Joint Hyper-Eutectoid Rail #2

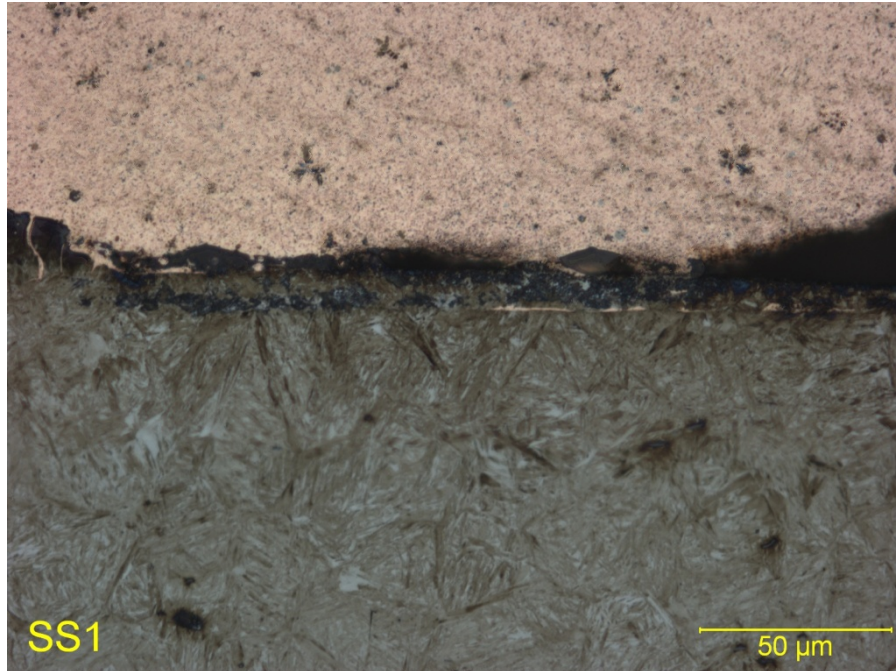
Figure 71. Bondline of Exothermic Weld onto Standard Chemistry Rail

Figure 71 shows a cross section of the fusion boundary between the rail steel in the bottom and the exothermic material in the top. Several items are apparent in this section. First, the steel is fully martensitic. Second, the copper has infiltrated the steel at the fusion boundary, as shown by the copper strands in the steel at the interface.

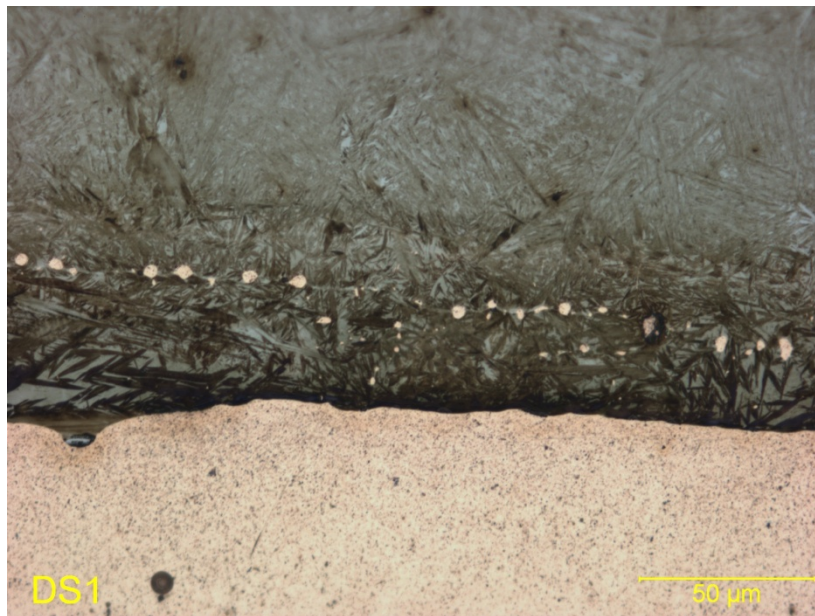
Figure 72. Section at Fusion Boundary Showing Resolidified Copper Globules in Resolidified Rail Steel

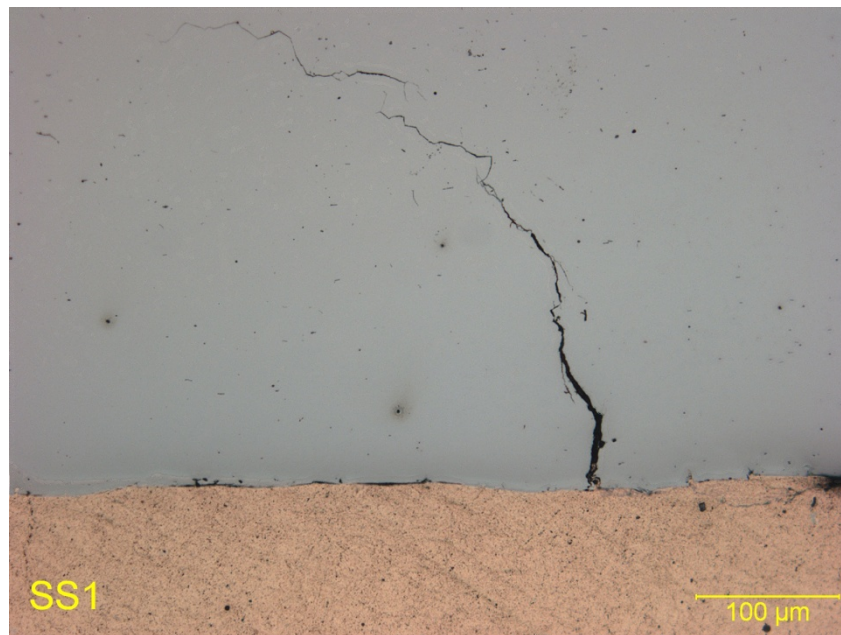
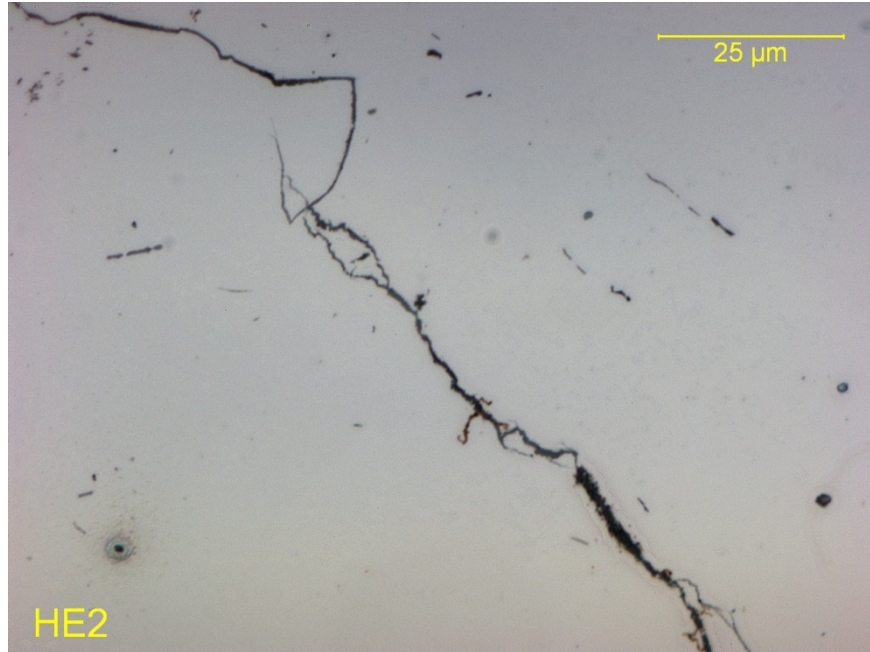
Further analysis of the metallographic sections showed a larger LME-driven crack in the rail steel which is shown in Figure 73 and Figure 74. Note that the cracking extends from the fusion boundary into the parent solid rail steel section. When this LME occurs, a crack of much larger size is created during the welding process. This crack may have initiated in a fusion zone in the steel, or simply ran into the base metal, as there was both tensile stress and liquid metal available in the weld joint.

**Figure 73. LME Crack into Parent Standard Chemistry Rail Steel**
