Montana Department of Transportation
Research Programs
February 2015

EXPERIMENTAL PROJECTS CONSTRUCTION AND 2014 SITE INSPECTION REPORT

EVALUATION OF THE BREAK-OUT SQUARE POST BREAKAWAY SYSTEM

Location:	Montana & Central Ave Jct. – Billings: Yellowstone County
Project Name:	Break-Out Square Post
Exp. Project Number:	MT-12-08
Project Type:	Sign Post Breakaway Trial
Principal Investigator:	Craig Abernathy, Experimental Project Manager (ExPM)
Installation Date:	August 28, 2012
Evaluation Dates:	April 2013, April/ May 2014 & October 2014

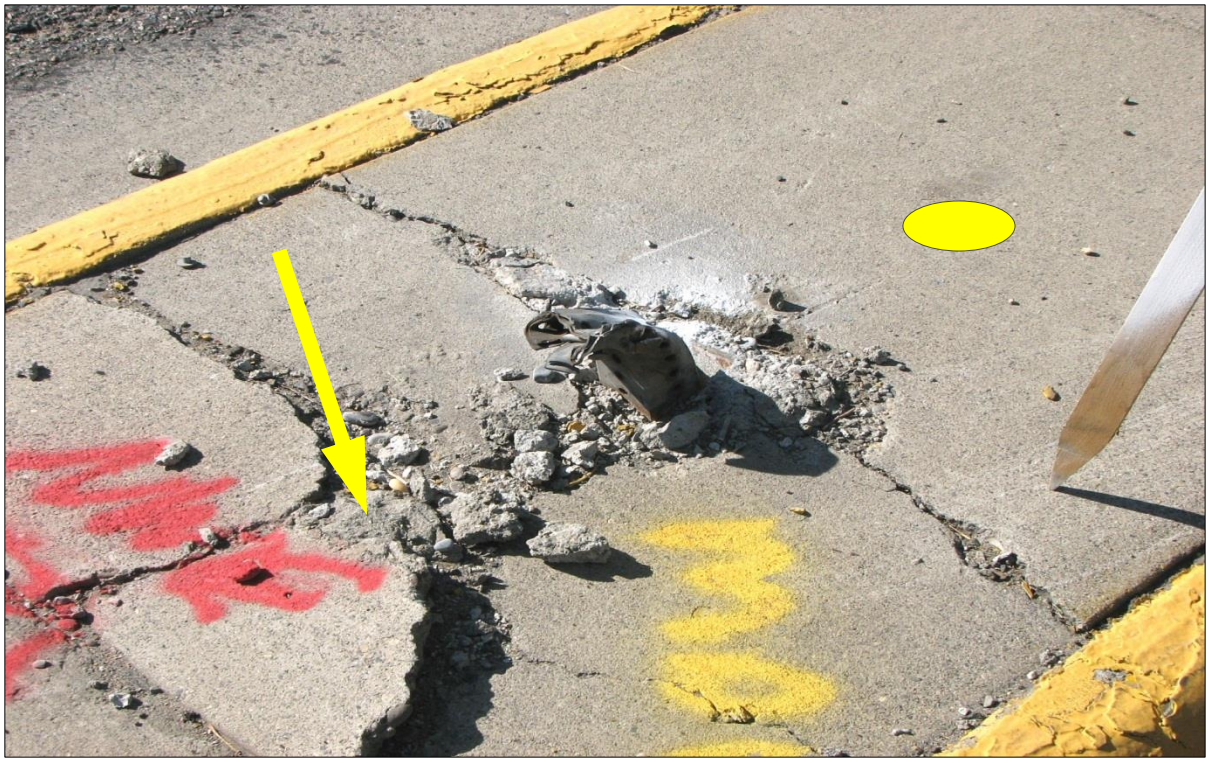
🡅 🡇 Condition of the lane divider after two sign impacts. Location of the original sign placement (yellow arrow). Yellow circle will approximate location of new sign base.

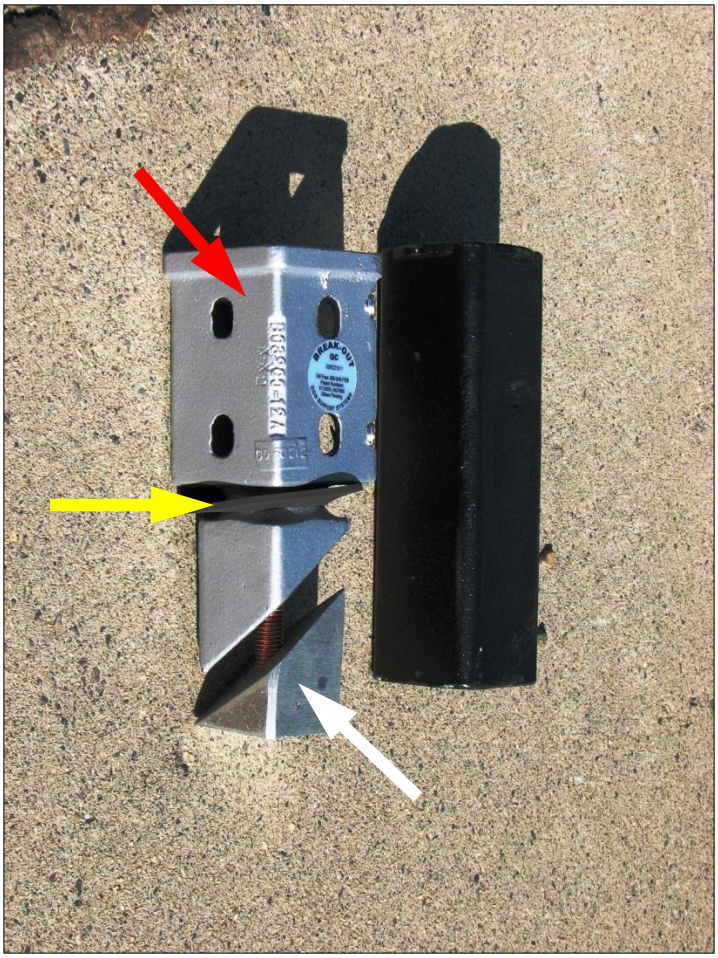
🡸 Main components of the Break-out. The top coupler (red arrow) is set above grade and the receptacle for the sign post base.

Although difficult to see with the black washer in place (yellow arrow), this is the 360 degree separation point that breaks flush with grade.

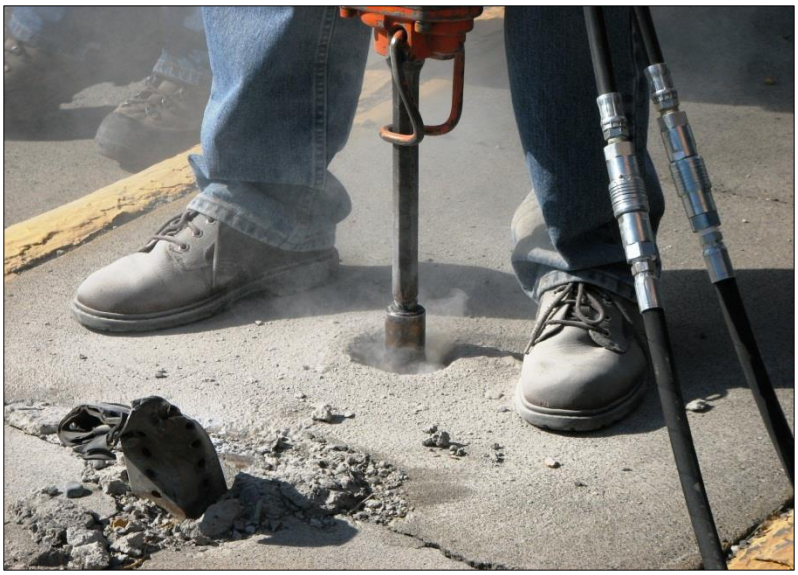
The installation of the Break-Out device took about forty (40) minutes. It was found when the drilling of the three (3) inch hole for the anchor adapter that the thickness of the concrete foundation was less than 2.5".

Normally in circumstances where the foundation has less than four (4) inches an extension would be attached to the base of the anchor adapter to aid in sign support. An extension was not available without delay in the installation. It was decided to install the adapter as is with the expectation it may not affect performance of the breakaway unit.

🡸 Boring completed. It was found the depth of the concrete was approximately 2.5" (6.4 cm).

Normally for slabs less than 4" thick an extension is added to the anchor adapter for added base support.

Since an extension was not supplied it was decided to use only the adaptor with this installation.

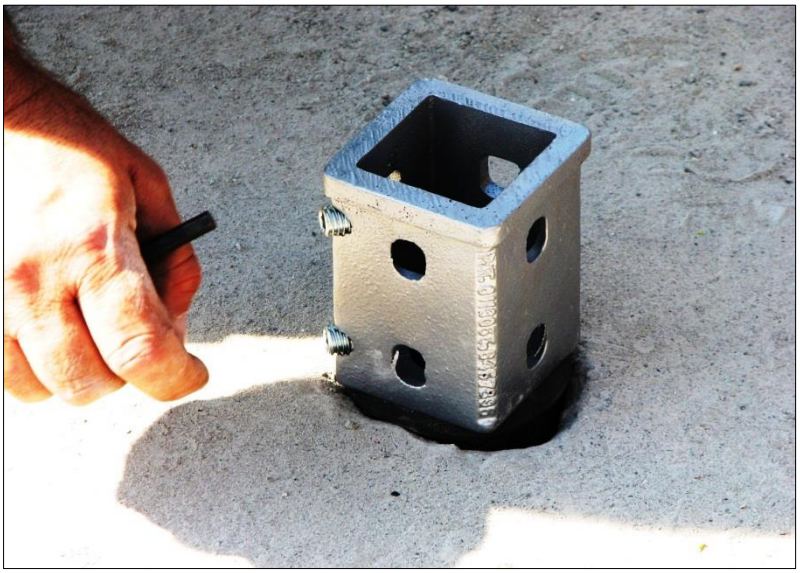
🡸 The Break-Out Square Post Breakaway is ready to receive the sign base.

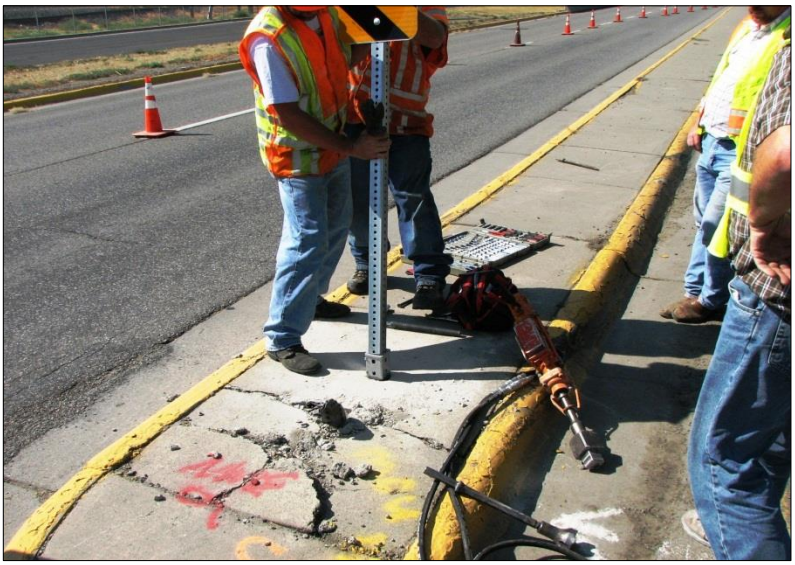
🡸 The sign post is inserted into the Break-Out receiver.

🡸 Corner hex screws are tightened first.

🡸 Round head socket cap screws are set parallel through the sign base and Break-Out and tightened firmly.

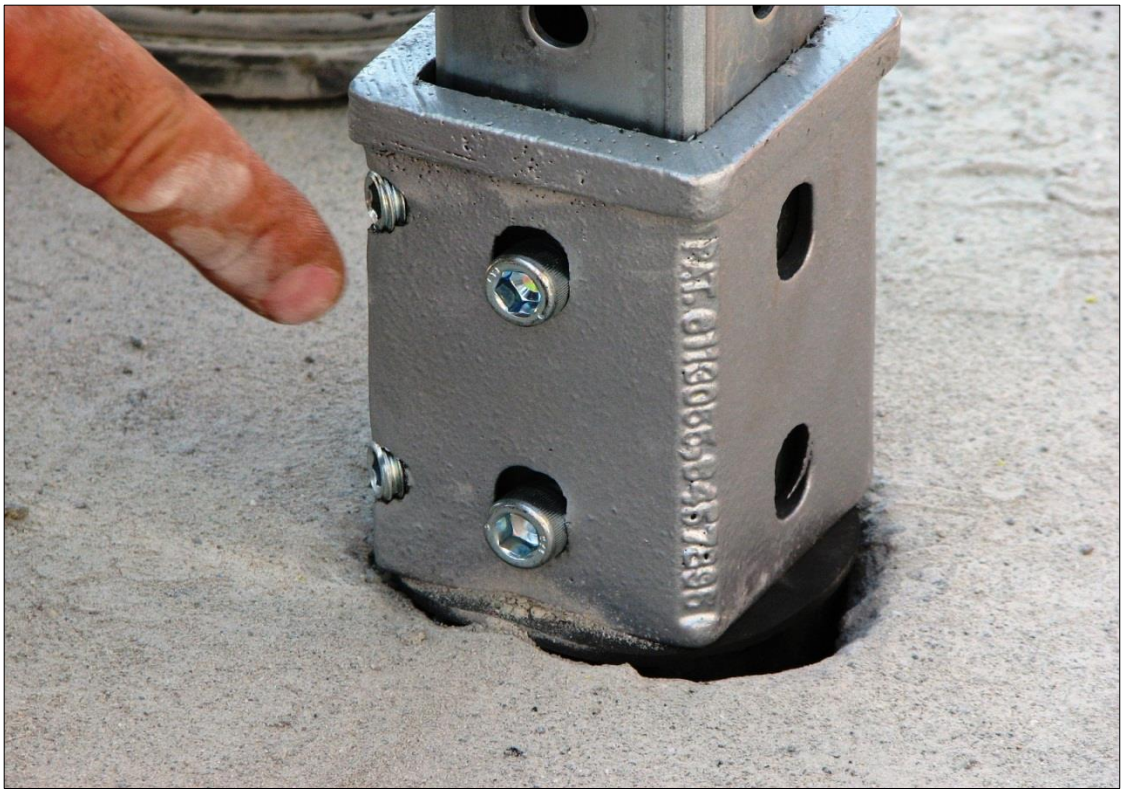
🡅 Note that the round cap screws are compressed against the sign pole square tube and not the coupler.

🡇 Completed sign base to coupler attachment.

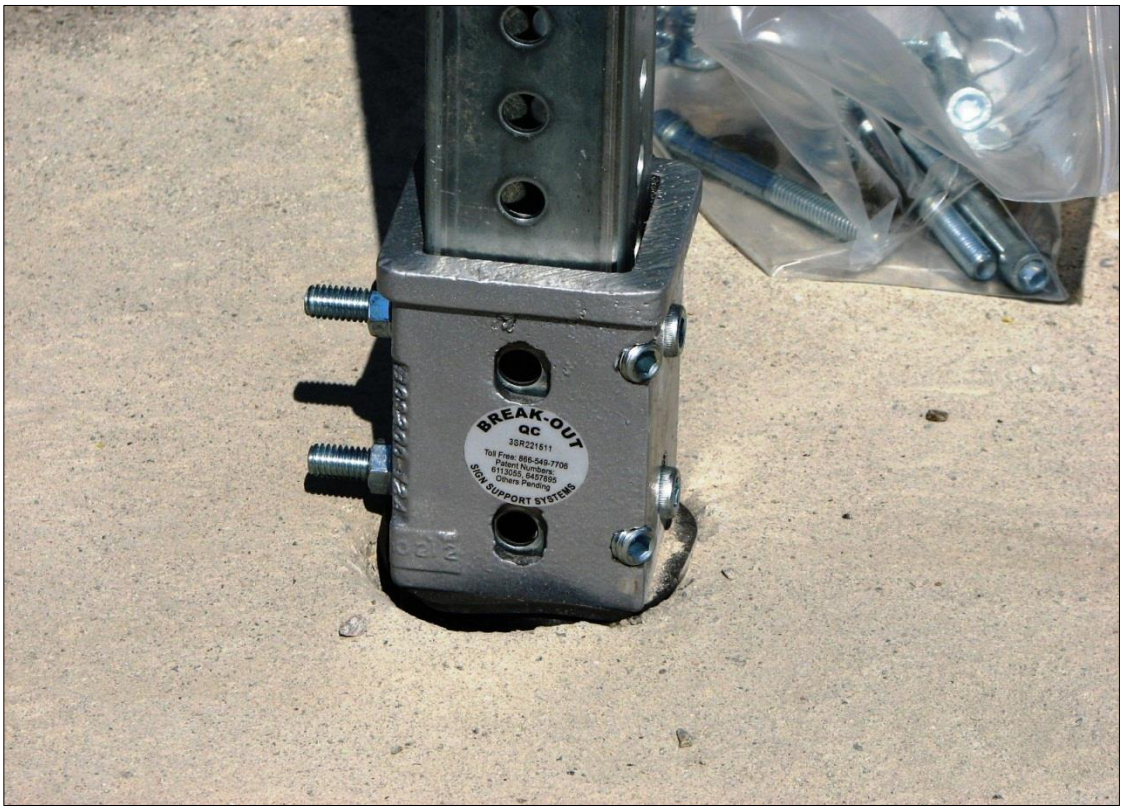
🡅 Completed installation of the Break-Out Square Post coupler (view west).

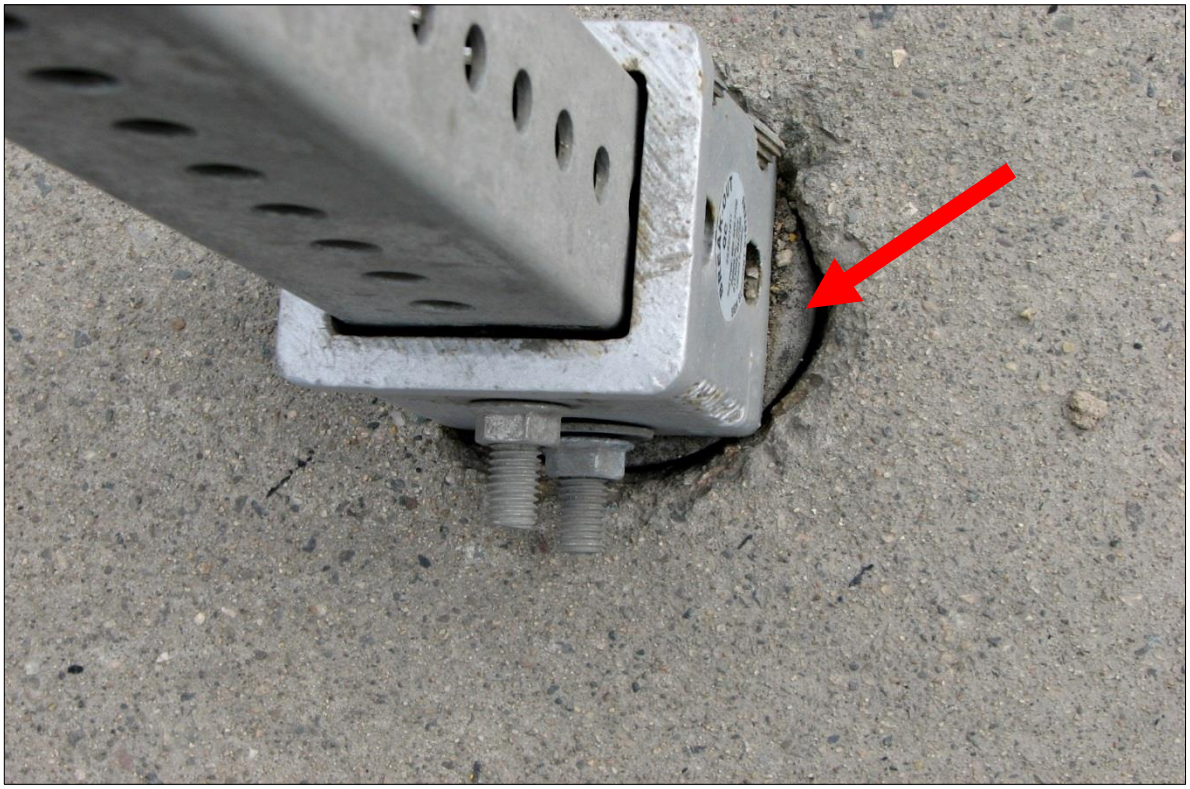
During this inspection it was found that the sign was leaning northwards about five degrees (5°) and leaning forward (easterly) about ten to fifteen degrees (10-15°).

🡐 Upon inspection it was noticed that the sign post had a northern tilt as seen from the rear (view east).

🡐From a side view (looking north) the sign post had a substantial forward lean.

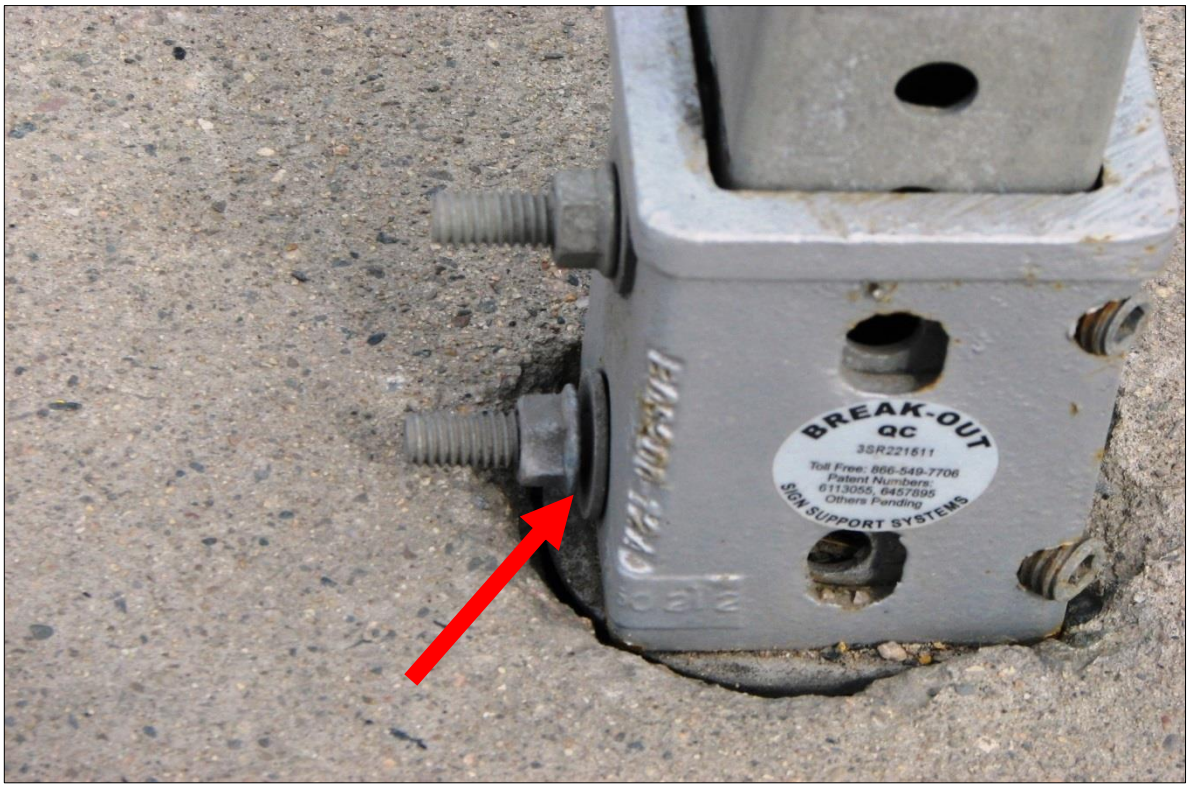
Several of the top coupler attachments (lower socket cap nut and corner hex screw) were loose. The anchor adaptor has depressed into the 3" drilled hole about ¼".

- ↑ The top coupler and wedge-lock unit appeared to be tight in the anchor base; however the anchor base was moveable in the drilled concrete.
- ↓ The rear lower base nut to socket cap attachment was loose. It could not be determined if the other socket cap nut attachment was tight or not.

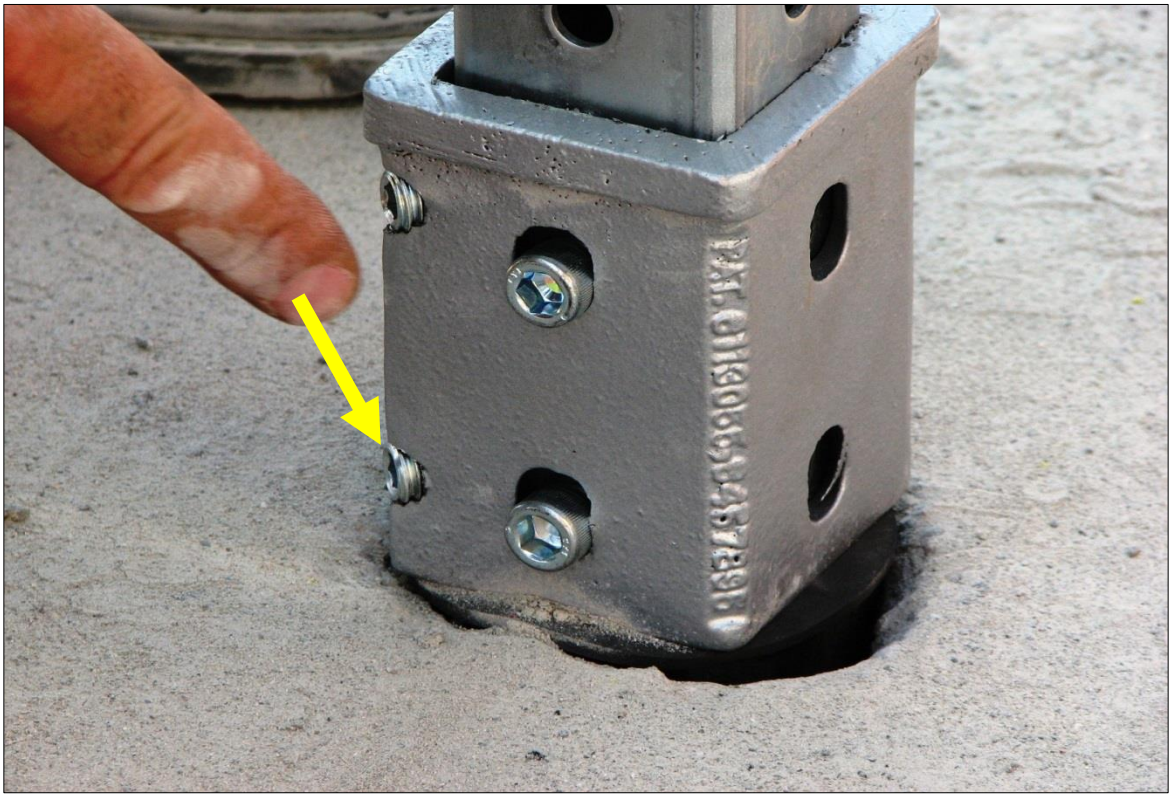
As stated above in the initial remarks, the concrete base thickness was less than 2.5" which to date, appears proven inadequate to support the anchor with sign; however the installation went ahead. In retrospect with the thickness of the base as it was, an anchor extension (which attaches to the anchor adaptor) may have kept the anchor to base a stable installation. These extensions range from twelve inches (12") to twenty-six inches (26"). Another option with the thinness of the PCC base would have been to apply concrete (or mortar) to the interior in and around the hole to make a solid connection.

A current assumption is that wind-generated vibration has caused the above conditions but that is only speculation.

🡸🡻 In comparing the lower image taken in 2012 of the completed BOS unit, and the upper image taken during the April 2013 inspection, shows that the anchor (wedge) adaptor has recessed almost a half inch (½") into the concrete base.

Also note the corner hex screws (yellow arrows) appear to have reversed out of the top coupler hex attachment.

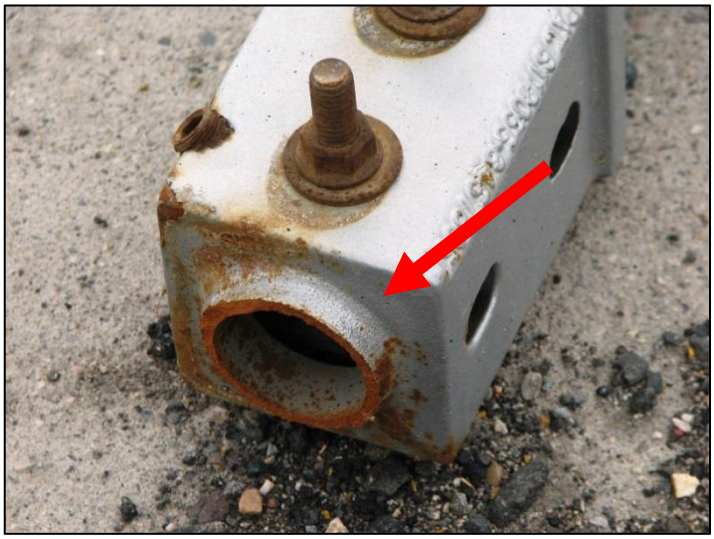
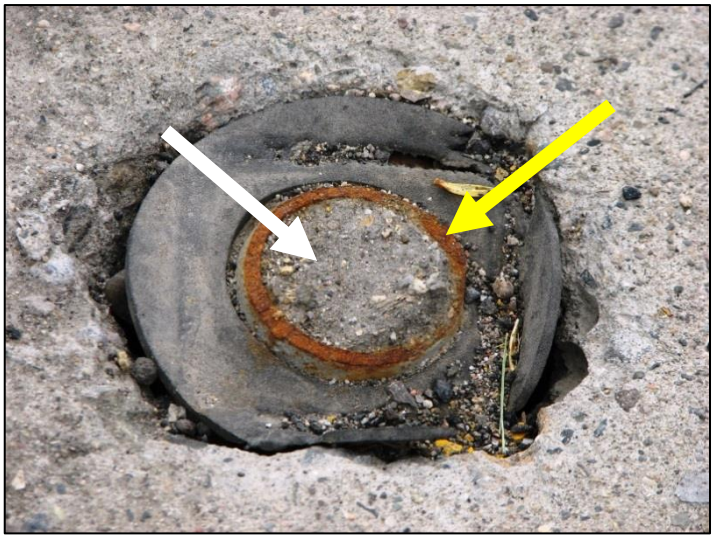
The District notified Research in early May that the sign unit had taken a vehicle hit and was down. Upon a site visit it was found the breakaway unit had performed exactly as designed snapping flush with the median surface with all sign components intact. See page for more details.

🡸🡻 The District notified Research that the Montana and Central Ave. Jct. sign unit had taken a vehicle hit in early May.

As these images show (even at the severe tilt of the base) the top coupler (red arrow) sheared cleanly from the 360º wedge-lock base insert (yellow arrow).

Note at the image at the bottom of the page, the round black deformed object is the seal washer (refer to page 7).

The impact did not affect the placement of the anchor base.

Conventionally, this design allows the wedge-lock to be removed from the anchor base by releasing and removing the tension bolt (in which sanding debris has covered – white arrow) to allow a new break-out unit to be reinserted into the anchor (refer to page 9).

Since the current median may be replaced or repaired the existing anchor can be removed and may be used again.
