Evaluation and Testing of a Lightweight Fine Aggregate Concrete Bridge Deck in Buchanan County, Iowa

Final Report
May 2016

Sponsored by
Iowa Highway Research Board
(IHRB Project TR-648)
Iowa Department of Transportation
(InTrans Project 12-434)
Federal Highway Administration

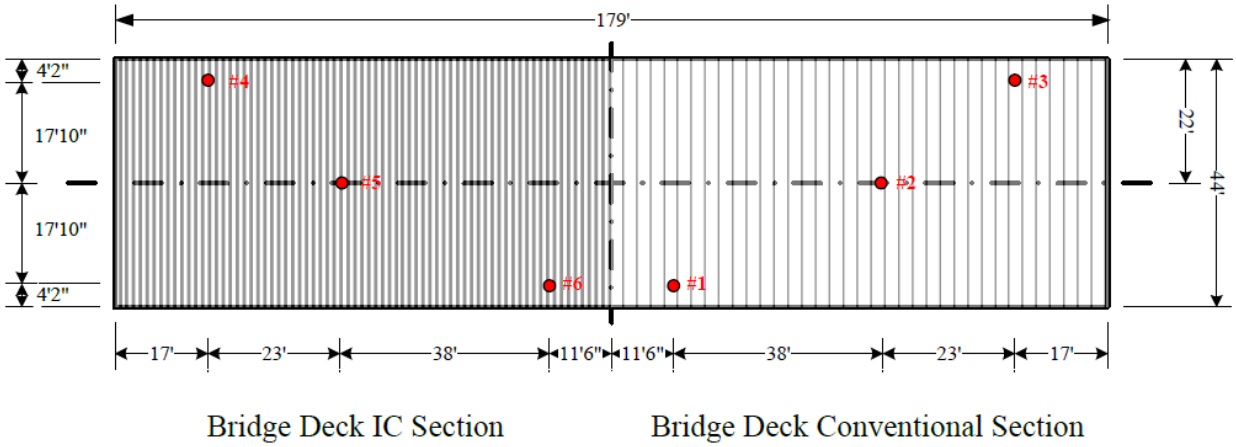
Figure 6. Corrosion sensor locations

#1 and #6 sensors: 1/2 in. below concrete surface
#1 and #6 sensors: 1 in. below concrete surface
#1 and #6 sensors: 1 1/2 in. below concrete surface

Four out of six corrosion sensors were located using the scanner and marked with green paint and indents drilled into the surface for future reference. Sensors #3 and #4 (Figure 6), located 1.5 in. below the surface, could not be detected by the scanner. No evidence of corrosion was detected.

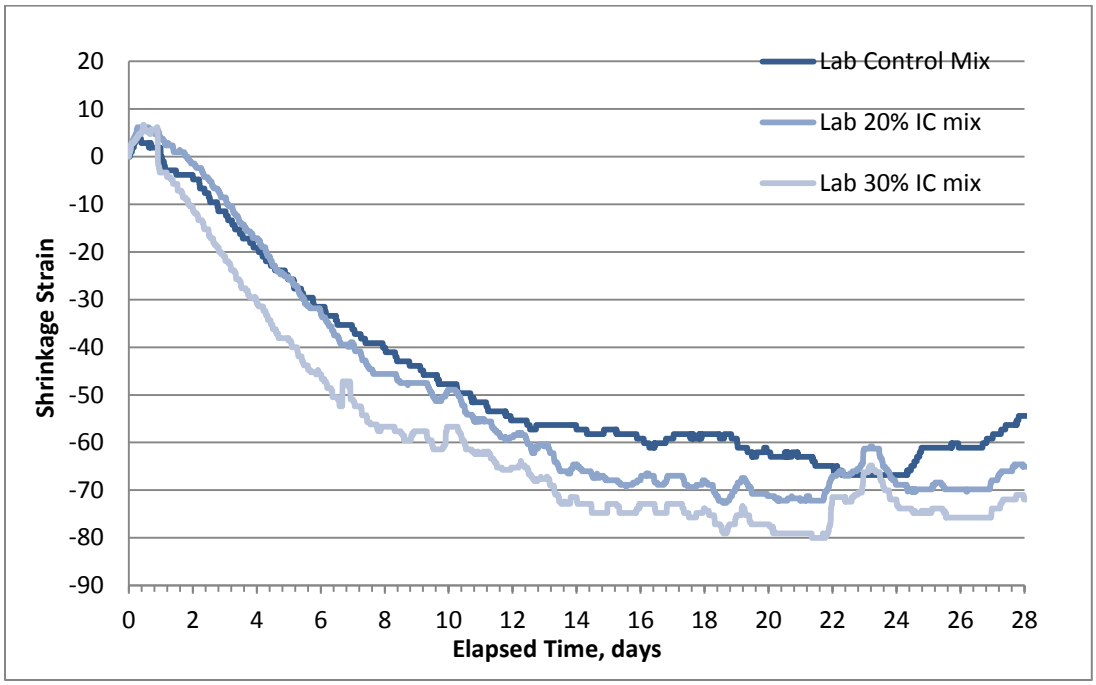
Figure 18. Restrained shrinkage test results

- The effect of the IC mixes on the elapsed time to reach peak temperature was small.
- Based on the average stress rate values, all three mixtures were classified as having a “low” potential for cracking.

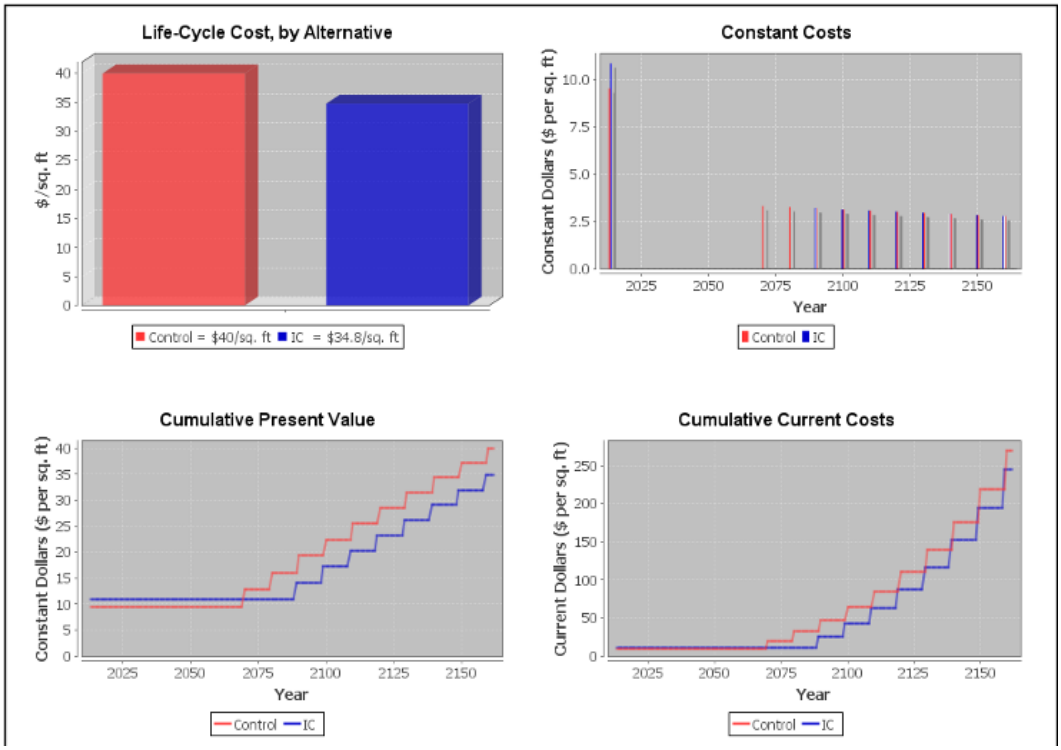
Figure 23. Lifecycle cost

The service life for the IC section is predicted to be 18.7 years longer than that of the control section. The initial cumulative present value is higher for the IC section, but it will be lower after about the year 2060.

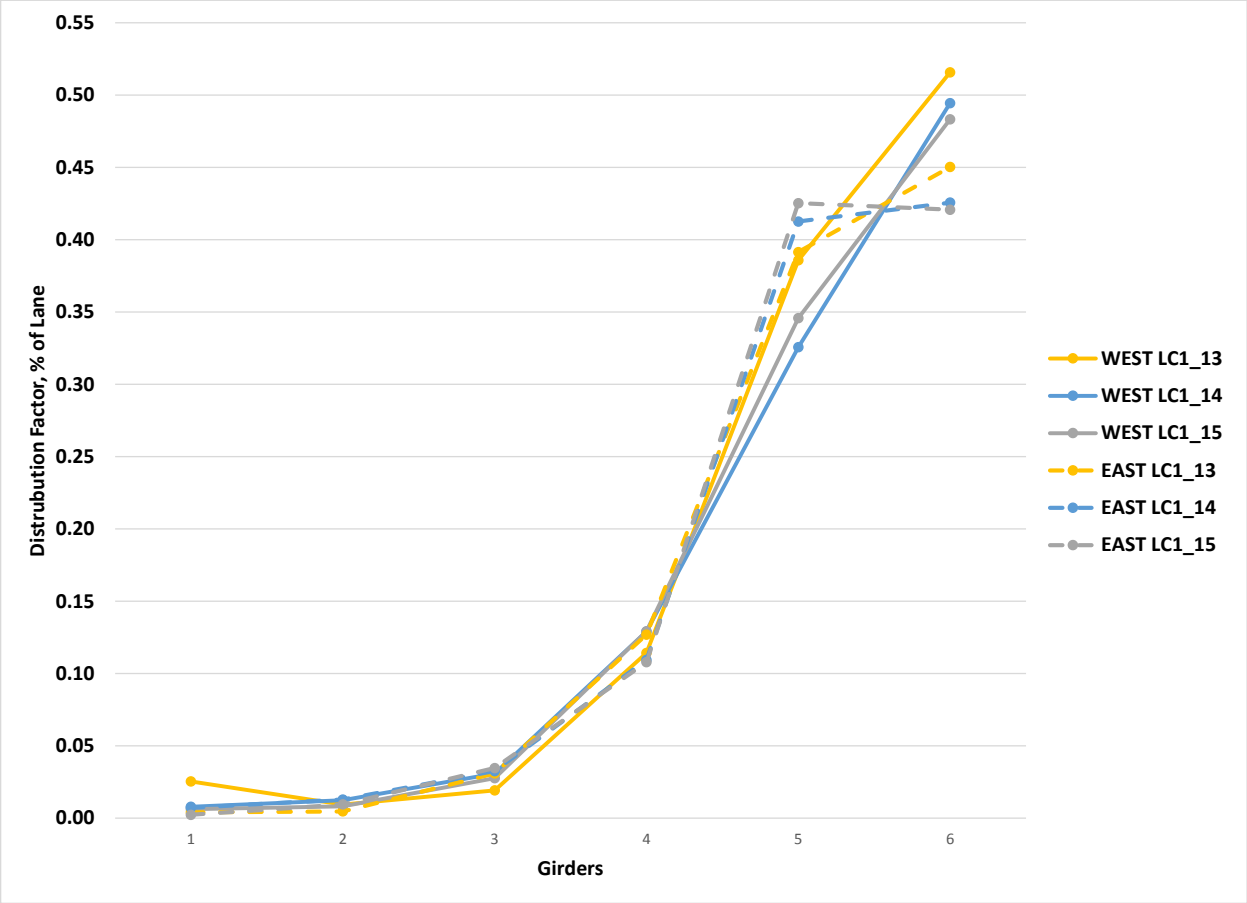
Figure 25. Transverse load distribution, Load Case 1

In all three graphs, the west span is represented by the solid colored lines, and the east span is represented by the dashed colored lines. In general, the transverse load distribution pattern for both the west and east spans were relatively similar when compared to each other for a given load case and from year to year, though some slight variances were evident. For instance, the east span appears to distribute more load to the girders nearest the truck, which could be a result of a number of factors or combination of factors, including but not limited to variances in girder stiffness, composite action, deck stiffness, girder end restraint, and the exact transverse placement of the load truck for a given load case. Further analysis of Figures 25 through 27 suggest, however, that in addition to the bridge possessing adequate transverse load distribution characteristics in both spans, the distribution of load is symmetric, as can be seen when comparing Figure 25 and 27 (they should be mirror images of each other), or by simply looking at Figure 26.

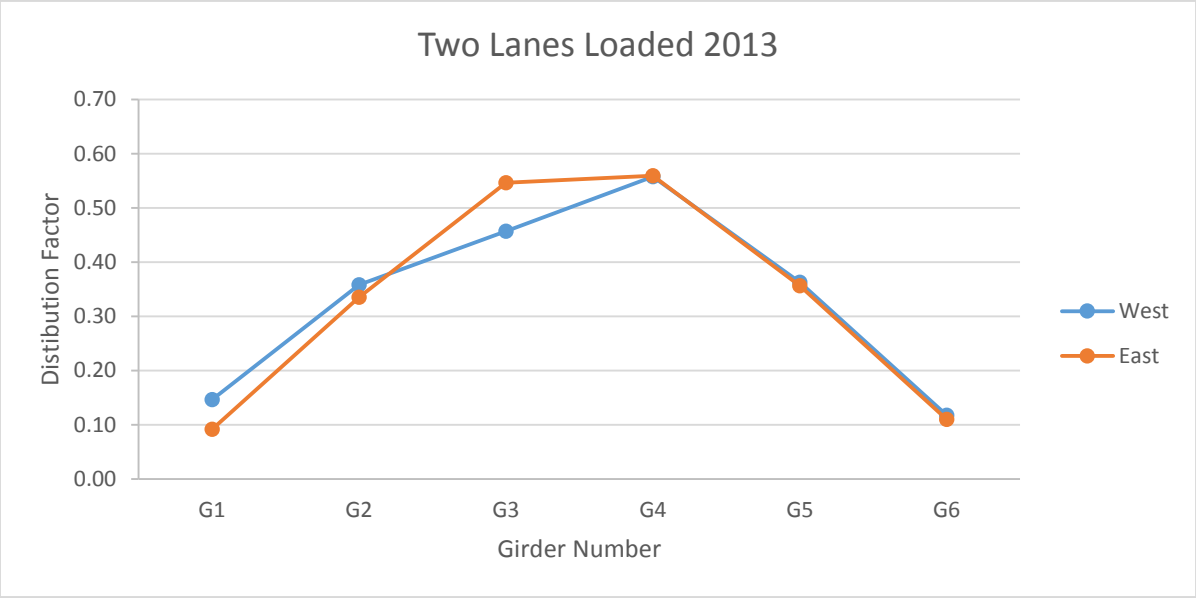
Figure 28. Distribution factors, two lanes loaded, 2013

In general, the west and east spans exhibit similar levels of transverse load distribution for any given year; additionally, though minor variances are evident, the performance of both spans remains relatively consistent from year to year, indicating little change in structural performance over the course of the three-year project.

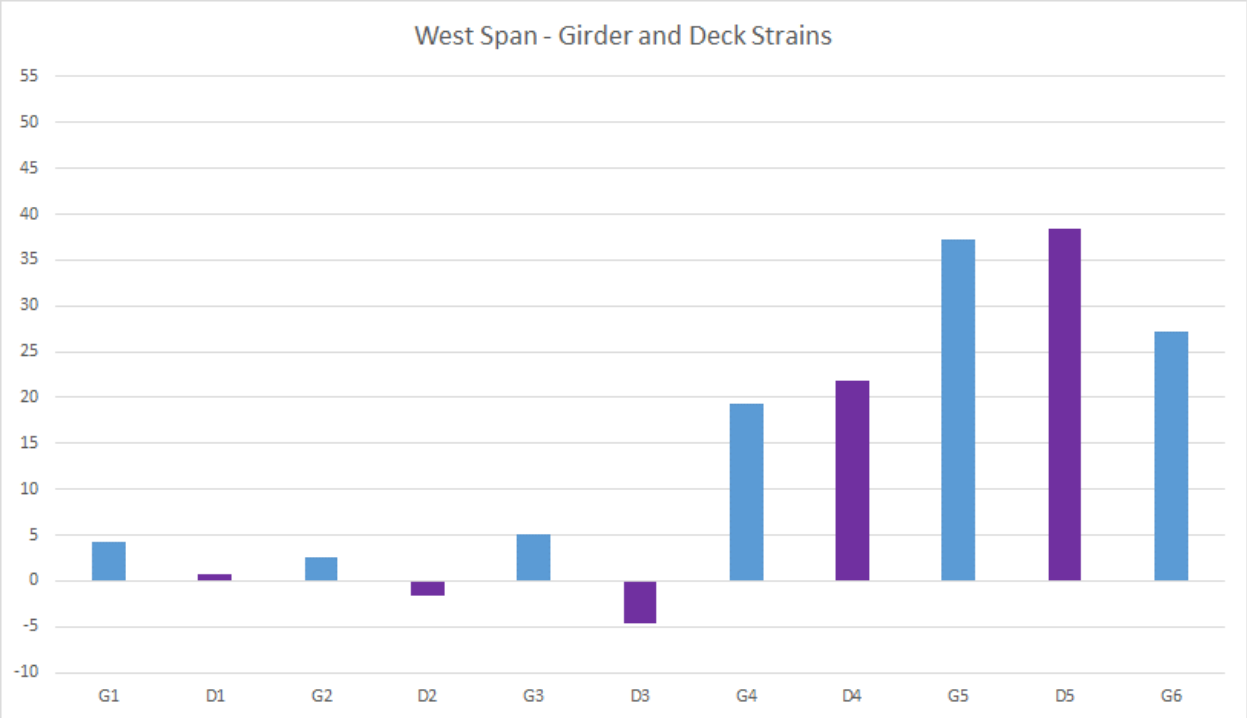
Figure 31. Typical girder and deck strain distribution for the west span

Deck strain magnitudes were evaluated using strain gauges mounted on the underside of the deck midway between each of the girders at midspan of both spans. To obtain a worst case scenario, Load Case 2 positioned the load truck such that its outside wheel line was directly over the deck gauge between girders G1 and G2. Figure 31 and 32 illustrate representative plots of peak girder and deck strains for both the west and east spans, respectively, for Load Case 2.

Peak strains in the deck gauges measured during Load Case 2 were in the range of 35–45 microstrain, which is relatively the same magnitude of strain measured in girders G1 and G2

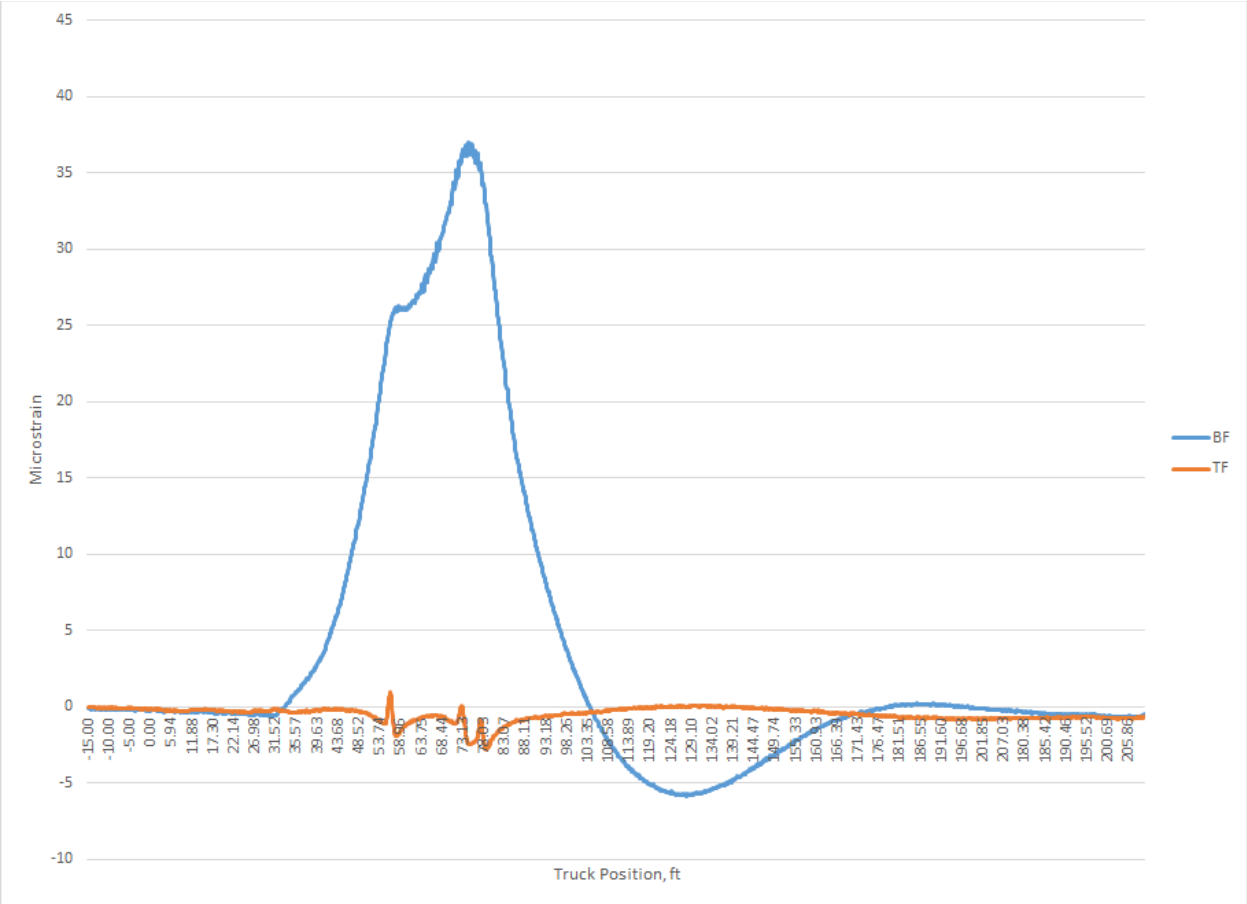
Figure 33. Top and bottom flange strains for girder G2, east span, Load Case 6, 2013

In each case, the bottom flange strains are relatively large compared to their corresponding top flange strains, indicating that the neutral axis of the section is located in the area of the top flange; in other words, the section is acting compositely.
