TESTING CERT # 2937.01

MASH TEST NOS. 3-11 AND 3-10 ON A NON-PROPRIETARY CABLE MEDIAN BARRIER

MwRSF Research Report No. TRP-03-327-16

May 17, 2016

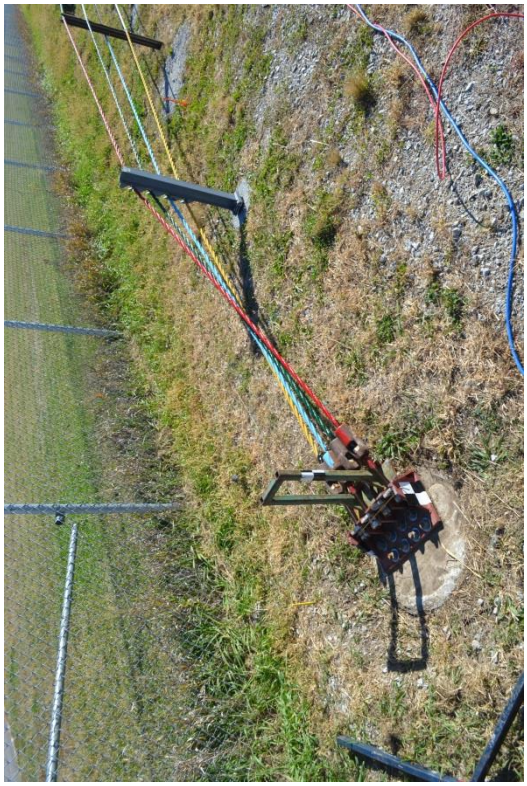
Figure 50. System Damage, End Anchorages, Test No. MWP-4

Damage to the barrier was moderate, as shown in Figures 49 through 59. Barrier damage consisted of bent posts, disengaged cables, and deformed brackets. At its final resting position, the vehicle was still in contact with the cables. Cable nos. 1 and 2 were beneath the vehicle, cable no. 4 was on the impact side of the vehicle, and cable no. 3 was on the non-impact side of the vehicle.

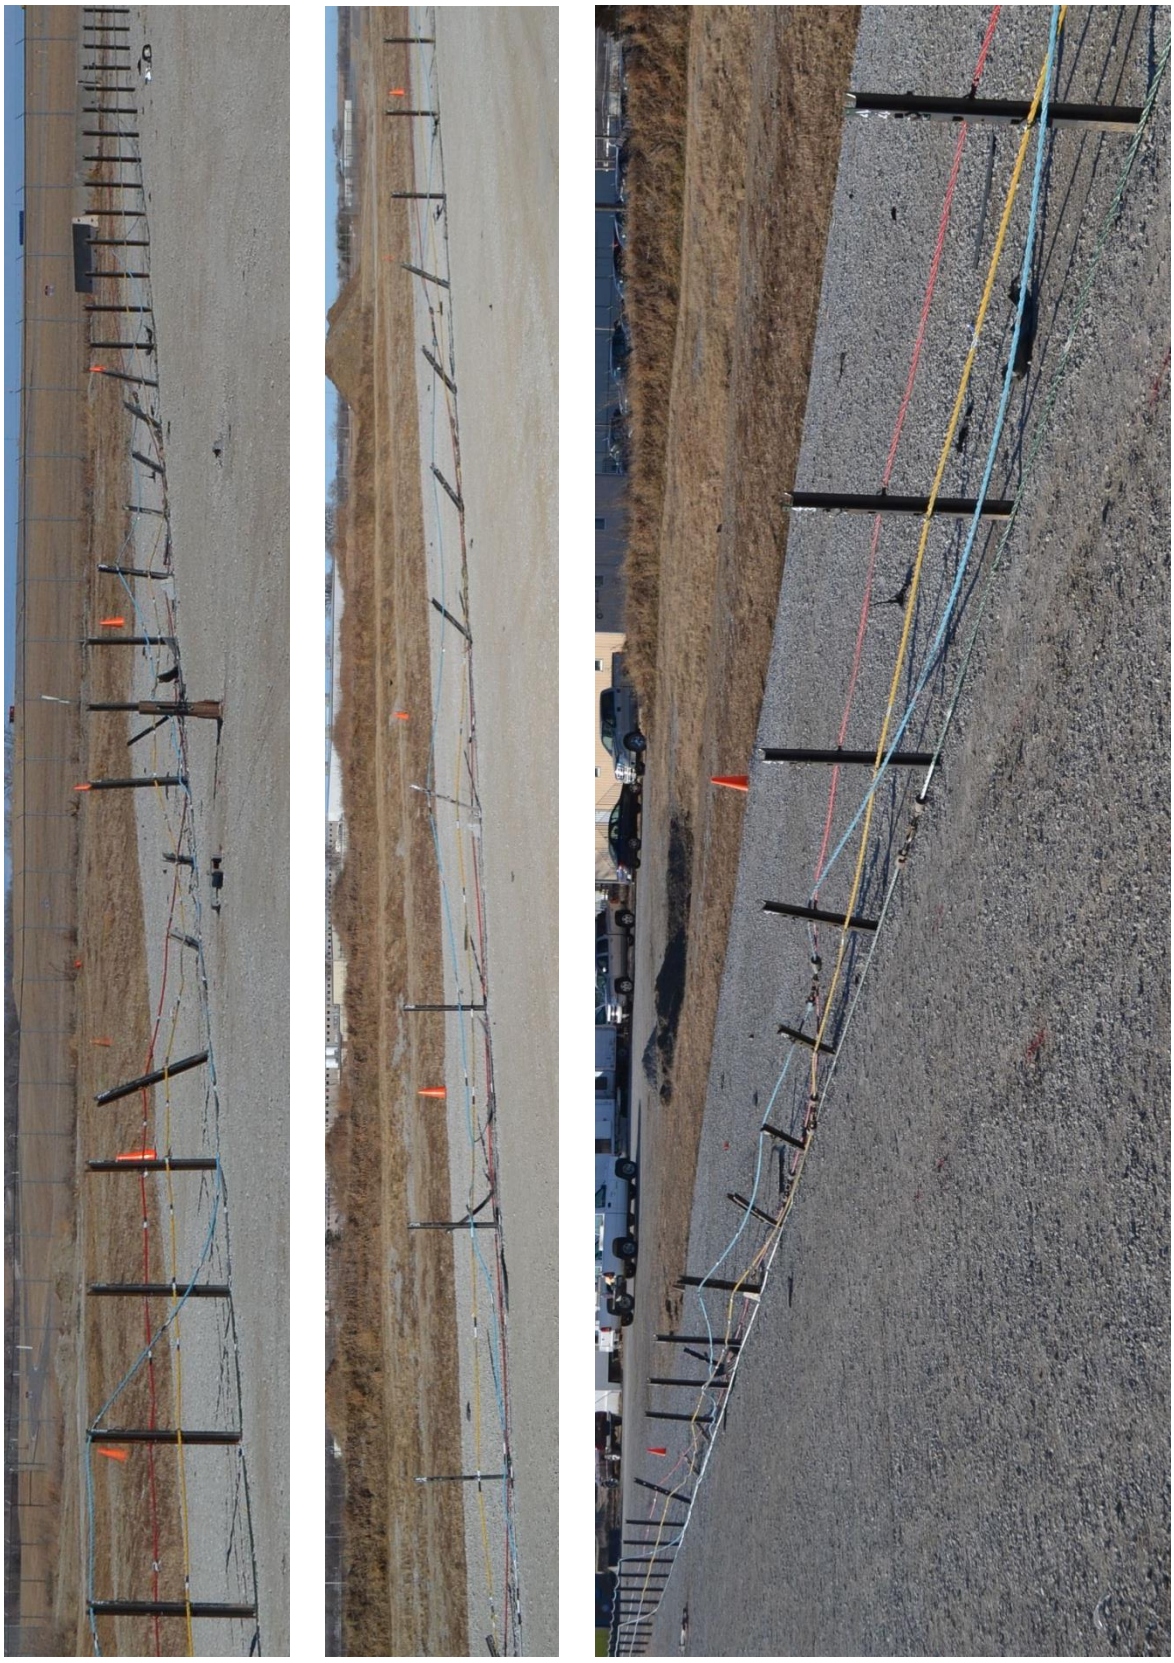
Figure 96. System Damage, Test No. MWP-6

Damage to the barrier was moderate, as shown in Figures 96 through 104. Barrier damage consisted of bent posts, disengaged cables, and bent and fractured brackets. At its final resting position, the vehicle was no longer in contact with the system.

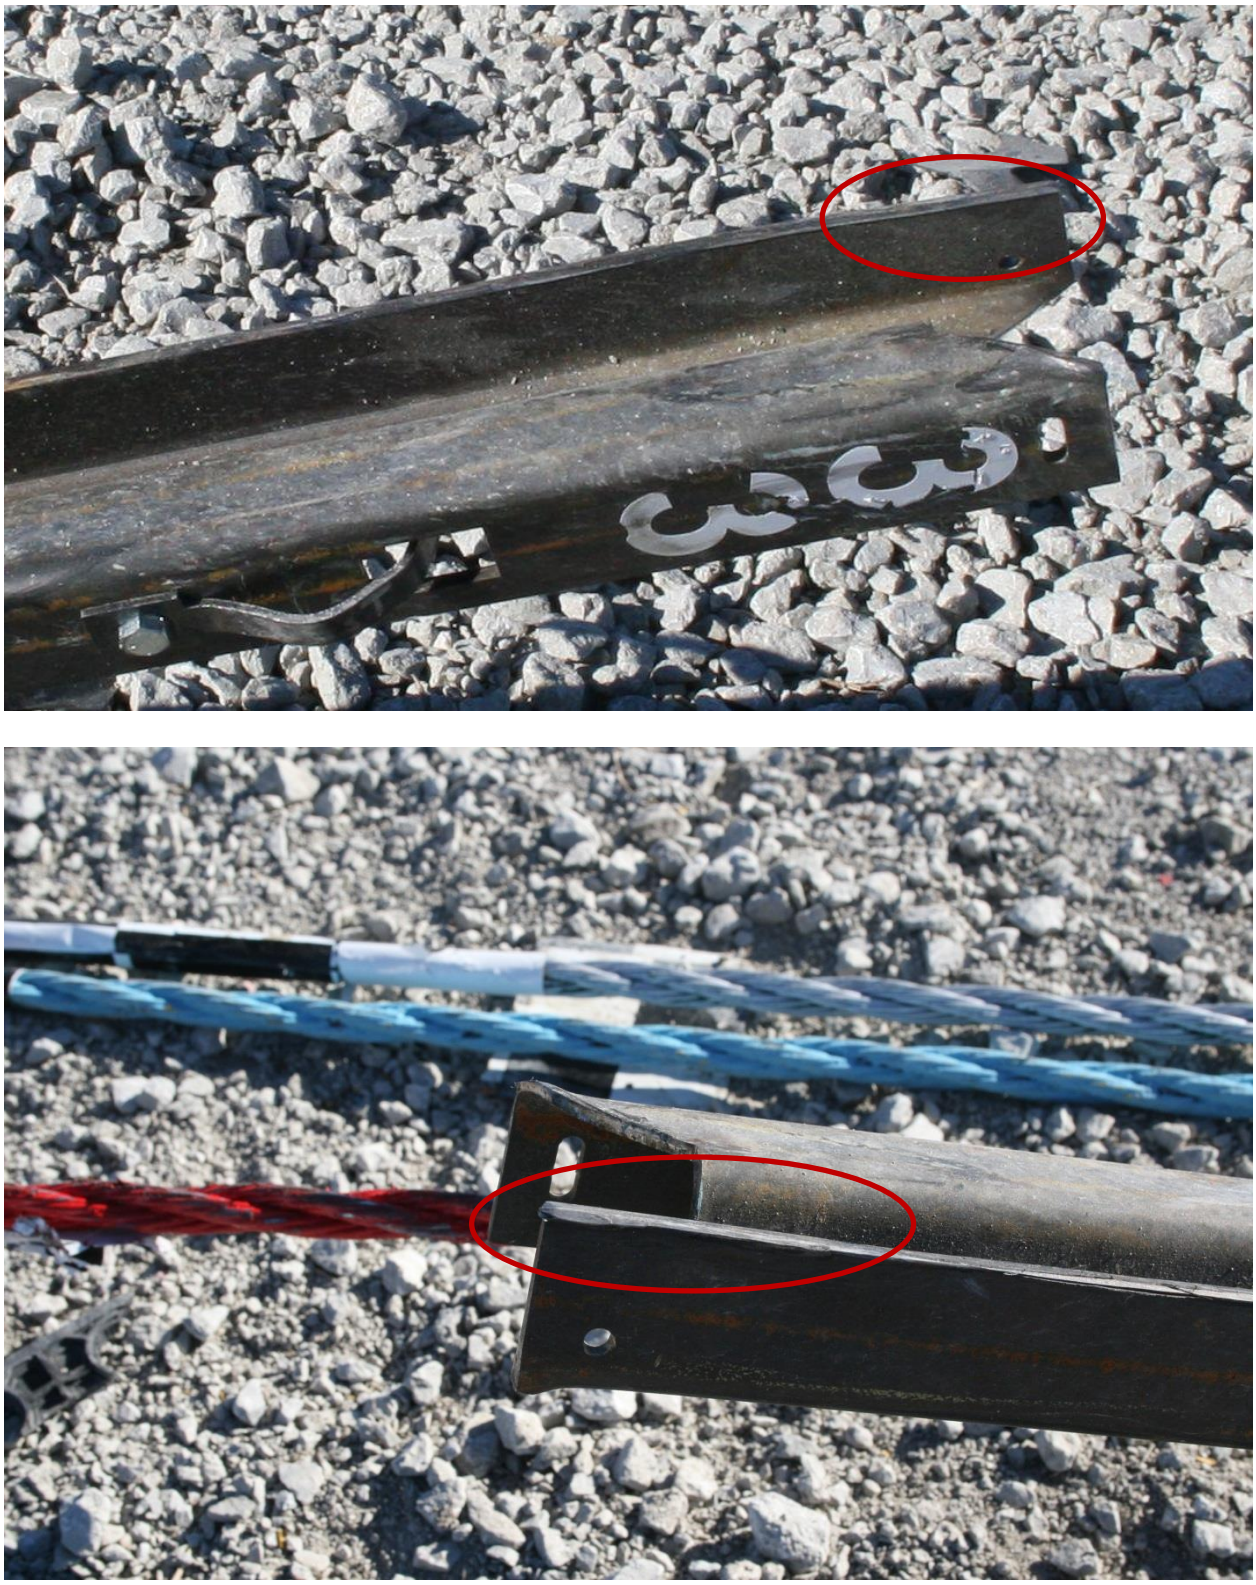
Figure 104. Post Contact Marks, Test No. MWP-6

Following the unsuccessful system performance in test no. MWP-6, the researchers brainstormed several potential design changes to mitigate floorpan penetrations. Analysis of the vehicle undercarriage and contact marks on both the system posts and the vehicle suggested that the floorpan tears were created as the post was overridden by the vehicle and the edges of the post scraped along the bottom of the vehicle. Contact marks from both the left and right flanges when bending about the weak axis of the post were visible in the deformed floorpan. A review of these contact marks indicated that the tearing was primarily caused by the free edges of the post, as shown in Figures 104 and 108.

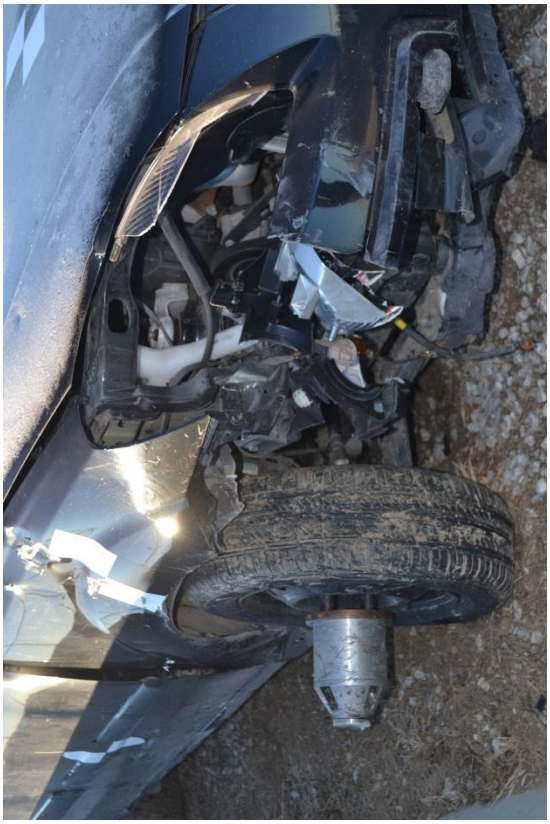
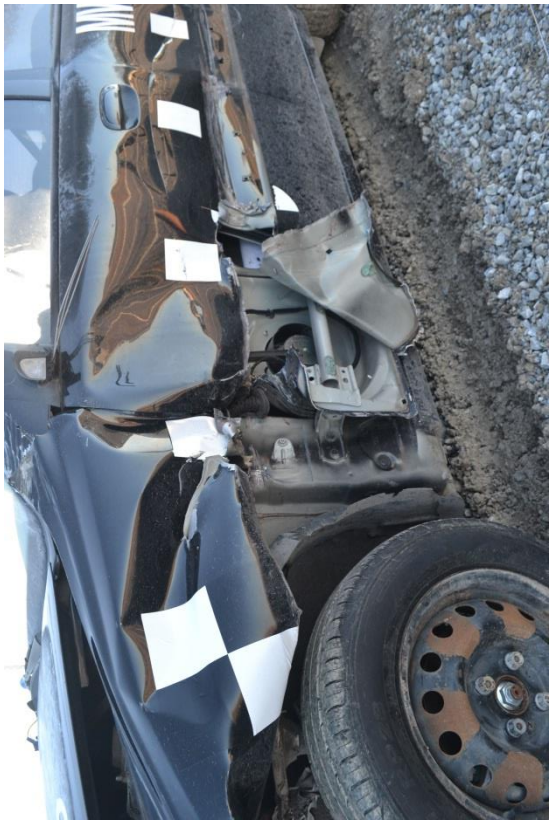
The damage to the vehicle was moderate, as shown in Figures 105 through 110. The maximum occupant compartment deformations are listed in Table 11 along with the deformation limits established in MASH for various areas of the occupant compartment. Note that none of the MASH-established deformation limits were violated. Complete occupant compartment and vehicle deformations as well as the corresponding locations are provided in Appendix D.

Figure 106. Vehicle Damage, Test No. MWP-6

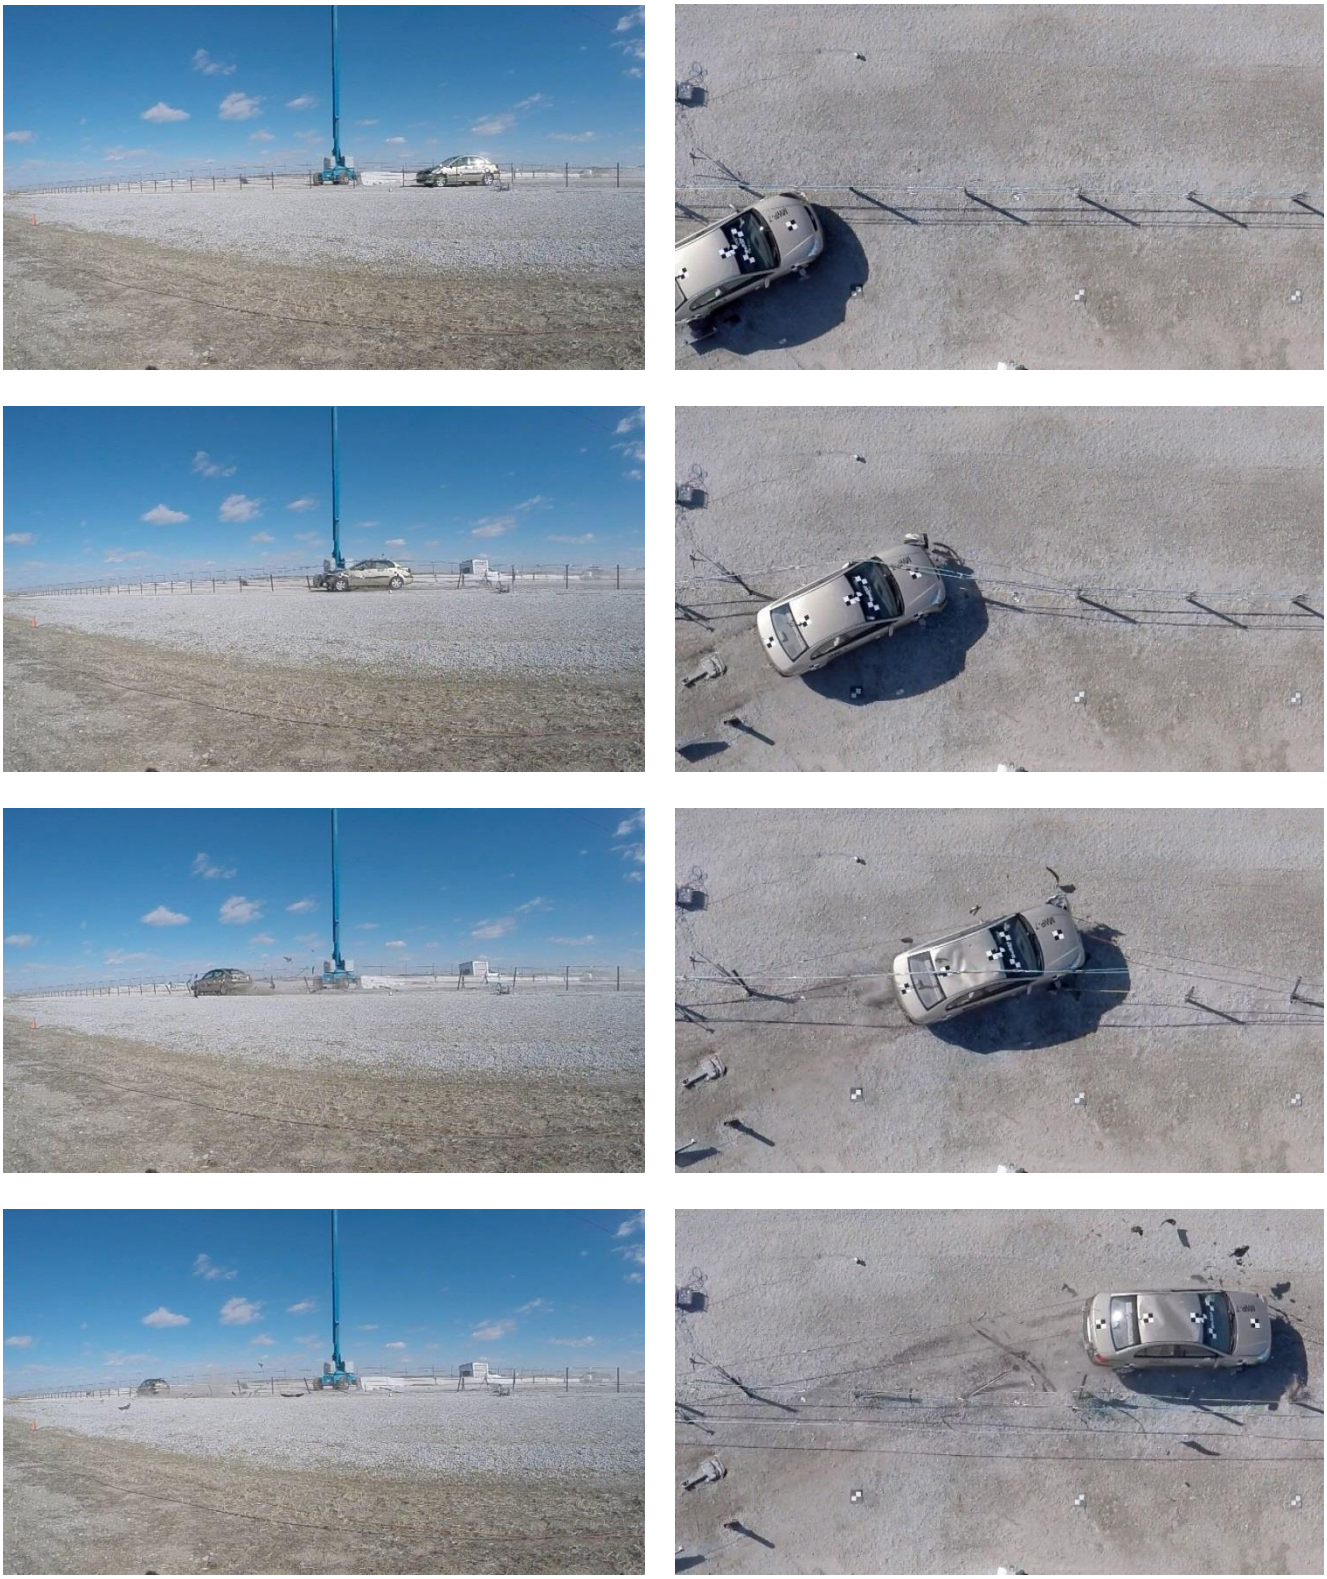
Figure 145. Documentary Photographs, Test No. MWP-7

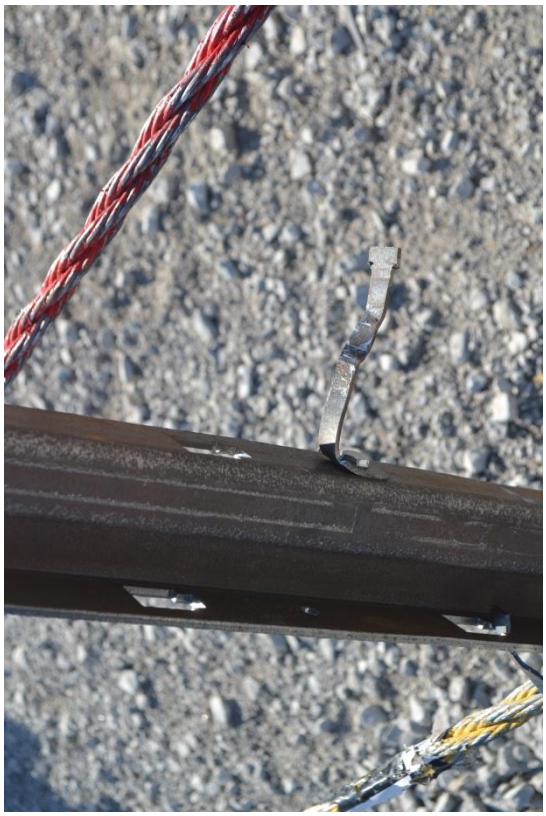
Damage to the barrier was moderate, as shown in Figures 148 through 158. Barrier damage consisted of bent posts, disengaged cables, and bent and fractured brackets. At its final resting position, the vehicle was still in contact with the cables. Cable no. 3 was beneath the vehicle, cable no. 2 was on the impact side of the vehicle, and cable nos. 1 and 4 were on the non-impacting side of the vehicle.

Figure 150. System Damage, Cable Brackets, Test No. MWP-7

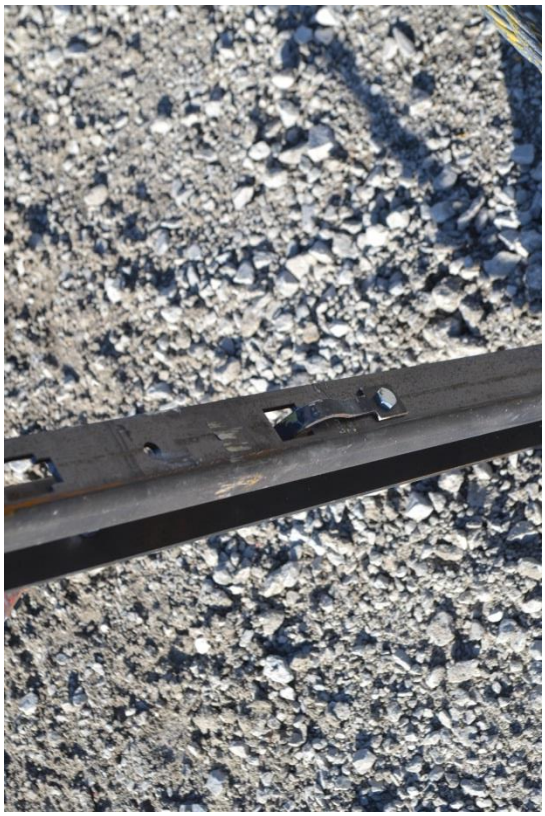
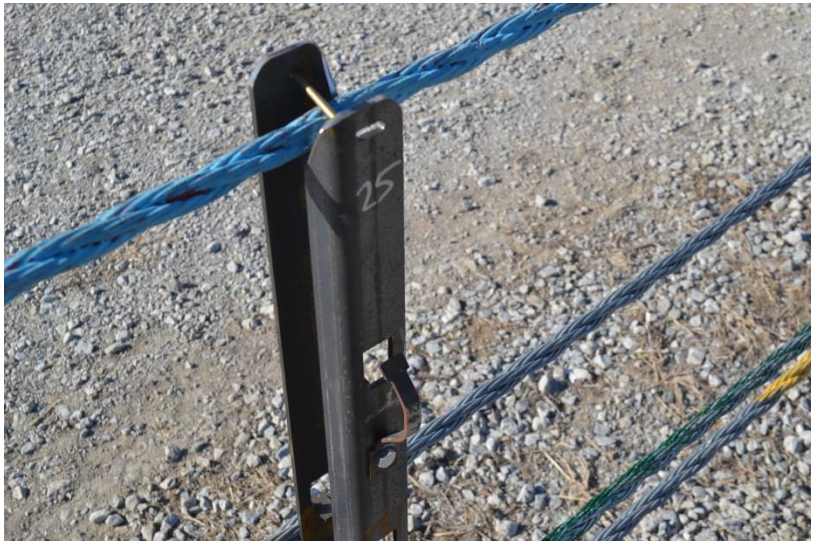
Figure 151. System Damage, Brass Rods, Test No. MWP-7

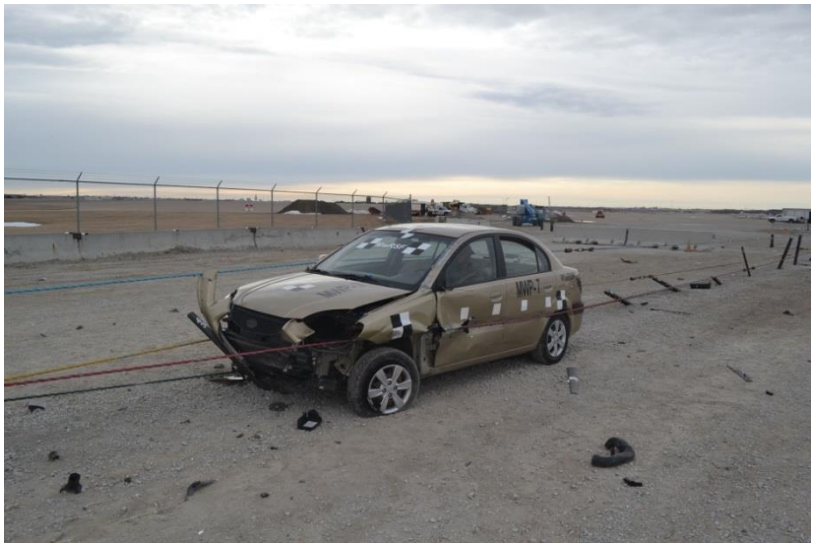
Figure 159. Vehicle Damage, Test No. MWP-7

The damage to the vehicle was moderate, as shown in Figures 159 through 162. The maximum occupant compartment deformations are listed in Table 16 along with the deformation limits established in MASH for various areas of the occupant compartment. Note that none of the MASH-established deformation limits were violated. Complete occupant compartment and vehicle deformations and the corresponding locations are provided in Appendix D.

- Vehicle Damage ..... Moderate
  - VDS [8] 11-FL-5
  - CDC [9] 11-FDAK-6
  - Maximum Interior Deformation ..... 3.46 in. (88 mm)
- Test Article Damage ..... Moderate
