Report No. FHWA-WY-16/07F

INVESTIGATION OF SILICA FUME
CONCRETE BRIDGE DECK OVERLAY FAILURES

by
Kim Basham, PhD. PE, FACI
KB Engineering, LLC
1716 Capitol Avenue
Cheyenne, WY 82001
kbashamatKBEngLLC.com

February 23, 2016

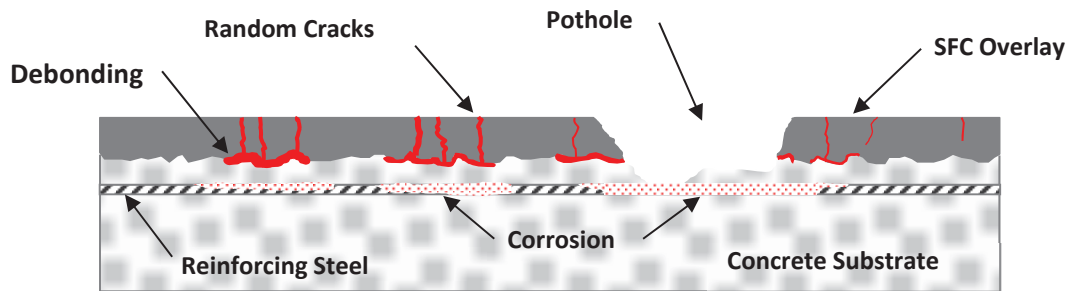
Figure 1.1.   Illustration of SFC overlay distress – cracks, debonding, steel reinforcement corrosion and potholes.

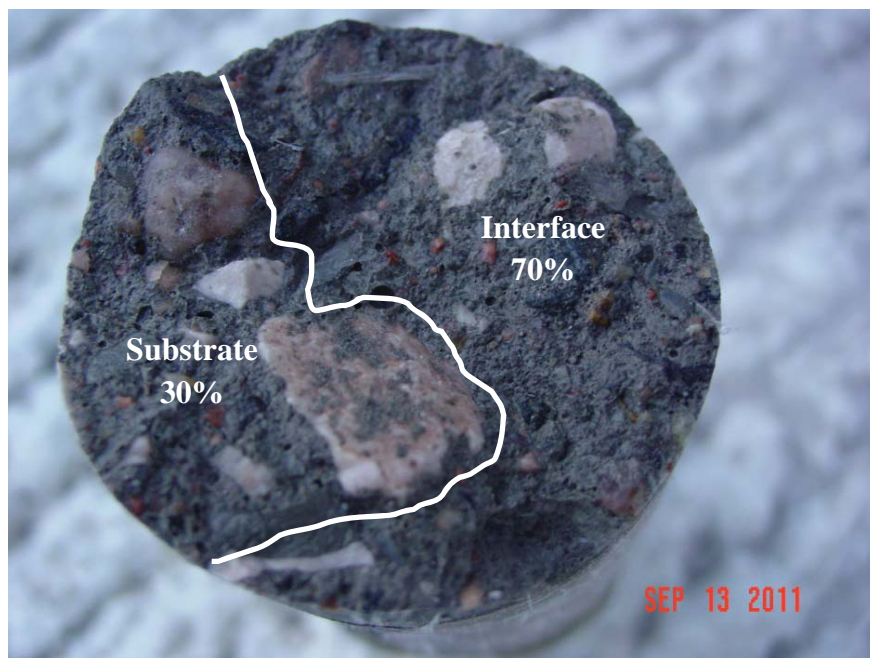
Figure 2.6. Photo - For pull-off test AYS-3N2A as shown in Table 2.5 in Section 3 below, 30-percent of the failure occurred in the concrete substrate and 70-percent was at the bond of the concrete/overlay interface.

In addition to presenting the pull-off strengths, Tables 2.2 – 2.7 present the estimated percentage of each failure mode as shown above in Figure 2.4. For pull-off test AYS-3N2A (New Silica Fume Overlay) as shown in Table 2.5, 30-percent of the failure occurred in the concrete substrate and 70-percent was at the bond of the concrete/overlay interface as shown above in Figures 2.5 and 2.6.

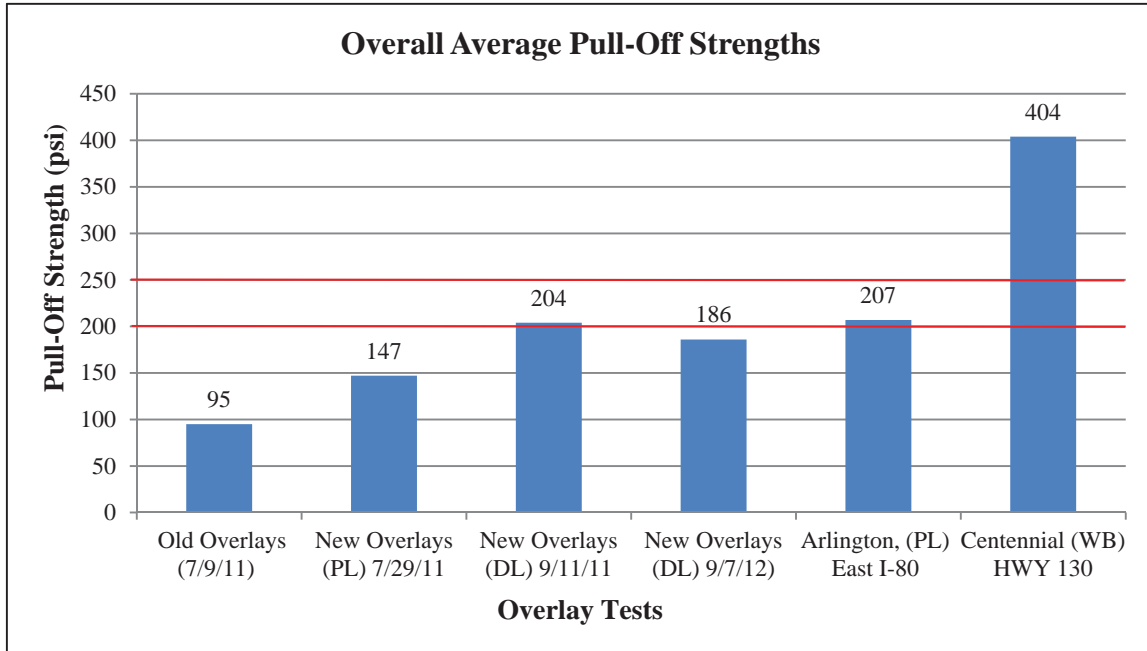
Figure 2.7. Bar chart of overall average pull-off strengths.

As shown in Figure 2.7 above, the overall average pull-off strengths for the old or existing overlays was 95 psi. Specifically, average pull-off strengths (Figure 2.8) for the Pine Bluffs I-80 and Round Top I-80 East and West bound lanes were 85, 36, 98 and 159 psi (586, 248, 676 and 1096 kPa), respectively.   All values were less than the 250 psi (1724 kPa) and the 200 psi (1379 kPa) bond strength recommended by the American Concrete Pavement Association for 3 inch overlays or thicker. In fact, all bond strengths were less than the 175 psi (1207 kPa) indicating a damaged or inadequate bond surface.

As shown in Figure 2.7 above, the overall average pull-off strengths for all of the new overlays were 147, 204, 186, 207 and 404 psi (1014, 1407, 1282, 1427, and 2786 kPa). For the Pine Bluffs and Round Top bridge decks and as shown in Figure 2.8, pull-off strengths for new overlays varied from a low of 107 psi (738 kPa) to a high of 234 psi (1613 kPa) with an average value of 177 psi (1220 kPa). All bond strengths for the Pine Bluffs and Round Top bridges were

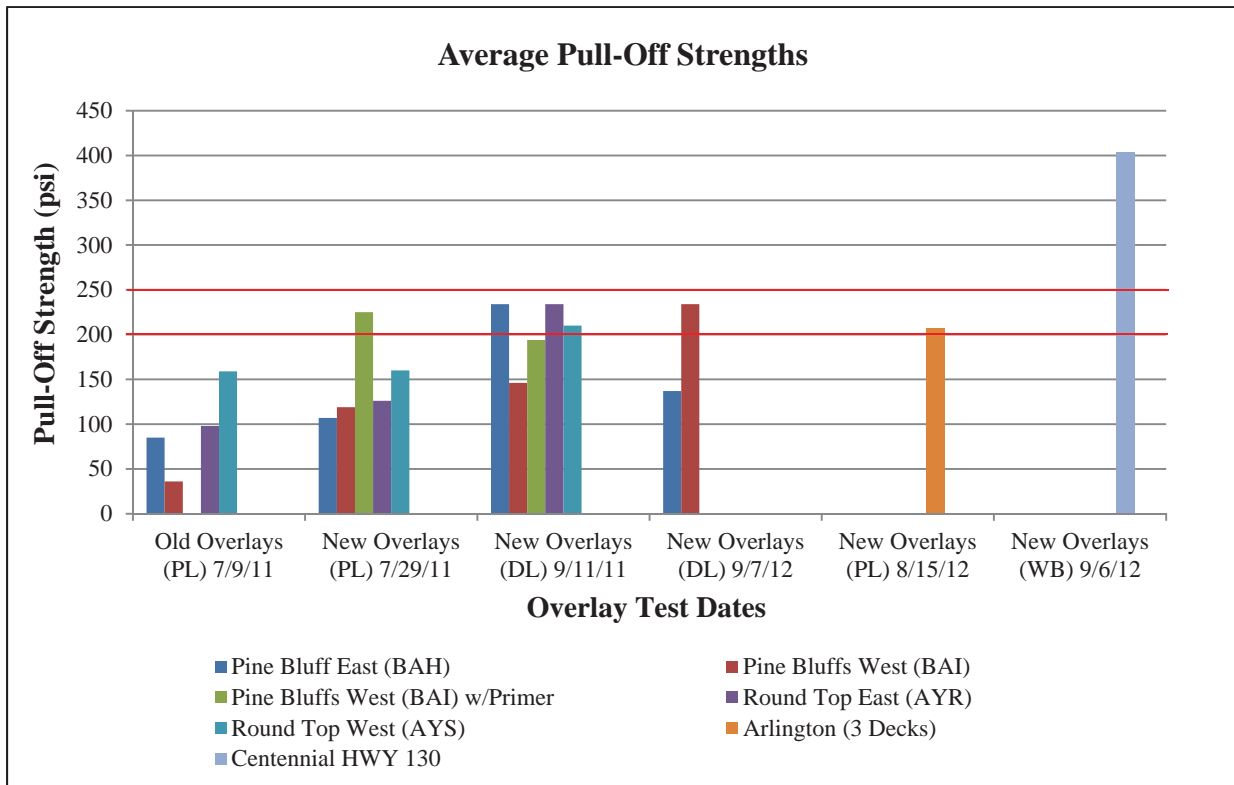
Figure 2.8. Bar chart for average pull-off strengths for each bridge deck.

As shown in Figure 2.8, only five out of the 12 data sets had bond strengths exceeding the recommended minimum 200 psi (1379 kPa) strength. Bond strength for seven of the data sets fell below the 200 psi (1379 kPa) value and six of those fell below 175 psi (1207 kPa). Most of the pull-off tests for the Pine Bluffs and Round Top bridges indicate the bond strength of the new overlays was inadequate to ensure proper bonding or to maintain bonding of the overlays.

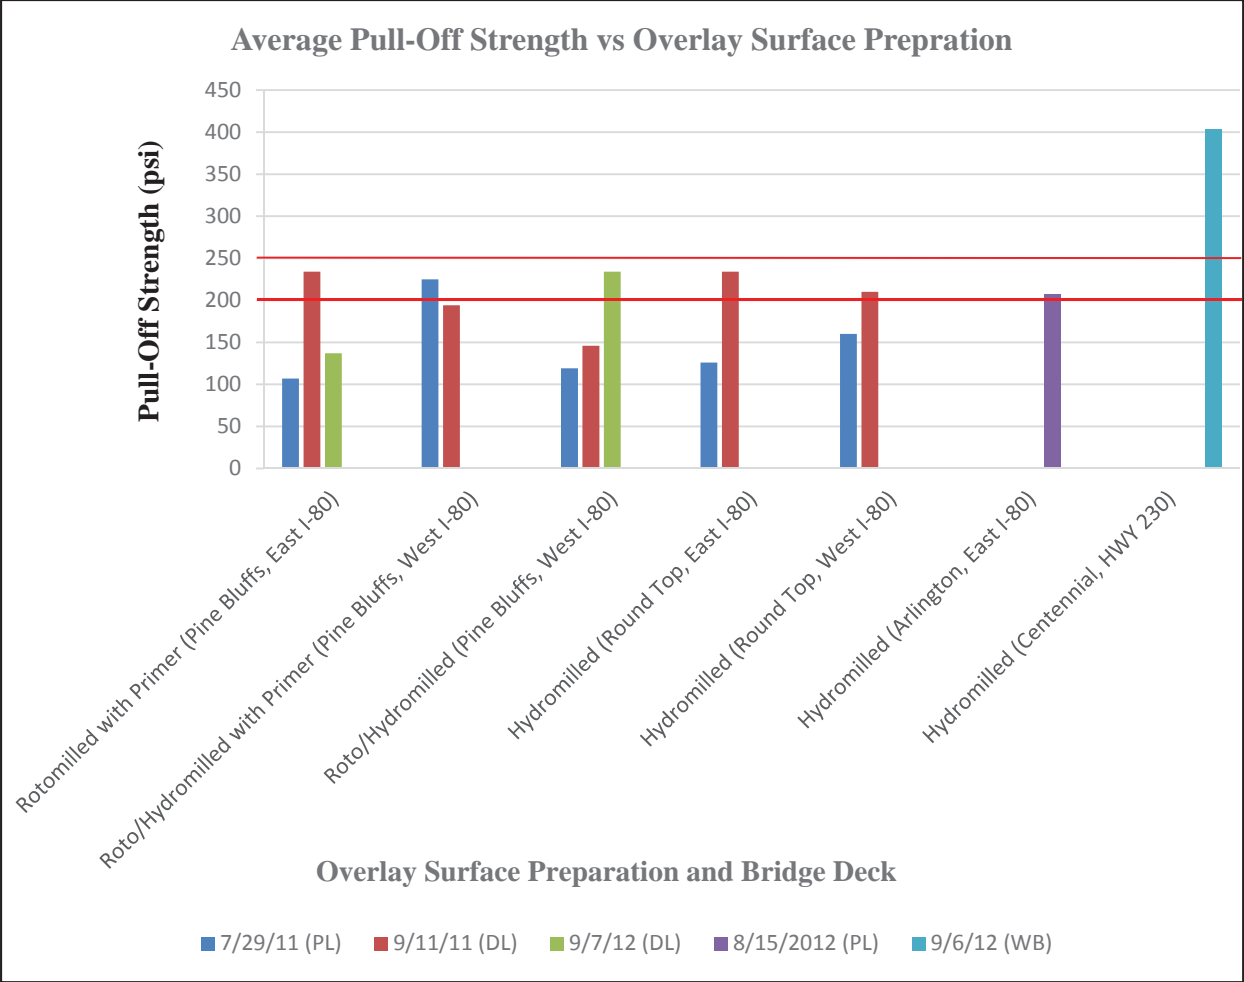
Figure 2.9. Bar chart for average pull-off strength versus overlay surface preparation.

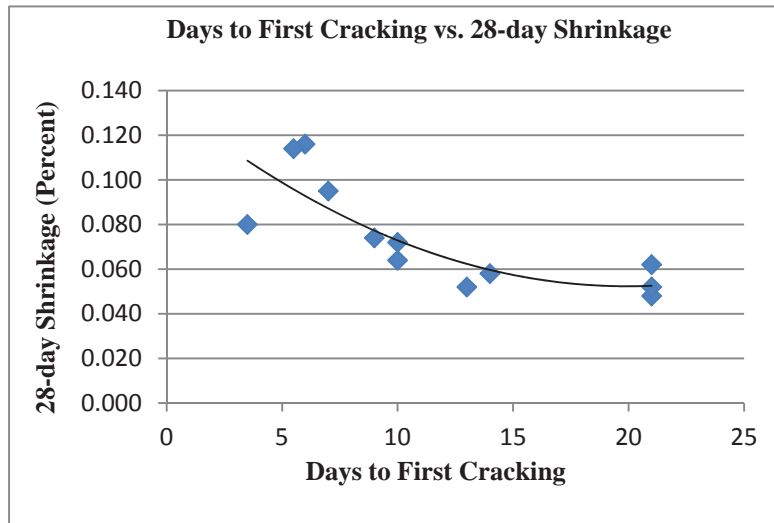
Figure 3.2. Days to First Cracking versus 28-day Air-dried Shrinkage for Silica Fume Concrete Overlay Mixtures.

As shown in Figure 3.2, there was a non-linear relationship between the measured 28-day (air-dried) shrinkage and the number of days to first cracking. In general, reducing the rate and magnitude of the concrete shrinkage reduces the risk of cracking. Therefore, reducing the shrinkage potential of the silica fume concrete overlay mixtures should reduce the potential for cracking, curling and subsequent debonding of the bridge deck overlays.

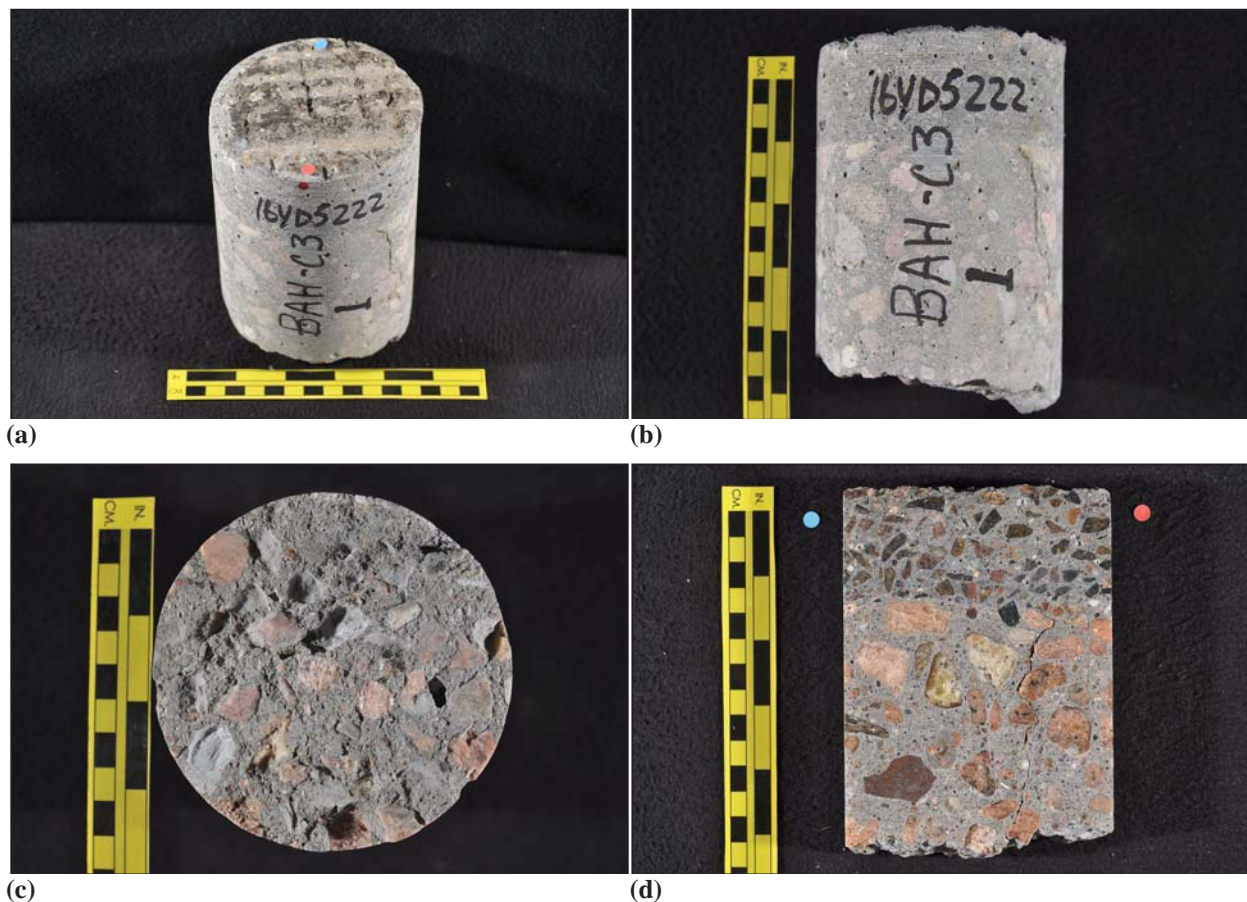
All the cores are vertical in orientation. The cores that are subjects of petrographic examinations measured 95 mm (3 ¾ in.) in diameter. The cores span from textured surfaces on top that display variable degrees of wear to fractured surfaces on the bottom such that the cores represent partial thicknesses of the deck slabs (Figure 4.1). The cores were all hard and compact. None of the cores contained embedded objects such as steel reinforcement but synthetic fibers were observed in some of the SFO concrete.

Figure 4.1. Photographs showing example of typical core. (a) Oblique view of the core showing top and side; the red and blue dots indicate the orientation of the saw-cuts used to prepare the sample. (b) The side of the core showing markings used to identify the core. (c) The bottom fracture surface. (d) Polished surface of the core. The yellow scale bar is ~ 150 mm (6 in.) long.

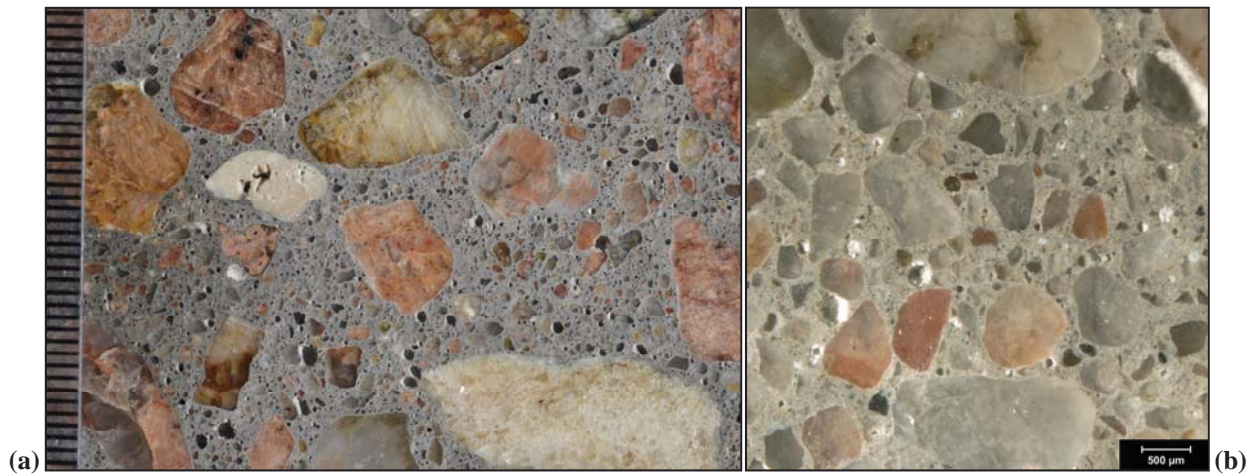
The BDC was made with two distinct types of aggregates. In the cores from Pine Bluffs, the BDC contains natural gravels that are siliceous in composition and consist primarily of granitic rocks (Figure 4.2). The nominal top size of the coarse aggregate ranges from 19-25 mm (¾-1 in.). The fine aggregate in the Pine Bluffs BDC is a natural sand that is siliceous in composition and consists primarily of granitic rocks, quartz and feldspar. In the Roundtop cores the BDC contains crushed quarried rocks that are carbonate in composition and consist of limestone (Figure 4.3). The nominal top size of the coarse aggregate is 19 mm (¾ in.). The fine aggregate in the Roundtop cores is a natural sand that is siliceous in composition and consists primarily of granitic rocks.

Figure 4.2. Aggregate in Pine Bluffs BDC. (a) Photograph and (b) reflected light photomicrograph of polished surface of Core 2 showing coarse aggregate and sand, respectively. Scale in millimeters in (a).

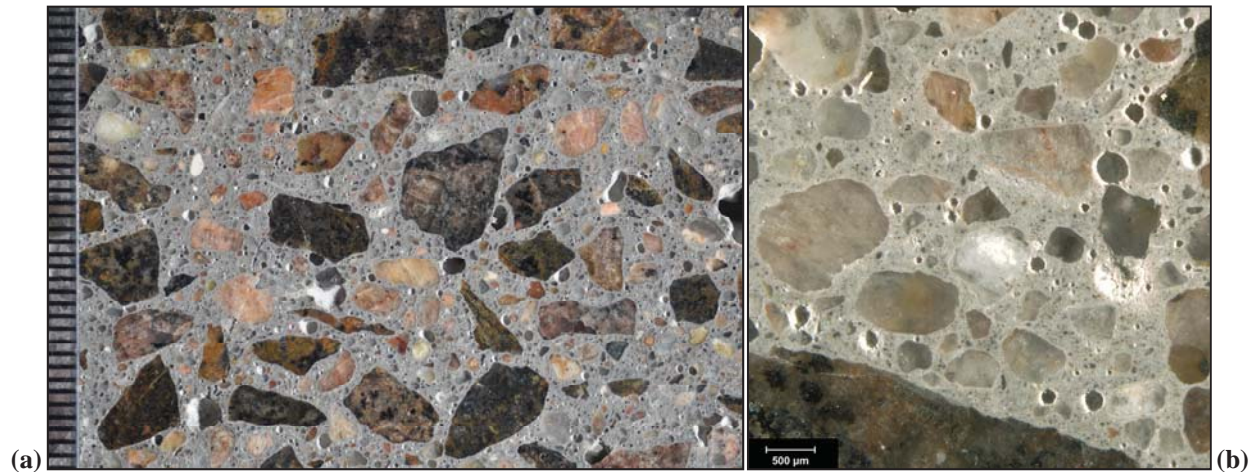
The SFO concrete was made with similar aggregates in all the cores. The coarse aggregate is a crushed gravel with a 9.5 mm (⅜ in.) nominal top size and the fine aggregate is a natural sand (Figure 4.4). The coarse and fine aggregates are siliceous in composition and consist primarily of granitic rocks, albeit different granites than were used in the production of the Pine Bluffs BDC.

Figure 4.4. Aggregate in Pine Bluffs SFO. (a) Photograph and (b) reflected light photomicrograph of polished surface of Core 2 showing coarse aggregate and sand, respectively. Scale in millimeters in (a).

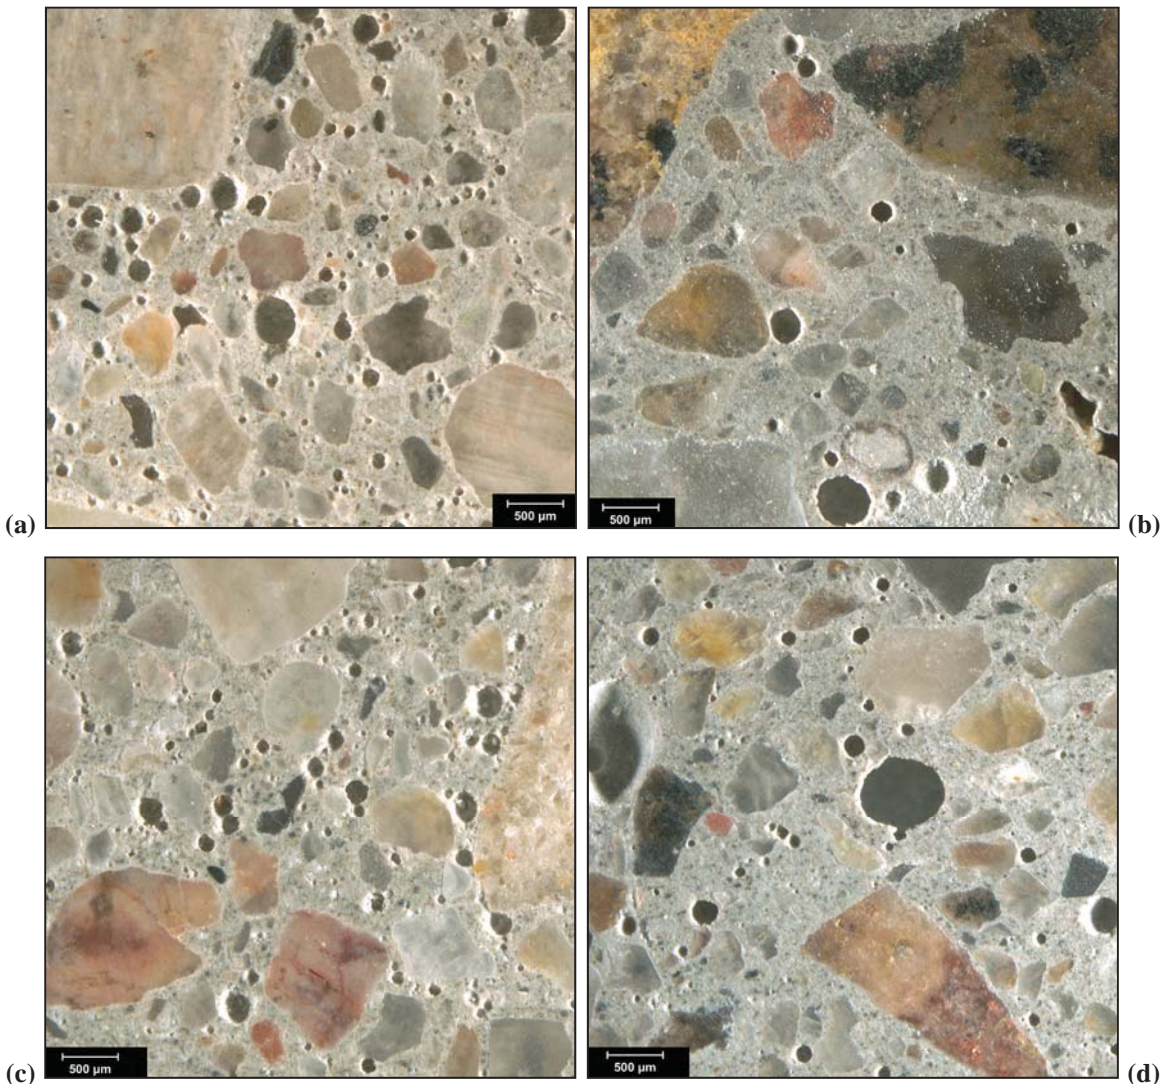
Figure 4.5. Photomicrographs showing examples of air void systems. (a) BDC in Core 3 (Pine Bluffs). (b) SFO in Core 3. This area of the overlay had low air (2-4 percent estimated) in the top of the overlay. (c) BDC in Core 7 (Roundtop). (d) SFO in Core 7. Note that all the photomicrographs are of polished slabs using oblique reflected light at the same magnification.

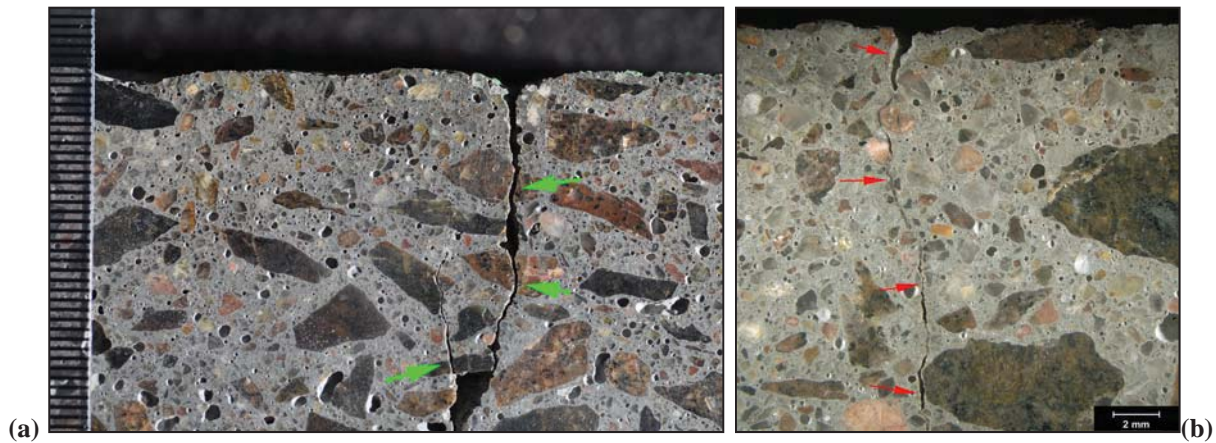
Several different types of cracks were observed in the cores. The SFO in cores from both Pine Bluffs and Roundtop commonly show sub-vertical cracks and microcracks. Examples were observed that wrap around aggregate particles and lack secondary deposits, which are typical of drying shrinkage, and cracks that cut through aggregate particles, which are typical of other mechanisms (Figure 4.6). Such cracks are typical of drying shrinkage and were observed only very rarely in the BDC in these cores. The BDC in the cores show sub-horizontal cracks and microcracks near the contact with the SFO (Figure 4.7). These cracks and microcracks are also free of secondary deposits but cut both around and through aggregate particles. Section 3.4 and Appendix *D* provide details regarding these cracks. Cracking and microcracking related to ASR in both SFO and BDC was also observed and is discussed in more detail below.

Figure 4.6. Sub-vertical cracks and microcracks in SFO. (a) Photograph and (b) reflected light photomicrograph of polished surface of Core 6 and Core 7, respectively showing sub-vertical cracks and microcrack in the SFO. Note the crack in (a) cuts through aggregate particles.

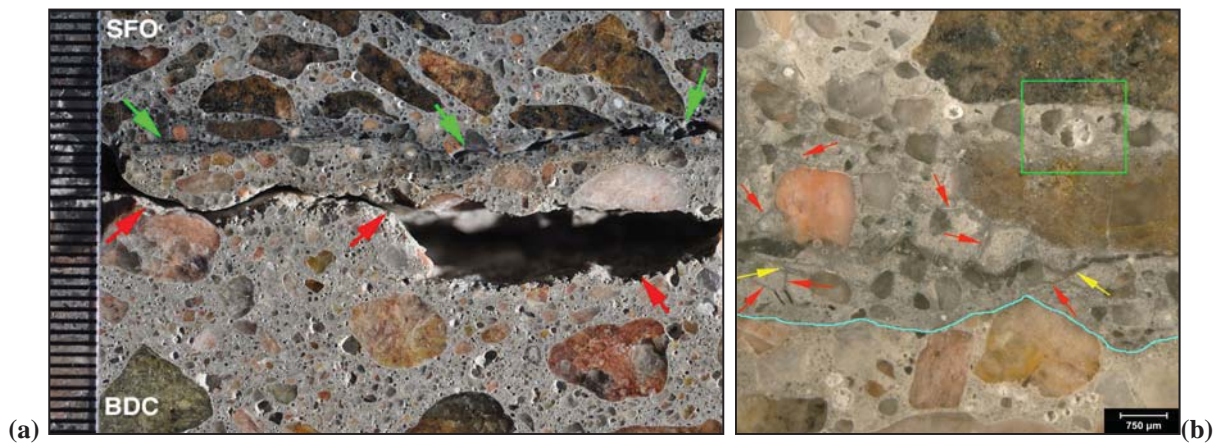
Figure 4.7. Sub-horizontal cracking near the BDC/SFO contact (Core 4). (a) Photograph of the polished surface where the green arrows show a sub-horizontal crack in the SFO and the red arrows show a crack in the BDC. (b) Reflected light photomicrograph of the polished surface where the red and yellow arrows highlight oblique and sub-horizontal microcracks, respectively, in the SFO. The blue line marks the contact between the BDC and SFO and the green box indicates a void with deposits of ettringite and gel.

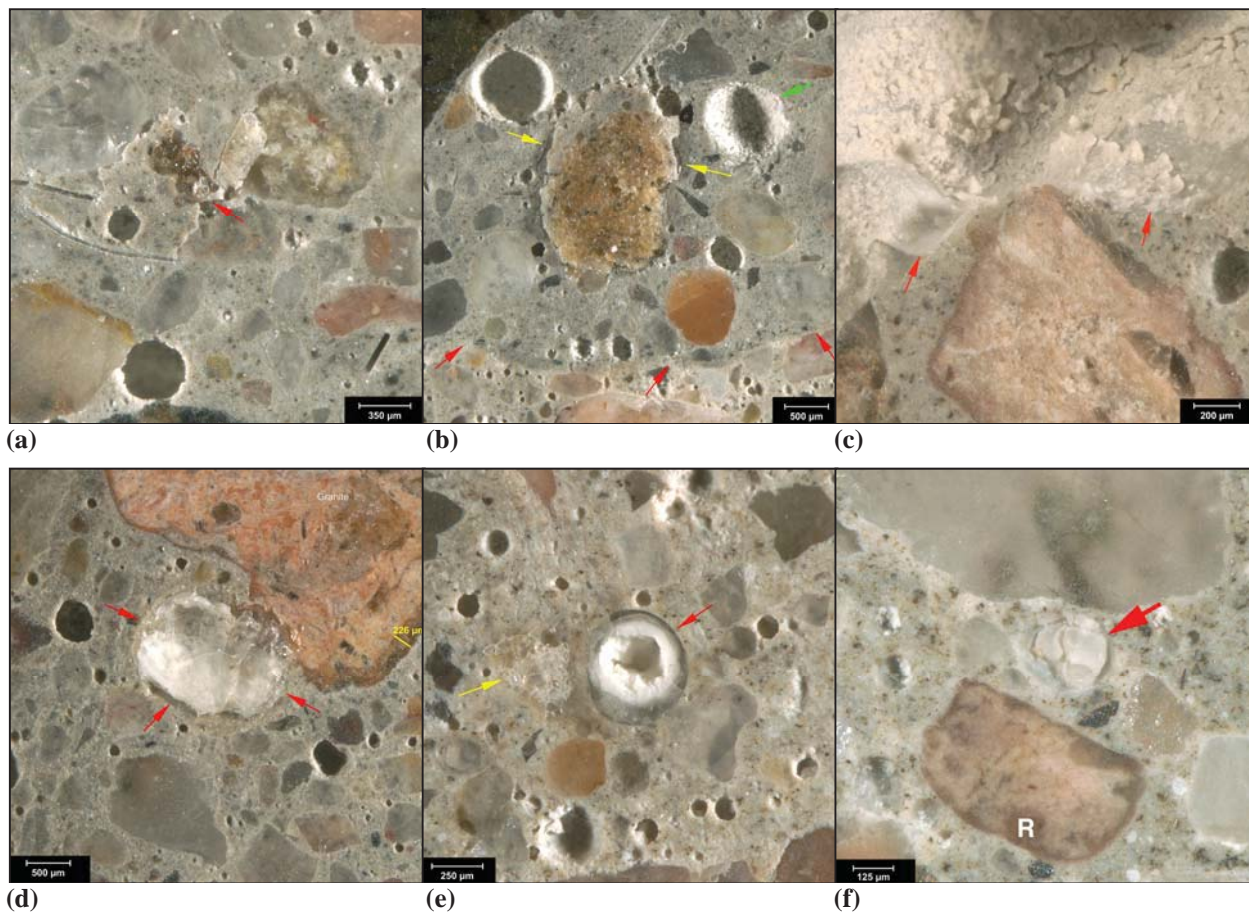
Figure 4.8. Examples of ASR in the SFO and BDC. Reflected light, polished surfaces showing (a)-(c) the SFO and (d)-(f) the BDC. (a) Core 2; the red arrow indicates a swollen siliceous volcanic rock. (b) Core 3; yellow arrows indicate margins of swollen granite particle, the green arrow indicates a void with deposits of ettringite and red arrows indicate the SFO/BDC contact. (c) Core 7; red arrows indicate gel lining void next to a rhyolite particle. (d) Core 2; red arrows highlight gel in void next to a granitic aggregate particle with a distinct reaction rim (yellow bar). (e) Core 4; red arrow highlights void with clear to white gel and yellow arrow indicates fractured aggregate particle. (f) Core 7; red arrow highlights deposit of gel in a void next to a rhyolite particle (R).

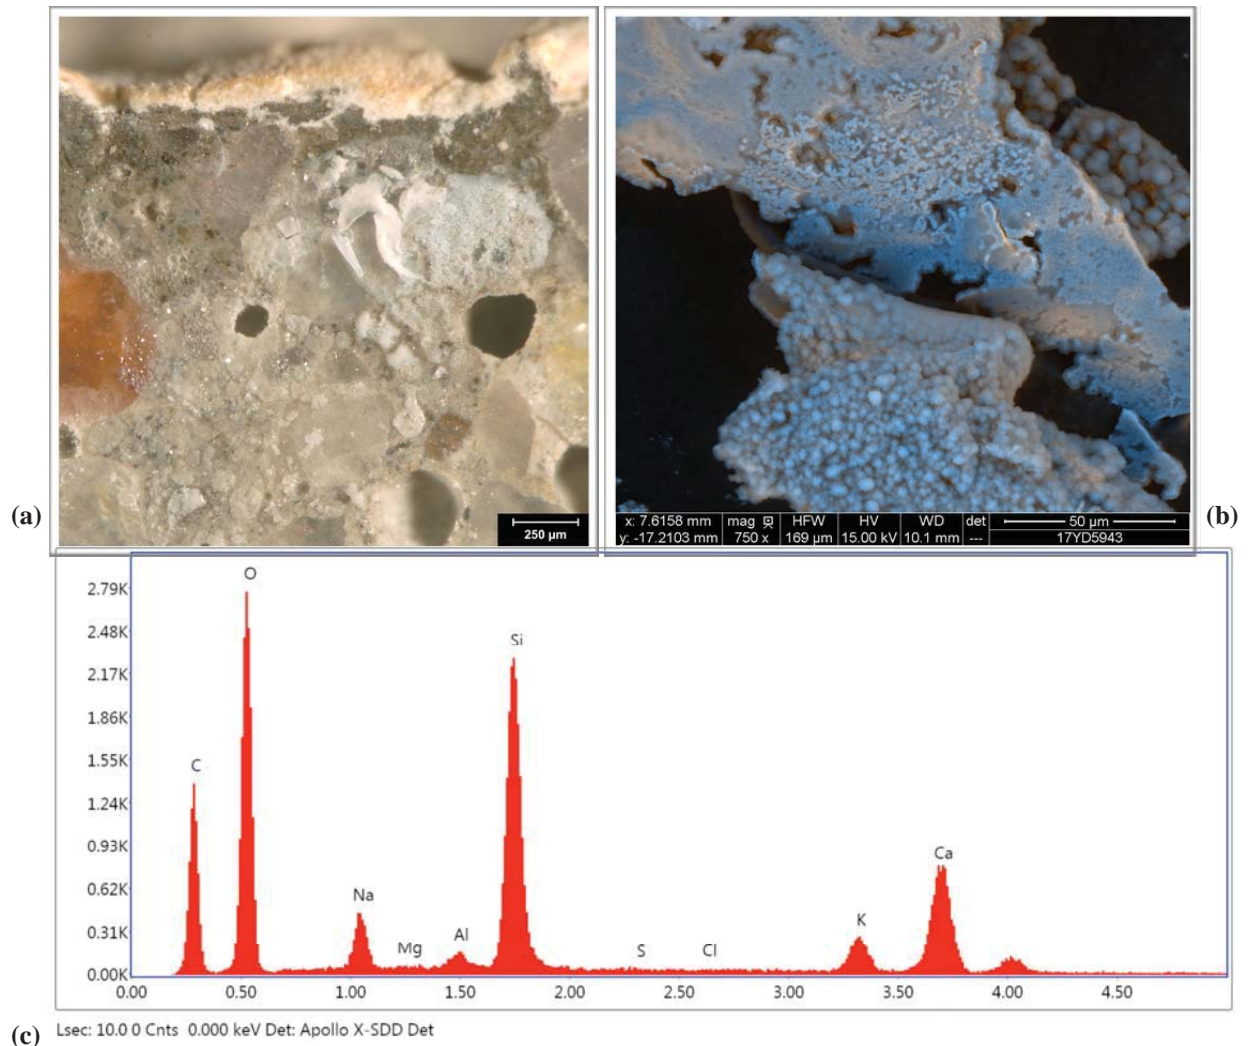
Figure 4.9. SEM/EDS analysis of gel exudation. (a) Reflected light photomicrograph of polished surface showing exudation in SFO after exposure to elevated T/RH conditions. (b) Combined backscatter and secondary electron micrograph of gel that was scraped from the surface and placed on a carbon tape. (c) EDS spectrum obtained from gel that indicates a composition consistent with alkali-silica reaction.

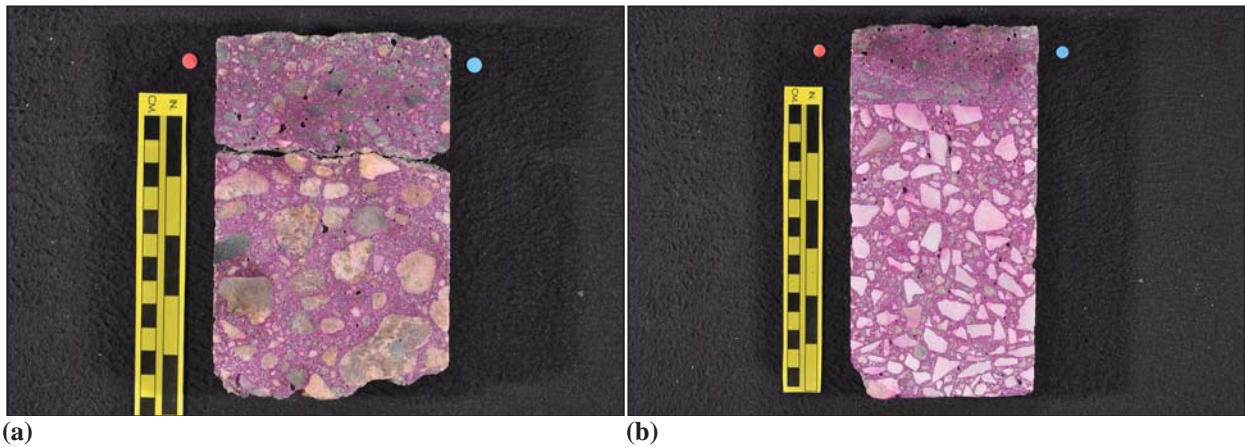
In general the cores show negligible levels of carbonation as detected from phenolphthalein staining (Figure 4.10); also see *Appendix B, Prepared Surfaces).* Deposits of ettringite are commonly observed in voids in both SFO and BDC from both Pine Bluffs and Roundtop cores (Figure 4.11). No cracking or microcracking due to ettringite mineralization was observed in any core.

Figure 4.10. Carbonation determined from phenolphthalein. Photographs showing examples of phenolphthalein stained surfaces in (a) Core 2 and (b) Core 8. The yellow scale bar is ~ 150 mm (6 in.) long.

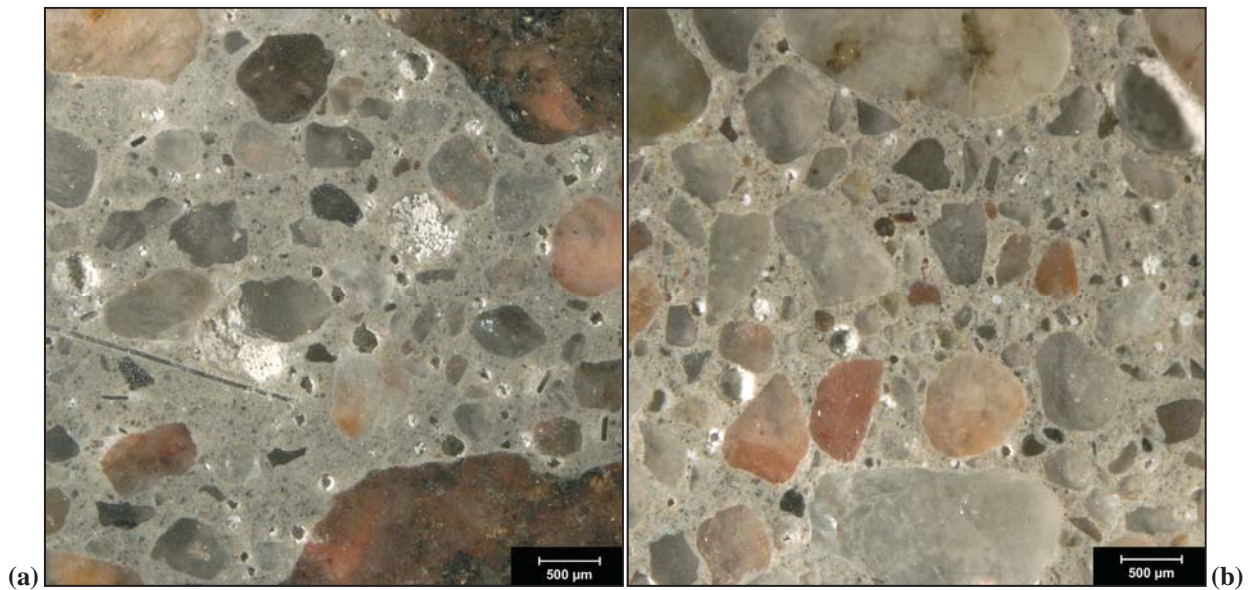
Figure 4.11. Deposits of ettringite in voids. Reflected light photomicrographs of polished slab from Core 2 showing examples of voids with deposits of ettringite in (a) the SFO and (b) the BDC.

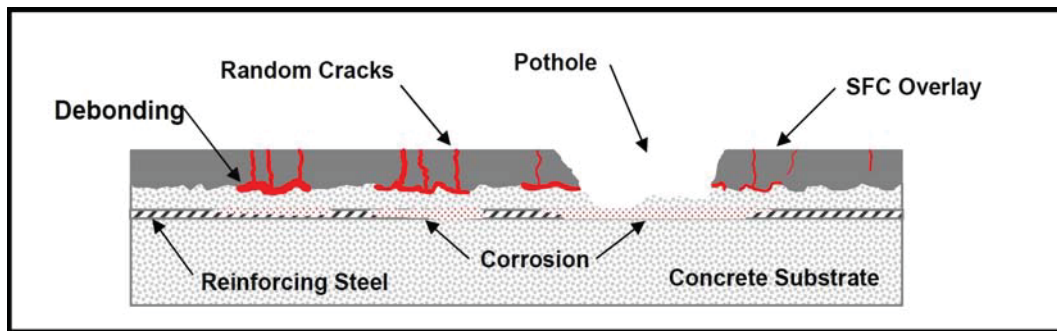
Figure 5.1. Cross section of bridge deck and overlay, description of issues.

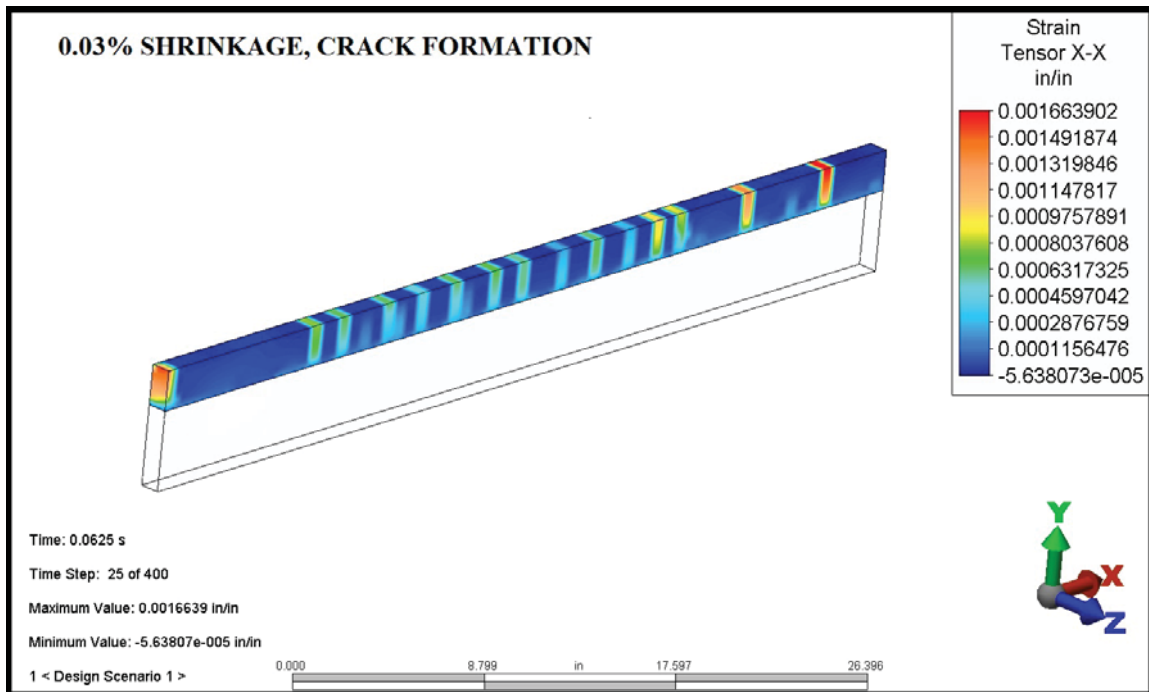
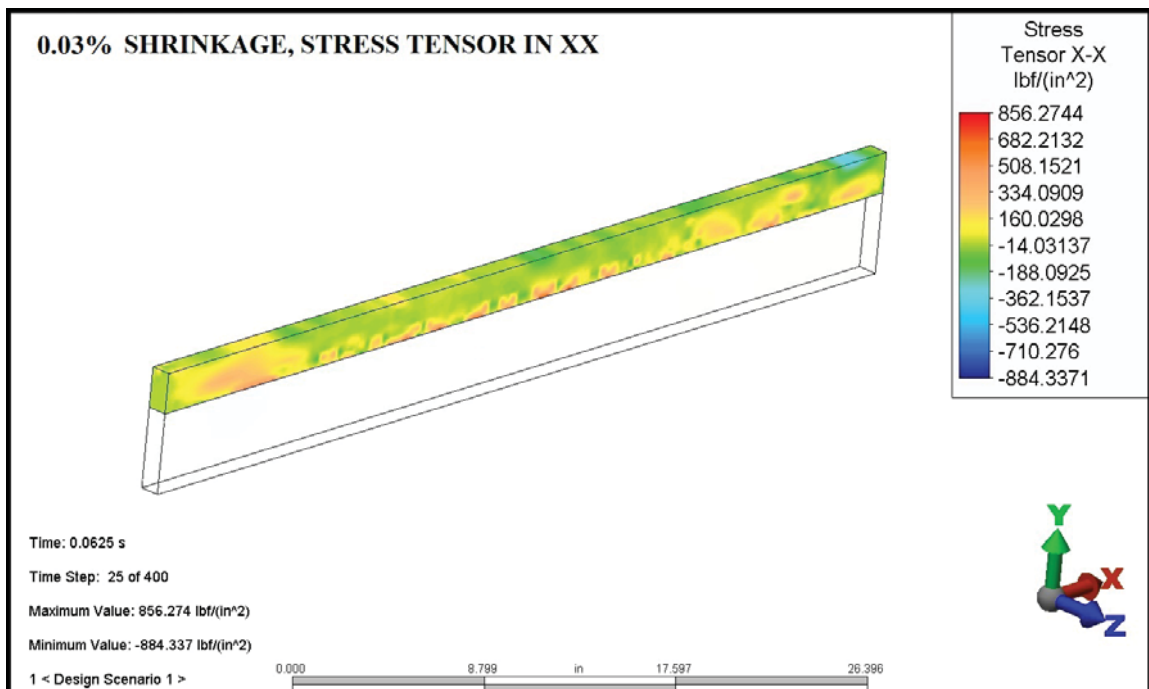
As shown in Figure 5.3 below, numerous microcracks appeared in this formulation with at least three larger cracks developing at the center and edge of the section. The strains of approximately 0.001 inch/inch (0.025 mm/mm) would not likely be visible but would admit moisture unless the overlay were sealed.

**Figure 5.3. 8,000 psi/800 psi FEA formulation at 0.03% shrinkage condition.**

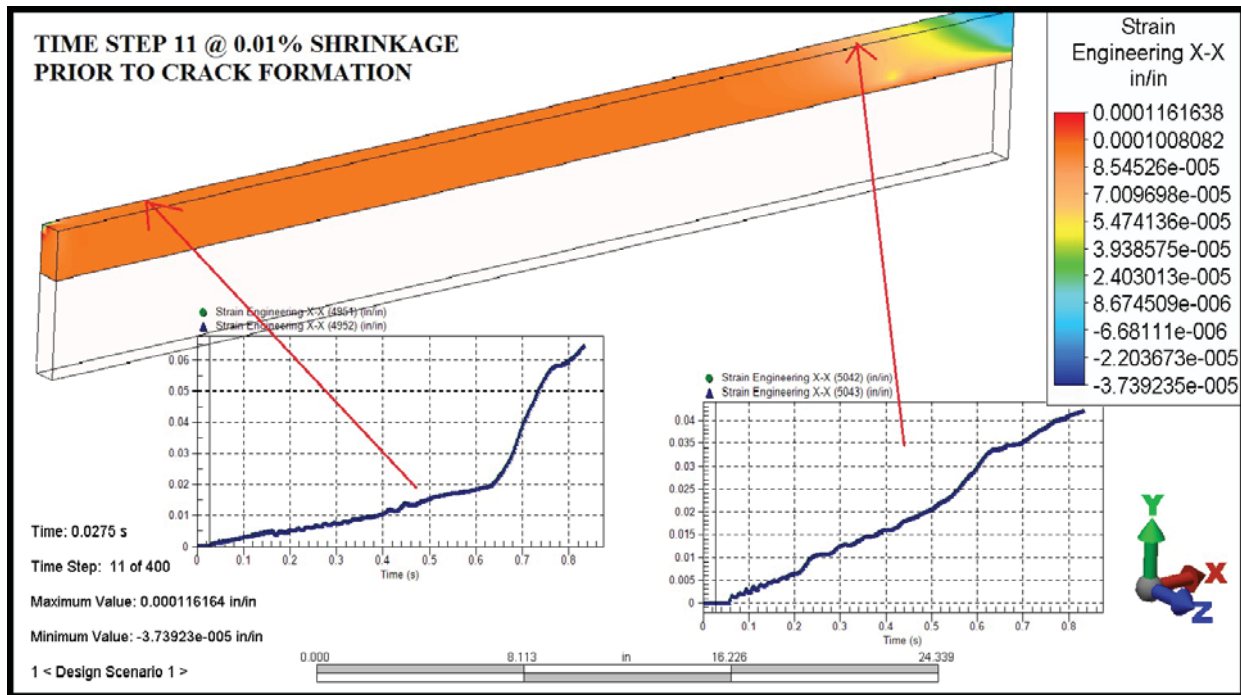
Figure 5.11. Two insipient crack locations prior to fracture (time step 11 at 0.01% shrinkage condition).

Figure 5.11 shows the strain tensor X-X due to 0.01 percent shrinkage pror to crack formation. As the shrinkage increases to 0.03 percent, cracks start to form as shown in Figures 5.12 and 5.13. Figure 5.14, shows the resulting stresses in the substrate concrete at the bond line. As the shrinkage increases to 0.07 percent, the number and size of the crack openings increase as shown in Figure 5.15.

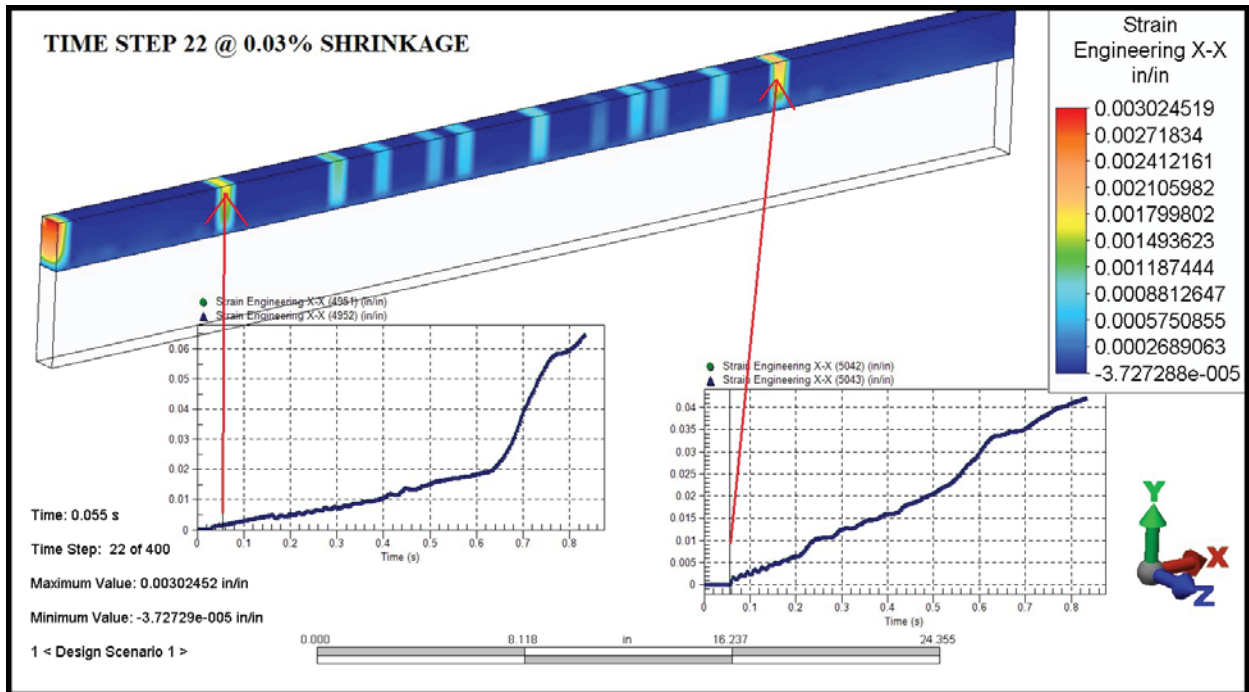
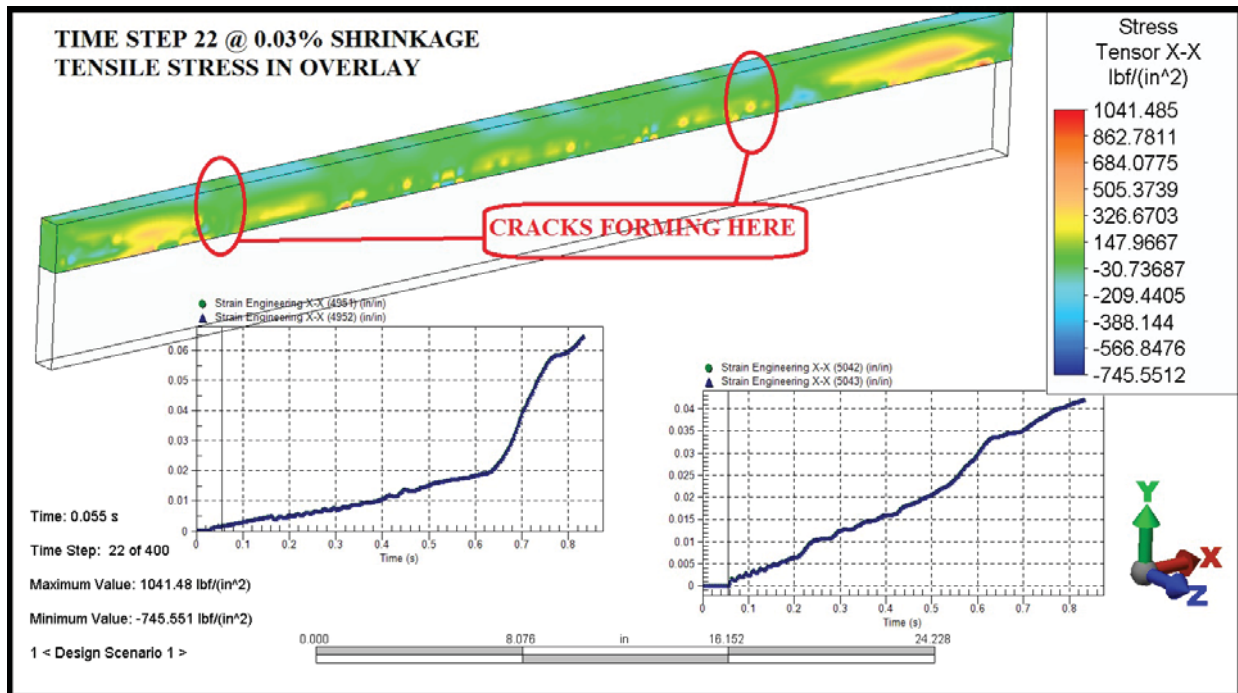
**Figure 5.12. Cracks forming at time Step 22 at 0.03% shrinkage condition.**

Figure 5.13. Stress Condition within overlay at crack locations at time step 22 at 0.03% shrinkage condition.

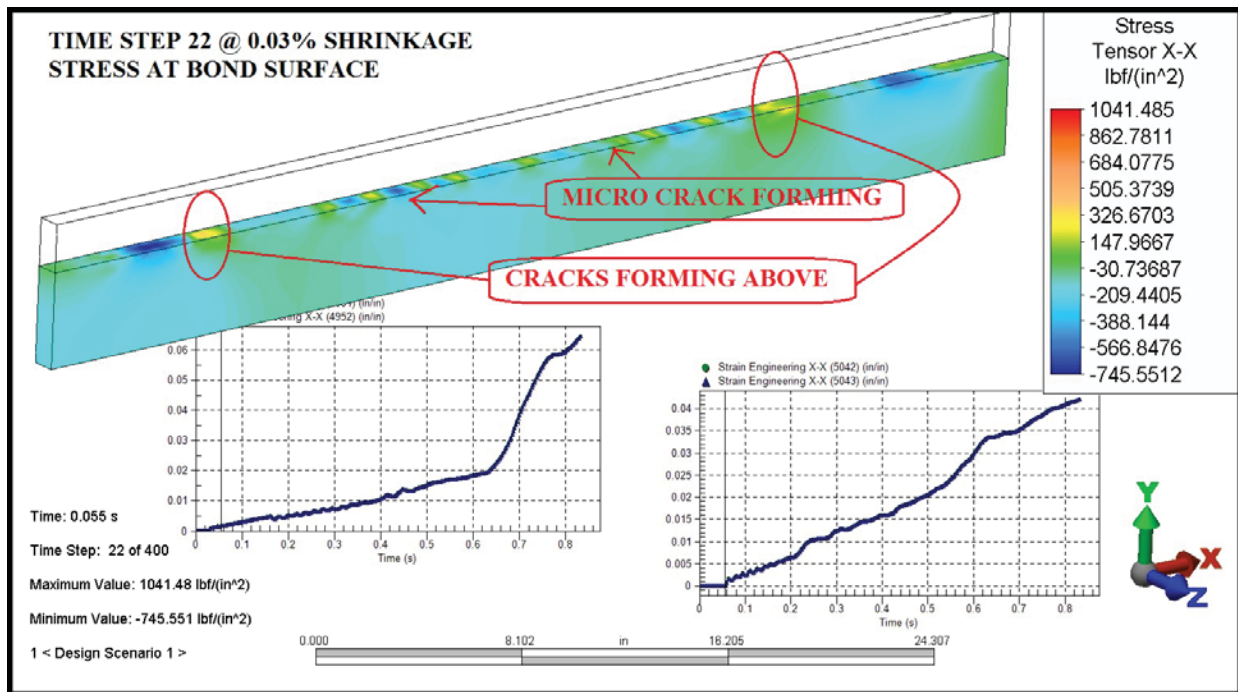
Figure 5.14. Conditions at bond surface at time step 22 at 0.03% shrinkage condition.

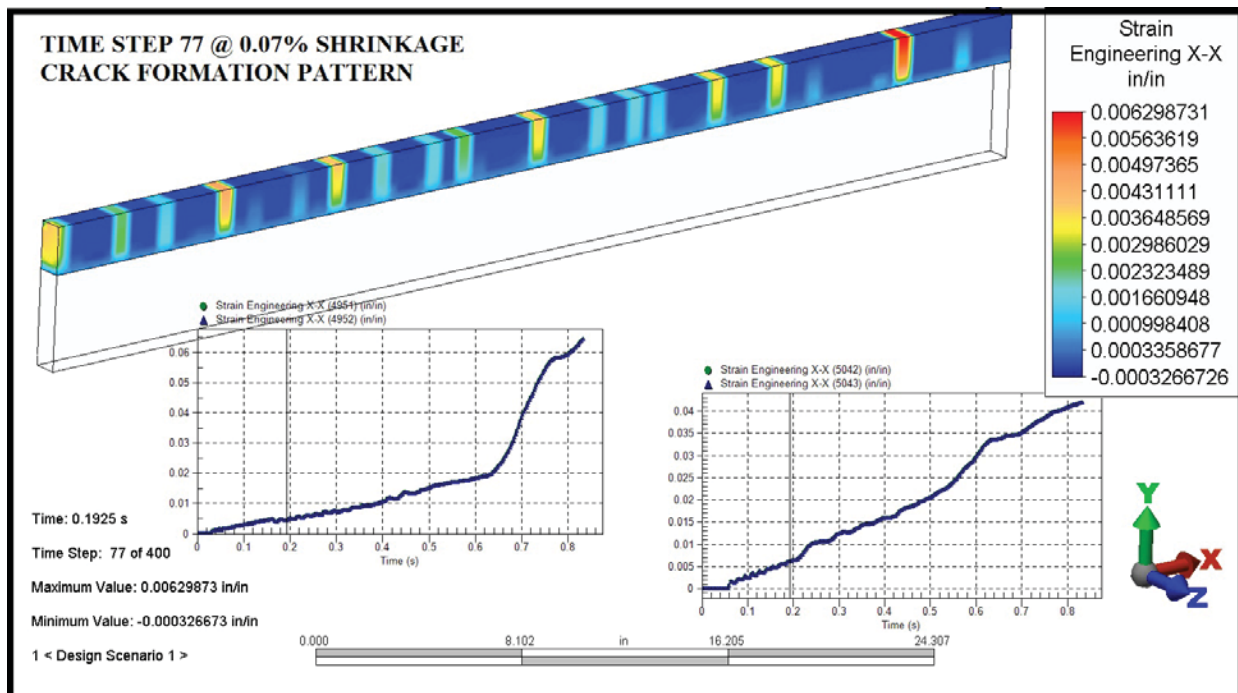
Figure 5.15. Crack pattern at 0.07% shrinkage condition with numerous microcracks and larger initial crack openings.

As shown in Figure 5.15, the crack pattern becomes more dense and previous cracks continue to open as the overlay shrinks relative to the bridge deck. Some cracks may also relax slightly as stresses are relieved in adjacent areas due to the formation of microcracks.
